BS5837:2012 Tree Survey  
Land off Surfleet Road  
Pinchbeck  
South Holland  
Lincolnshire  
NGR TF24479 26600

| | Report ref:<br><b>P2473 /0122 / 01</b> | C B E Consulting<br>Highbank, 5 Grantham Road, Navenby<br>Lincoln. LN5 0JJ.<br>Telephone (01522) 810086.<br>www.cbeconsulting.co.uk |

# **BS5837 Tree Survey, Land off Surfleet Road, Pinchbeck**

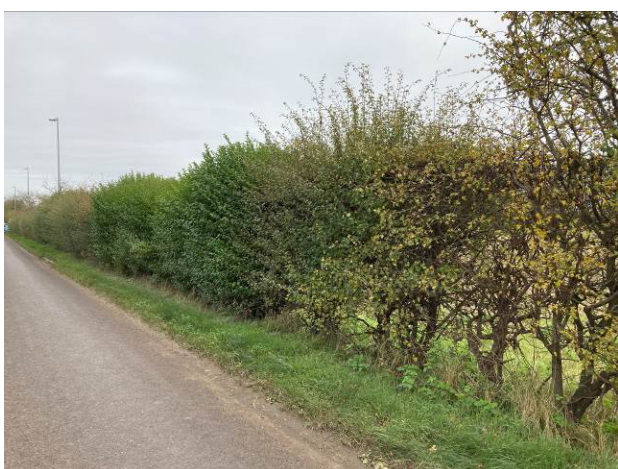
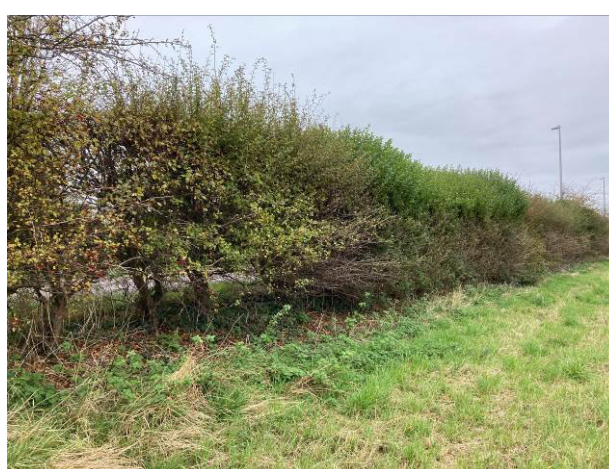
Hedgerow H1

**Hedgerows H1 and H2** run along the western boundary of the survey area screening the field from Surfleet Road. There is a significant gap between the two hedgerows and there are minor gaps within each. However, the majority of the hedgerow lengths are uniform and continuous. Both hedgerows have been seasonally box trimmed and have been placed into Category C2.

| Tree No | Species | Ht (m) | Stem Diam mm@ 1.5m | Canopy Spread (m) | Height of Crown Clearance | Age Class | Est yrs | Overall Condition | Structural condition | Recommendations | BS 5837 Category | RPA Radius (m) |
|---|---|---|---|---|---|---|---|---|---|---|---|---|
| H1 | Hawthorn<br>Rose<br>Privet | 1.5 | <150 | N-1<br>S-1<br>E-1<br>W-1 | 0 | SM | 10+ | G | Box trimmed hedgerow dominated by Hawthorn. Some gaps present along the road frontage but generally uniform.<br>No structural faults visible from ground level | Maintain as a box trimmed hedge to maintain screening of the site area | C2 | 1.8 |

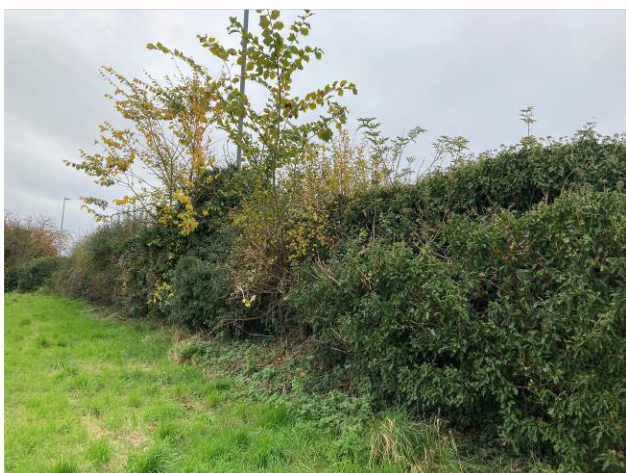
Hedgerow H2

| Tree No | Species | Ht (m) | Stem Diam mm@ 1.5m | Canopy Spread (m) | Height of Crown Clearance | Age Class | Est yrs | Overall Condition | Structural condition | Recommendations | BS 5837 Category | RPA Radius (m) |
|---|---|---|---|---|---|---|---|---|---|---|---|---|
| H2 | Hawthorn<br>Elm | 2 | <150 | N-1<br>S-1<br>E-1<br>W-1 | 0 | SM | 10+ | G | Box trimmed hedgerow dominated by Hawthorn with significant sections of Elm. Some gaps present along the road frontage but generally uniform.<br>No structural faults visible from ground level | Maintain as a box trimmed hedge to maintain screening of the site area | C2 | 1.8 |

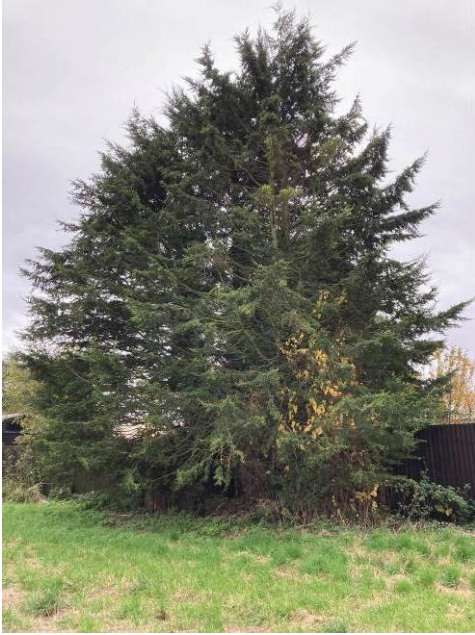
Thuja T3

**Thuja T3** is positioned on the southern boundary of the site growing on a strip of land between the boundary fence and the shallow drainage channel that runs along the boundary of the cultivated field. It is presumably within the field ownership as it lies outside the garden fence which it is quite close to. This is a tree of good quality which has been placed into Category B. However, there may be a possibility of nuisance in the future if this tree causes damage to the adjacent property boundary fencing. **Damson T4** is a young tree situated within the garden of the property to the south and the crown of the tree is visible above the garden fence but appears to have been trimmed back. This tree is placed into Category C.

| Ref | Tree | Category | Impact of development |
|---|---|---|---|
| T3 | Thuja | B2 | Not shown on the development plan. If this tree is retained the RPA extends into a landscaped area close to the proposed surface water attenuation area and can be protected by fencing. |

| Tree No | Species | Ht (m) | Stem Diam mm@ 1.5m | Canopy Spread (m) | Height of Crown Clearance | Age Class | Est yrs | Overall Condition | Structural condition | Recommendations | BS 5837 Category | RPA Radius (m) |
|---|---|---|---|---|---|---|---|---|---|---|---|---|
| T3 | Thuja<br><i>Thuja sp</i> | 10 | <450 | N-4<br>S-4<br>E-4<br>W-4 | 1 | M | 20+ | G | Three merging trees situated adjacent to the boundary fence on the opposite side of the drainage ditch. Dense ivy on the trunks and canopy extending over the field edge.<br>No structural faults visible from ground level | If retained the ivy should be removed from the trunks and provide protection to the crown and RPA. | B2 | 5.4 |

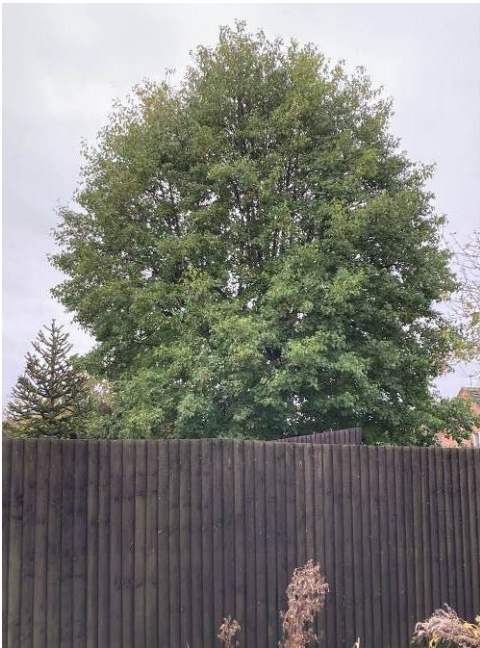
Poplar T5

Situated further to the south within the garden interior set back from the field boundary is **Poplar T4**. This is a tree of reasonable shape and moderate size, the canopy of which does not extend across the garden boundary and encroach the site area surveyed. This tree is visible from the site and has been placed into Category B.

| Ref | Tree | Category | Impact of development |
|---|---|---|---|
| T5 | Poplar | B2 | This tree is situated within an adjacent garden and the canopy and RPA do not extend into the proposed development area and pose no constraint to development. |

| Tree No | Species | Ht (m) | Stem Diam mm@ 1.5m | Canopy Spread (m) | Height of Crown Clearance | Age Class | Est yrs | Overall Condition | Structural condition | Recommendations | BS 5837 Category | RPA Radius (m) |
|---|---|---|---|---|---|---|---|---|---|---|---|---|
| T5 | Poplar<br><i>Populus nigra</i><br><i>cul</i> | 11 | 400est | N-4<br>S-4<br>E-4<br>W-4 | 2 | SM | 20+ | G | Single trunk supporting a balanced upright canopy which does not extend to reach the field boundary. No structural faults visible from ground level | None | B2 | 4.8 |

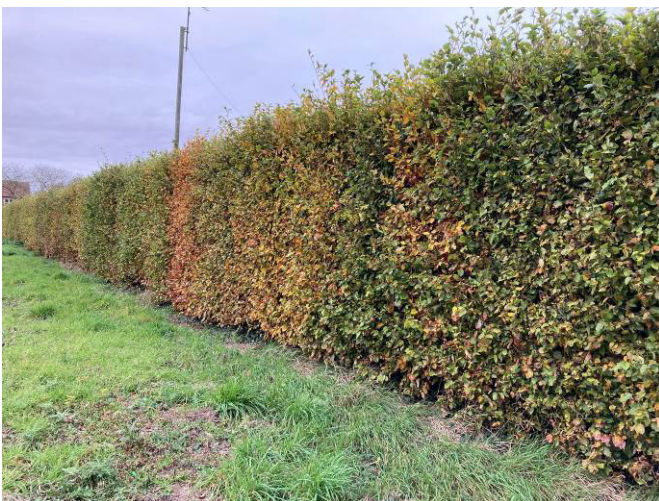
Hedgerow H7 is a uniform box trimmed Beech hedge running along the boundary of the garden adjacent to the northern boundary of the field. This is a good quality hedgerow providing effective screening to the residential garden and it is placed within Category B.

| Ref | Tree | Category | Impact of development |
|---|---|---|---|
| H7 | Beech | B2 | This hedgerow lies outside the proposed development area and poses no constraint to development. |

| Tree No | Species | Ht (m) | Stem Diam mm@ 1.5m | Canopy Spread (m) | Height of Crown Clearance | Age Class | Est yrs | Overall Condition | Structural condition | Recommendations | BS 5837 Category | RPA Radius (m) |
|---|---|---|---|---|---|---|---|---|---|---|---|---|
| H7 | Beech<br><i>Fagus sylvatica</i> | 2 | <150 | N-1<br>S-1<br>E-1<br>W-1 | 0 | Y | 20 | G | Dense trimmed boundary hedgerow around the residential garden adjacent to the field. No structural faults visible from ground level | Protect the RPA where this extends across the site boundary. | B2 | 1.8 |
