BS5837:2012 Tree Survey  
Land off Surfleet Road  
Pinchbeck  
South Holland  
Lincolnshire  
NGR TF24479 26600

| | Report ref:<br><b>P2473 /0122 / 01</b> | C B E Consulting<br>Highbank, 5 Grantham Road, Navenby<br>Lincoln. LN5 0JJ.<br>Telephone (01522) 810086.<br>www.cbeconsulting.co.uk |

# **BS5837 Tree Survey, Land off Surfleet Road, Pinchbeck**

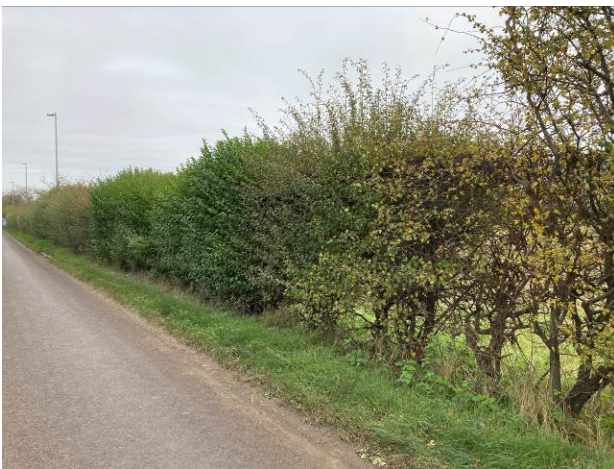
Hedgerow H1

**Hedgerows H1 and H2** run along the western boundary of the survey area screening the field from Surfleet Road. There is a significant gap between the two hedgerows and there are minor gaps within each. However, the majority of the hedgerow lengths are uniform and continuous. Both hedgerows have been seasonally box trimmed and have been placed into Category C2.

| Tree No | Species | Ht (m) | Stem Diam mm@ 1.5m | Canopy Spread (m) | Height of Crown Clearance | Age Class | Est yrs | Overall Condition | Structural condition | Recommendations | BS 5837 Category | RPA Radius (m) |
|---|---|---|---|---|---|---|---|---|---|---|---|---|
| H1 | Hawthorn<br>Rose<br>Privet | 1.5 | <150 | N-1<br>S-1<br>E-1<br>W-1 | 0 | SM | 10+ | G | Box trimmed hedgerow dominated by Hawthorn. Some gaps present along the road frontage but generally uniform.<br>No structural faults visible from ground level | Maintain as a box trimmed hedge to maintain screening of the site area | C2 | 1.8 |

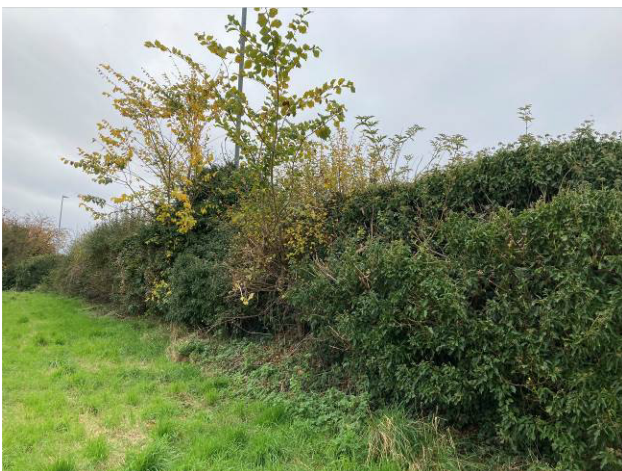
Hedgerow H2

| Tree No | Species | Ht (m) | Stem Diam mm@ 1.5m | Canopy Spread (m) | Height of Crown Clearance | Age Class | Est yrs | Overall Condition | Structural condition | Recommendations | BS 5837 Category | RPA Radius (m) |
|---|---|---|---|---|---|---|---|---|---|---|---|---|
| H2 | Hawthorn<br>Elm | 2 | <150 | N-1<br>S-1<br>E-1<br>W-1 | 0 | SM | 10+ | G | Box trimmed hedgerow dominated by Hawthorn with significant sections of Elm. Some gaps present along the road frontage but generally uniform.<br>No structural faults visible from ground level | Maintain as a box trimmed hedge to maintain screening of the site area | C2 | 1.8 |

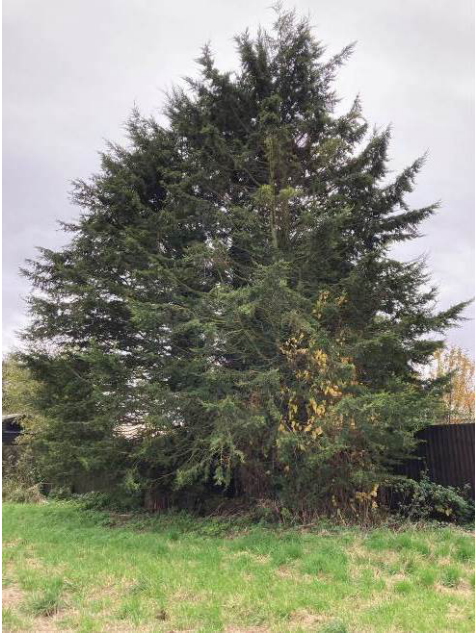
Thuja T3

**Thuja T3** is positioned on the southern boundary of the site growing on a strip of land between the boundary fence and the shallow drainage channel that runs along the boundary of the cultivated field. It is presumably within the field ownership as it lies outside the garden fence which it is quite close to. This is a tree of good quality which has been placed into Category B. However, there may be a possibility of nuisance in the future if this tree causes damage to the adjacent property boundary fencing. **Damson T4** is a young tree situated within the garden of the property to the south and the crown of the tree is visible above the garden fence but appears to have been trimmed back. This tree is placed into Category C.

| Ref | Tree | Category | Impact of development |
|---|---|---|---|
| T3 | Thuja | B2 | Not shown on the development plan. If this tree is retained the RPA extends into a landscaped area close to the proposed surface water attenuation area and can be protected by fencing. |

| Tree No | Species | Ht (m) | Stem Diam mm@ 1.5m | Canopy Spread (m) | Height of Crown Clearance | Age Class | Est yrs | Overall Condition | Structural condition | Recommendations | BS 5837 Category | RPA Radius (m) |
|---|---|---|---|---|---|---|---|---|---|---|---|---|
| T3 | Thuja<br><i>Thuja sp</i> | 10 | <450 | N-4<br>S-4<br>E-4<br>W-4 | 1 | M | 20+ | G | Three merging trees situated adjacent to the boundary fence on the opposite side of the drainage ditch. Dense ivy on the trunks and canopy extending over the field edge.<br>No structural faults visible from ground level | If retained the ivy should be removed from the trunks and provide protection to the crown and RPA. | B2 | 5.4 |

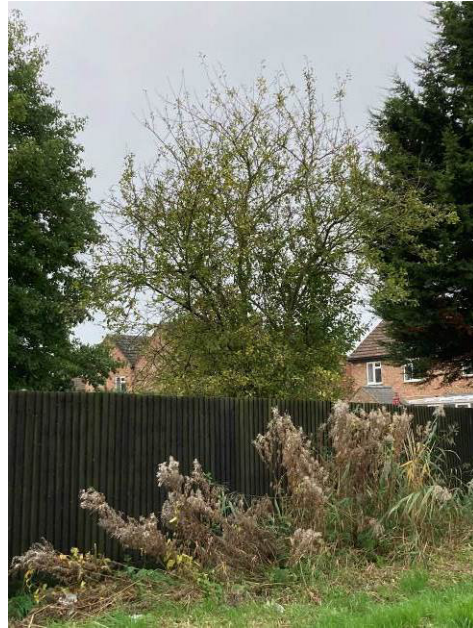
Damson T4

| Ref | Tree | Category | Impact of development |
|---|---|---|---|
| T4 | Damson | C2 | This tree lies within an adjacent garden. The canopy poses no constraint. The RPA does not extend into the landscaped area within the site and poses no constraint. |

| Tree No | Species | Ht (m) | Stem Diam mm@ 1.5m | Canopy Spread (m) | Height of Crown Clearance | Age Class | Est yrs | Overall Condition | Structural condition | Recommendations | BS 5837 Category | RPA Radius (m) |
|---|---|---|---|---|---|---|---|---|---|---|---|---|
| T4 | Damson<br><i>Prunus domestica</i> | 5 | 150<br>150 | N-1<br>S-2<br>E-2<br>W-2 | 1 | Y | 10+ | F | Two trunks supporting an irregular canopy which has been trimmed on the north side.<br>No structural faults visible from ground level | None | C2 | 2.5 |

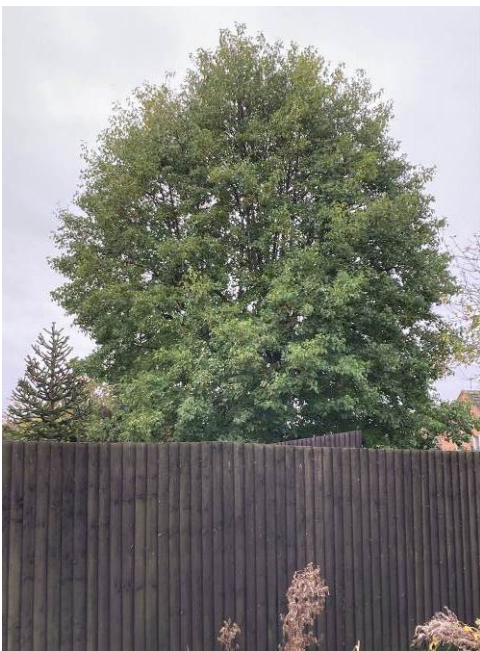
Poplar T5

Situated further to the south within the garden interior set back from the field boundary is **Poplar T4**. This is a tree of reasonable shape and moderate size, the canopy of which does not extend across the garden boundary and encroach the site area surveyed. This tree is visible from the site and has been placed into Category B.

| Ref | Tree | Category | Impact of development |
|---|---|---|---|
| T5 | Poplar | B2 | This tree is situated within an adjacent garden and the canopy and RPA do not extend into the proposed development area and pose no constraint to development. |

| Tree No | Species | Ht (m) | Stem Diam mm@ 1.5m | Canopy Spread (m) | Height of Crown Clearance | Age Class | Est yrs | Overall Condition | Structural condition | Recommendations | BS 5837 Category | RPA Radius (m) |
|---|---|---|---|---|---|---|---|---|---|---|---|---|
| T5 | Poplar<br><i>Populus nigra</i><br><i>cul</i> | 11 | 400est | N-4<br>S-4<br>E-4<br>W-4 | 2 | SM | 20+ | G | Single trunk supporting a balanced upright canopy which does not extend to reach the field boundary. No structural faults visible from ground level | None | B2 | 4.8 |

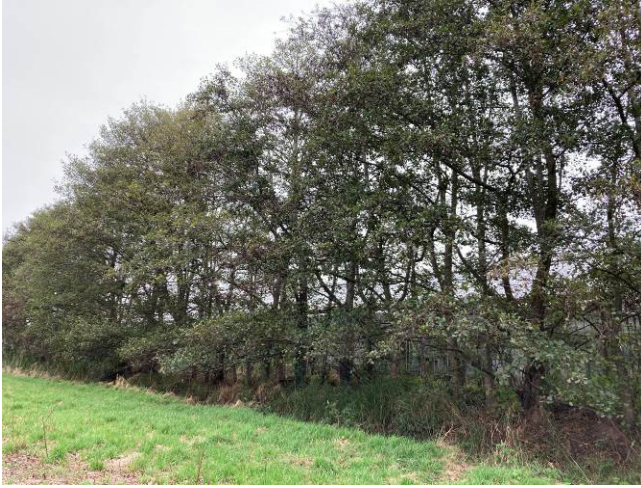
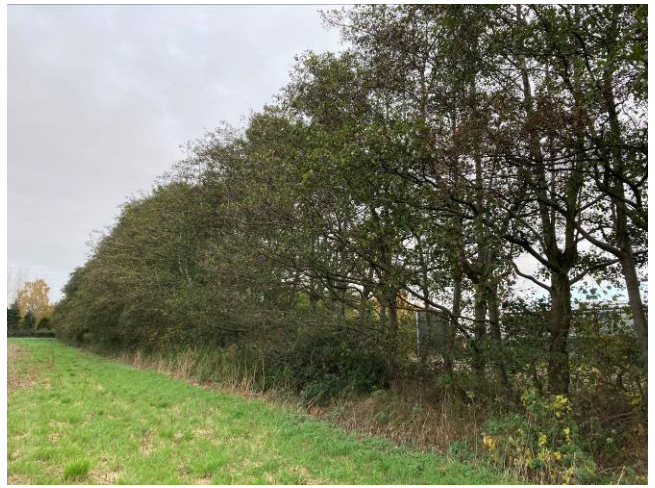
Alder G6 along eastern boundary

The most significant group of trees in the area surveyed is **Group G6** which comprises a long line of Alder. These trees are within the land adjacent to the field surveyed, separated from this by a boundary drainage ditch. The trees are lined along the opposite side of this close to the edge of the drain and form a long, continuous canopy along this boundary effectively screening the glasshouses situated to the east. The trees are of good quality and appear to be of similar stature and age. The drainage ditch may be a partial constrain to rooting on the western side but the calculated RPA of this group, based on the trunk diameter of the largest trees, will extend across the field boundary and the canopy extents of the trees does extend across the field edge. This group is placed within Category B2.

| Ref | Tree | Category | Impact of development |
|---|---|---|---|
| G6 | Alder | B2 | The RPA and canopy of this tree group extend into the field and will lie within the edge of the residential gardens or landscaped area. The RPA of this group will have to be protected by fencing but does not pose a constrain to development based on the plan provided. Lying along the eastern edge of the development these trees will cast shade during the morning period but this will reduce towards midday. |

| Tree No | Species | Ht (m) | Stem Diam mm@ 1.5m | Canopy Spread (m) | Height of Crown Clearance | Age Class | Est yrs | Overall Condition | Structural condition | Recommendations | BS 5837 Category | RPA Radius (m) |
|---|---|---|---|---|---|---|---|---|---|---|---|---|
| G6 | Alder<br><i>Alnus glutinosa</i> | 10-14 | <400 | Varies up to 5m on the west | 1 | SM | 20+ | G | A dense line of Alder planted behind the boundary drainage channel but with the merging canopy extending across this over the edge of the field area survey. This screen planting shelters to the glasshouses to the east. No structural faults visible from ground level | Protect the canopy and RPA where this extends across the site boundary. | B2 | 4.8 |

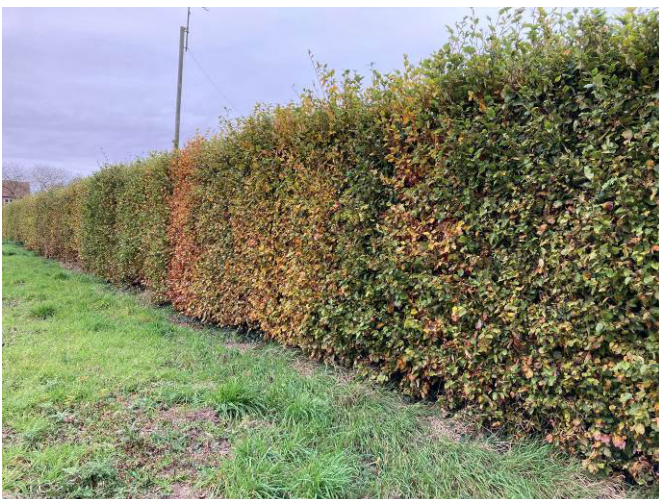
Hedgerow H7 is a uniform box trimmed Beech hedge running along the boundary of the garden adjacent to the northern boundary of the field. This is a good quality hedgerow providing effective screening to the residential garden and it is placed within Category B.

| Ref | Tree | Category | Impact of development |
|---|---|---|---|
| H7 | Beech | B2 | This hedgerow lies outside the proposed development area and poses no constraint to development. |

| Tree No | Species | Ht (m) | Stem Diam mm@ 1.5m | Canopy Spread (m) | Height of Crown Clearance | Age Class | Est yrs | Overall Condition | Structural condition | Recommendations | BS 5837 Category | RPA Radius (m) |
|---|---|---|---|---|---|---|---|---|---|---|---|---|
| H7 | Beech<br><i>Fagus sylvatica</i> | 2 | <150 | N-1<br>S-1<br>E-1<br>W-1 | 0 | Y | 20 | G | Dense trimmed boundary hedgerow around the residential garden adjacent to the field. No structural faults visible from ground level | Protect the RPA where this extends across the site boundary. | B2 | 1.8 |
