| Contractor To Check All Dimensions On Site Before Work Commences. | | | |
|---|---|---|---|
| Project:<br>MR & MRS A.D. BOOR.<br>PROPERTY AT<br>MILESTONE LANE, PINCHBECK. | | | |
| Drawing:<br>PLAN AS EXISTING | | | |
| Scale:<br>AS SHOWN | | Drawing No.<br>3366-1 | |

Project:  
MR & MRS A. D. BOOR.  
PROPERTY AT  
MILESTONE LANE, PINCHBECK.

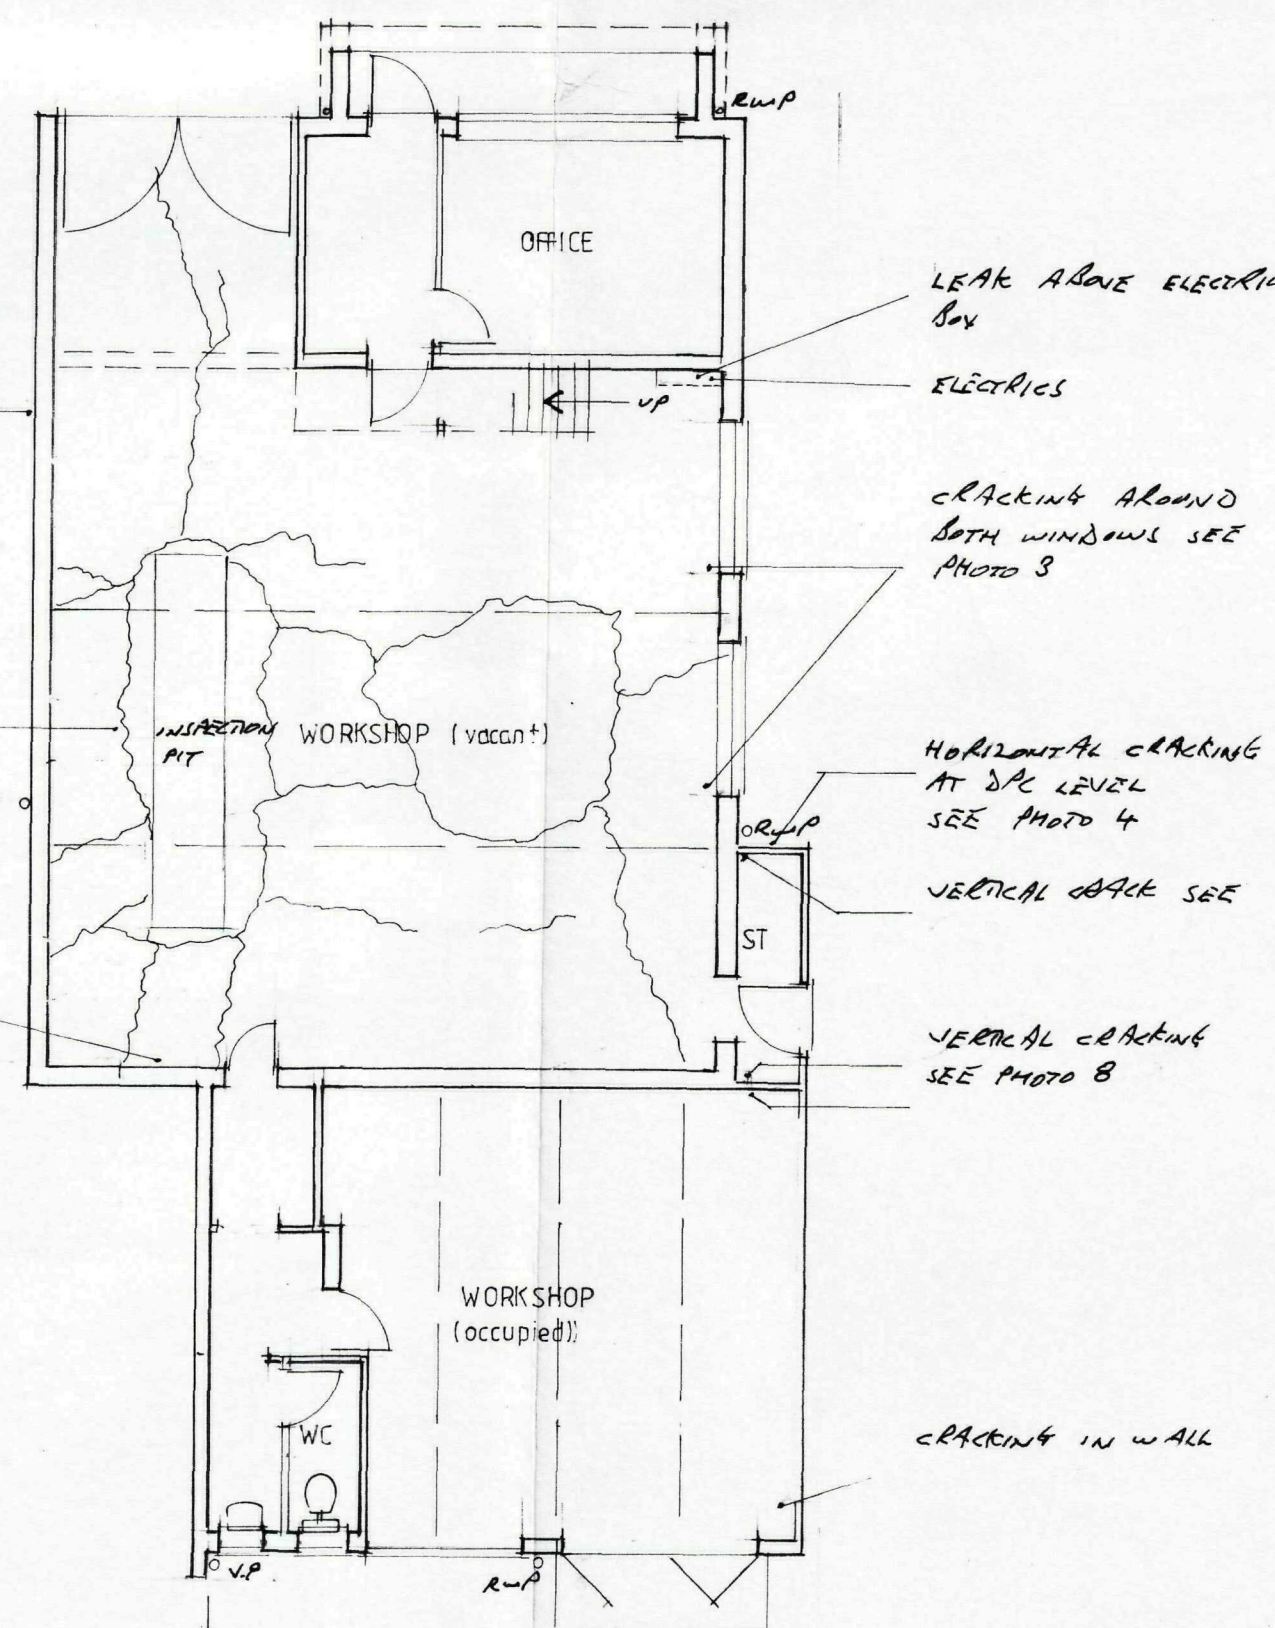
GROUND FLOOR 1-100

LEAK ABOVE ELECTRIC BOX

ELECTRICS

CRACKING AROUND BOTH WINDOWS SEE PHOTO 3

HORIZONTAL CRACKING AT DPC LEVEL SEE PHOTO 4

VERTICAL CRACK SEE

VERTICAL CRACKING SEE PHOTO 8

CRACKING IN WALL
