Proposed Residential Development at Vernatt's Strategic Urban Extension Phase 1: Parcel 1 – Yews Farm 100 Plots

Arboricultural Implications Assessment

8th December 2021

Client: Ashwood Homes

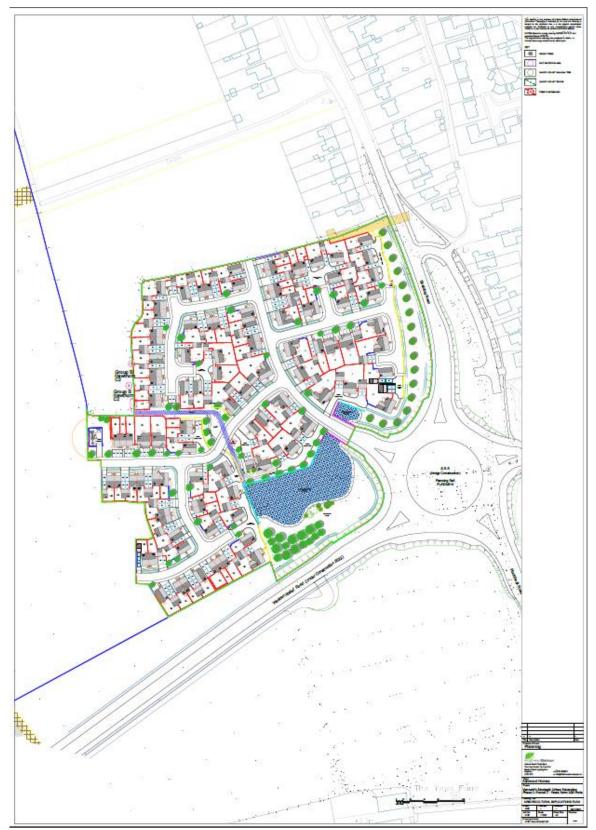
Appendix D – Arboricultural Implications Plan

5.1.1 The proposed development will not result in the loss of any trees; however, those trees in Group B Hawthorn are recommended for removal as a result of their health and condition regardless of any layout. These trees are indicated on the Arboricultural Implications Plan (see Appendix D) by way of a red dashed line.
