Protected Species Survey  
Land and Buildings at Millfield Nurseries  
Spalding Common  
South Holland  
Lincolnshire  
NGR TF23416 20081

Report prepared by:  
Christopher Barker CEnv  
Licensed Bat Consultant

| | Report ref:<br><b>P1033/ 0216/ 01 v2</b> | |

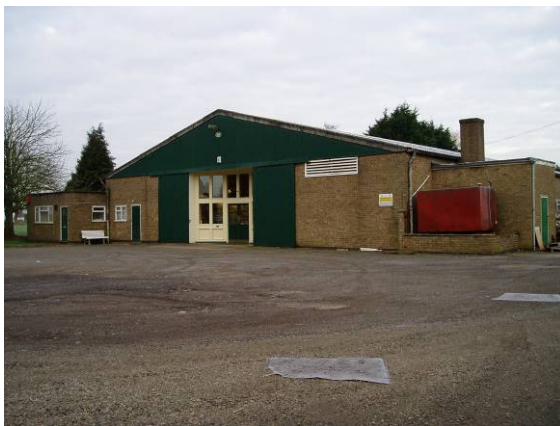
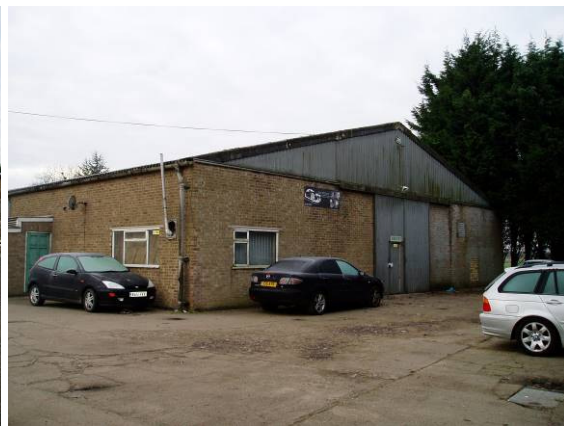
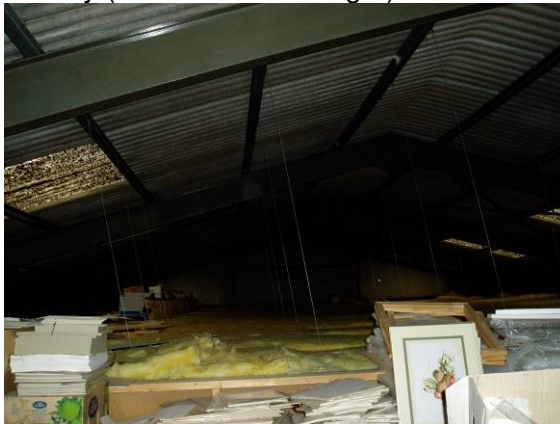
Gallery (south side Building 1)

Garage (north side Building 1)

Roof space over Gallery

The brickwork of the building is in excellent repair throughout and there are no cracks or gaps within this. The roof is also in excellent repair with no lifted sheeting edges or areas of flashing / joints visible. Structurally the building, in particular the roof structure, appears in excellent condition with no features that would be of potential interest to roosting bats or nesting birds. The inspection of the building found no evidence of roosting bats or nesting birds and it is considered to have **negligible roost potential** i.e. there are no features offering potential for roosting. No evidence of any other protected species or habitats of potential ecological significance were found in this location.

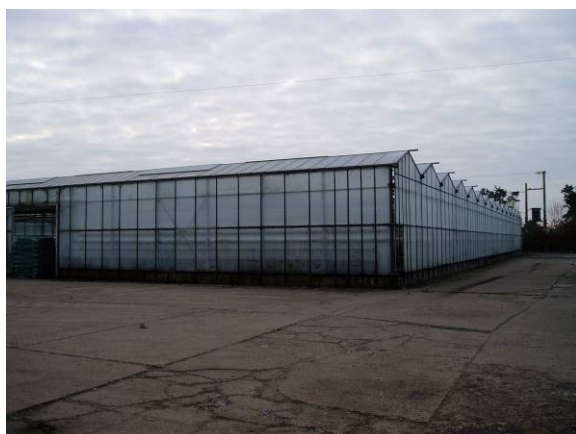
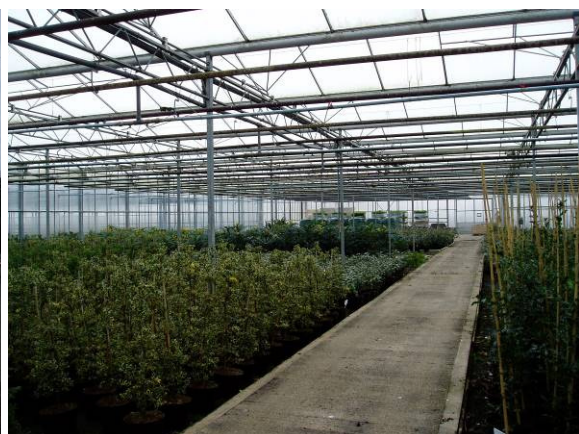
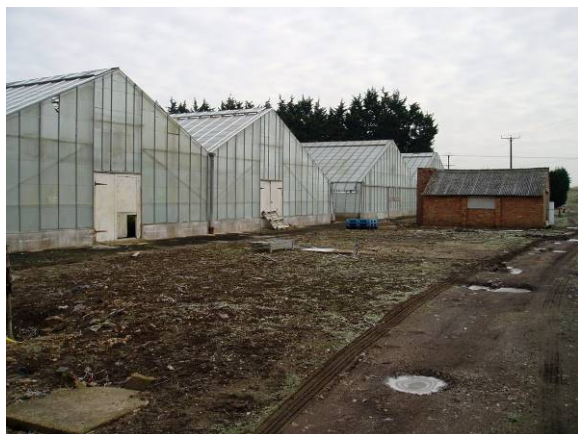
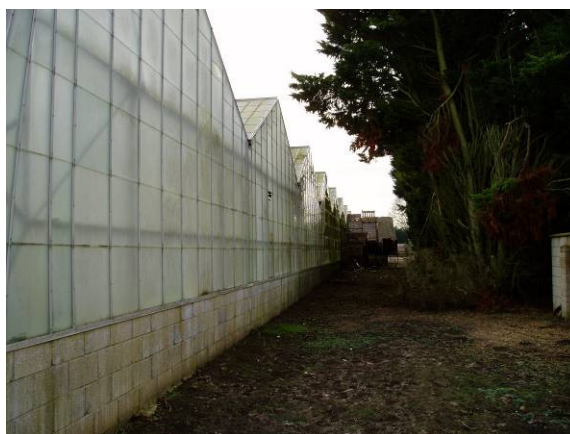
The inspection of Glasshouse 2, 3, 4, 5 and 6 found no evidence of any activity by protected species such as roosting bats or nesting birds either externally or internally and all five structures are considered to have **negligible roost potential** i.e. these buildings display no features that will be of potential interest to roosting bats. No evidence of nesting bird activity was found in or on any of the glasshouse buildings.

Glasshouse 2

Interior of glasshouses

Glasshouses 3 /4 with building 4A

Glasshouses 5/6

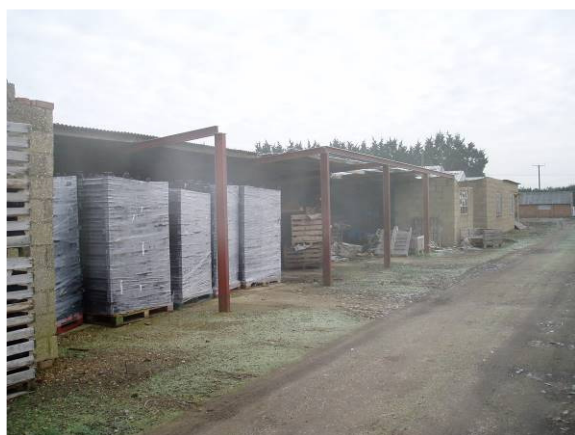
Buildings 2A and 2B are both small single storey lean-to style storage buildings constructed from steel frame and cinder block open fronted on the south side as can be seen in the photograph below. The roof comprises corrugated asbestos cement sheeting affixed directly to the steel frame with no lining of felting. This building is open and exposed and contains materials and equipment used by the nursery operation. Buildings 2A and 2B are considered to have **negligible roost potential** i.e. these buildings display no features that will be of potential interest to roosting bats. No evidence of nesting bird activity or any indication of the presence of protected species was found in or on either of these buildings.

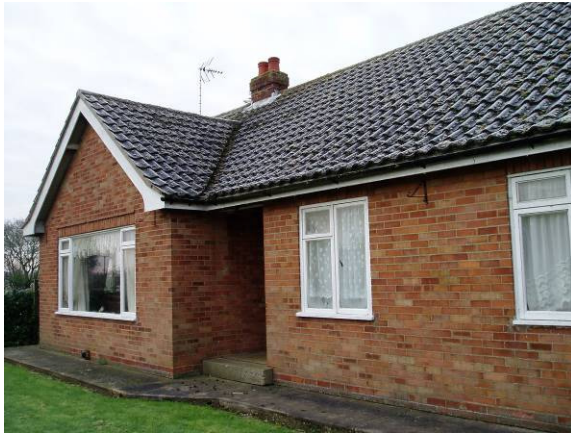
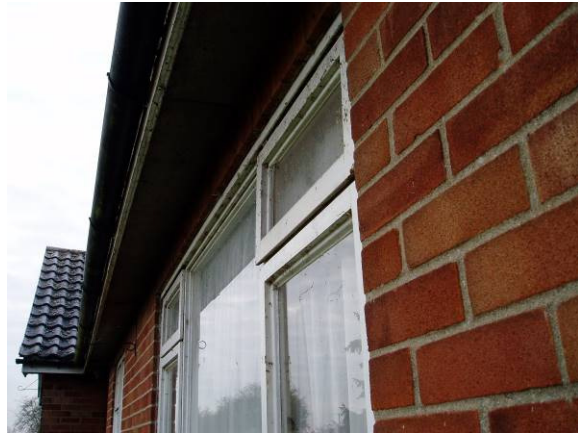
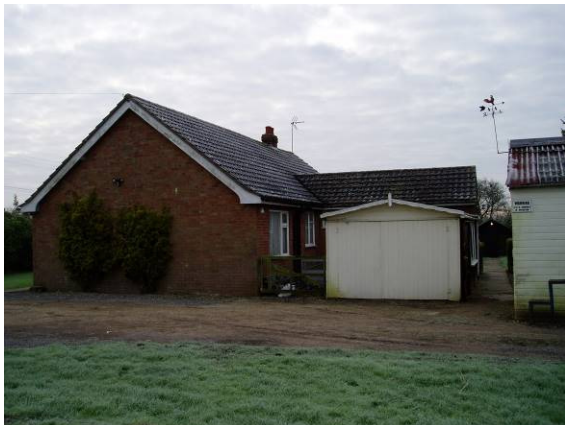
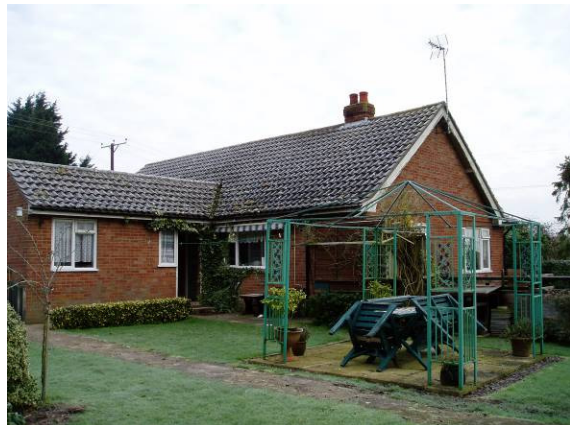
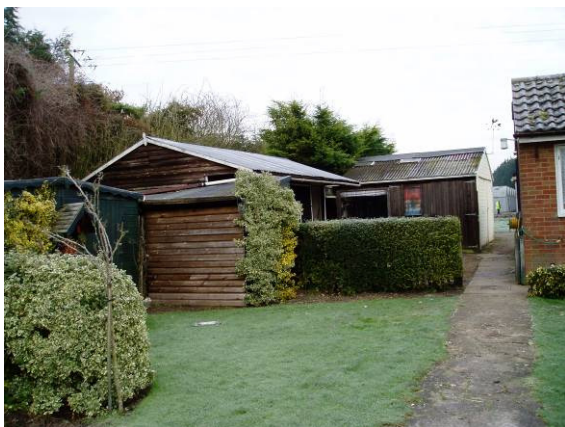
The enclosed soffits are in reasonable repair but there are some small gaps noted at joints and edges which could potentially allow access by bats into the interior void behind the soffit base.

The inspection of the house and outbuildings found no evidence of roosting bats or nesting birds. Due to the enclosed wooden soffits and felting under the tiled roof, the residential house is considered to have **low / moderate roost potential**. This building is positioned close to the River

**Building 7** – Whilst no physical evidence of any activity by protected species was found associated with this residential house, the structure contains features such as a lined roof and enclosed wooden soffits which have some potential access points that could be of potential interest to species such as Pipistrelle Bat. A search of the outbuildings and garden areas revealed no features or habitats of potential interest to protected species. The residential house is considered to have **low / moderate roost potential**

A building with low / moderate roost potential should be subjected to at least one emergence / activity survey in accordance with the Bat Survey Guidelines 2<sup>nd</sup> Edition. In this instance, such a survey will only be required in the development proposals for the site area require this building to be renovated, disturbed or demolished.

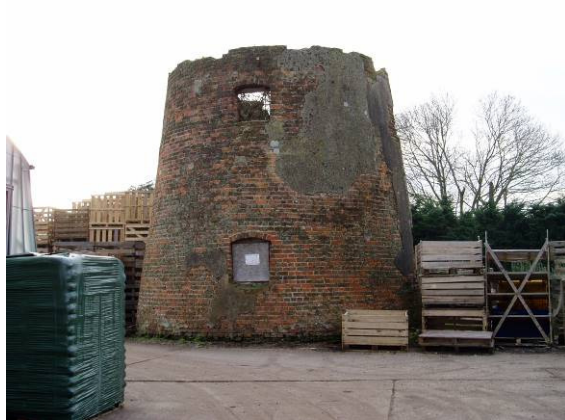
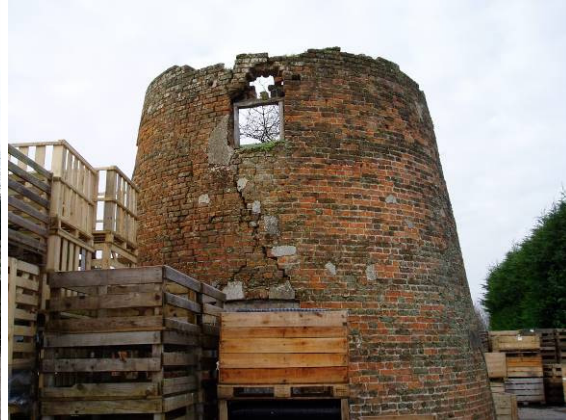
Building 8

Externally no evidence of any bat or bird activity could be found. Since the brick work to the building is in such poor repair and gaps are visible on the structure that could potentially be of interest to bats this building is considered to have **low roost potential** on the basis that there are minor features on this structure that could be of potential interest to roosting bats but it is not in a particularly good location.

**Building 8** – No evidence of any activity by protected species was found associated with this building but it is in a poor state of repair and internal access could not be obtained. The brick structure of the building displays holes, cracks and other gaps that could be of minor interest to roosting bats and therefore this building is classed as having **low roost potential**. There is also a possibility that nesting birds may be making use of internal features remaining in the brickwork although no evidence of this could be seen when looking through the open doorway and window.

A building with low roost potential should be subjected to at least one emergence / activity survey in accordance with the Bat Survey Guidelines 2<sup>nd</sup> Edition. In this instance, such a survey will only be required in the development proposals for the site area require this building to be renovated, disturbed or demolished.

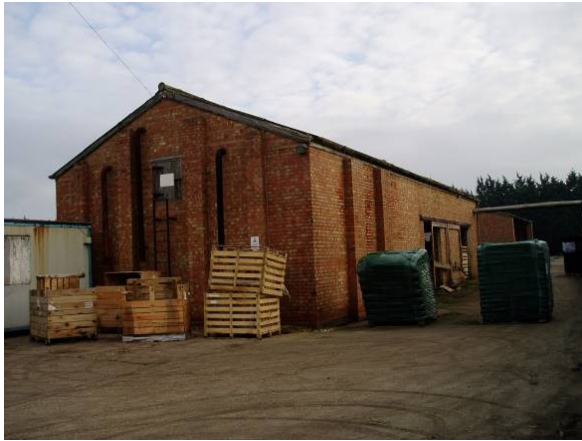
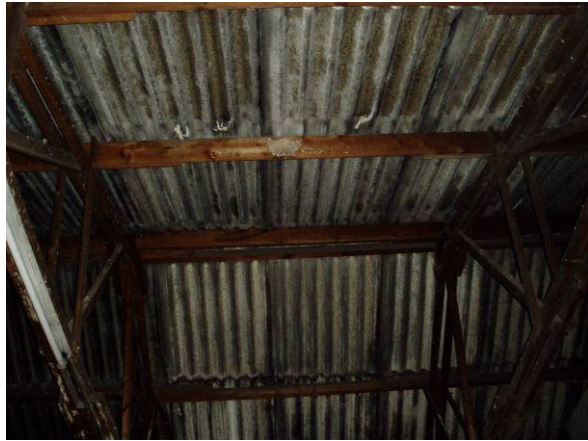
Building 9 is a tall storage building constructed from two courses of brickwork with a wood and steel frame pitched roof over which corrugated asbestos cement sheeting has been laid. The brickwork is in excellent repair and access to the building is via large open double doorways on the south side. The roof is not lined or under felted and internally open to the roof apex. There are also light panels in the roof structure. The interior of the building has high levels of artificial light and it is being used to store pallets and nursery equipment. The internal and external inspection of this building found no evidence of bat or bird activity and it is considered to have **negligible roost potential**.

Internal roof of building 9

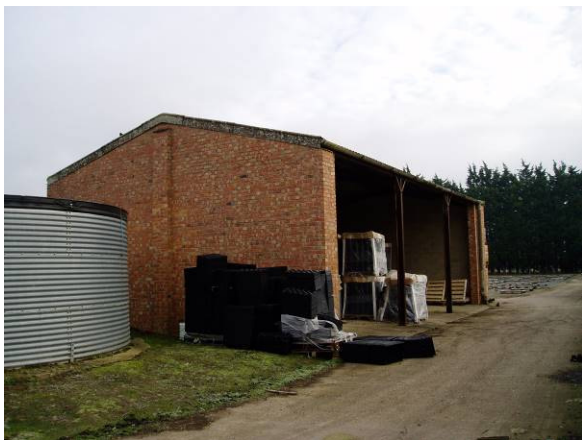
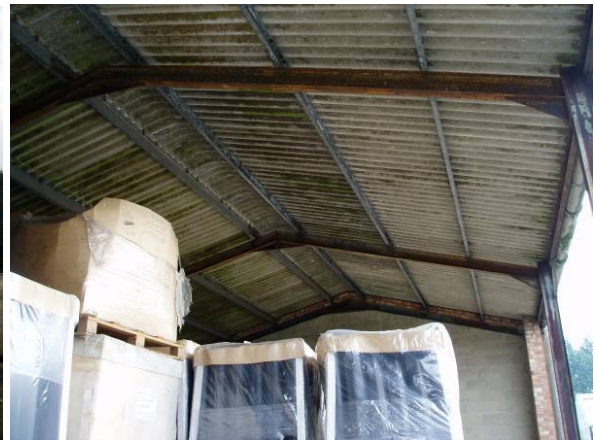
Building 10 is nearly identical to building 9 in that it is a tall storage building constructed from two courses of brickwork / cinderblock with a steel frame and wooden beam pitched roof over which corrugated asbestos cement sheeting has been laid. The brickwork and cinderblocks are in excellent repair and the building is entirely open-fronted to the south side. The roof is not lined or under felted and internally open to the roof apex. There are also light panels in the roof structure. The interior of the building has very high levels of artificial light and it is being used to store pallets and nursery equipment. The internal and external inspection of this building found no evidence of bat or bird activity and it is considered to have **negligible roost potential**.

Internal roof of building 10

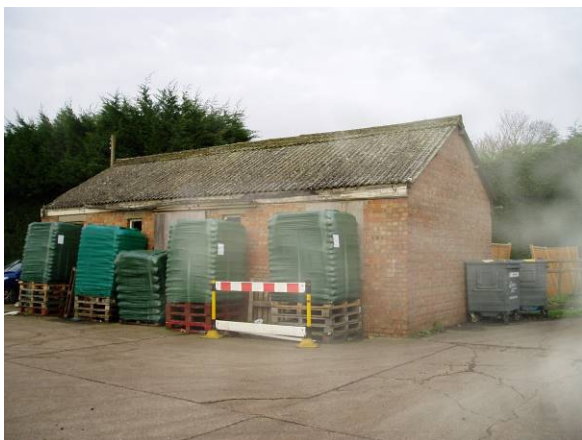
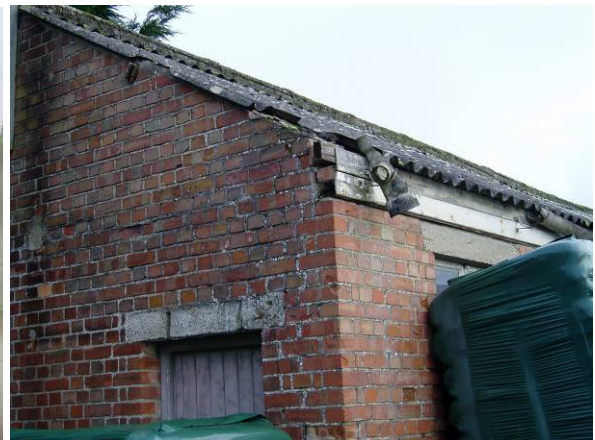
Building 11 is smaller and constructed from two courses of red brick over which a timber beam roof has been constructed over which corrugated asbestos cement sheeting has been laid. There is no felting or lining under this. The doorways and windows to this building have been boarded up or covered up by pallets so full internal access could not be obtained. However, where windows were exposed the interior could be seen and there is no evidence of any bat or bird activity visible on the walls or concrete floor of the building. The roof is in poor repair with gaps along the ridge and at the roof edges where the roof cladding has broken away.

Roof of building 11

Whilst the structure of the building is far from attractive to bats and birds wishing to roost or nest, access into the interior of the building by these species is possible. As full internal access could

not be obtained and there are potential access points, this building is considered to have **low roost potential**. It is unlikely that bats will use this building and there is no internal evidence of any nesting activity.

**Building 11**– No evidence of any activity by protected species was found associated with this building but it is in a poor state of repair and internal access could not be obtained. The roof structure of the building displays holes and other gap that could be of minor interest to roosting bats and therefore this building is classed as having **low roost potential**. No evidence of any activity by protected species was found associated with this building.

A building with low roost potential should be subjected to at least one emergence / activity survey in accordance with the Bat Survey Guidelines 2<sup>nd</sup> Edition. In this instance, such a survey will only

be required in the development proposals for the site area require this building to be renovated, disturbed or demolished.
