## ARBORICULTURAL IMPACT ASSESSMENT

Site at:  
Former Bull & Monkie PH  
Churchgate  
Spalding  
Lincolnshire  
PE11 2RA

| Job ref | Report Version | Author | Checked | Date |
|---|---|---|---|---|
| ATS0552 | V1 | IL | IL | May 2023 |

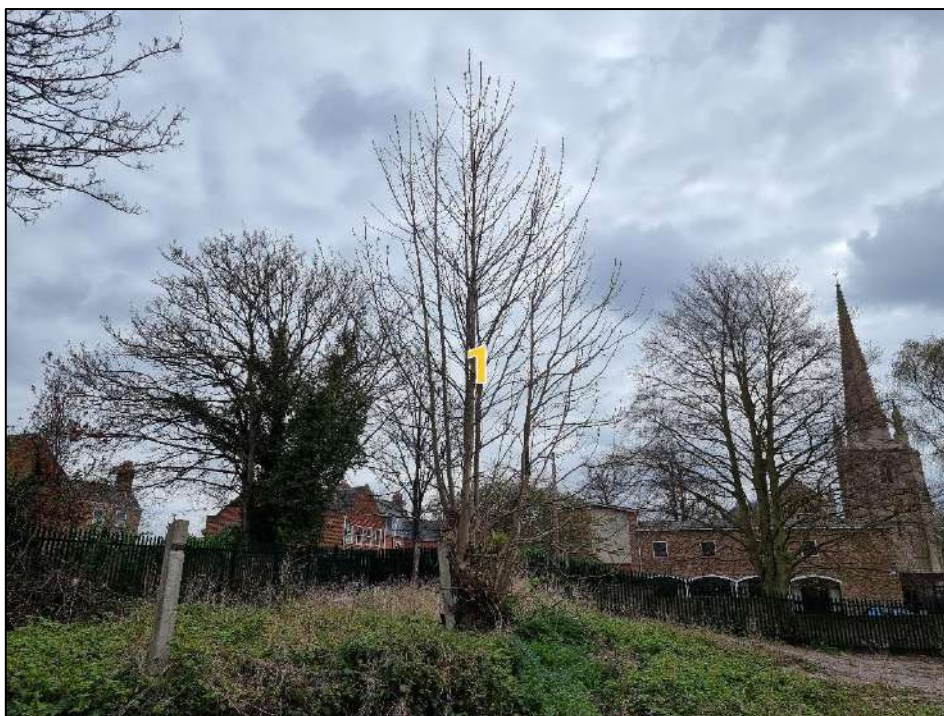
- Below: Tree 1 (Sycamore) – a sprouted stump to be removed

9.1.1 One tree is to be removed. This is a Sycamore that comprises multiple stems that have sprouted from a stump. It has negligible amenity value. It does not contribute to the special character of the Conservation Area.

| Tree number/Tag | Species | Tree height | Stem Dia (s) | RPA Radius | Crown spread | 1st large branch height above ground | Canopy height above ground | Life stage | Observations; structural / physiological condition and any preliminary recommendations | Estimated remaining contribution | Category & Sub category |
|---|---|---|---|---|---|---|---|---|---|---|---|
| 1 | Sycamore | 10 | 100<br>100<br>100<br>100<br>100 | 2.68<br><br>23 | N 3.5<br>E 3.5<br>S 3.5<br>W 2.5 | | 0 | Mature | Sprouted stump. Growing on top of a crumbling retaining wall<br>Physiological condition - Poor<br>▪ Fell to implement development | 10+ | C1 |

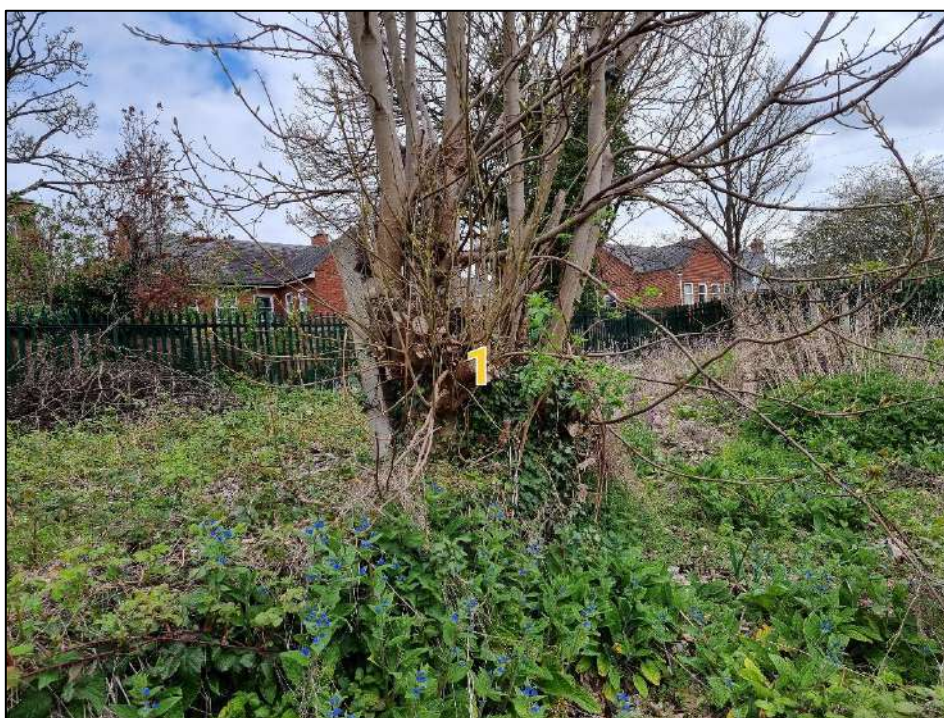
- Below: Tree 1 (Sycamore) - to be removed

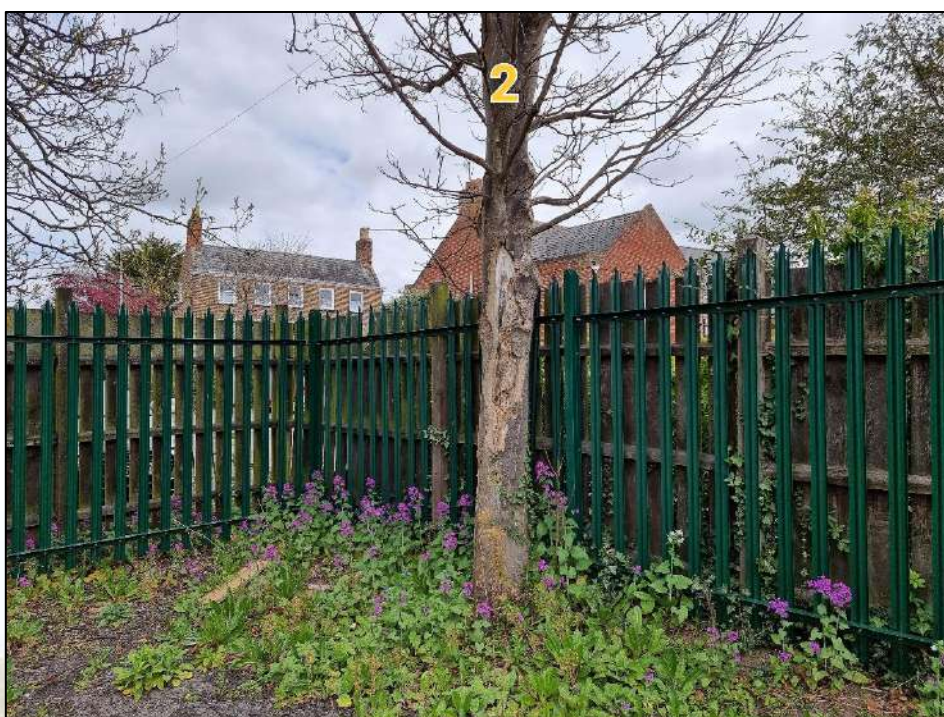
- Below: Tree 2 (Sycamore)

9.3.3 The RPA of tree 2 (Sycamore) will be transformed into soft landscaping (lawn and ground cover planting).

| Tree number/Tag | Species | Tree height | Stem Dia (s) | RPA Radius | Crown spread | 1st large branch height above ground | Canopy height above ground | Life stage | Observations; structural / physiological condition and any preliminary recommendations | Estimated remaining contribution | Category & Sub category |
|---|---|---|---|---|---|---|---|---|---|---|---|
| 2 | Sycamore | 11 | 300 | 3.60<br><br>41 | N 4.5<br>E 4.5<br>S 2.5<br>W 2 | | 2.5 | Mature | Large wound on trunk at southwest side from 1 metre to 2.5 metres with exposed sapwood and internal decay. Low vigour. Interfering with telephone line<br>Physiological condition - Poor<br>▪ No action | 10+ | C1 |

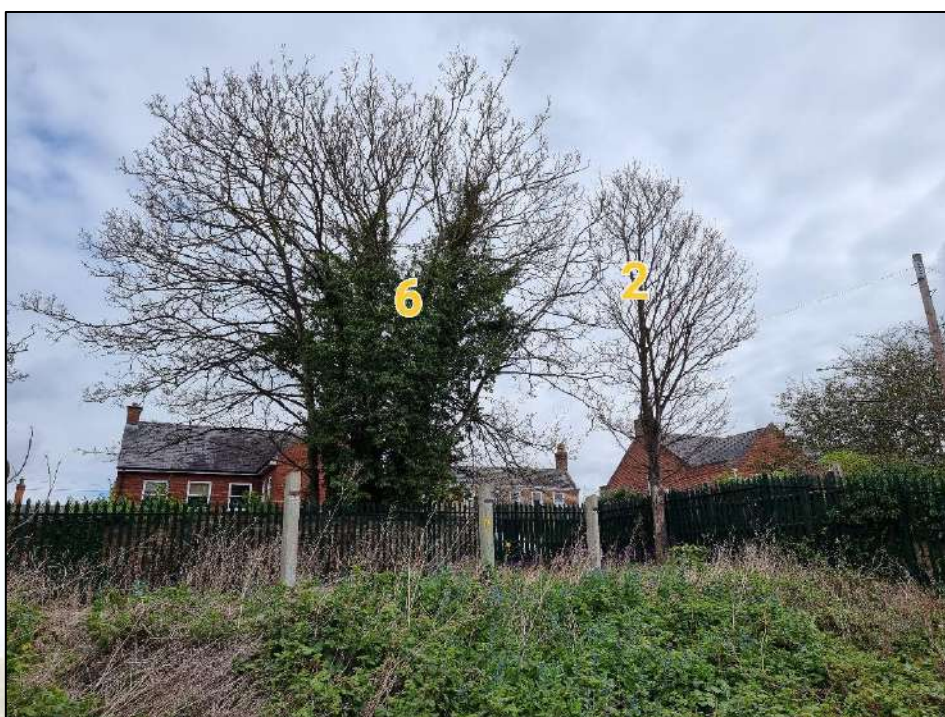
- Below: Tree 6 (Sycamore) – Off site

9.3.6 Trees 5 & 6 (Sycamore) can be viewed as a single entity due to their extremely close proximity. Their RPAs will be transformed into soft landscaping (lawn and ground cover planting) but with a small area of new hard surface. The area of hard surface concerned is not large enough to cause significant harm to either tree. It is therefore not justified to go to the expense and complexity of using a proprietary 'no-dig' system.

| Tree number/Tag | Species | Tree height | Stem Dia (s) | RPA Radius | Crown spread | 1st large branch height above ground | Canopy height above ground | Life stage | Observations; structural / physiological condition and any preliminary recommendations | Estimated remaining contribution | Category & Sub category |
|---|---|---|---|---|---|---|---|---|---|---|---|
| 6<br>(off site) | Sycamore | 13 | 400<br>300<br>300 | 7.00<br><br>154 | N 7<br>E 6<br>S 6.5<br>W 6.5 | | 5 | Mature | Trunk divides into three stems close to ground level. Dense Ivy on trunk and branches up to mid crown. Behind retaining wall which looks recently repaired<br>Physiological condition - Moderate<br>▪ No action | 20+ | C1 |

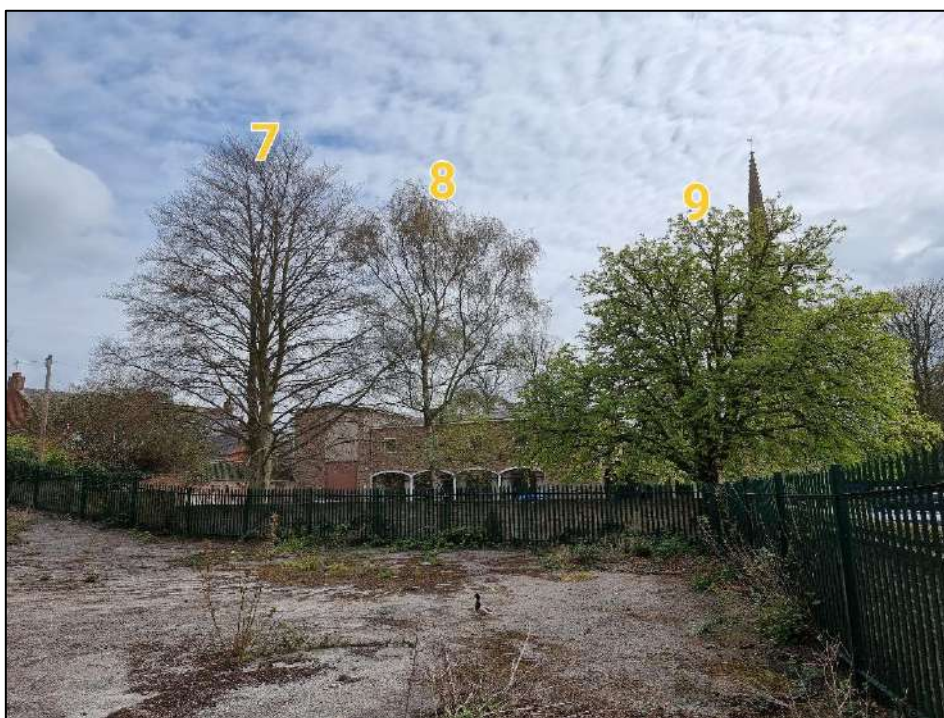
- Below: Trees 7 (Beech), 8 (Birch) & 9 (Horse Chestnut) – Off site

- 9.3.8 Trees 8 (Birch) and 9 (Horse Chestnut) are barely affected, and only in a positive way.
- 9.3.9 Tree 10 (Horse Chestnut) is an important tree at the junction of Churchgate and The Vista. The RPA here will be subjected to the existing tarmac surface being taken up, and then replaced by a combination of soft and hard surfaces (path and terrace). There will be no additional excavation within the RPA.
- 9.3.10 The tree protection measures are described in detail on the attached tree protection plans.
- 9.4 Evaluation of tree constraints

| Tree number/Tag | Species | Tree height | Stem Dia (s) | RPA Radius | Crown spread | 1st large branch height above ground | Canopy height above ground | Life stage | Observations; structural / physiological condition and any preliminary recommendations | Estimated remaining contribution | Category & Sub category |
|---|---|---|---|---|---|---|---|---|---|---|---|
| 7<br>(off site) | Common Beech | 21 | 850 | 10.20<br><br>327 | N 8.5<br>E 9<br>S 8.5<br>W 8.5 | | 2 | Mature | Trunk divides into three co-dominant stems at 3 metres above ground level with bark included union<br>Physiological condition - Good<br>▪ No action | 40+ | B1 |

| Tree number/Tag | Species | Tree height | Stem Dia (s) | RPA Radius | Crown spread | 1st large branch height above ground | Canopy height above ground | Life stage | Observations; structural / physiological condition and any preliminary recommendations | Estimated remaining contribution | Category &Sub category |
|---|---|---|---|---|---|---|---|---|---|---|---|
| 8<br>(off site) | Silver Birch | 17 | 350 | 4.20 | N 4.5<br>E 5.5<br>S 4.5<br>W 4.5 | | 5 | Mature | No notable defects<br>Physiological condition - Good<br>▪ No action | 20+ | B1 |
| 9<br>(off site) | Common Horse Chestnut | 13 | 725 | 8.70 | N 8.5<br>E 7.5<br>S 7.5<br>W 7 | | | Mature | Severe chronic bleeding canker disease and advanced decay in major branches<br>Physiological condition - Poor<br>▪ No action | <10 | U |

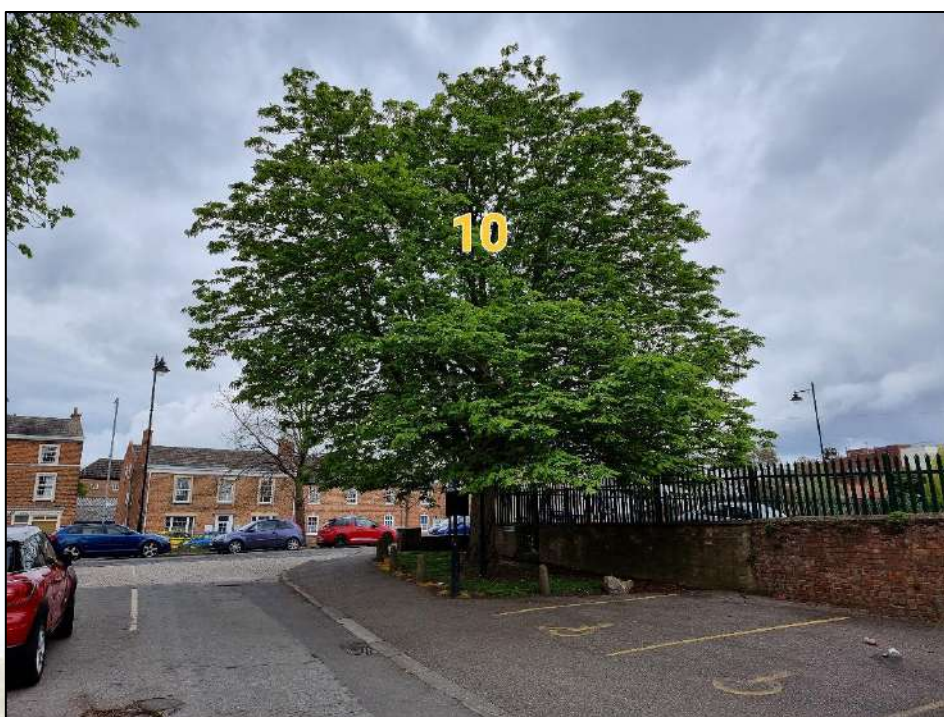
- Below: Tree 10 (Horse Chestnut) - Off site

| Tree number/Tag | Species | Tree height | Stem Dia (s) | RPA Radius | Crown spread | 1st large branch height above ground | Canopy height above ground | Life stage | Observations; structural / physiological condition and any preliminary recommendations | Estimated remaining contribution | Category &Sub category |
|---|---|---|---|---|---|---|---|---|---|---|---|
| 10<br>(off site) | Common Horse Chestnut | 14 | 575 | 6.90 | N 6.5<br>E 8<br>S 7<br>W 6 | | 2 | Mature | Chronic but non-severe bleeding canker disease<br>Physiological condition - Moderate<br>▪ No action | 20+ | B1 |
