BS5837 Tree Survey  
Land to the east of Coalbeach Lane  
Surfleet  
Lincolnshire  
NGR TF262 289

Survey by  
Christopher Barker CEnv dipHort ACIEEM

# **BS5837 Tree Survey, Land at Coalbeach Lane, Surfleet**

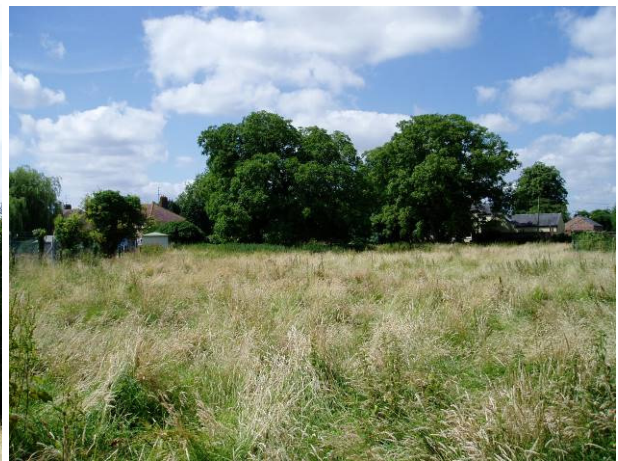
T1, T2 and T3 from the east
