## **Heritage Appraisal and Proposals for The East Bank Lighthouse (Sir Peter Scott Lighthouse)**

**PE12 9YT**

**Date 01/02/2021**

**Ref: SPS/HA**

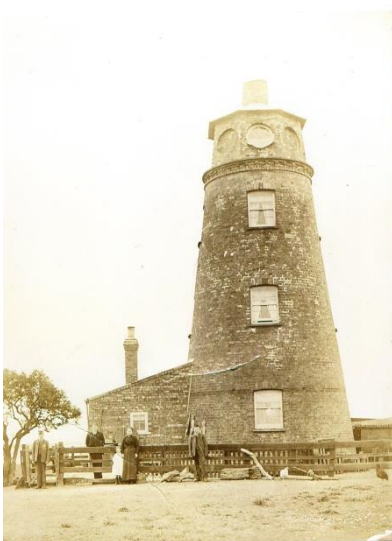
The tower itself may be the only original 1830 fabric. There is an etching that supports this. The kitchen shown in this 1910 photograph was added at some later date but probably fairly soon after. Examination of the 1910 photograph shows that the single storey lean-to brickwork courses do not align with those on the tower and are of a different appearance.

Since this photograph was taken in 1910, lighthouse has seen significant changed. These include rendering inside and out, loss of the blind windows and most of the original joinery.

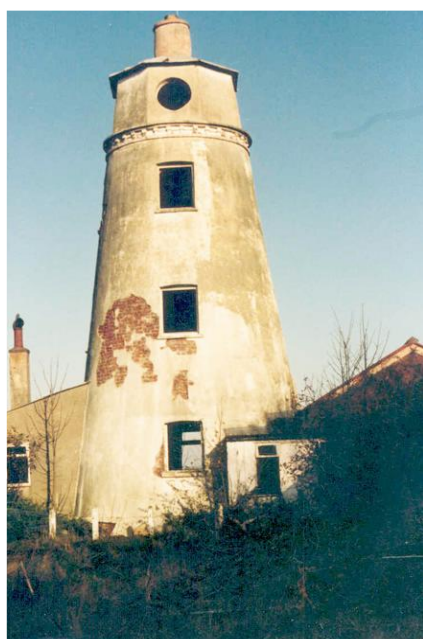
All interior finishes and joinery had been destroyed once more. Every window had rotted out, the tower render had fallen away in large patches. Gone was the Sketching Window and most of the rest of the exterior cladding front porch. It was sold for the first time in 1985 to Commander David Joel. His restoration used UPVC windows of financial necessity, profiled steel roof sheeting and modern internal finishes. The timber framed front entry porch was reconstructed in brickwork as was the main bathroom and the kitchen extended once more to become a second bathroom.

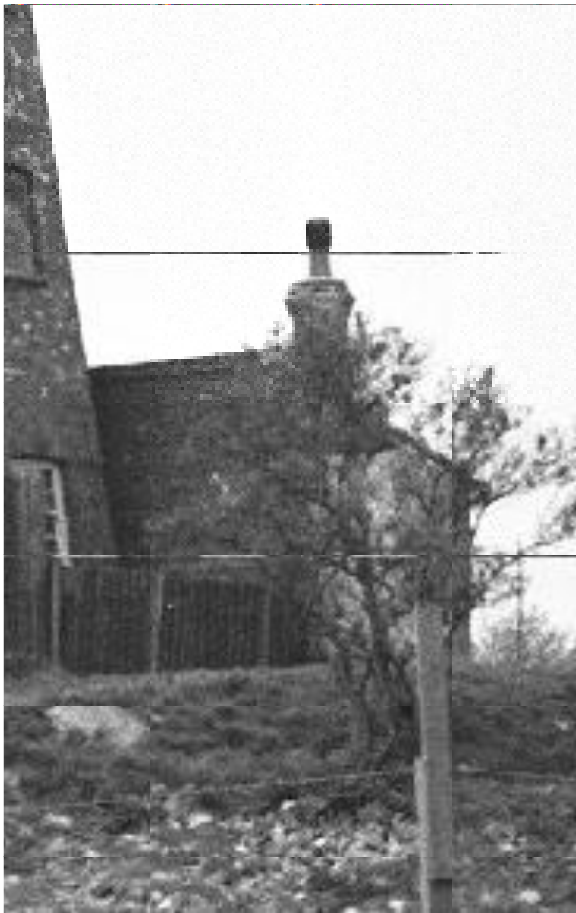
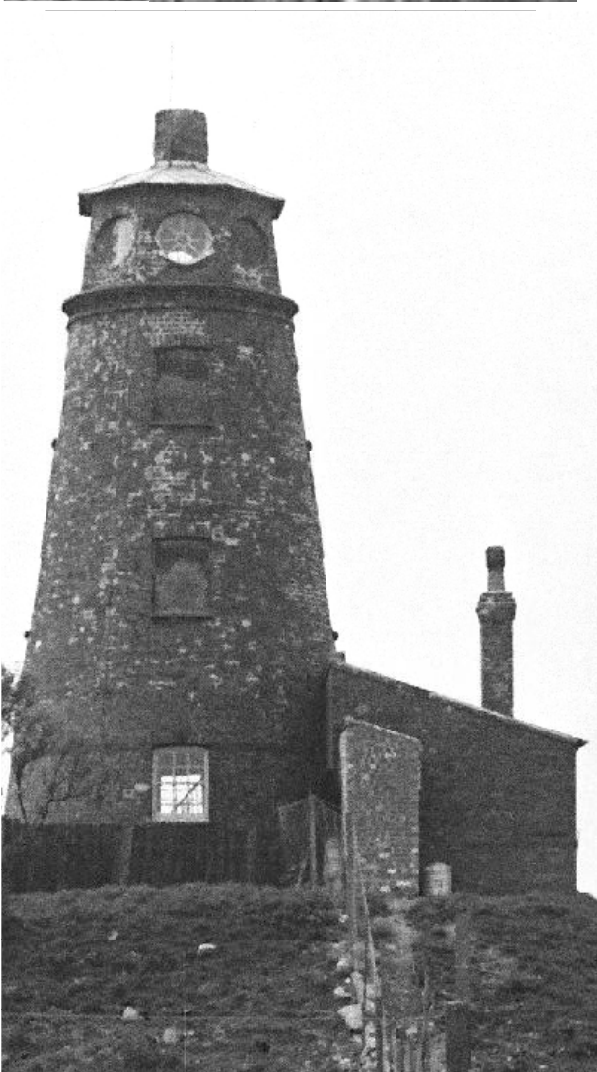
### **1933 photographs taken by Sir Peter Scott showing the kitchen wall**

Wall 2 is almost certainly the remains of the original 225mm thick external brick kitchen wall that was added some time after the lighthouse tower was built. Photographs clearly show this external kitchen wall projecting some meters to the north of the tower, with what looks like a small (1933?) toilet or larder addition to the north eastern side of it.

'Existing drawing' LH2001/1, shows only part of this wall now remains to the western side after the alterations of the 1950's and 1985. It is possible that even this may have been substantially rebuilt in order to make the brickwork secure.

Internal wall 2 is not therefore considered to be of any particular historic structural or original architectural significance or interest and neither in our estimation will the removal adversely affect the character or appearance of the lighthouse.

Kitchen wall 1' is of less interest because it is in the wrong place and too thin to have been part of an original kitchen external wall. We have considered the possibility that it might have been an internal larder wall, especially with the small window shown in the 1933 photograph on drawing LH/2021/1. It is however unlikely that a larder would have extended across an entire outside wall prone to catch the weather and even less likely that a larder would only be accessed from one end - as it would have to be if the present doorway was original. It is therefore more likely to be a new wall constructed during the 1950's restoration and rebuilding works. Other extensive alterations were made at that time including kitchen windows 1, 2 & 8 (see drawing LH/2001/1) being altered and installed and the roof appearing to have been slightly lowered. The single mid-span purlin supporting new roof joists rests on this wall and the external wall to the south. When the blocking up of the rear kitchen door shown in the 1933 photograph is also taken into account, it supports a total kitchen reconstruction theory.

Remove remaining walls between the kitchen area, shower and W.C internally.

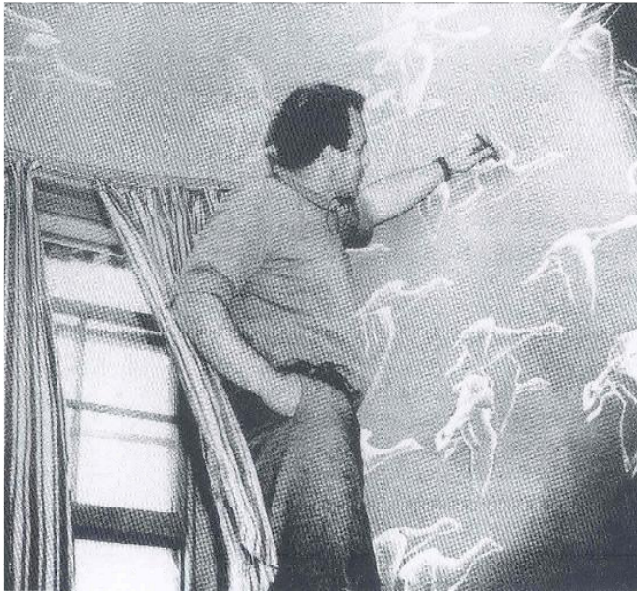
On them he painted white silhouettes of flying geese. He says in his book, 'The Eye of the Wind' that they would be 'forever circling the tower'.

It is unknown if any of his fibre walling board remains but this will be investigated and if so, it will be examined to see if any of the original murals remain and can be restored. If the boarding is from the 1985 restoration, the owners intend to recreate the shades of green and the 'forever circling geese' mural.
