# **Heritage Impact Assessment Design and Access Statement**

Broadgate House, 696 Broadgate, Weston, Lincolnshire, PE12 6JA

Broadgate House, 696 Broadgate, Weston, Lincolnshire, PE12 6JA  
MR AND MRS TEEUW

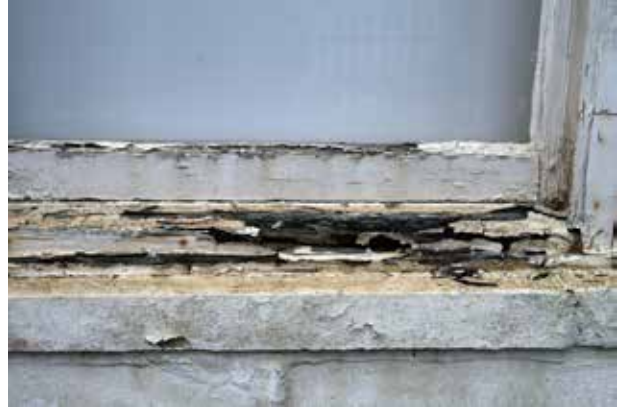
Figure A-3

The two bay windows are showing signs of decay but are possible to repair. **Figure A2-4**. The open porch at the front of the house is showing significant signs of rot and is at risk of collapse. The lead over the top is tired and allowing water ingress. We have a skilled joiner to repair the porch and replace the lead. **Figure A5-8**.

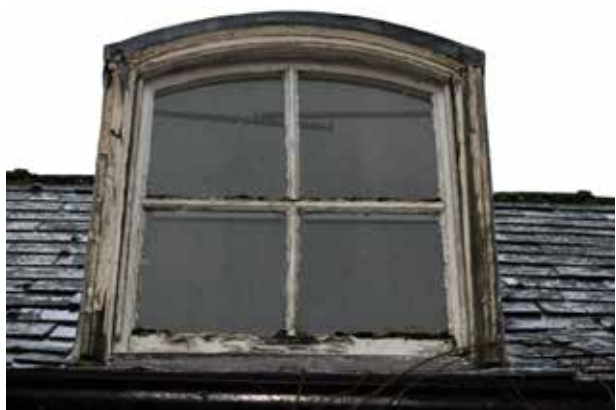
Figure A-9

The dormer windows on the second floor **Figure A9-10** are showing advanced decay and no longer close properly. They currently open by pivoting horizontally which is a worry as the top two bedrooms of the house are to be inhabited by small children. We have found an old slide photo of the property dating back to 1967 it shows that there were sliding sashes in these windows. **Figure A11**. Our intention is to replace these with sash windows of the correct design for the period. These would incorporate safety features. Please see the intended designs in **Figure A12**. We would also replace the leadwork.

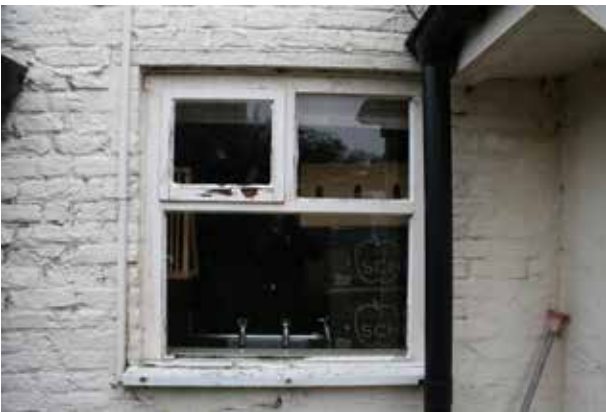
Figure B-2

See **Figure B1** for the south side of the property. The scullery window **Figure B2-3**, the kitchen window **Figure B4-5** and the three dormer windows **Figure B7-9** appear to be more recent than

others, possibly 1960s and 1970s and are in an irreparable condition. We believe it would be sensible to replace these with new windows of the correct design. Please see attached designs for the scullery and kitchen windows **Figure B10** and for the dormer windows **Figure B11**. The leadwork has failed on the dormer windows and we will replace this. **Figure B12-13** This bay window will be repaired where necessary.

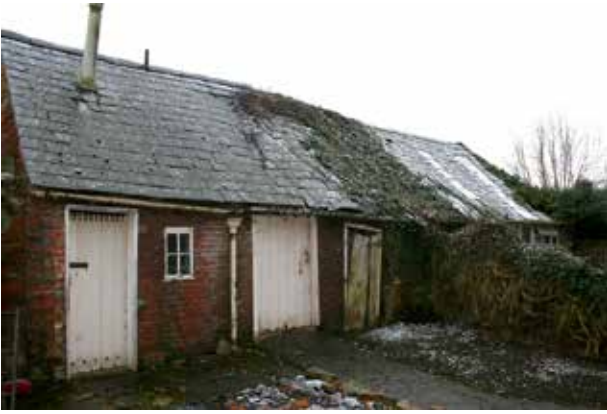
Figure D-1

The outbuildings that lead from the rear of the house are in a extremely dangerous condition and should only be accessed with caution. North side (garden) **Figure D1-4**. West side (back) **Figure D5-6**. South side (yard) **Figure D7-10**.

In order to save the buildings and make safe, it is essential that the roof slates are removed as soon as possible. This build is very close to collapse and as we have small young children and it can not be unleft. We will then rebuild the collapsed walls **Figure D2** and **Figure D1-5** using reclaimed bricks and a lime mortar. Where the brickwork has blown an example shown in **Figure D11** this will be repaired, the modern cement will be raked out and replaced by lime mortar.

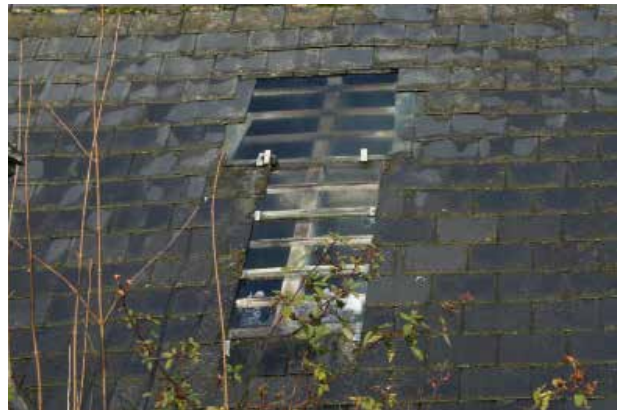
Figure D-12

**Figure D12-15** There is a garden room within the rear outbuildings that has glass sheets on the roof to allow in daylight. In the interest of safety, we intend to replace the glass with Conservation Rooflights **Figure D16**. Please see **Figure D17** for placement of these windows. The future use of this room will be for the enjoyment of the garden and entertaining. We intend to add a sink, a small number of kitchen units and a toilet.

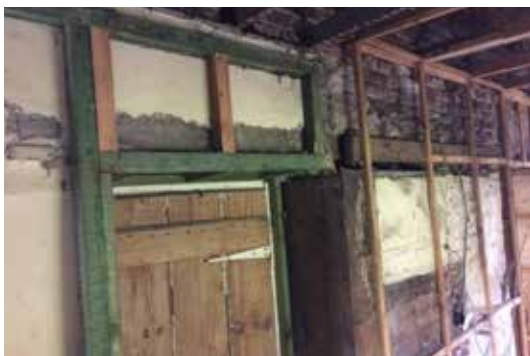
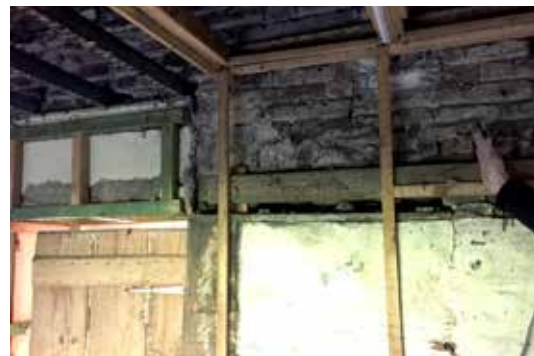
Figure E-7

The kitchen cupboards in **Figure E7** may have been built in along with the door when the extra roof space was added as there is a wooden lintel that runs along quite a significant length over the cupboard and the door frame. They have suffered significant dry rot. This does indicate that there was once a fairly large opening going into the outbuilding.

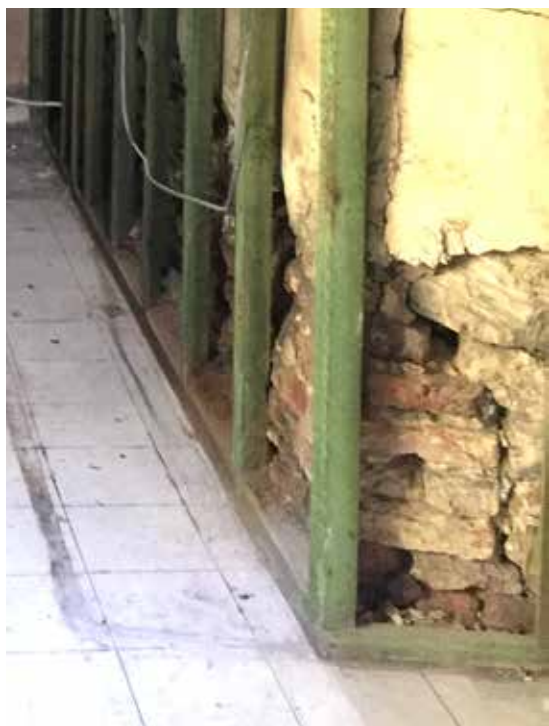
Figure E-10

We appreciate that the removal of **Wall A** in **Figure E9** could be viewed as fairly significant to the building but there is also an argument to say that there once was a large opening. More critically though the wall is in a extremely poor state of repair see **Figure E10-14**. The base of the wall has suffered mass erosion. We are not sure if it is salt damage but the volume of brick dust found when we removed the panelling (6-10 inches deep), showed that the erosion is worryingly active. This wall is a critical load bearing wall therefore it needs immediate attention. The advice we have been given is to remove and install proper supporting material. See **Figure E15** for structural illustration. It is already showing signs of strain in **Figure E16**.
