**Report number 17-02-01**

## **Environmental Risk Assessment of Land adjacent to**

**355 High Road, Whaplode, Spalding, PE12 6TG**

**Planning Application No. H23-0508-16**

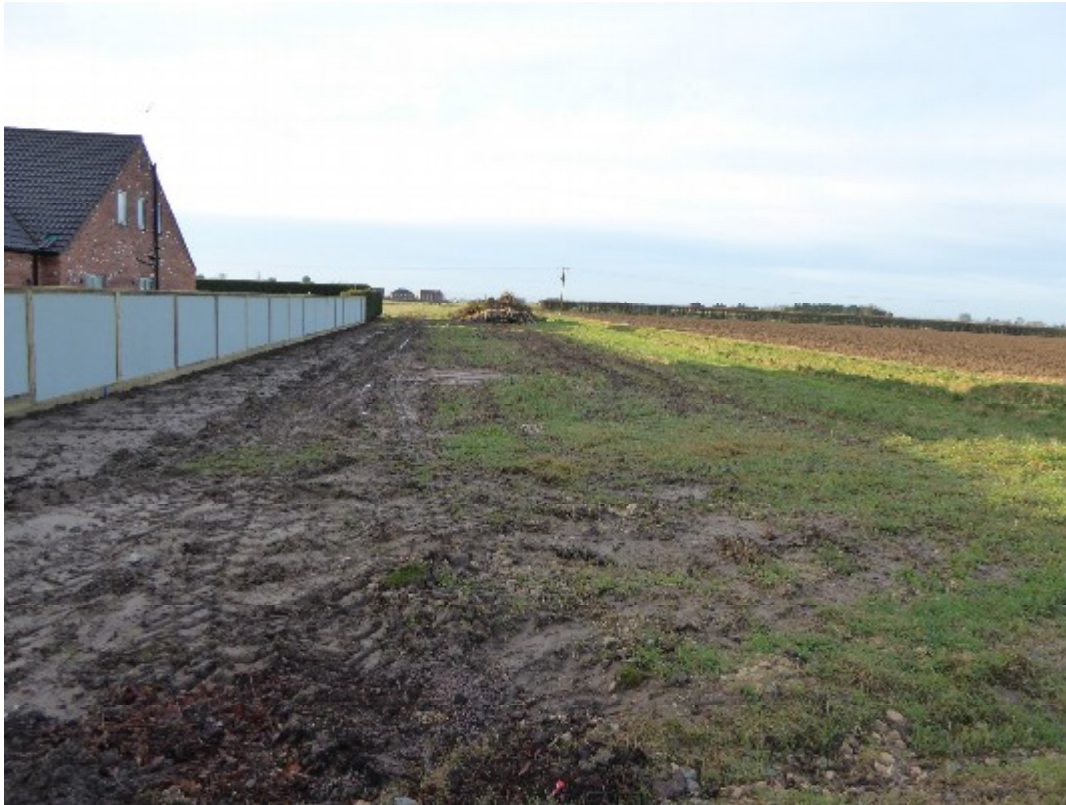
3.1 The site was visited when the weather was dry and sunny. The whole area is flat and level and house number 355 is located in the middle of the site adjacent to High Road (photos 1 & 2). The planned development is to construct 33 houses on the 1.8 ha site around the existing number 355. The fields have stubble on them from cereal crops grown in the previous year (photo 3) and the soil appears to be silty slightly clayey sand. The ditches along the southern and western boundary have been maintained and the water in the bottom is clear (photos 4 & 5). A pile of bushes/saplings that appeared to have originated from the High Road boundary and some clean wood and chipboard panels were on site between the western boundary and garden fence of number 355 (photo 6).

Photo 1 Western side of site with house number 355 in middle of site

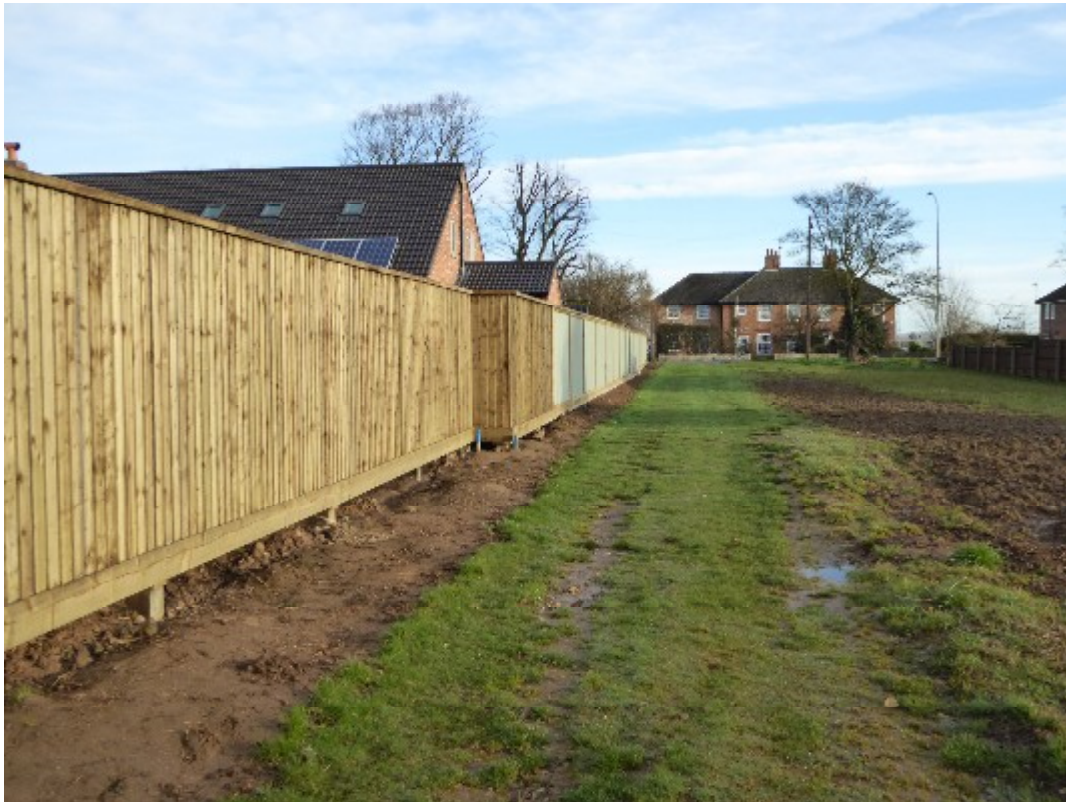
Photo 2 Eastern side of site looking towards road, number 355 on left

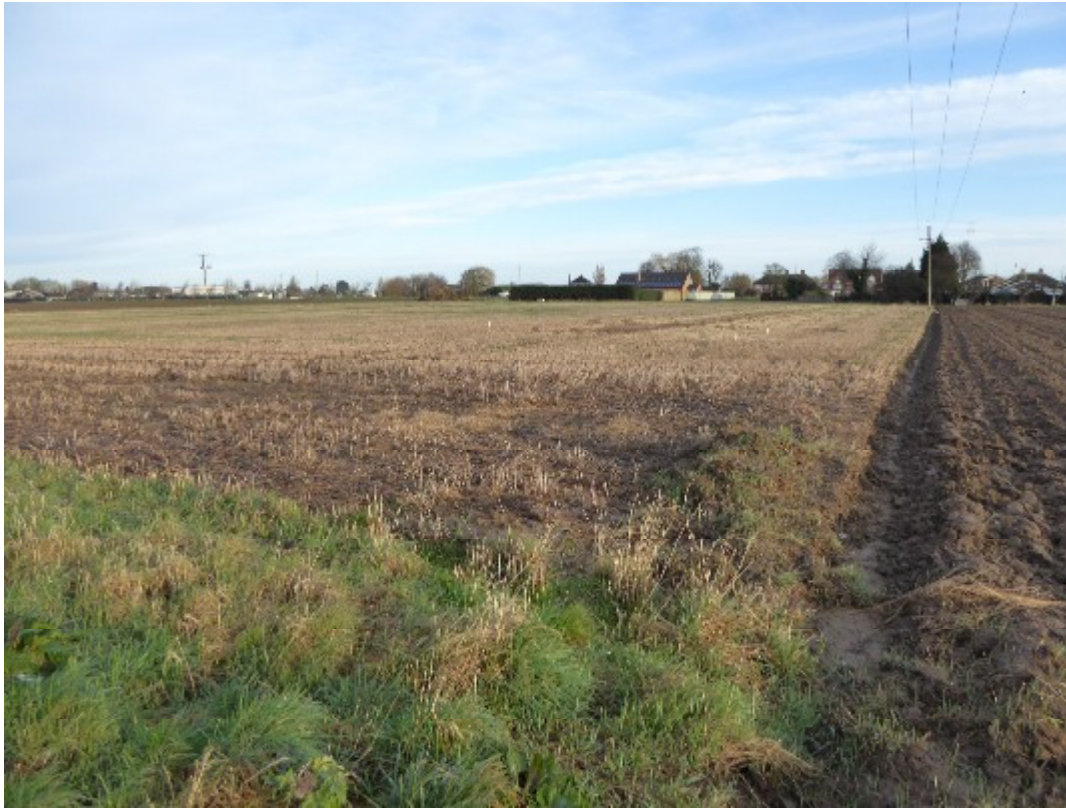
Photo3 Field looking from southeast corner of the site

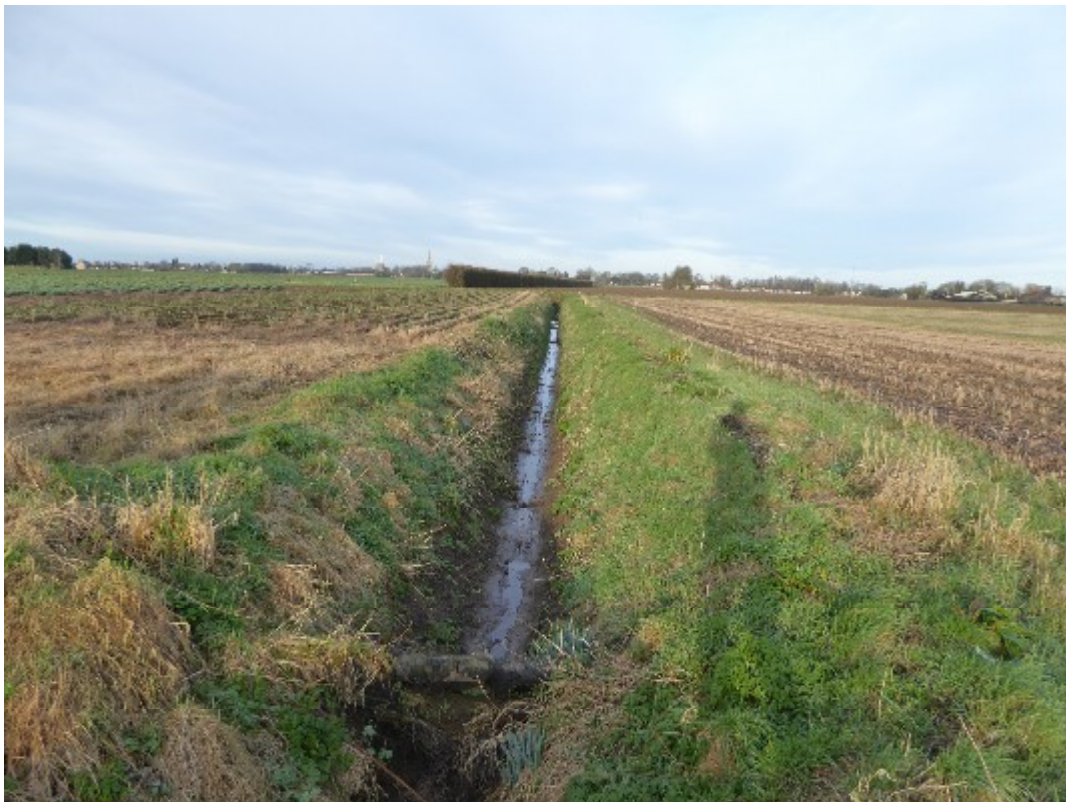
Photo 4 Ditch on southern boundary looking to west

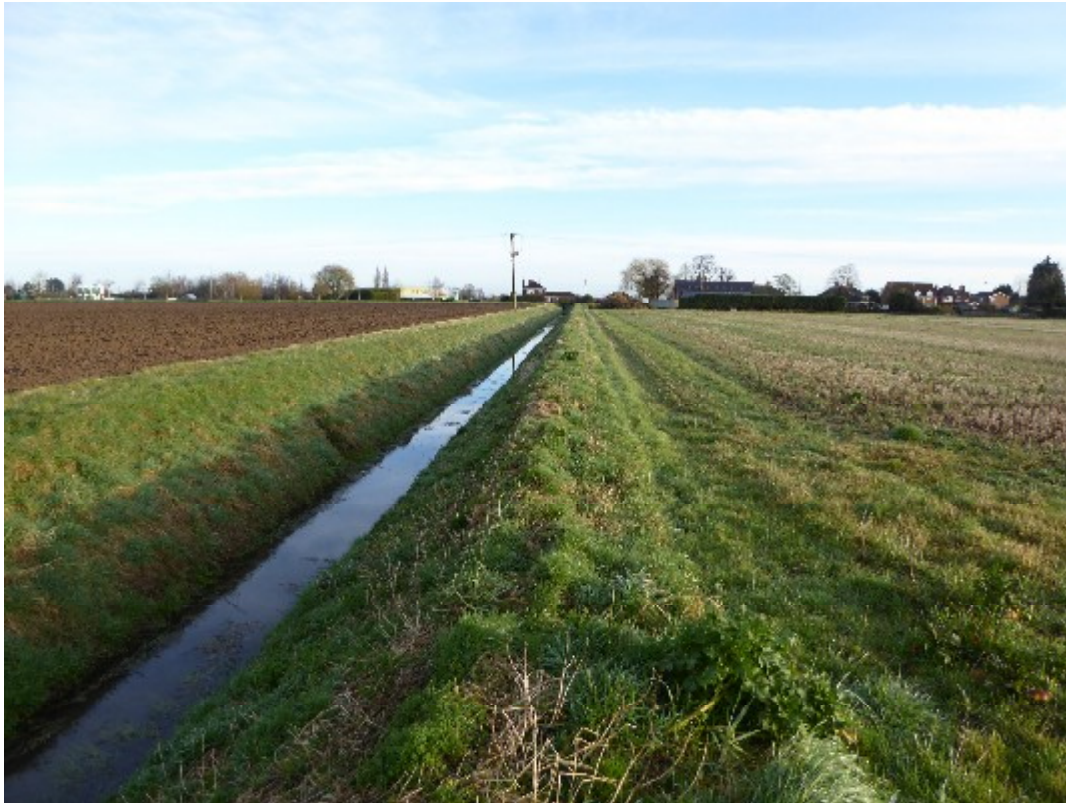
Photo 5 Ditch on western boundary looking to High Road

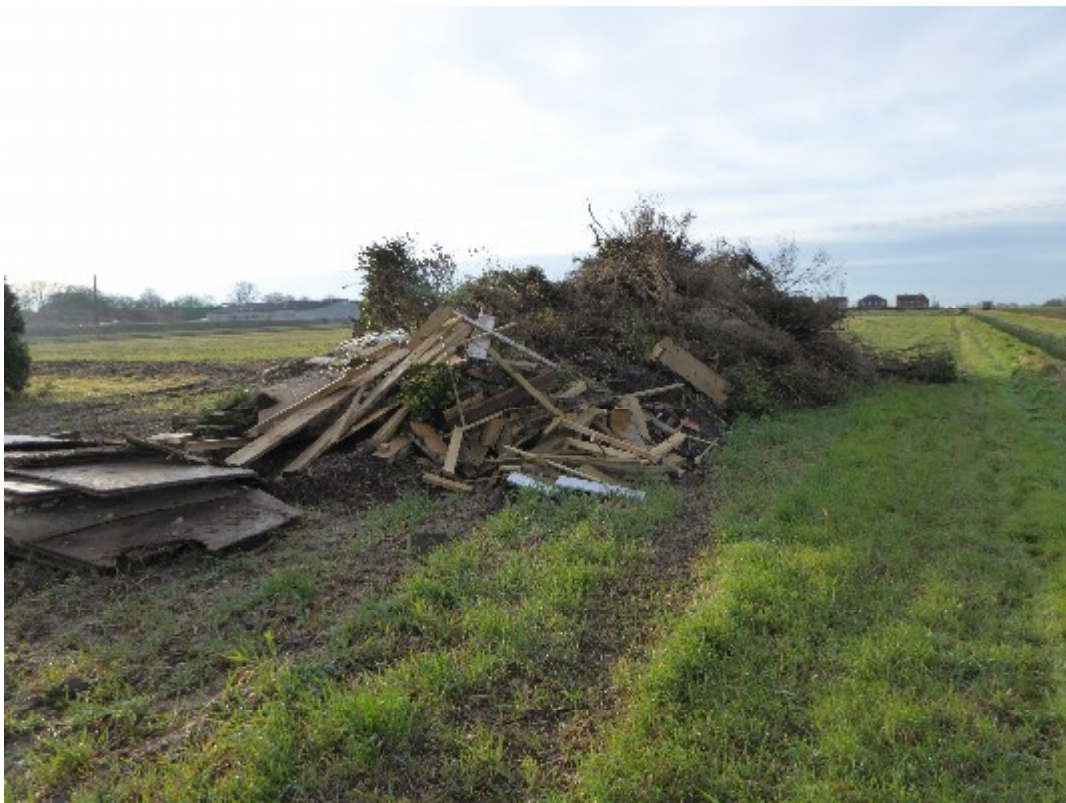
Photo 6 Bushes/saplings from road boundary and scrapped clean wood
