# Elemental **GI** Ltd

**REPORT:** PHASE 2 GEO-ENVIRONMENTAL  
INVESTIGATION FOR LAND NORTH OF  
STONEGATE, COWBIT

**CLIENT:** ARK PROPERTY CENTRE

## PHASE II GEO-ENVIRONMENTAL INVESTIGATION: LAND NORTH OF STONEGATE, COWBIT

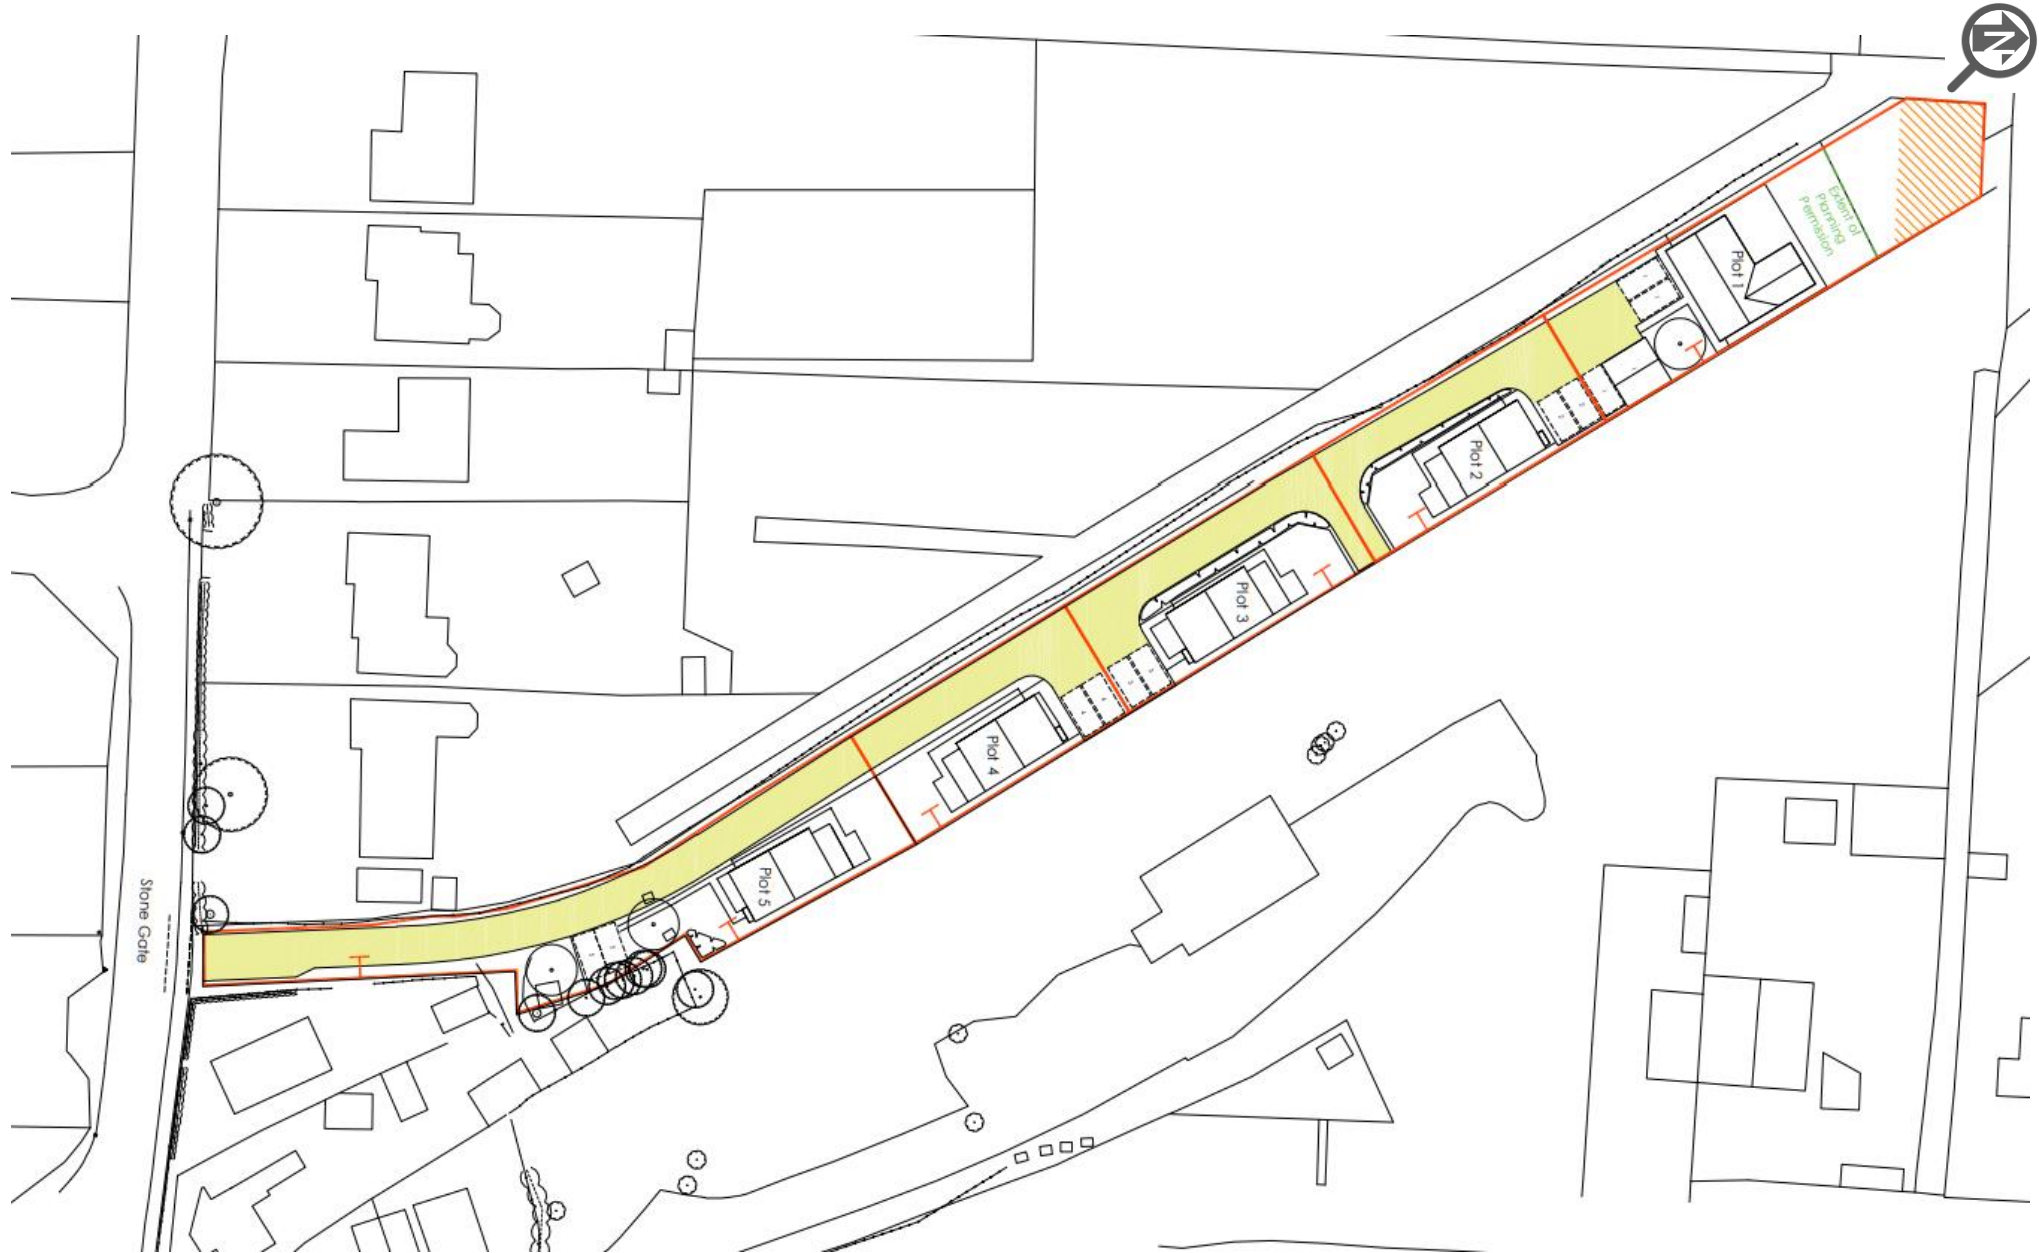
| | | <div>DRAWING No:</div> <div>E22208_001</div> | <div>DESIGN/DRAWN:</div> <div>JR</div> | |

| <div>CLIENT:</div> <div></div> | <div>TITLE:</div> <div>Proposed Site Layout Plan</div> | <div>DATE:</div> <div>Jan. 2023</div> | <div>SCALE@SIZE:</div> <div>NOT TO SCALE</div> | <div>Elemental GI Ltd</div> |

This report has been prepared on the understanding that the site is to undergo redevelopment to support residential housing. We have been supplied with a copy of the proposed layout Ref: 551.LTP.03 and extracts of this plan are presented in the Proposed Site Layout Plan (Drawing 001) in Appendix I.

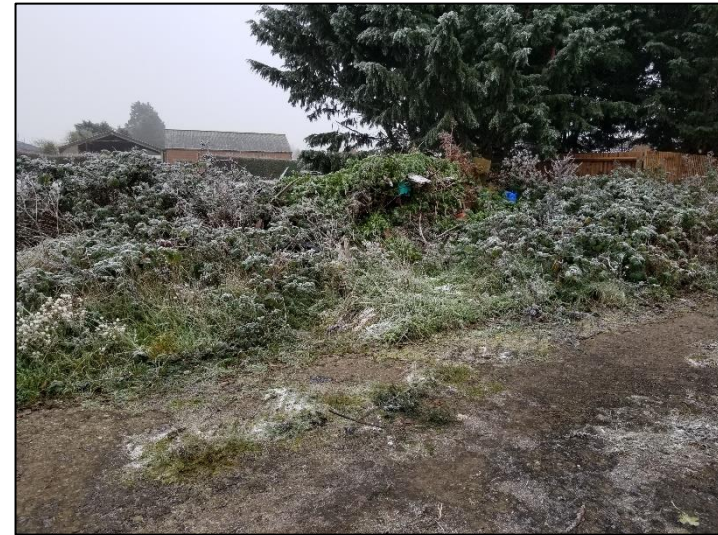
Photo 2 - Construction Waste Stockpile near Site Entrance.

- General construction waste including bricks, plastic and concrete were found along the eastern boundary of the site as well as derelict machinery and other stockpiles containing wood (since removed from site);

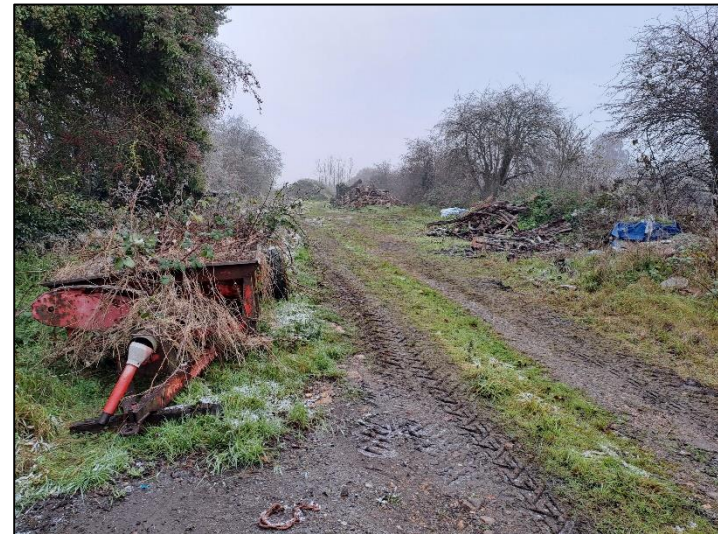
Photo 4 - Stockpiles and Derelict Trailer.

- A small tyre stockpile and derelict trailers were found along the western boundary of the site (since removed from site); and
- A small compost shed with a vegetation stockpile was observed near the gate in the southern area of the site.

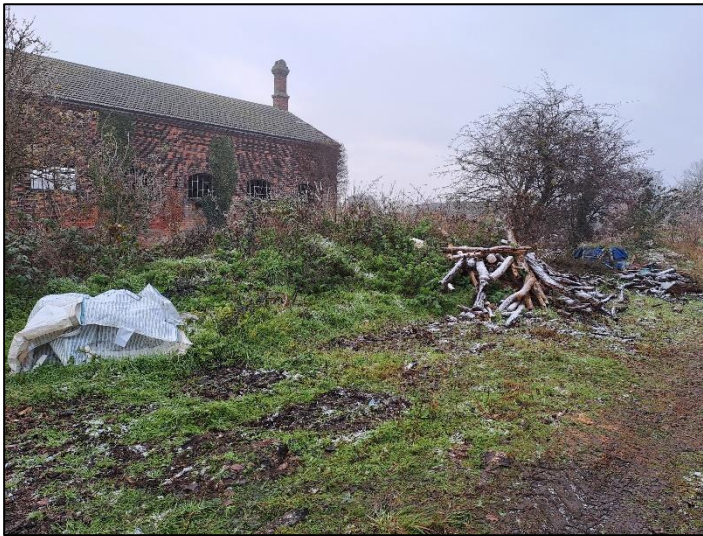
Photo 5 - Stockpiles and Waste Along Eastern Boundary.

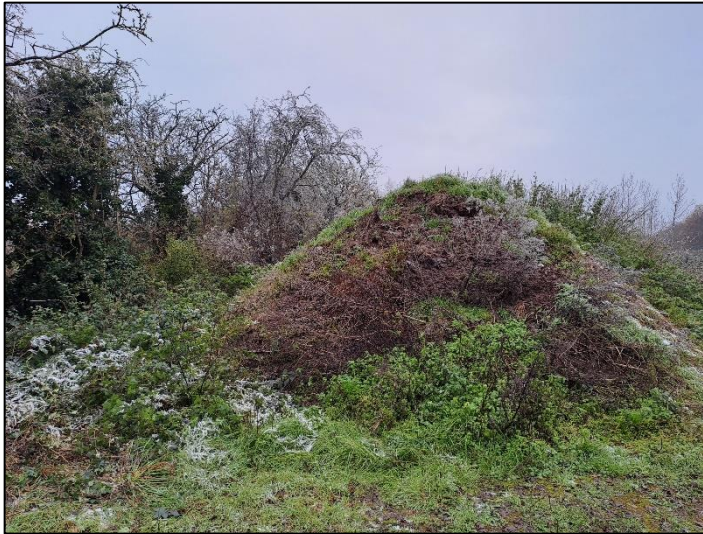
Photo 7 - Stockpile in Northern Area of Site.

- No obvious overall topographical gradients were noted across the site;
- Large stockpiles containing mixed topsoil and waste materials were noted in the northern end of the site (since removed from site);

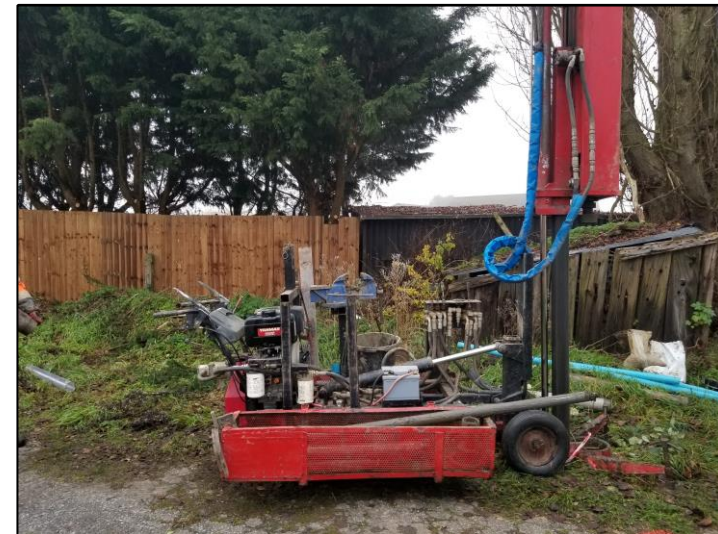
Photo 8 - Drilling of WS06.
