## **LAND OFF MOULTON CHAPEL ROAD, COWBIT, SPALDING**

### **PHASE I & II GEO-ENVIRONMENTAL INVESTIGATION FOR COWBIT HOMES LTD**

**Project No:**  
GML18201/1/1

**Date:**  
September 2018

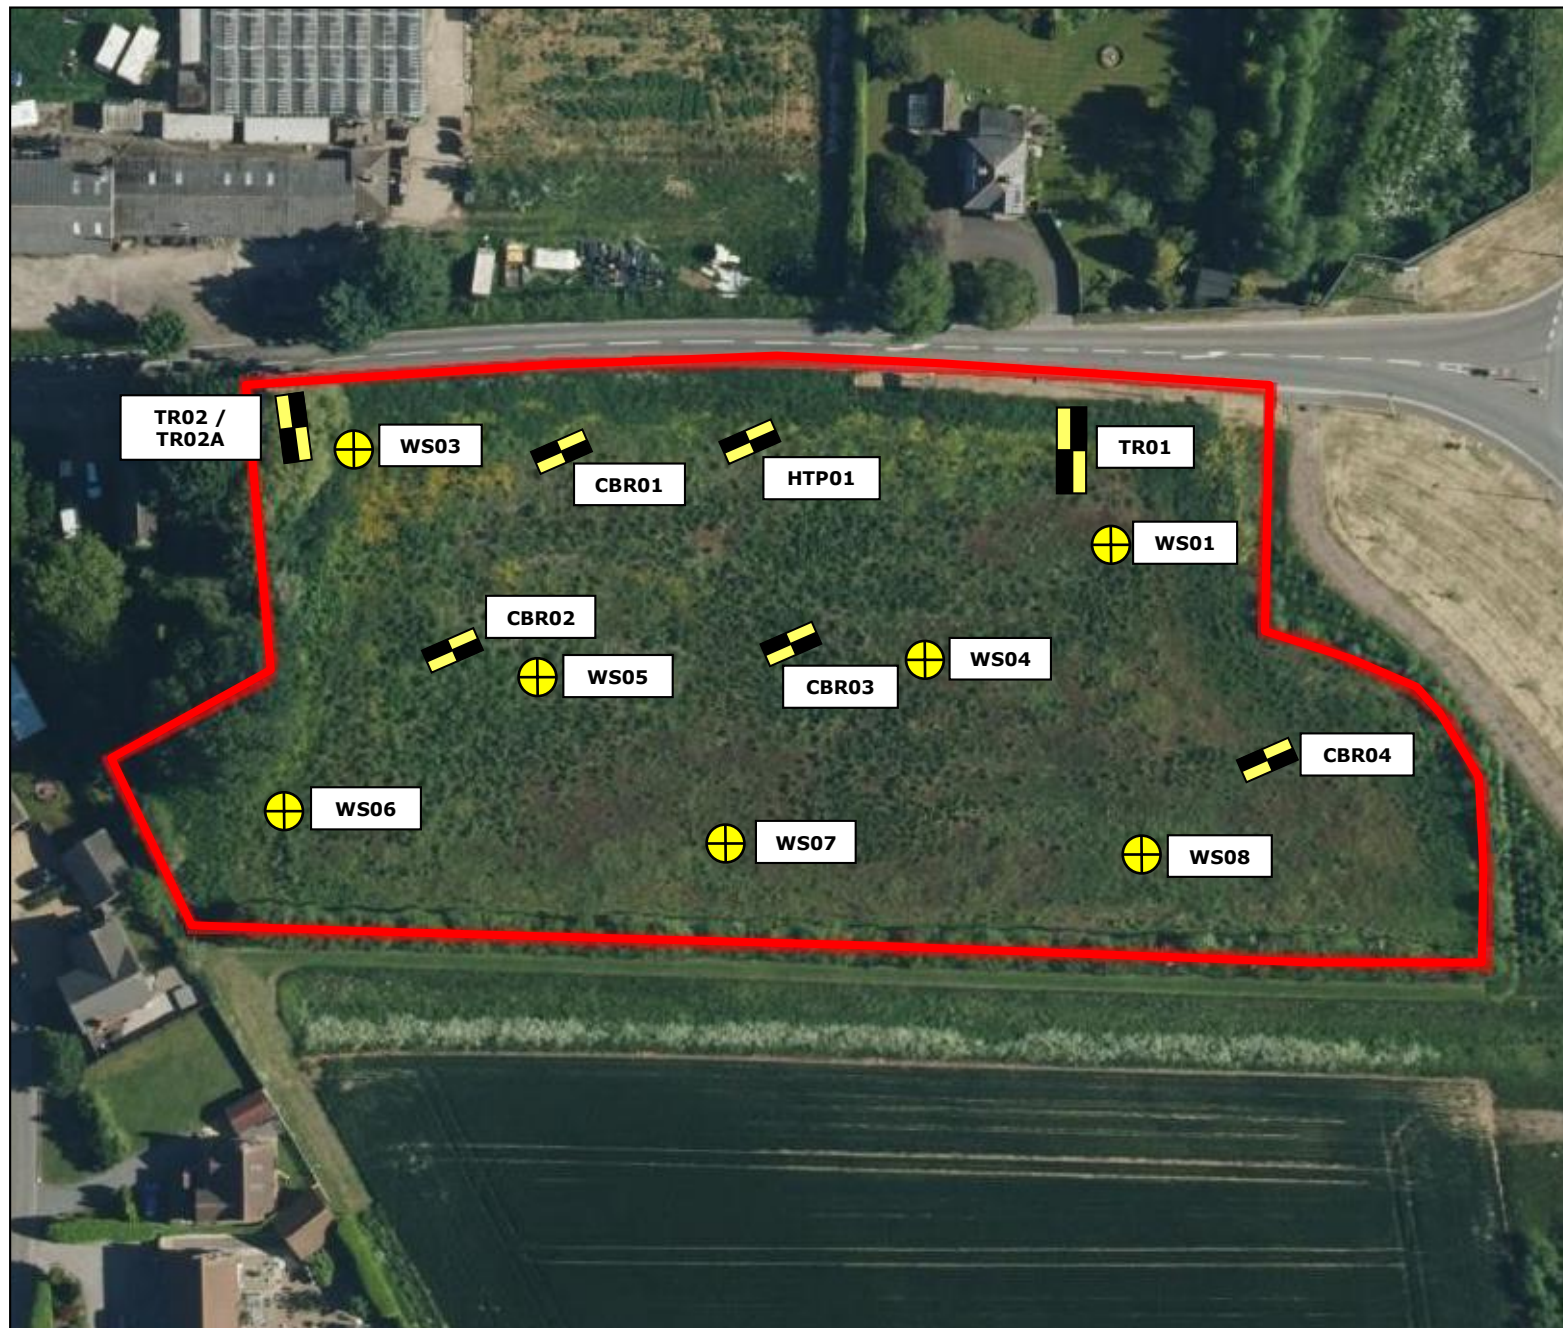
### Site Investigation Layout Plan

The geotechnical element of the works was undertaken concurrently with the environmental investigation. The ground conditions encountered within the exploratory locations are summarised in the table below with the logs presented in Appendix VIII.
