## **Phase I Geo-Environmental Desk Study**

### **6 Backgate**

Cowbit  
Spalding  
Lincolnshire  
PE12 6AP

**EPS Project Reference:** UK21.5370

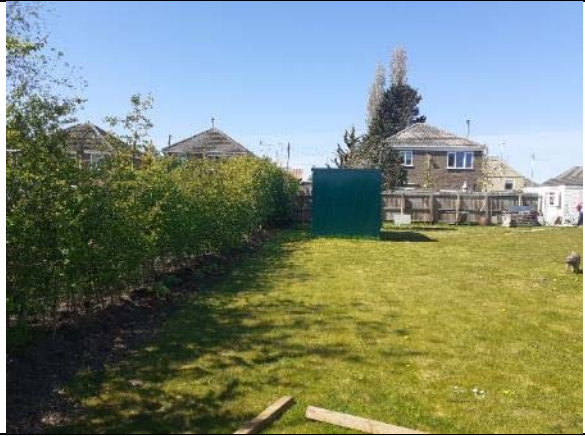
| <p>Photo 1: Photo looking approximately west along the southern perimeter of the site.</p> | <p>Photo 2: View looking approximately east showing the wooden shed in the north eastern corner.</p> |

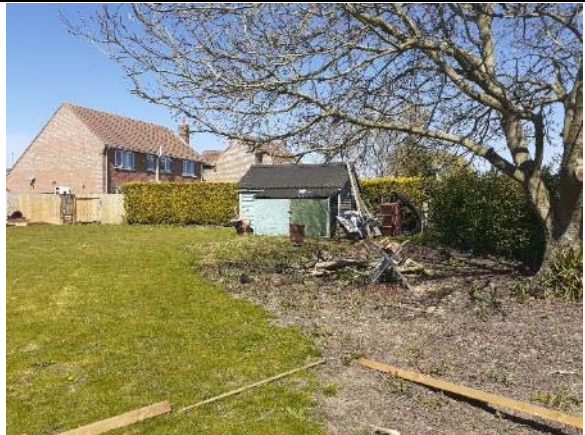
| <p>Photo 3: Photo looking roughly north along the eastern perimeter.</p> | <p>Photo 4: Image looking approximately west, showing the gravel area and outbuilding/ office.</p> |

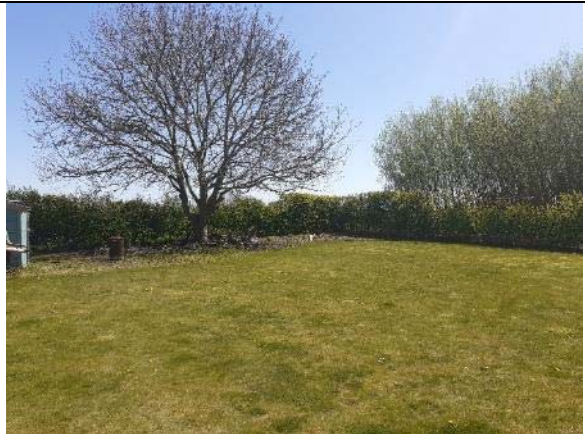
| <p>Photo 5: View looking towards the south eastern corner of the property.</p> | <p>Photo 6: Image looking towards the north western corner of property.</p> |
