## **Verification Statement for land off Stonegate, Cowbit**

**8th October 2024**

The purpose of this Verification Statement is to demonstrate that the site has been remediated in accordance with the Remediation Strategy and to allow the discharge of condition 13 part iv) of H01-0823-19.

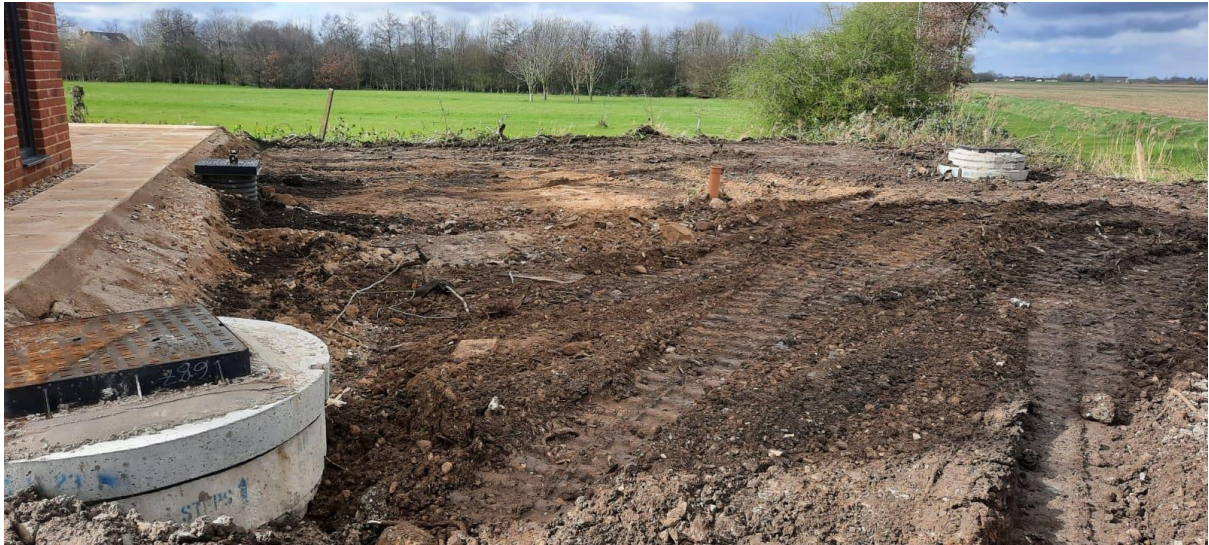
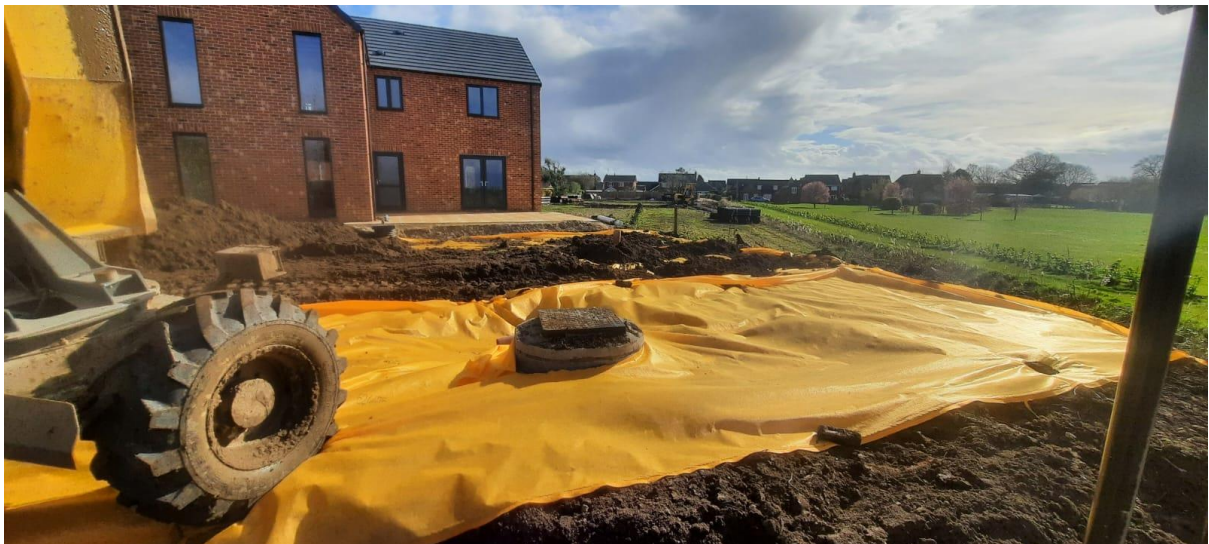
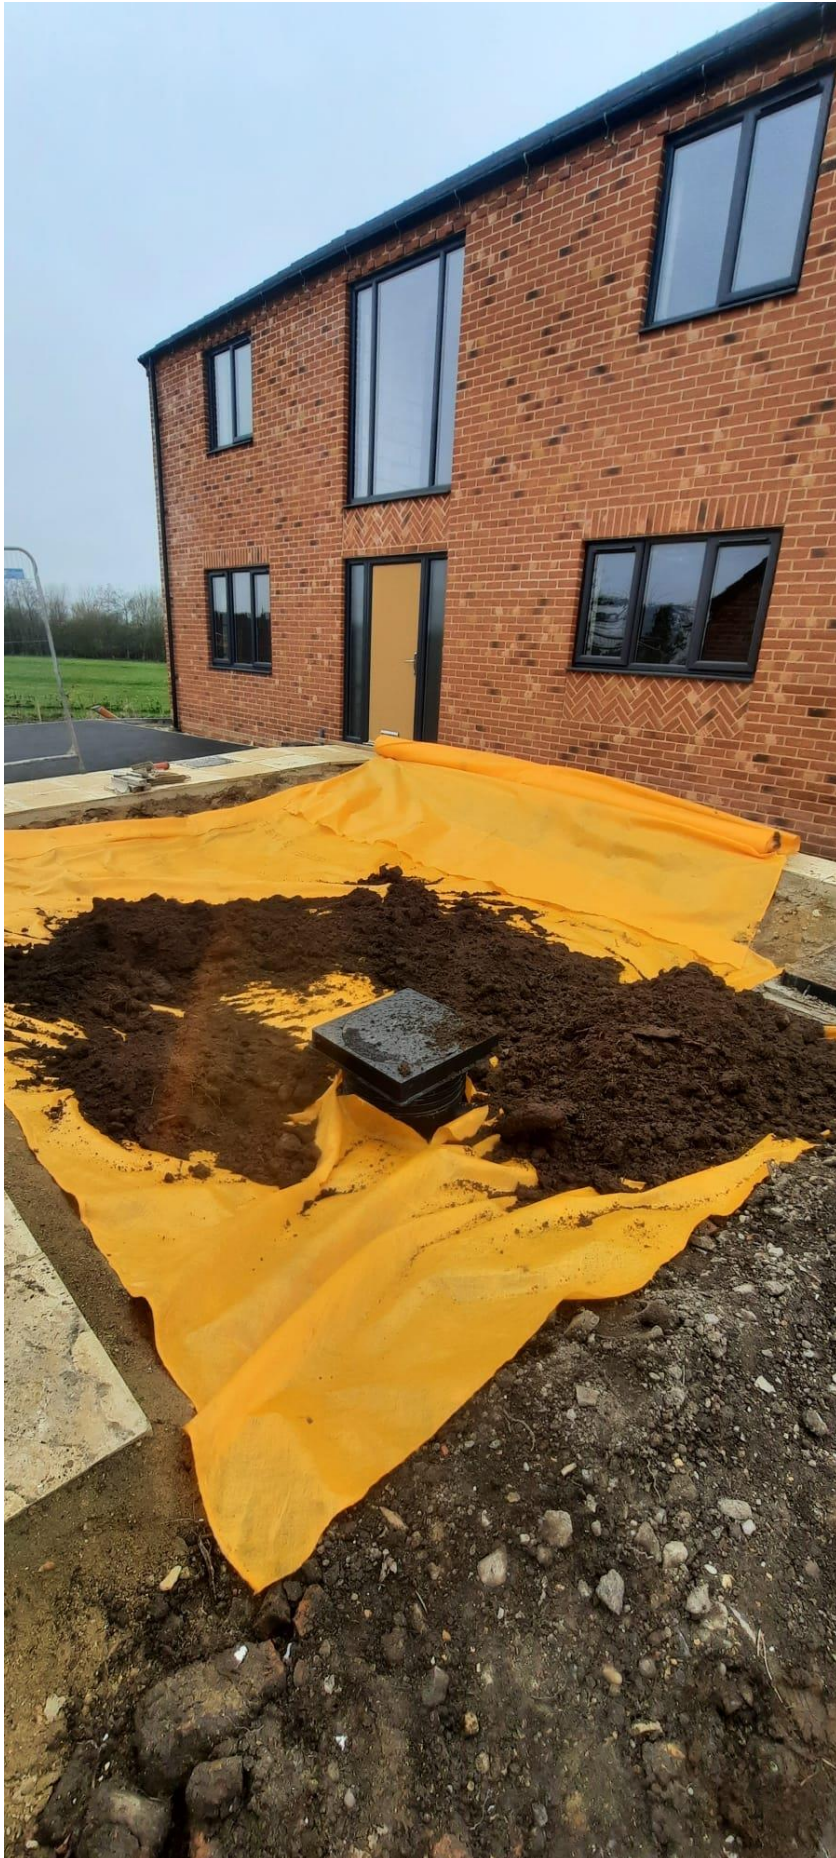
## Plot 1 Installation Photographs

All garden areas were provided with a Terram Hi-Vis geotextile membrane and 600mm of imported clean topsoil. No form of cover was required where the material was under permanent hardstanding such as roads, buildings or paved areas. Details of the extent of soft and hardstanding areas are shown within Appendix B.

Studio 11 Architecture have been provided with photos from the client showing the placement of the topsoil at the appropriate soil thicknesses to each garden area. Certificates for the imported topsoil are contained within Appendix C.

Based on the above information, the photographs provided by the Client and the findings of previous reports, it appears that the remedial requirements have been appropriately implemented. A Terram Hi-Vis geotextile membrane does appear to have been laid with at least 600mm clean soil placed on top. Each plot has been provided with a gas membrane and details of the installation and verification are included within the appendices of this document.
