**Supplementary Sampling Report  
Former Broadway PFS  
Crowland  
Lincolnshire  
PE6 0BH**

**EPS Project:** UK14.1470

## FORMER BROADWAY PFS, CROWLAND

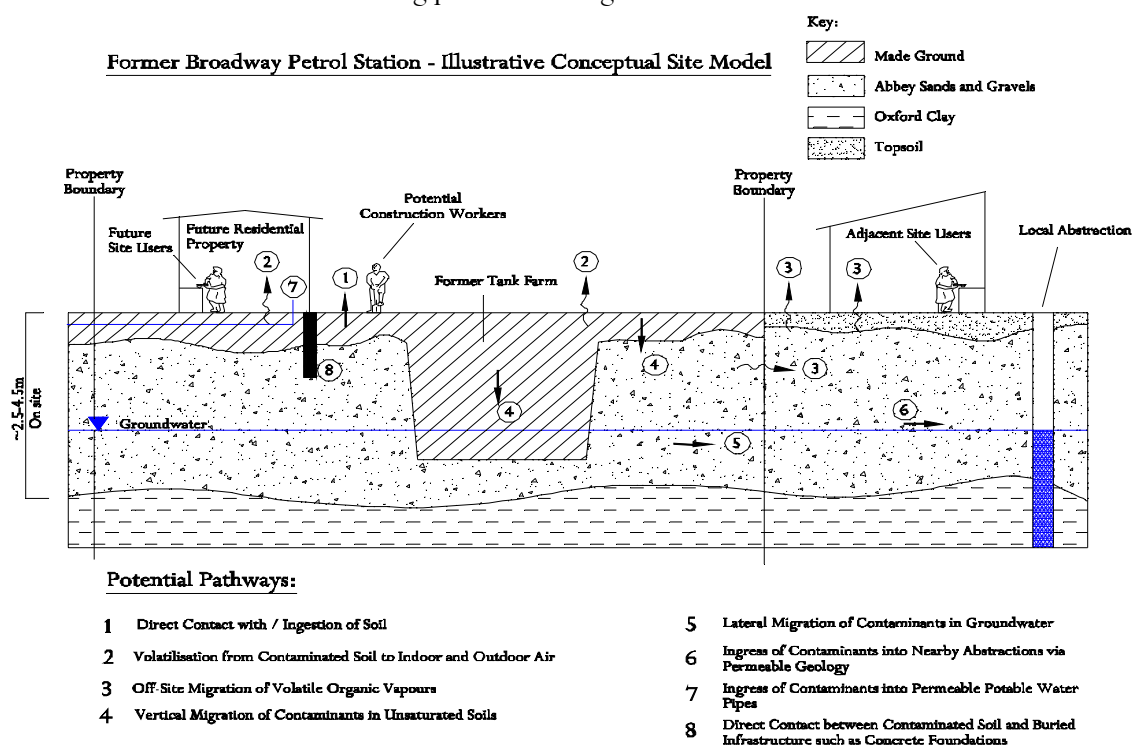
The following diagram provides a schematic representation of the conceptual site model, which includes detail of the above remaining pollutant linkages:

On this basis EPS recommends carrying out a more detailed site-specific assessment of the risk posed to surrounding controlled waters to confirm whether remedial actions are required to reduce the dissolved contaminant impacts.

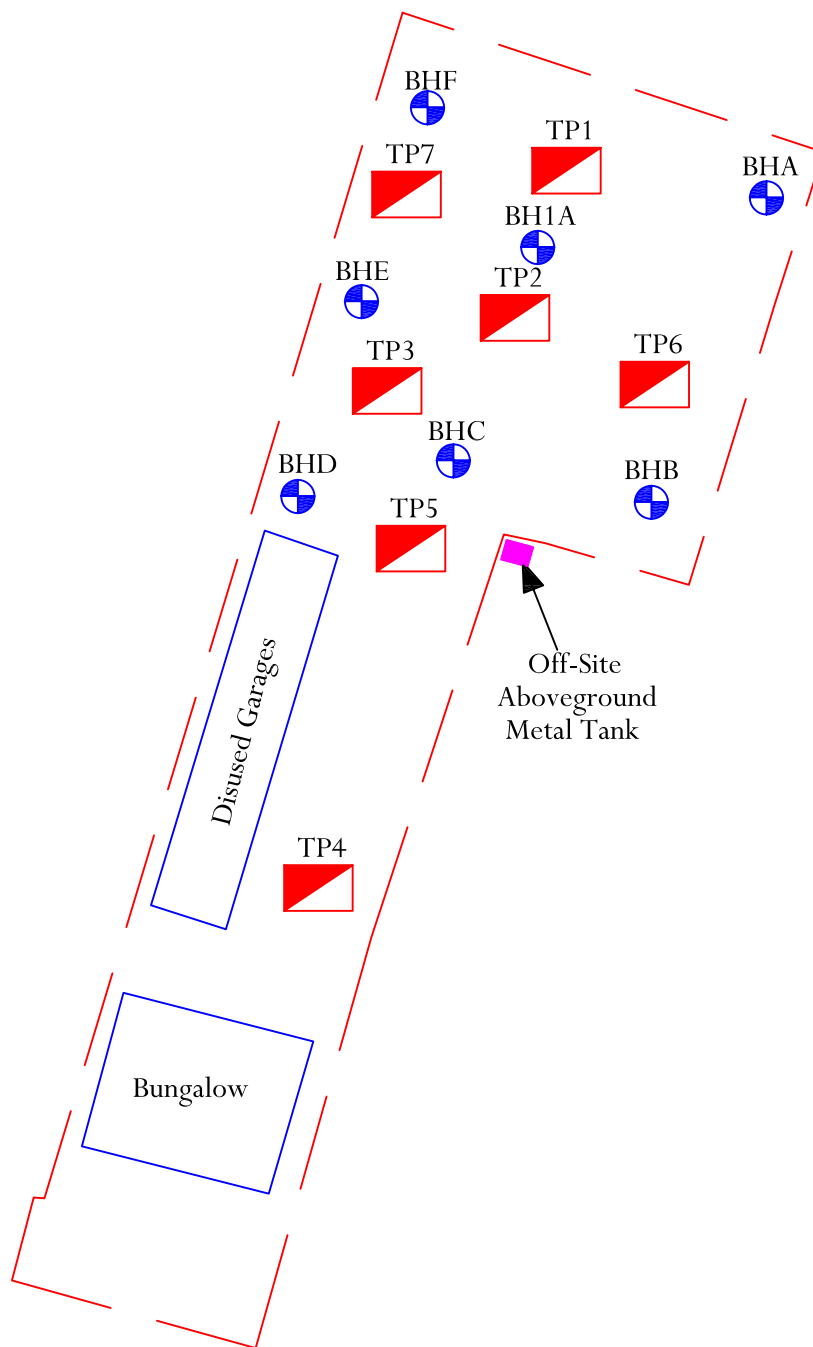
**Dwg No:** Ladds/Broadway/0214/02

| Figure 2 | Groundwater Monitoring Well & Trial Pit Location Plan |

The trial pits were excavated in accordance with standard EPS drilling methodologies, and subcontractors were supervised at all times by an EPS engineer. A detailed plan showing the locations of the trial pits excavated during the investigation is presented as Figure 2.

Groundwater samples were obtained from seven on-site groundwater monitoring wells (BHA-F & BH1A) which were installed during previous intrusive investigations undertaken at the site. A detailed plan showing the locations of the monitoring wells sampled during the investigation is presented as Figure 2.

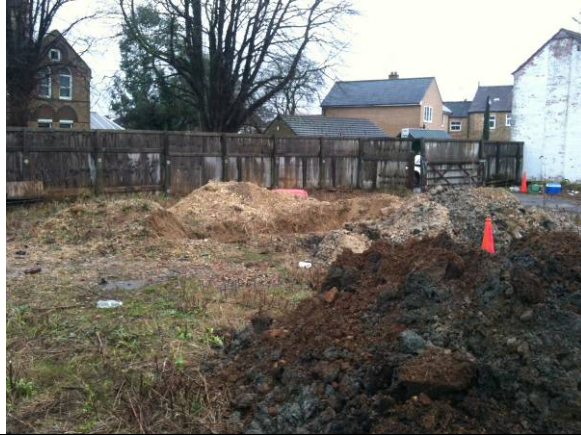
| Photo 1: View looking northeast across the northern edge of the site | Photo 2: View looking southeast across the north-eastern corner of the site. |

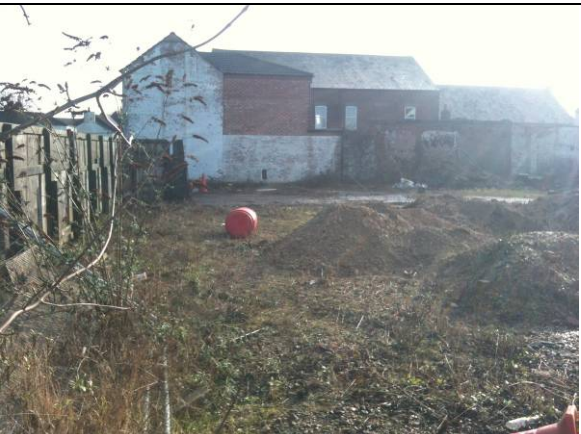
| Photo 3: View looking east along the northern edge of the site. | Photo 4: View looking northeast across the site from the southern end. |

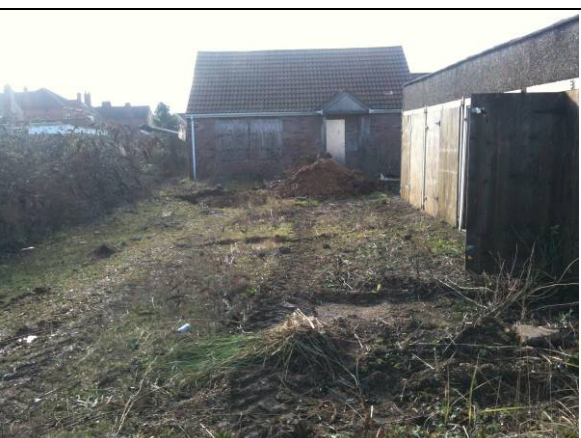
| Photo 5: View looking south-west across the southern end of the site. | Photo 6: View looking southeast across the location of the off-site aboveground storage tank located adjacent to the eastern edge of the site. |

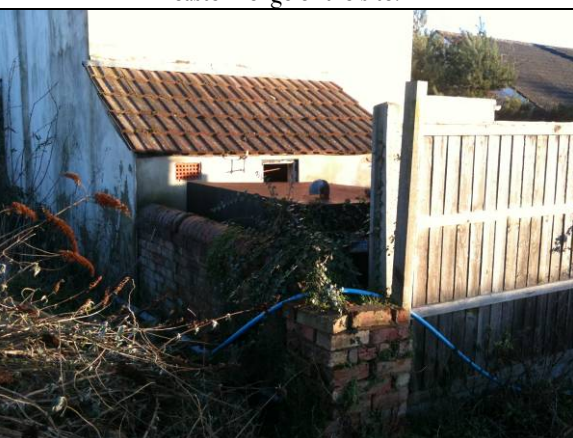
The site is currently a disused area of predominantly undeveloped land which is surrounded to the south, east and west by residential properties. Directly to the north is a road, Broadway, from which the site is accessed, while an off-site metal aboveground storage tank was observed adjacent to the eastern edge of the site. It is unknown if this tank is currently in use, but it is believed likely to have at some point used to store domestic heating oil (Kerosene).

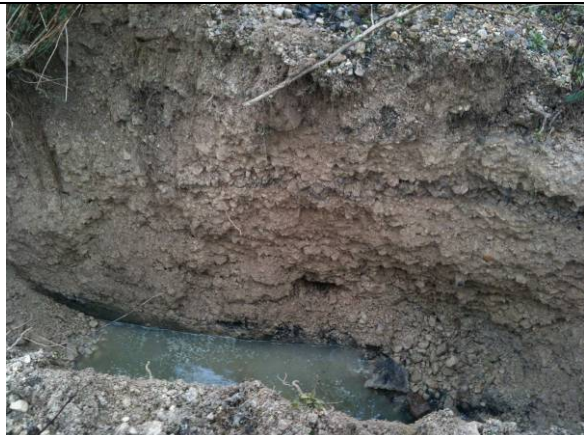
No evidence of residual underground fuel tanks or associated pipework were encountered during the trial pit investigation. Inspection of the shallow unsaturated made ground found materials that were visually free of hydrocarbon contamination but, as described in Section 4.2.1 above, fragments of brick and concrete were noted. Black and grey staining of the soils was noted in trial pits TP1-3 and TP5 from between 1m and 3m below ground level (bgl), with slightly odorous contaminated groundwater observed flowing into trial pits TP1-3, TP5 and TP7.

| Photo 7: View looking into trial pit TP1. | Photo 8: View looking into trial pit TP2. |

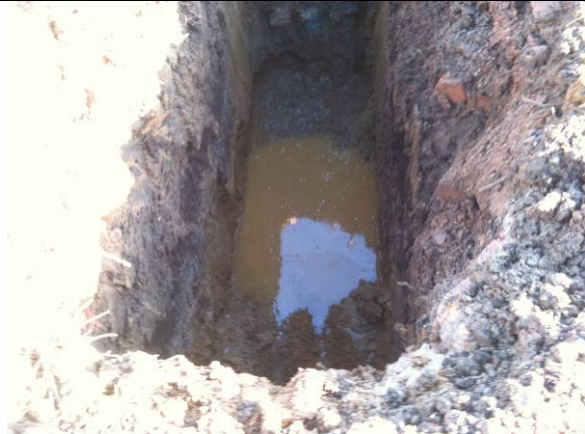
| Photo 9: View looking into trial pit TP3. | Photo 10: View looking into trial pit TP5 |

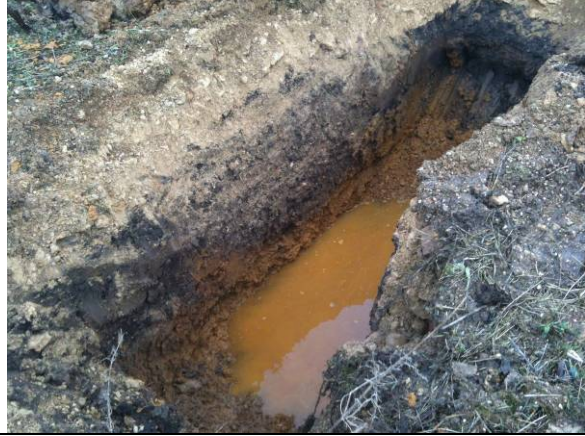
| Photo 11: View looking into trial pit TP4. | Photo 12: View looking into trial pit TP7. |

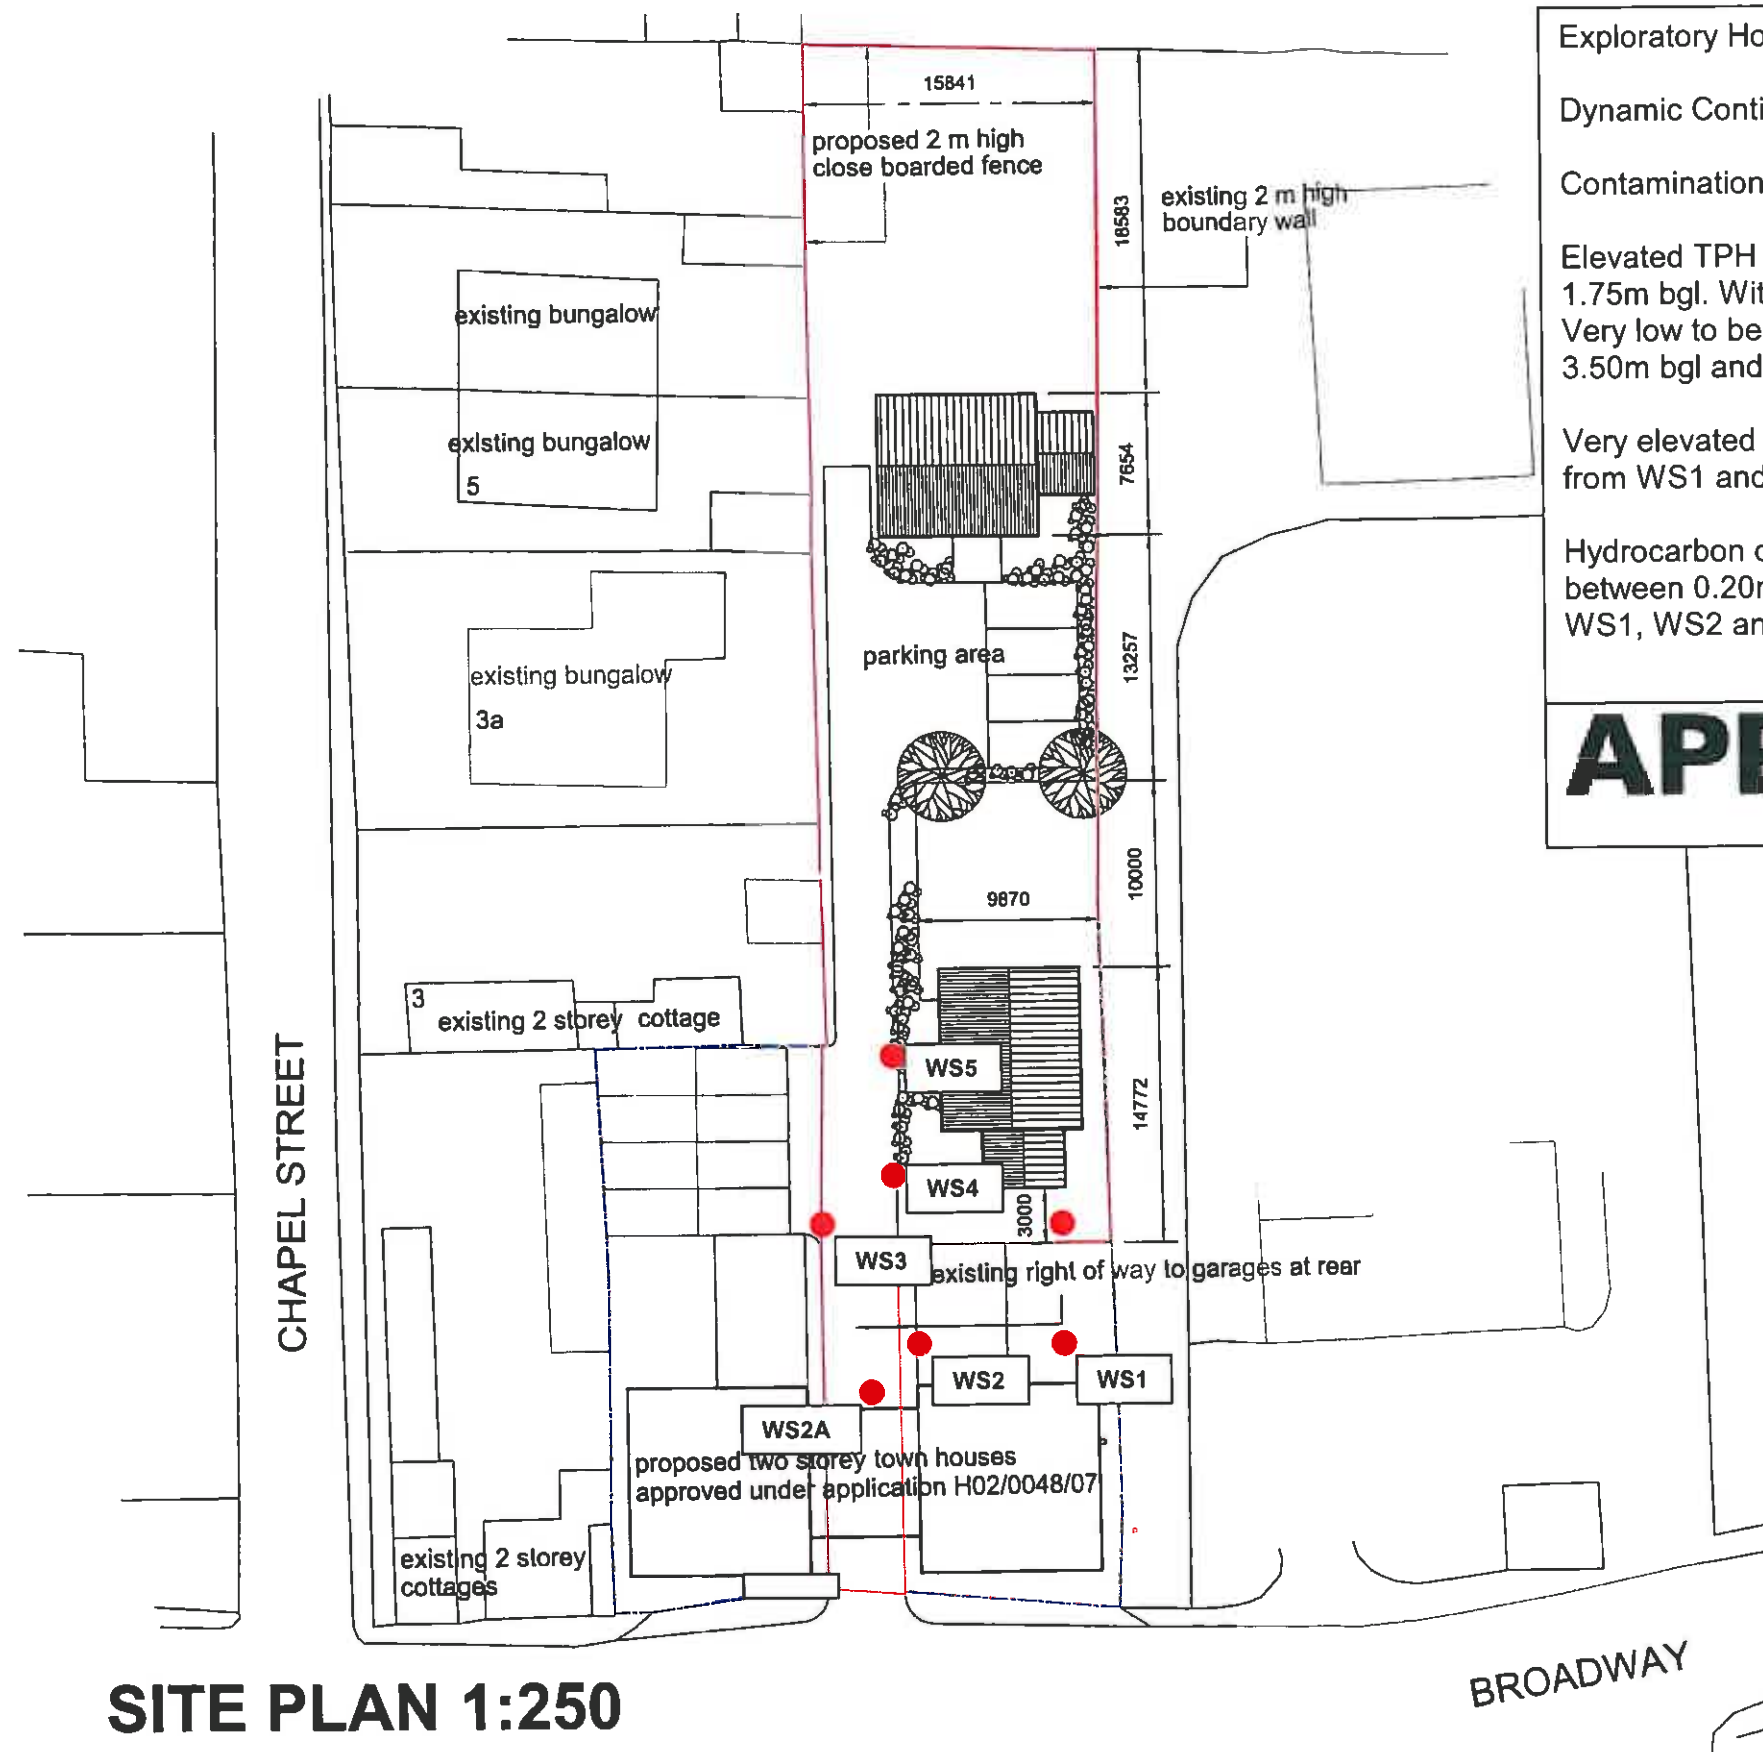
## Exploratory Hole Location Plan - Ground Engineering Report 2001

Hydrocarbon odours were noted on the exploratory hole records from depths of between 0.20m and 1.10m to depths of between 3.00m and 3.40m bgl within WS1, WS2 and WS5.

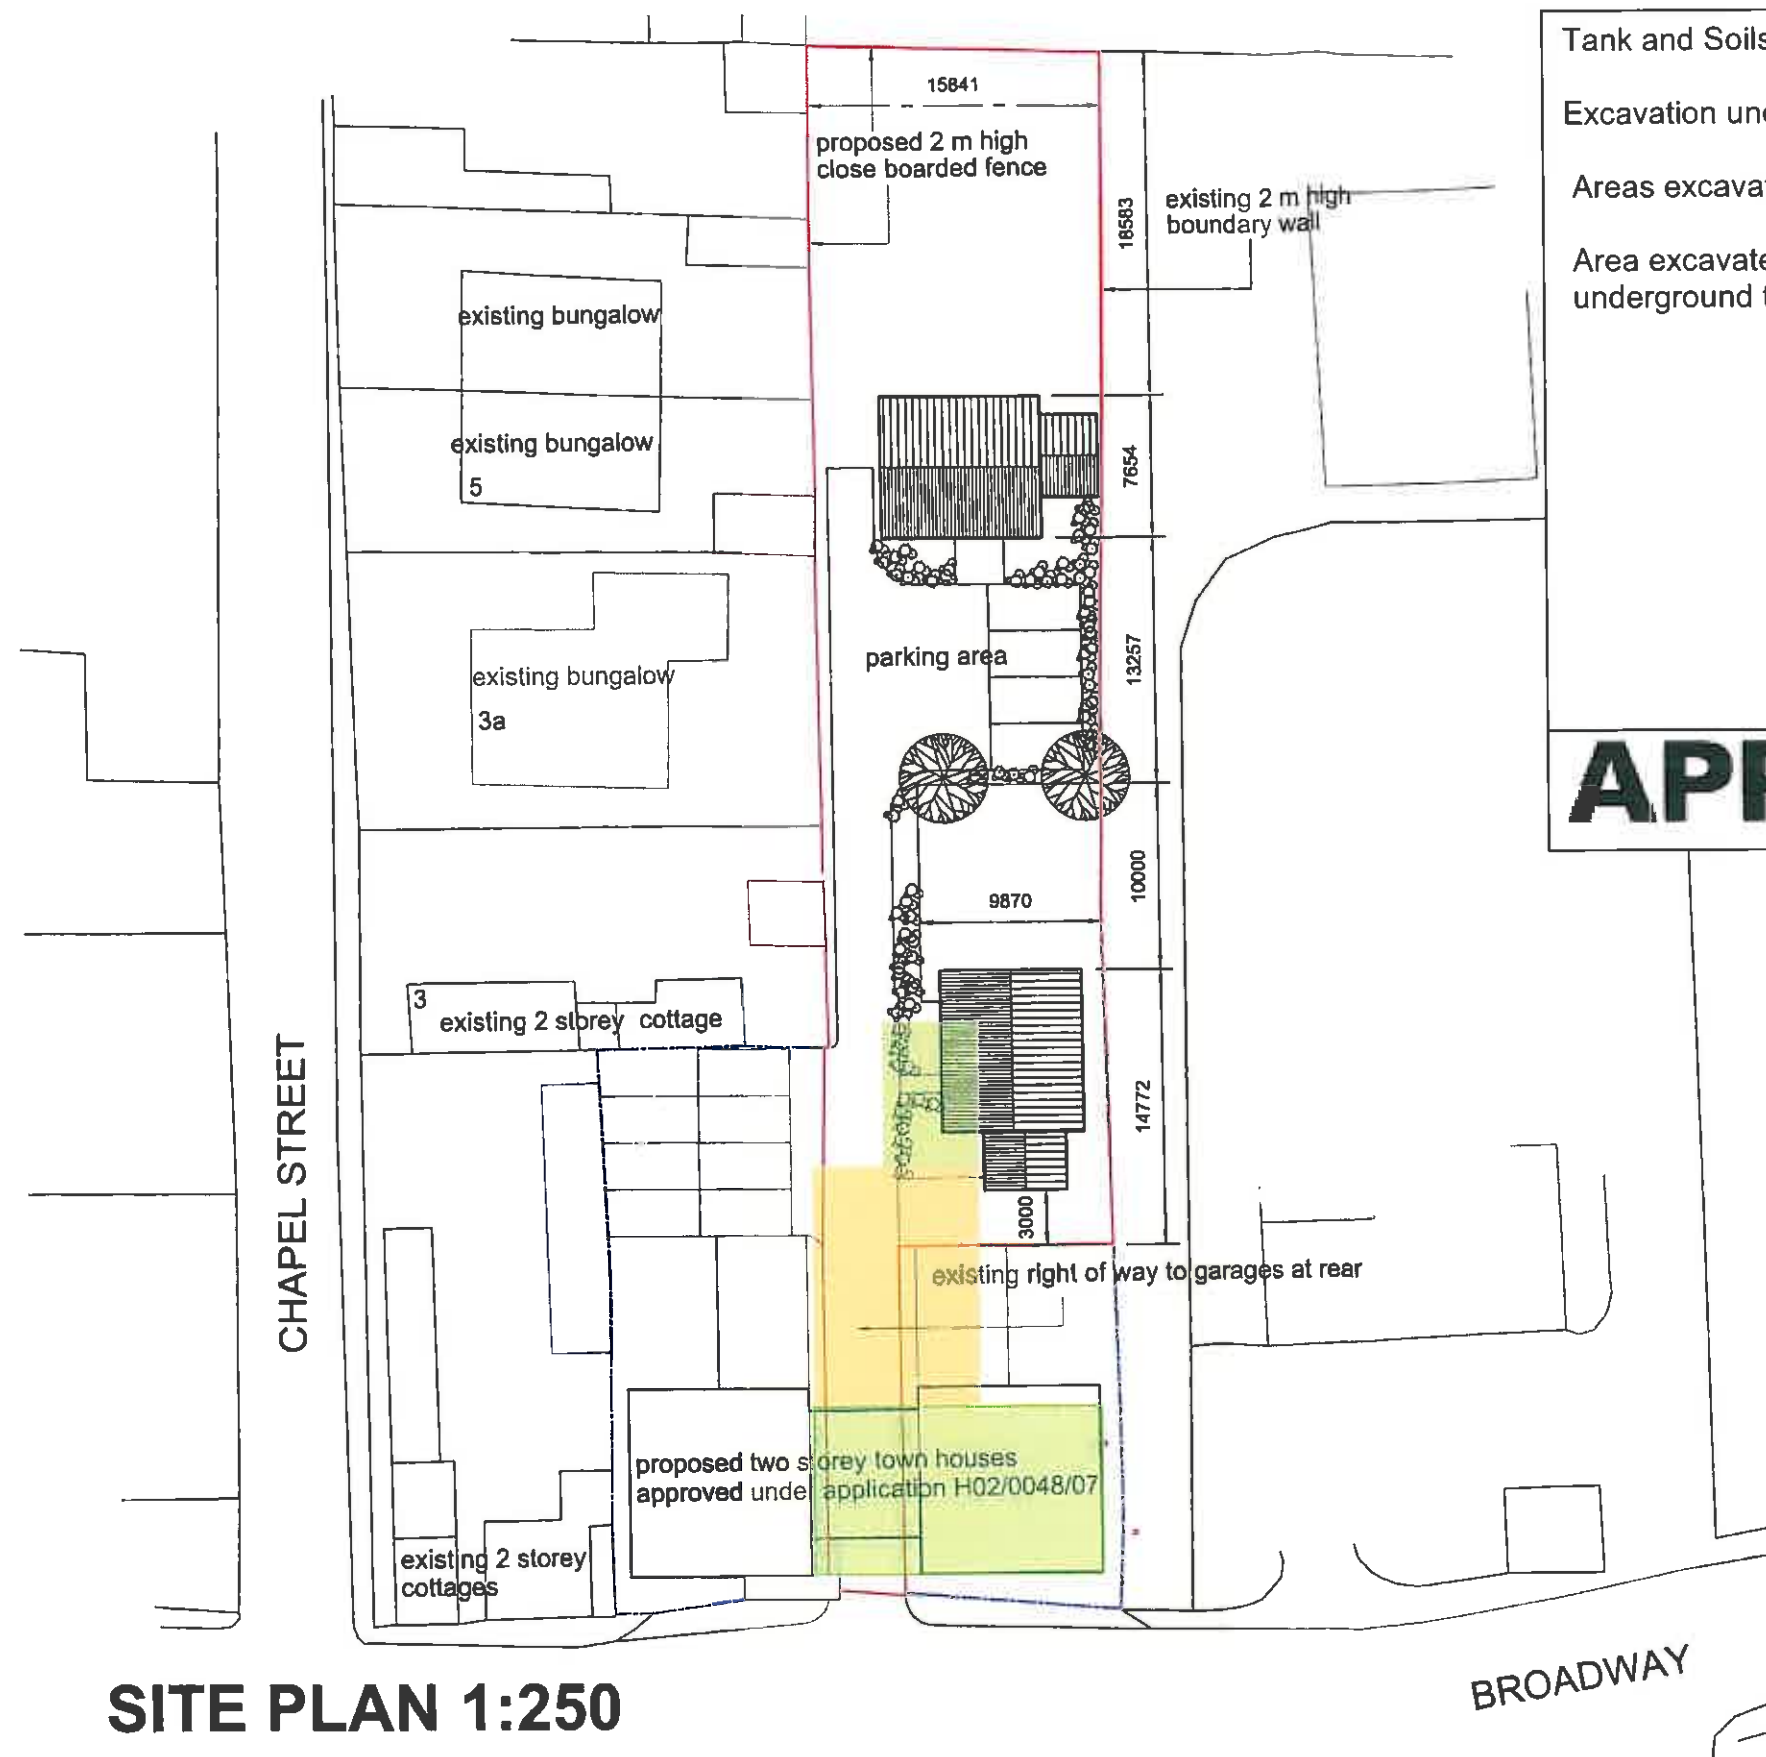
## Tank and Soils Excavation Plan - 2003

Excavation undertake under supervision of JP Chick & Partners

Area excavated to locate possible further underground tanks and soils replaced

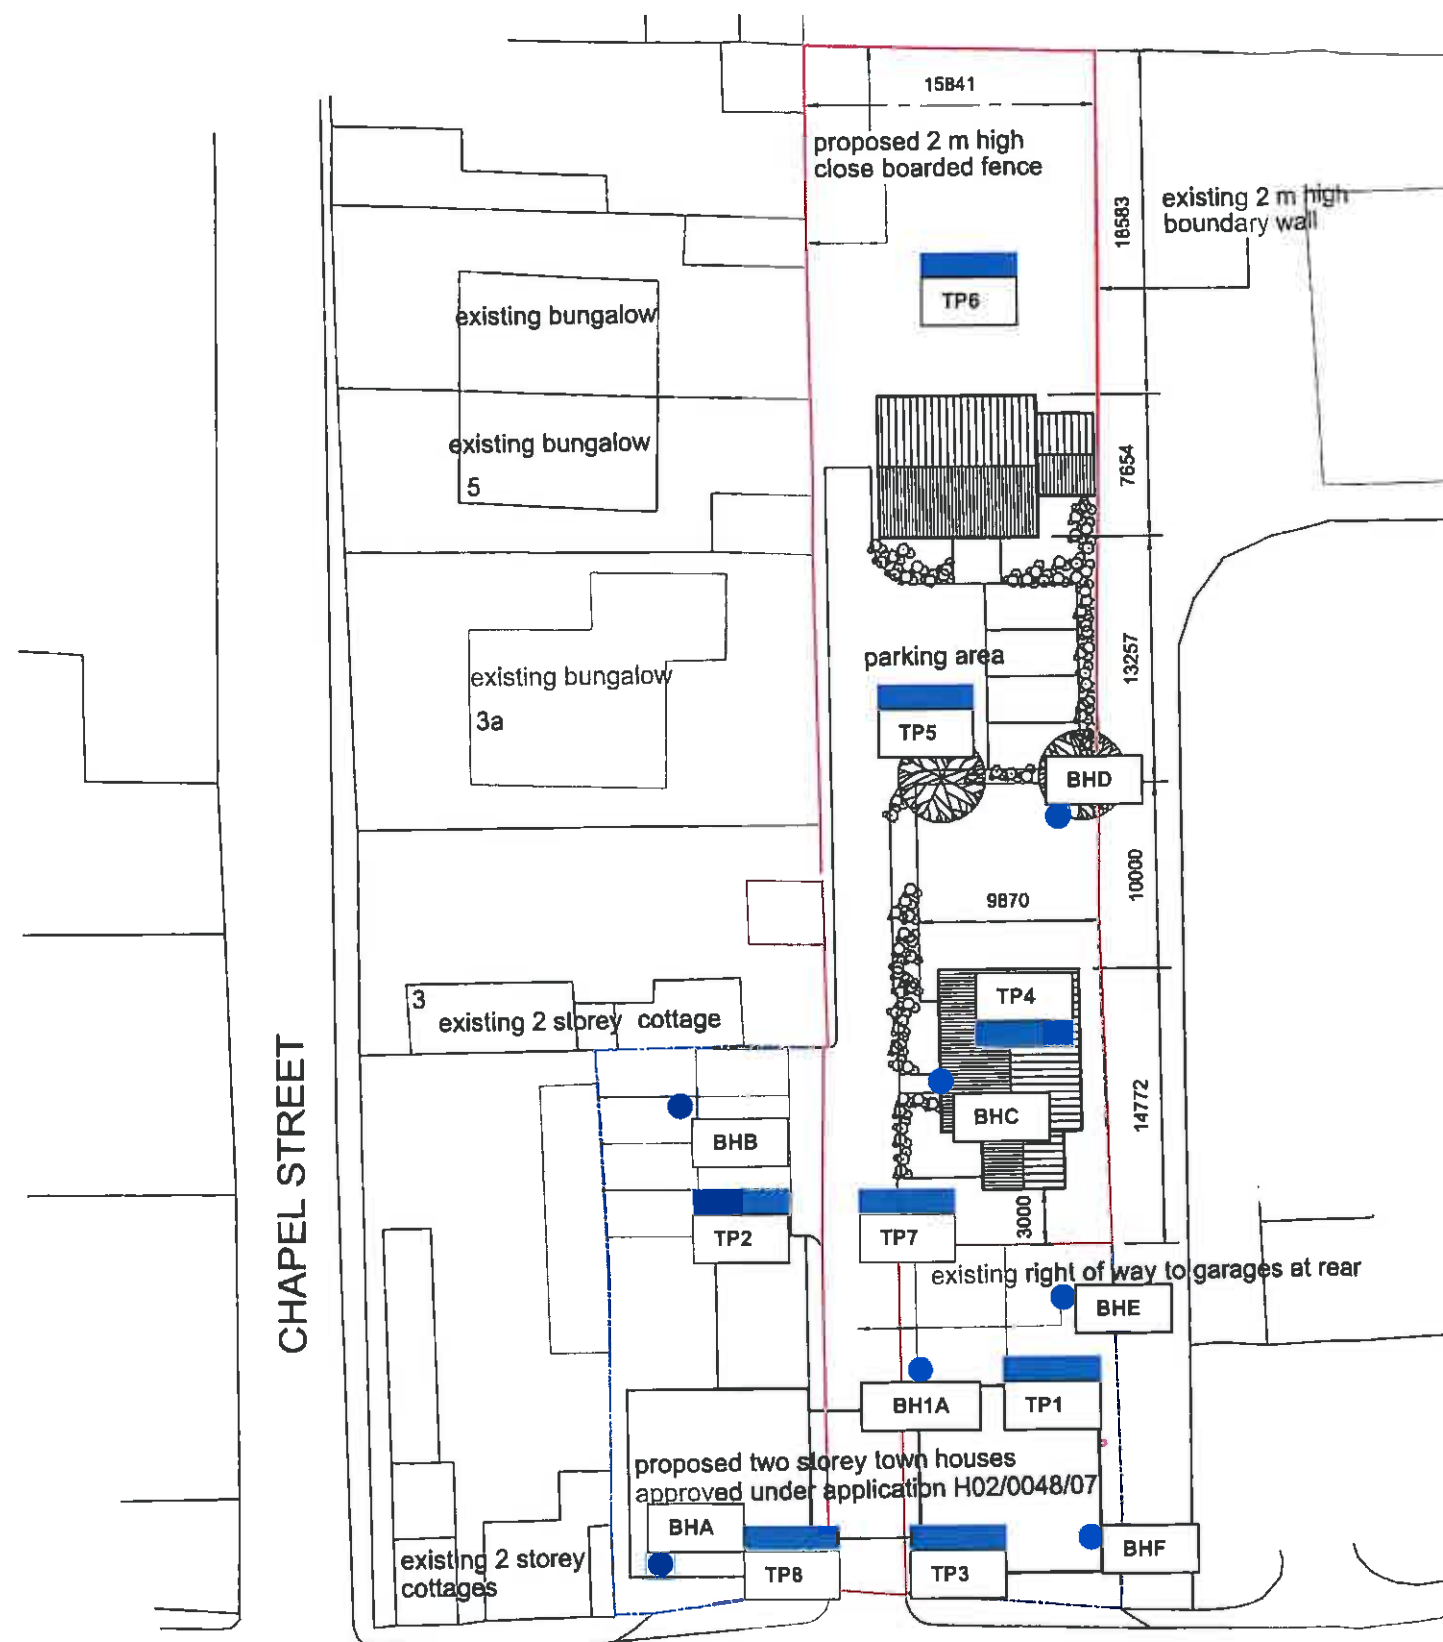
## Summary Exploratory Hole Location Plan – 2008

The Trial Pits and BH 1A were undertaken to assist with foundation design and therefore contamination testing was not undertaken upon the soil samples. Strong hydrocarbon odours were encountered within the Made Ground and underlying gravel deposits from depths of between 0.05m bgl and 1.70m bgl and to depths of between 0.90m bgl and 4.60m bgl, within Borehole 1A and Trial Pits TP1, 3, 4, 5, 7 and 8.

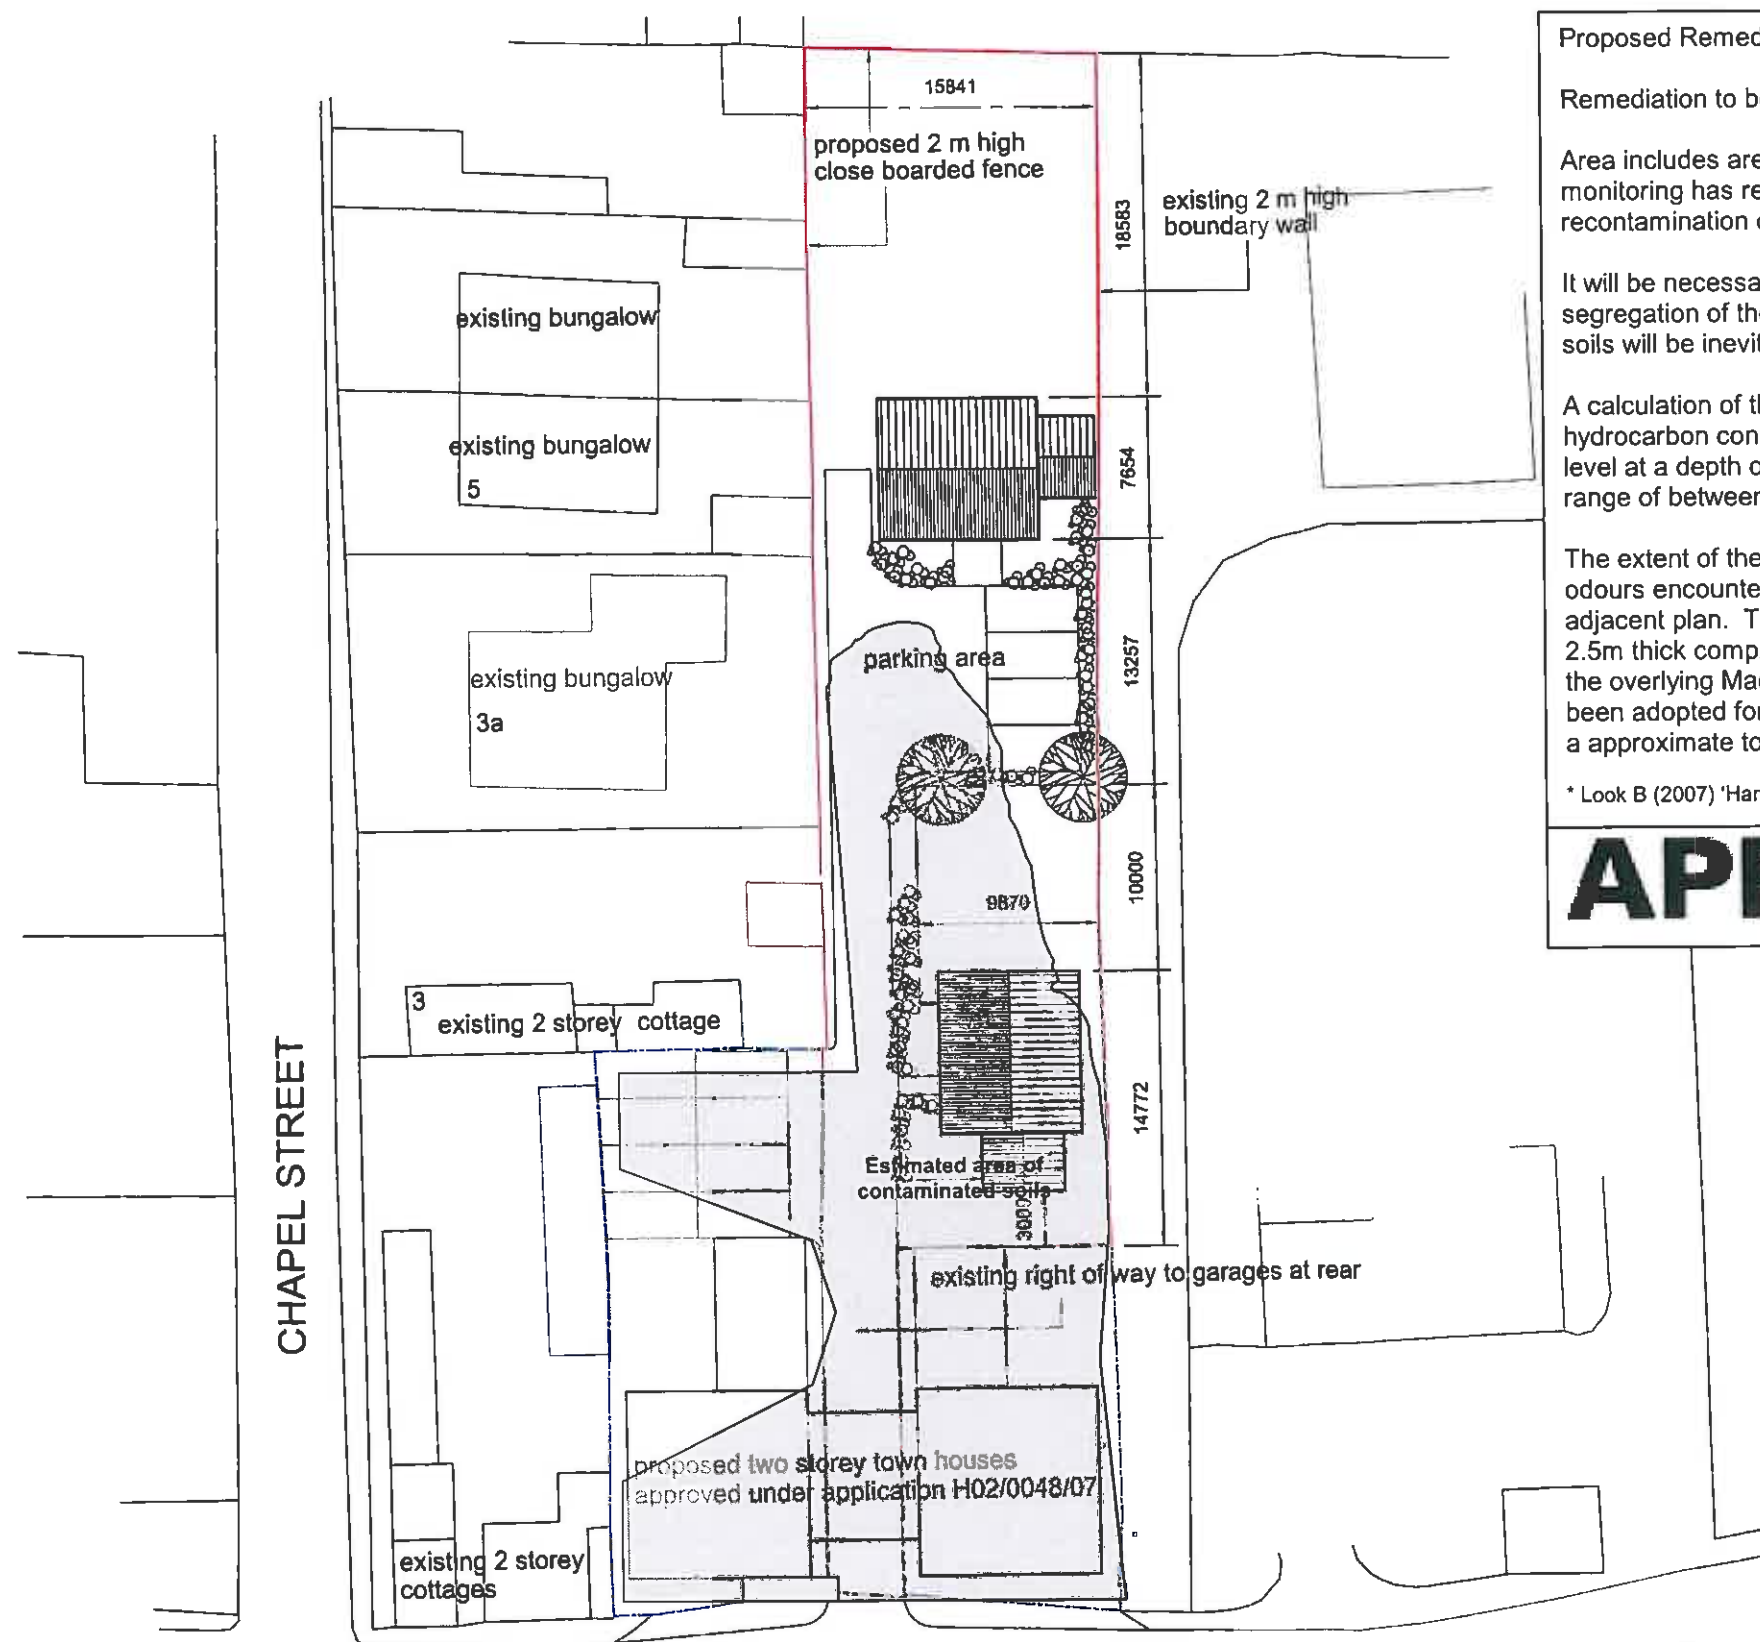
## Proposed Remediation Areas Plan - 2008

Remediation to be undertaken by Celtic Technologies Limited.
