**NEVILLE HALL  
FREELANCE ARCHAEOLOGIST & CONSULTANT**

ARCHAEOLOGICAL MONITORING AND RECORDING  
ON LAND TO THE REAR OF  
21, SOUTH STREET,  
CROWLAND, LINCOLNSHIRE.

**National Grid Reference: TF 2401 1012**  
**Site Code: SSCR20**  
**Accession No: LCNCC: 2020.171**  
**Planning Reference: H02-0443-20**

January 2021

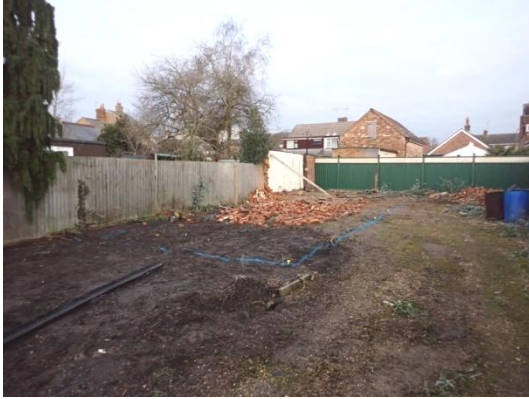
- 7.1 The foundations for the new residential dwelling had already been set out and a former outbuilding of brick on the site had been demolished prior to arrival [**Plate 1**]. The foundation trenches for the new build were excavated under archaeological supervision to varying lengths, to a width of 0.70m and to depths of between 1.10m-1.40m below site levels. [**Plates 3-15 and 17-32**].

**Plate 1:** Pre-groundworks, from the south

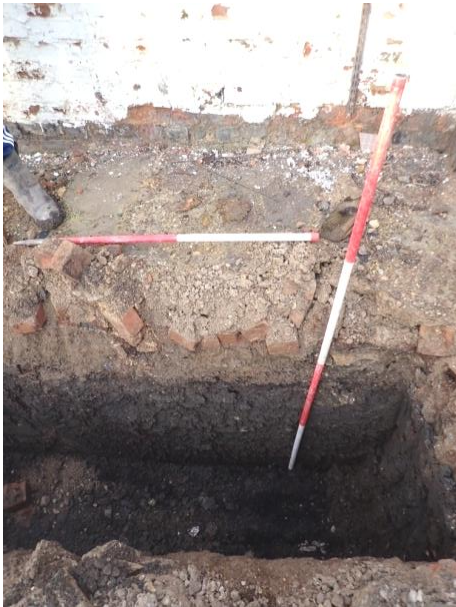
**Plate 2: Representative Section 1,** from the east

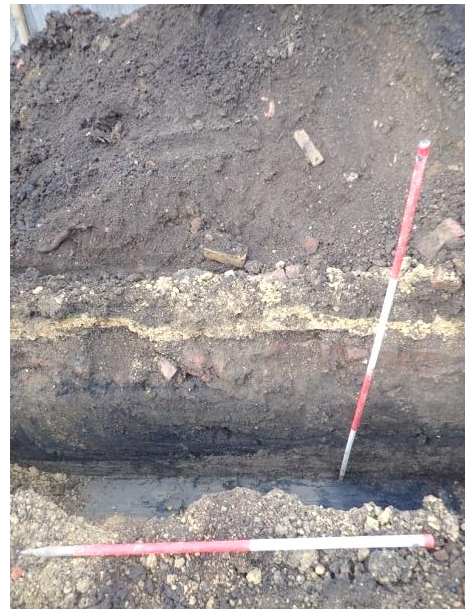
**Plate 16:** Representative Section 2, from the east

- 004.** Natural horizon. Occurs as an outcrop in one of the foundation trenches. Soft, mid orange brown silt with no inclusions. Below **(003)**. Recorded within **Representative 2**. Depth - >0.16m.

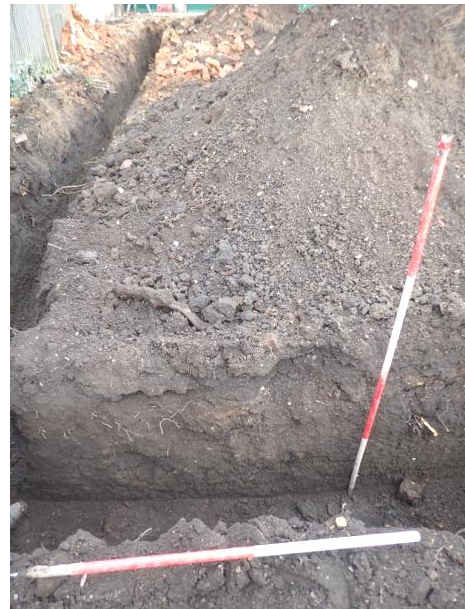
**Plate 33: Representative Section 3,**  
from the south
