## **Verification Report**

### **Land Adjacent 59-61**

Broadway  
Crowland  
Lincolnshire  
PE6 0BH

## **BROADWAY, CROWLAND**

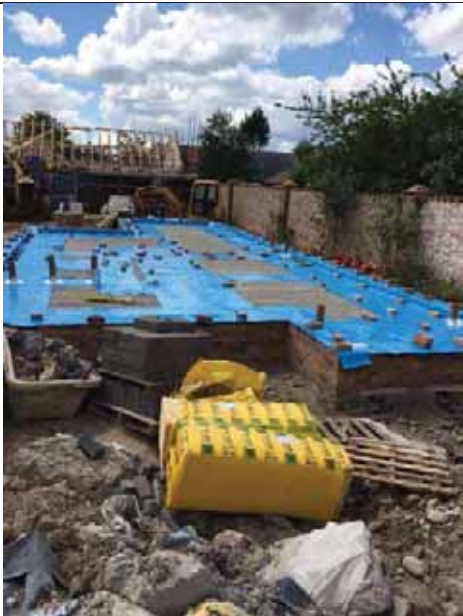
| Photo 1: Image of gas membrane being installed within plot 3 | Photo 2: Image of gas membrane being installed within plot 3 |

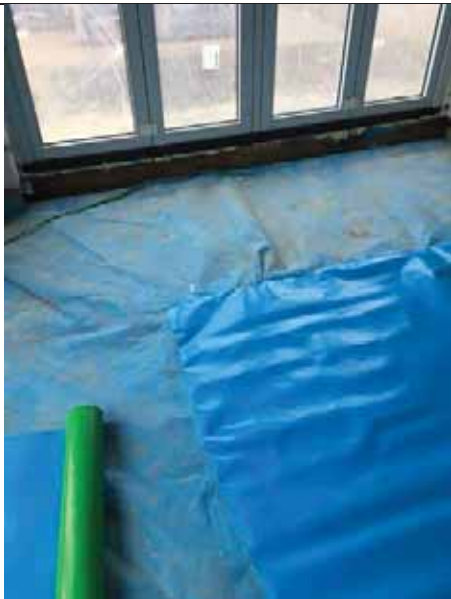
| Photo 3: Image of gas membrane being installed within unknown plot | Photo 4: Image of gas membrane being installed within unknown plot |

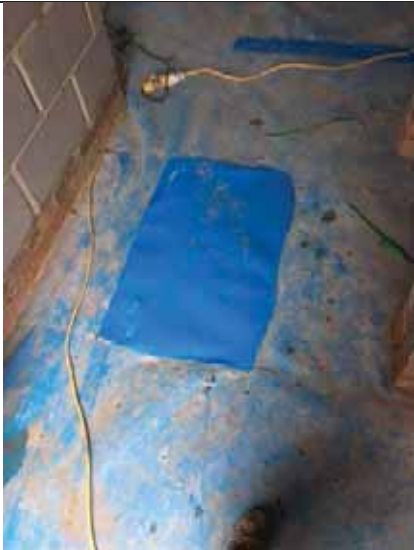
| Photo 5: Image of gas membrane being installed within unknown plot | Photo 6: Image of gas membrane being installed within unknown plot |

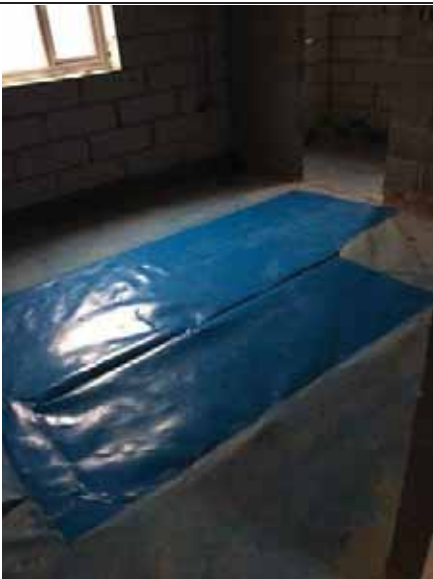
| Photo 7: Image of gas membrane being installed within unknown plot | Photo 8: Image of gas membrane being installed within unknown plot |

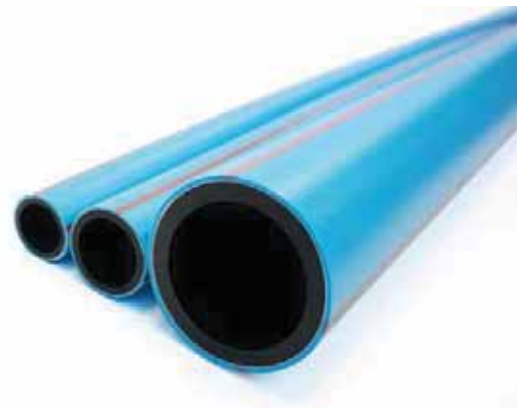
Available in diameters 25 to 63 mm, our Puriton® service pipe is manufactured from a black PE80 core, protected by an aluminium barrier layer and a light blue PE80 external skin with brown stripes.

Available in coils and in straight lengths for the 63 mm pipe, our Puriton® service pipe is quick and easy to join without surface preparation, using our range of cutting edge mechanical fittings and Redman™ fittings for our 63 mm pipe.

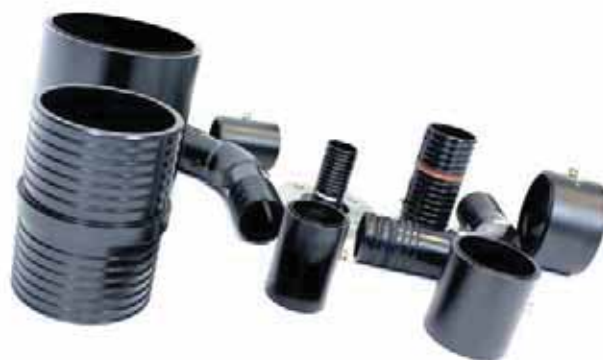
Simple and quick to install with little pipe preparation, the Redman™ joint is made by pressurising the outer shell of the fitting using a dedicated hydraulic pump. Once made, our Redman™ fitting provides a 'fit and forget' end-load-bearing joint. Available in diameters 63 mm to 180 mm, the fittings are colour coded black for Puriton® pipe\*. They are supplied ready to install with the appropriate number of outer shells and inserts, offering full corrosion resistance and barrier protection against contamination to your potable water.

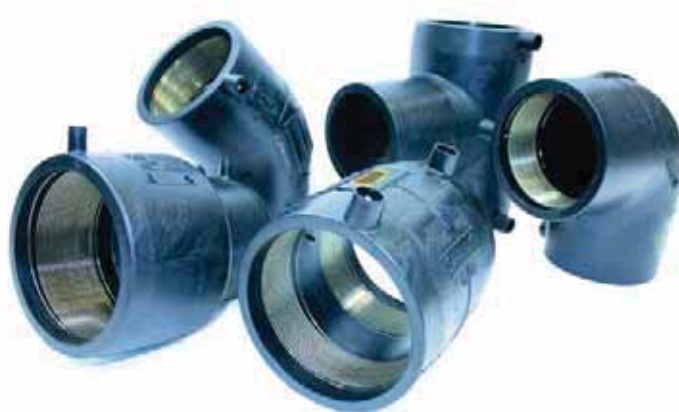
Available in diameters 90mm to 180mm, our range of Puriton® electrofusion fittings are manufactured from high strength black PE100. The fittings are welded in a single fusion operation using a 40V electrofusion control unit and when correctly installed in accordance with Radius Systems' guidance, there is no requirement to post-wrap the joint.

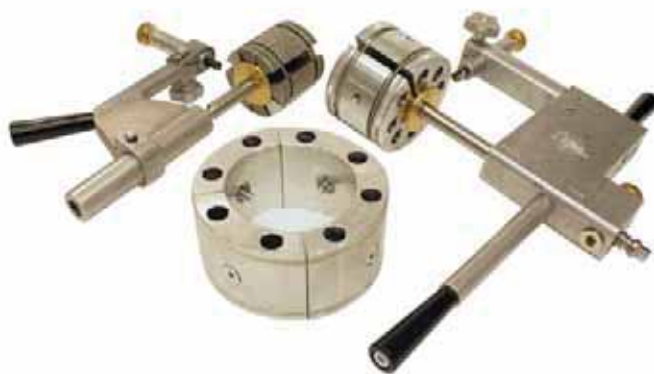
When joining Puriton® pipe in diameters 90 to 180 mm using electrofusion or butt-fusion joining techniques, pipe surface preparation is mandatory. Dedicated equipment has been designed to locally remove the outer polyethylene and aluminium barrier layers. This equipment is available for sale or hire from the suppliers below:

Rotary pipe surface preparation tools

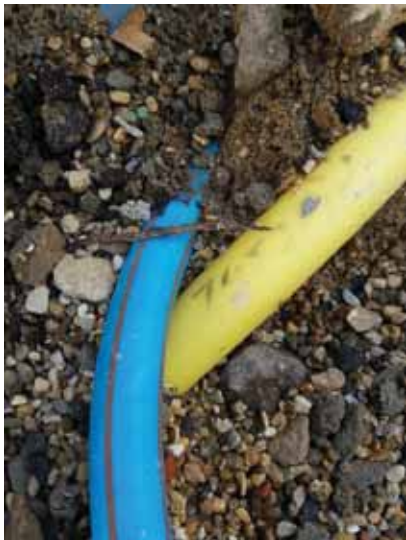
| Photo 1:Image displaying the water barrier pipe has been installed below ground level | Photo 2:Image of the water barrier pipe |

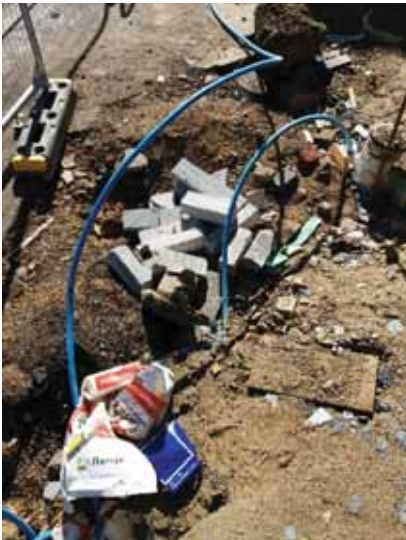
| Photo 3:Image of water barrier pipe outside the front of Plot 2 | Photo 4: Image of water barrier pipe along the front of plot 1 & plot 2 |

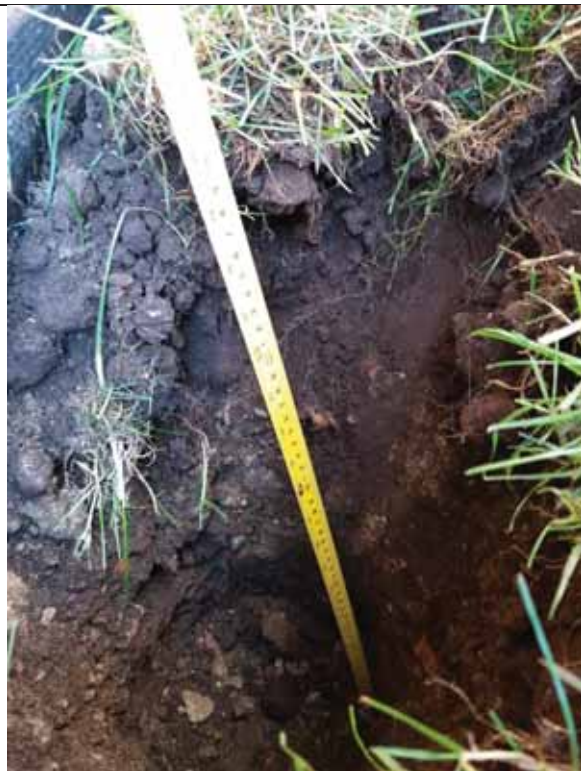
Photo 1: Image of the measured thickness of topsoil imported to Plot 4

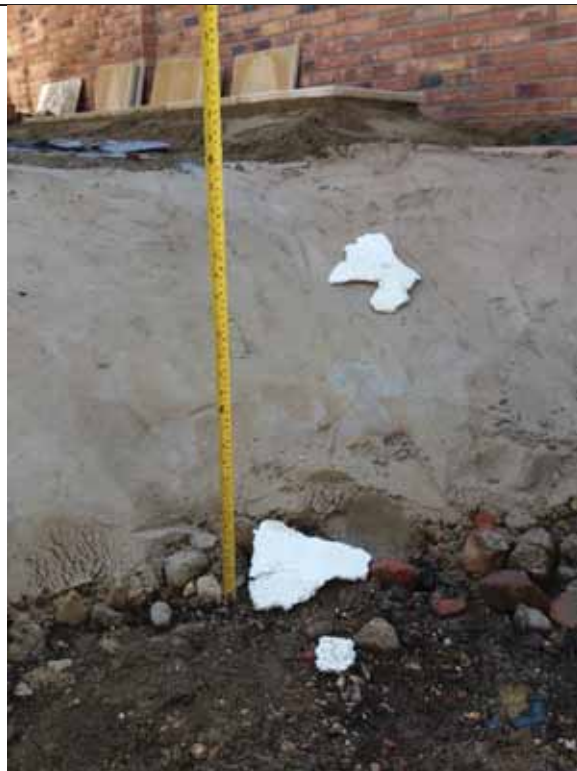
Photo 2: Image of concrete lined hole prepared to receive soil for Plot 1

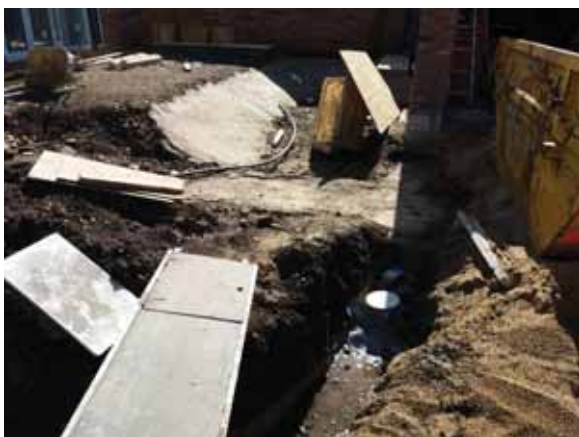
Photo 3: Image of plot one in the background and Plot 2 in the foreground

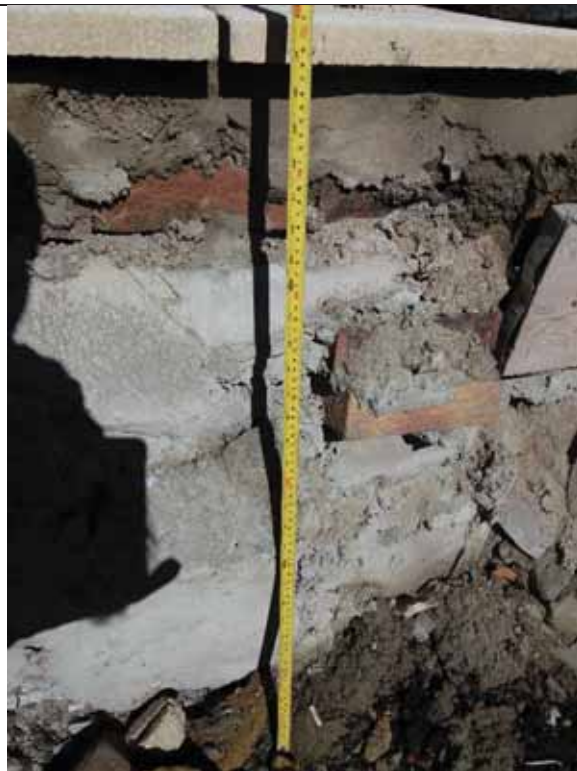
Photo 4: Image indicating the depth of concrete lined hold ready to receive imported topsoil in Plot 3

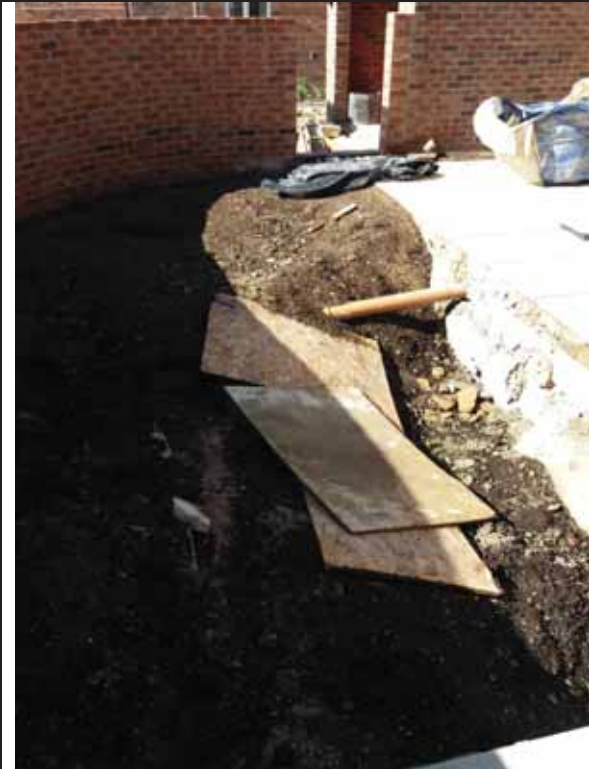
Photo 5:Image of plot 3

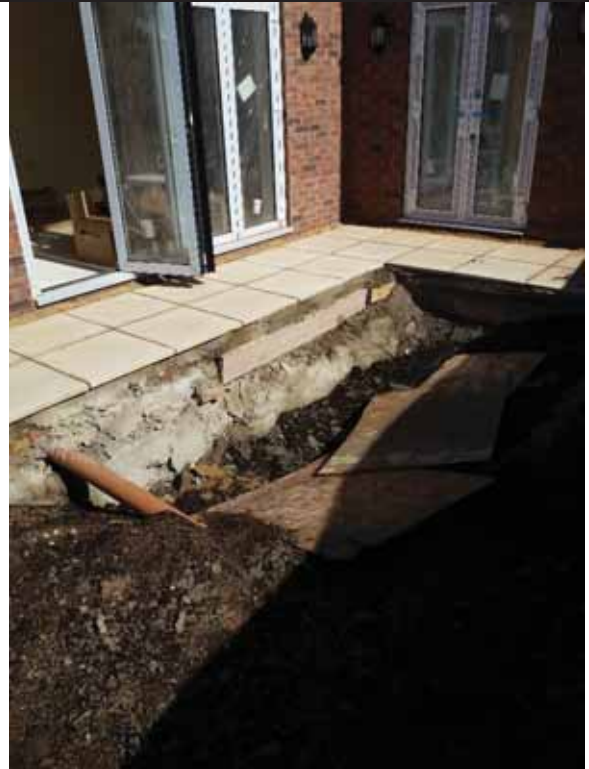
Photo 6:Image of plot 3 from the southern boundary

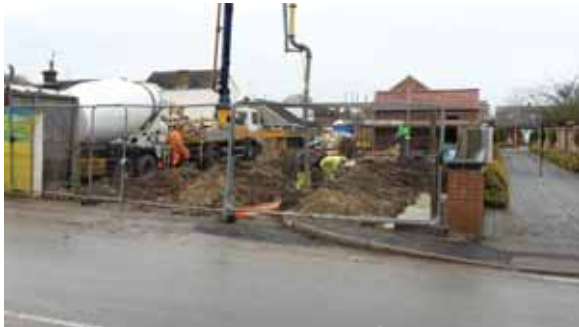
| <p>Photo 1: Image of the site taken from the adjacent road during installation of concrete footings</p> | <p>Photo 2: Image of the ground encountered during the footing excavation in plots 1,2 &amp; 3</p> |

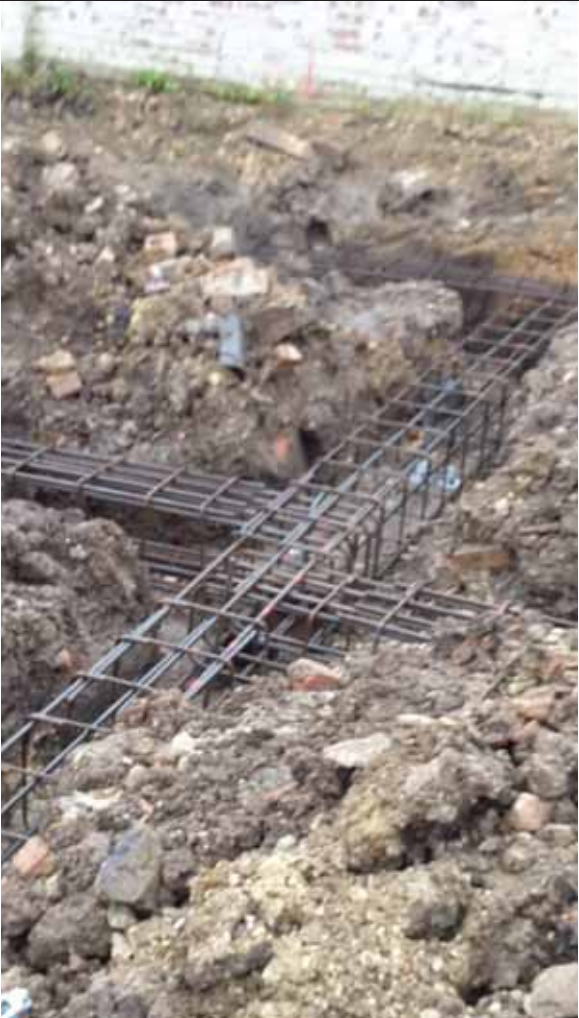
| <p>Photo 3: Image of the ground encountered during the footing excavation in plots 1,2 &amp; 3</p> | <p>Photo 4: Image of the ground encountered during the footing excavation in plots 1,2 &amp; 3</p> |

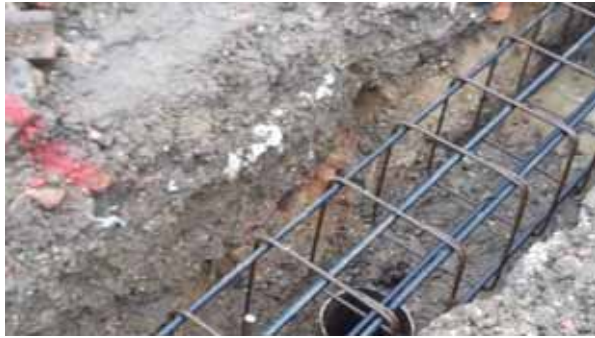
Photo 5: Image of the ground encountered during the footing excavation in plots 1, 2 & 3

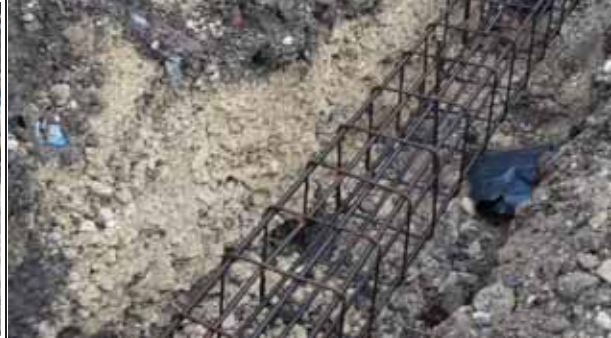
Photo 6: Image of the ground encountered during the footing excavation in plots 1, 2 & 3
