# Site Investigation Report

144858.2.TSI

Auger were commissioned by Admiral (Subs) to undertake a site investigation within the area of concern (AOC) at the property.

# Trial Hole Log No.1

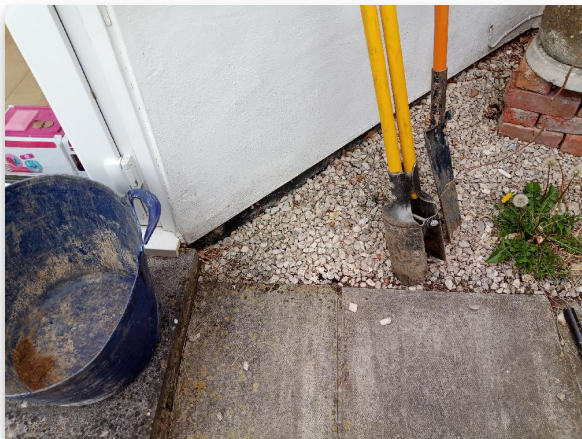
Fig 1.1: Trial Hole 1 Location

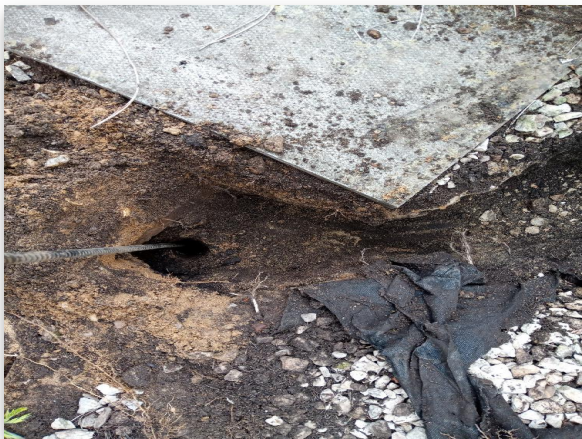
Fig 1.2: Trial Hole 1 Footing
