## **Phase I Geo-Environmental Desk Study**

Proposed Fenland Centre  
Carrington Drove  
Crowland  
Peterborough  
PE6 0BZ

**EPS Project Reference:** UK15.1838

**Date Issued:** 20<sup>th</sup> April 2015

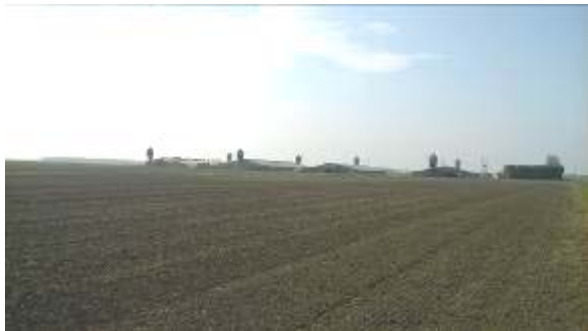
| <p>Photo 1: Photograph looking south across the entire site (agricultural field/disused poultry sheds)</p> | <p>Photo 2: View south east along the southern boundary. Note above ground LPG tanks</p> |

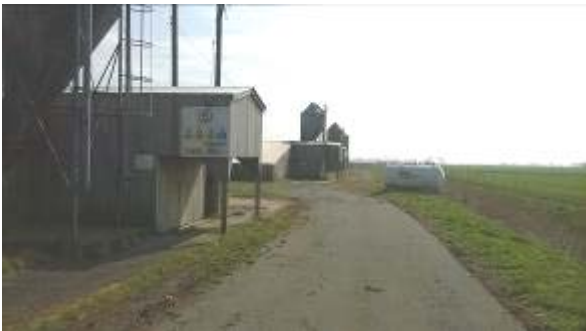
- A set of three above ground LPG calor gas tanks were identified located to the south of the poultry sheds. These tanks were noted to be in good condition, located on a concrete pad and presumed to be disused at the time of inspection. Additionally, LPG is stored under high pressure and any discharge of liquefied gas would be expected to vaporise upon release, therefore not posing any risk to the site sub-surface

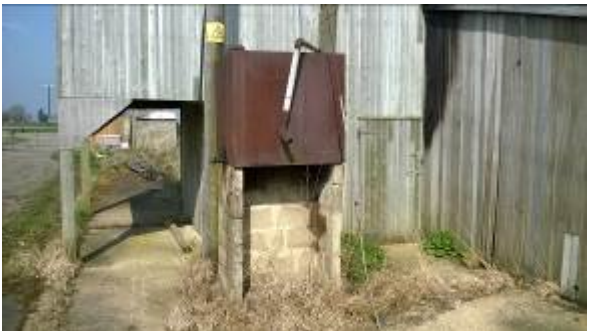
- A single skinned above ground fuel tank was identified at the site. Its historical contents remain unknown however, hydrocarbon staining and odour was noted around the tanks base and across the breeze block stilt / concrete surface at ground level. The concrete at the base of the tank was noted to be in good condition with little to no weathering, and so vertical migration of any fuel spillages through the hardstanding and into underlying soils is anticipated to be minimal. Additionally, the site is not reported to be within an environmentally sensitive location, with local geology not identified for groundwater resource potential. Finally, any potential minor fuel spillages that may have infiltrated into underlying soils, are anticipated to be capped beneath proposed building footprint / hardstanding surface and so no risk of exposure to future site users has been recognised.

| <p>Photo 3: A collapsed feed silo</p> | <p>Photo 4: Above ground fuel storage tank identified towards the south west of the poultry sheds</p> |

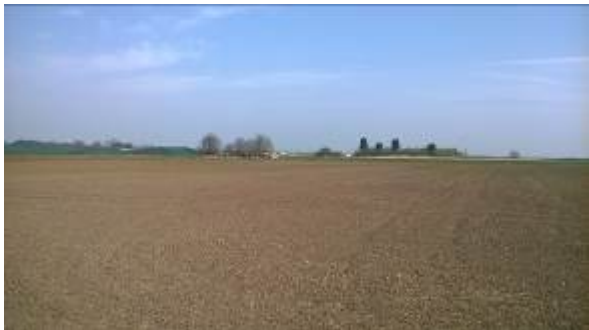
| <p>Photo 5: Looking north across the ploughed agricultural field towards the small shed</p> | <p>Photo 6: Dilapidated shed at the north eastern boundary. Asbestos cement roofing and other suspected asbestos items are located in the area</p> |
