## SITE INVESTIGATION REPORT

LAND OFF HARRINGTON DRIVE

CROWLAND

Report Reference C15350

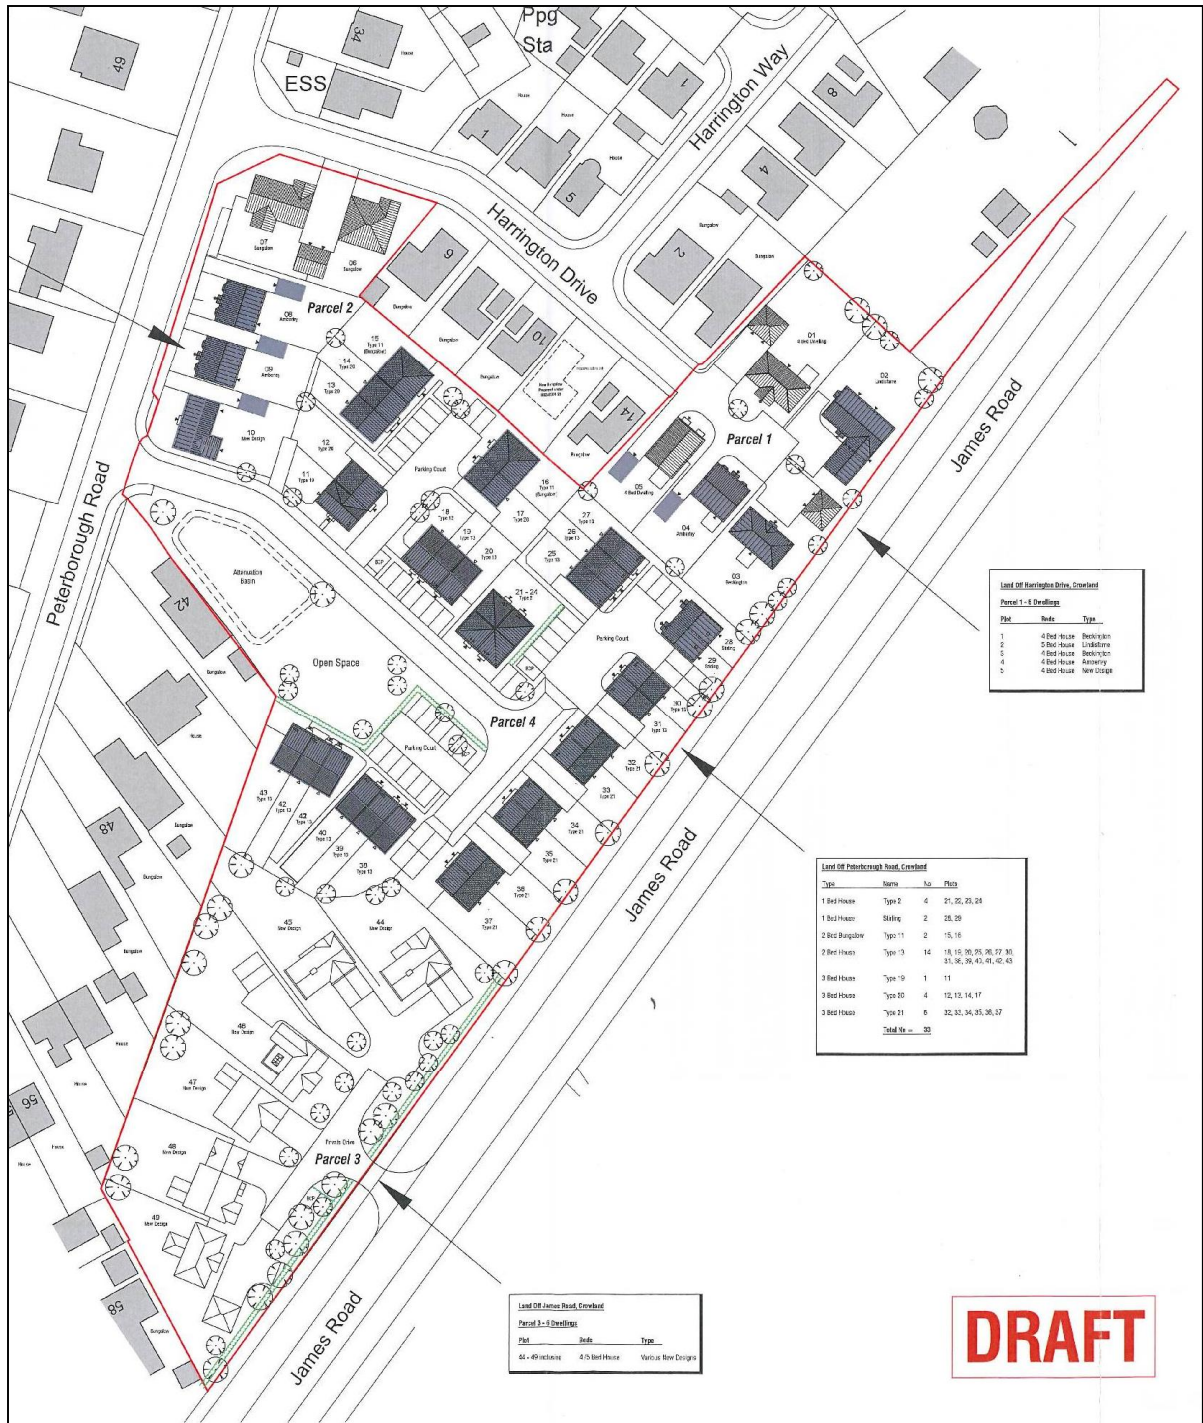
# Proposed Development Plan

Based on plan provided by client. With the permission of the Controller of Her Majesty's Stationery Office, © Crown Copyright. All rights reserved. Licence number AL100005523
