**Site Investigation**

**YEX1928 – 3 Maltings Lane**

**April 22**

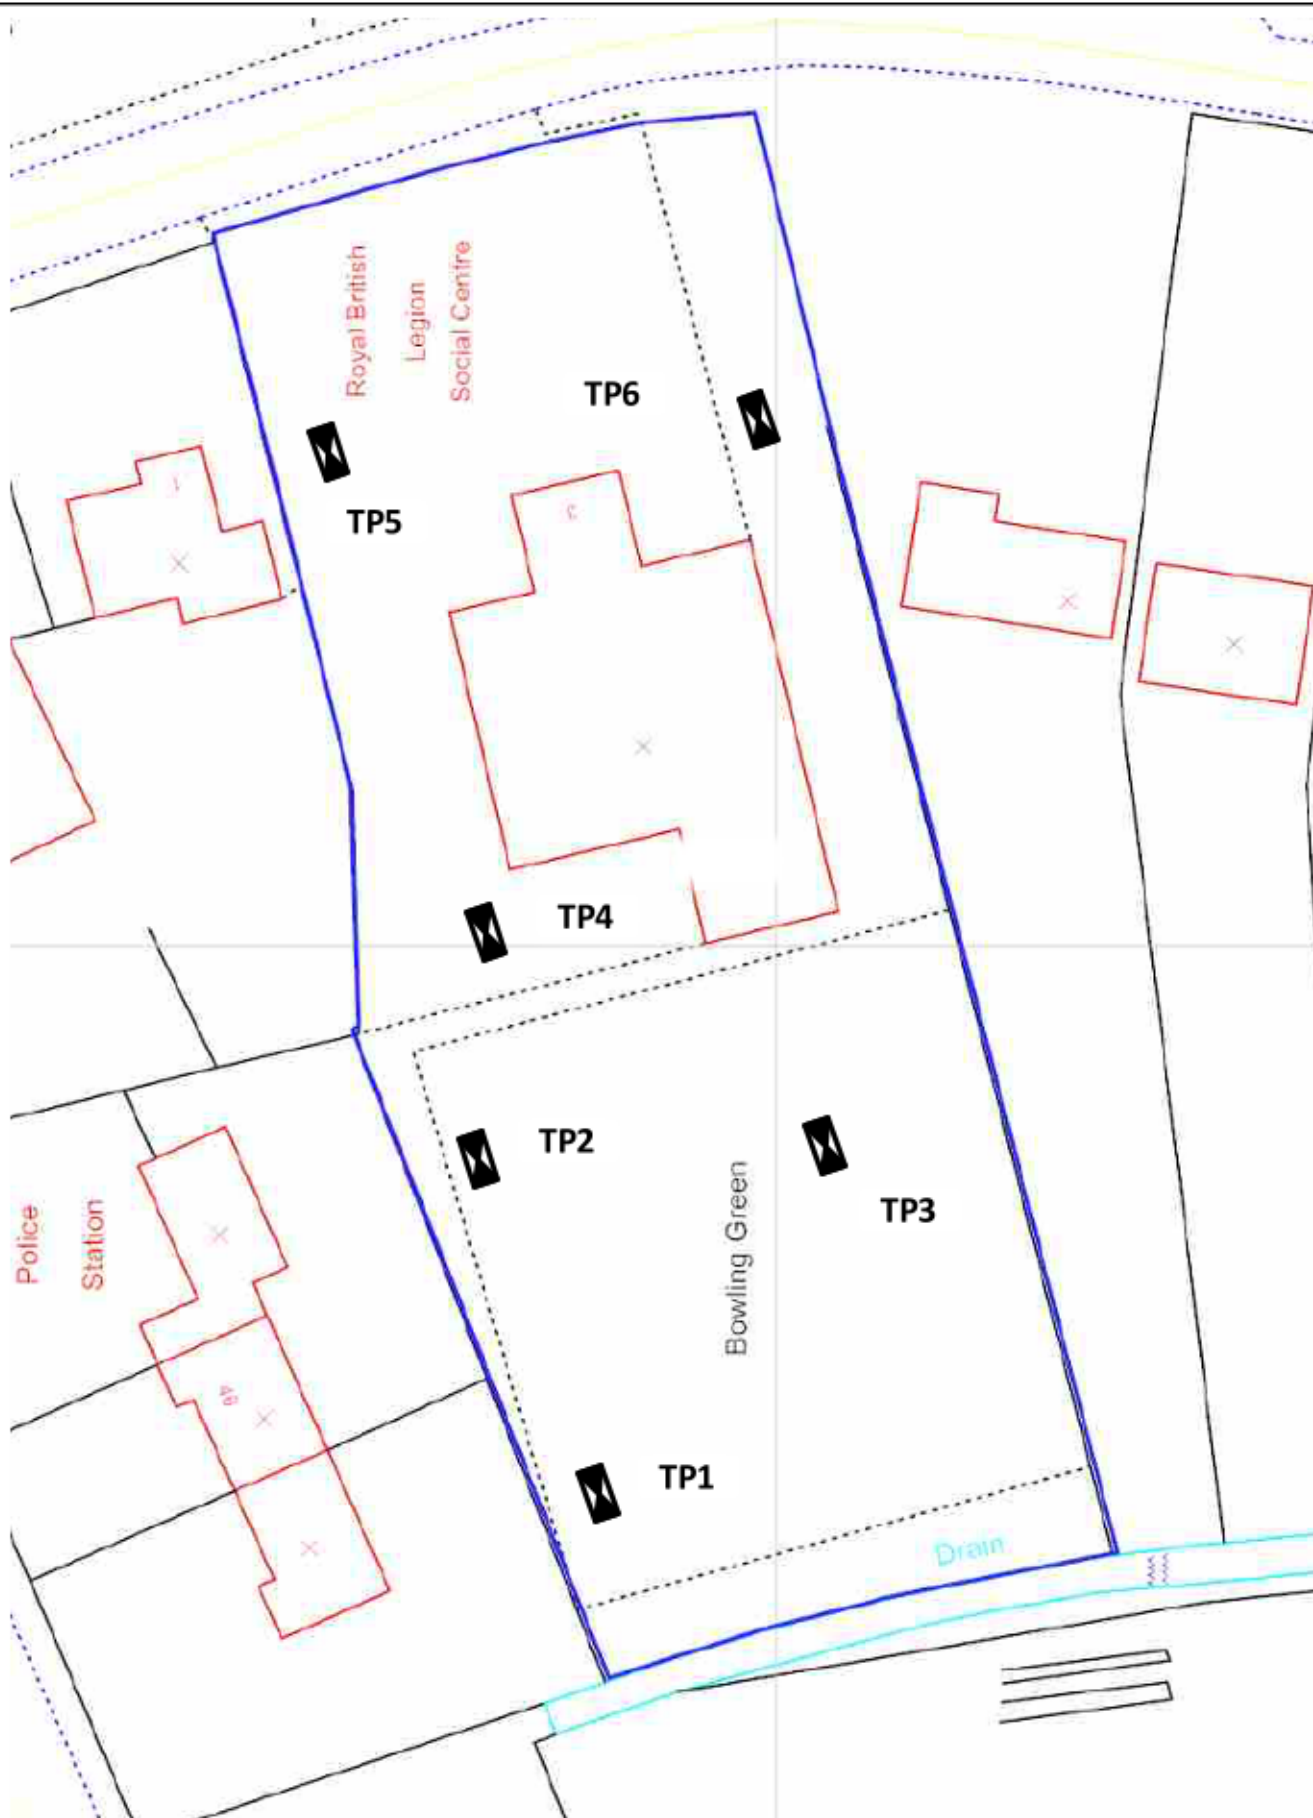
Title: **Investigation Location Plan**

Excavation of six (6no.) machine dug trial pits (TP01 to TP06) were completed to a maximum depth of 2.00mbgl. The locations of exploratory positions were selected relative to the historic land use and current proposed redevelopment plans for the site whilst providing a broad coverage of the site as feasibly as possible.

The positions of exploratory holes in relation to the existing site layout can be reviewed within Appendix A.
