### **PRELIMINARY ECOLOGICAL APPRAISAL**

**THE RED COW, HIGH STREET, DONINGTON, LINCOLNSHIRE.  
PE11 4YF**

**Prepared by: Emma Parnwell MSc BA (Hons)  
On behalf of: Swann Edwards**

**FEBRUARY 2015**

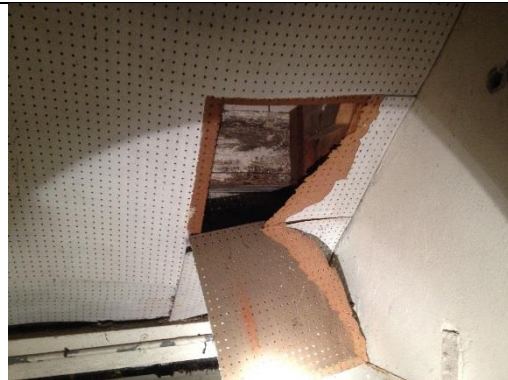
Basement/Cellar	<p>Divided into 2 sections. 1 part only accessible through a hole in the external wall. No hibernation potential due to exposure to elements.</p> <p>The larger part is accessible through the most southern stable. This is more enclosed than the other part, there are some holes in the ceiling plaster which create holes between ballroom and this space.</p>	1 bat dropping – no other evidence found: likely result of exploratory bat (TN3).	<p><b>N</b></p> <p><b>L</b></p>
Ground Floor	<p>The ground floor toilets are within a very derelict structure. Half of the roof is completely missing. The remaining pan tiles are heavily waterlogged and broken. A small open hatch (H4) was accessed over the toilet area. Very small void with a wall of cobwebs just inside the hatch. <b>A small remnant birds' nest in doorframe (characteristic of wren).</b></p>	Overall there is a general lack of roosting features, with no evidence found.	<b>N</b>

Structure 1- Basement

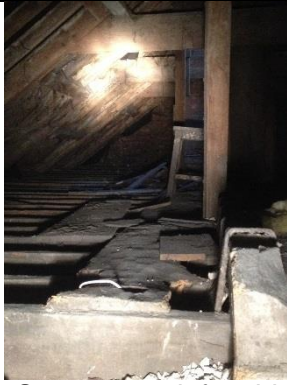
Structure 1- loft void

Static detectors should also be placed in the areas that were inaccessible during the survey including two loft voids within Structure 1, the loft void of Structure 4, and in the ground floor area of Stable 1. These should be supplemented by a minimum of one dusk emergence survey and one dawn re-entry survey to be undertaken between the months of May-August (all surveys to be spread out during these months), in accordance with BCT's Good Practice Guidelines (Collins, 2016).

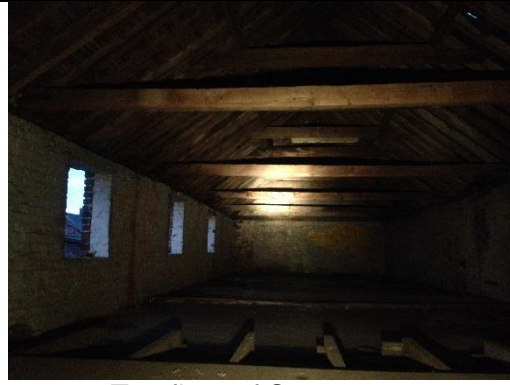
Stable 6	Medium sized, roof open and ceiling mostly collapsed.		
Stable 7	Medium sized, no ceiling, holes in roof and no under felting of roof. Ivy growth inside.		
First Floor	Only able to access area around the stairs when on upper level of stables due to unsafe floor. Open windows on western side and some holes in roof on eastern side. Lathe and plaster ceiling. Draughty.	No evidence found and lack of roosting features.	<b>N</b>

Top floor of Structure 5

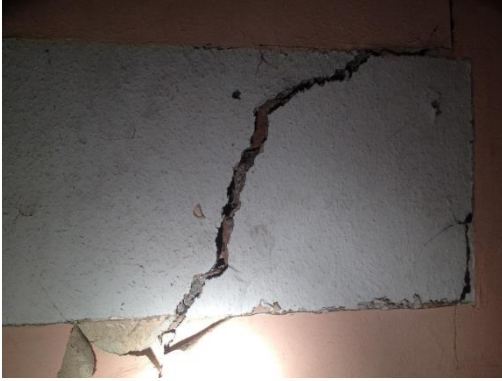
Structure 1- crack in wall on first floor

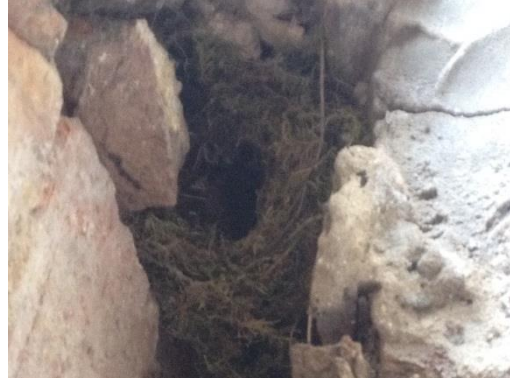
There are opportunities for nesting birds throughout the buildings within the site as most areas are open and accessible by birds. Evidence of previous nesting birds included remnant nests characteristic of small birds such as wren and mud nests within the eaves of the stable block characteristic of swallows. A large number of sparrows were also seen to be present within the ivy cladding on the external stable area, suggesting that birds nest in this vegetation during the nesting season.

Nest in Structure 3

It is recommended that the operational set-up should ideally avoid the bird-breeding season (late February to August inclusive) to avoid damage to nesting species. If this is not practicable then a nesting bird survey should be undertaken by an experienced ecologist prior to site clearance commencement to identify whether active nests are present. If any are found, they should be clearly marked and avoided until after the young have fledged and left the nest.

It is recommended that the new site plans include a provision of alternative nesting habitats in the form of nest boxes (see Appendix Four) and that ivy vegetation should be retained as much as possible. The loss of habitat for nesting swallows cannot be mitigated for by the provision of bird boxes as they require open structures to build their nests within- however as the area of suitable habitat to be lost is relatively small this is assessed as being a minor adverse impact.

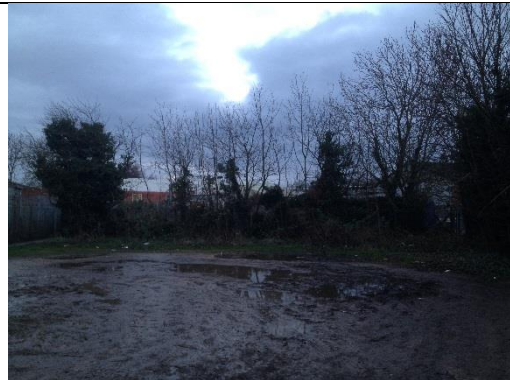
Along the southern boundary of the car park area is a line of semi-mature trees consisting of lime, sycamore and ash. There is some thin-stemmed ivy growth on these trees. Along the eastern boundary is a line of young ash trees.

Tree lined hard standing car park

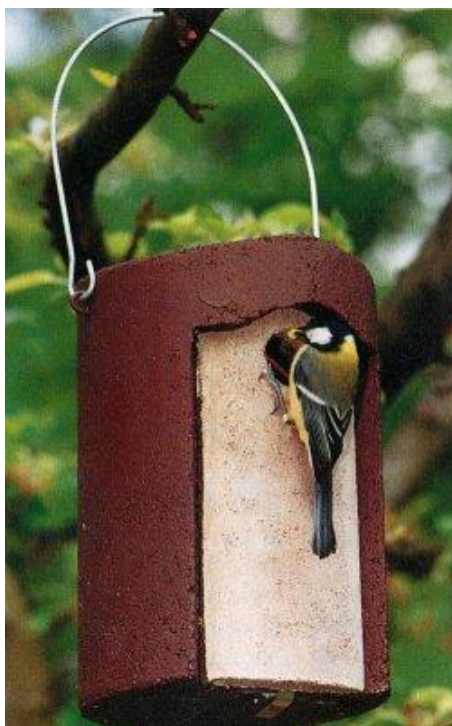
### **Example of Bird Mitigation**

Example of Schwegler 1B Nest Box two with 26 mm holes and two with 32mm holes to cater for a range of species should be provided and installed on posts at a height of 2 metres
