## **Phase 2 – Intrusive Ground Investigation Report**

Proposed Residential Development,  
Maple Way,  
Donington,  
South Holland,  
Lincolnshire

6<sup>th</sup> January 2022

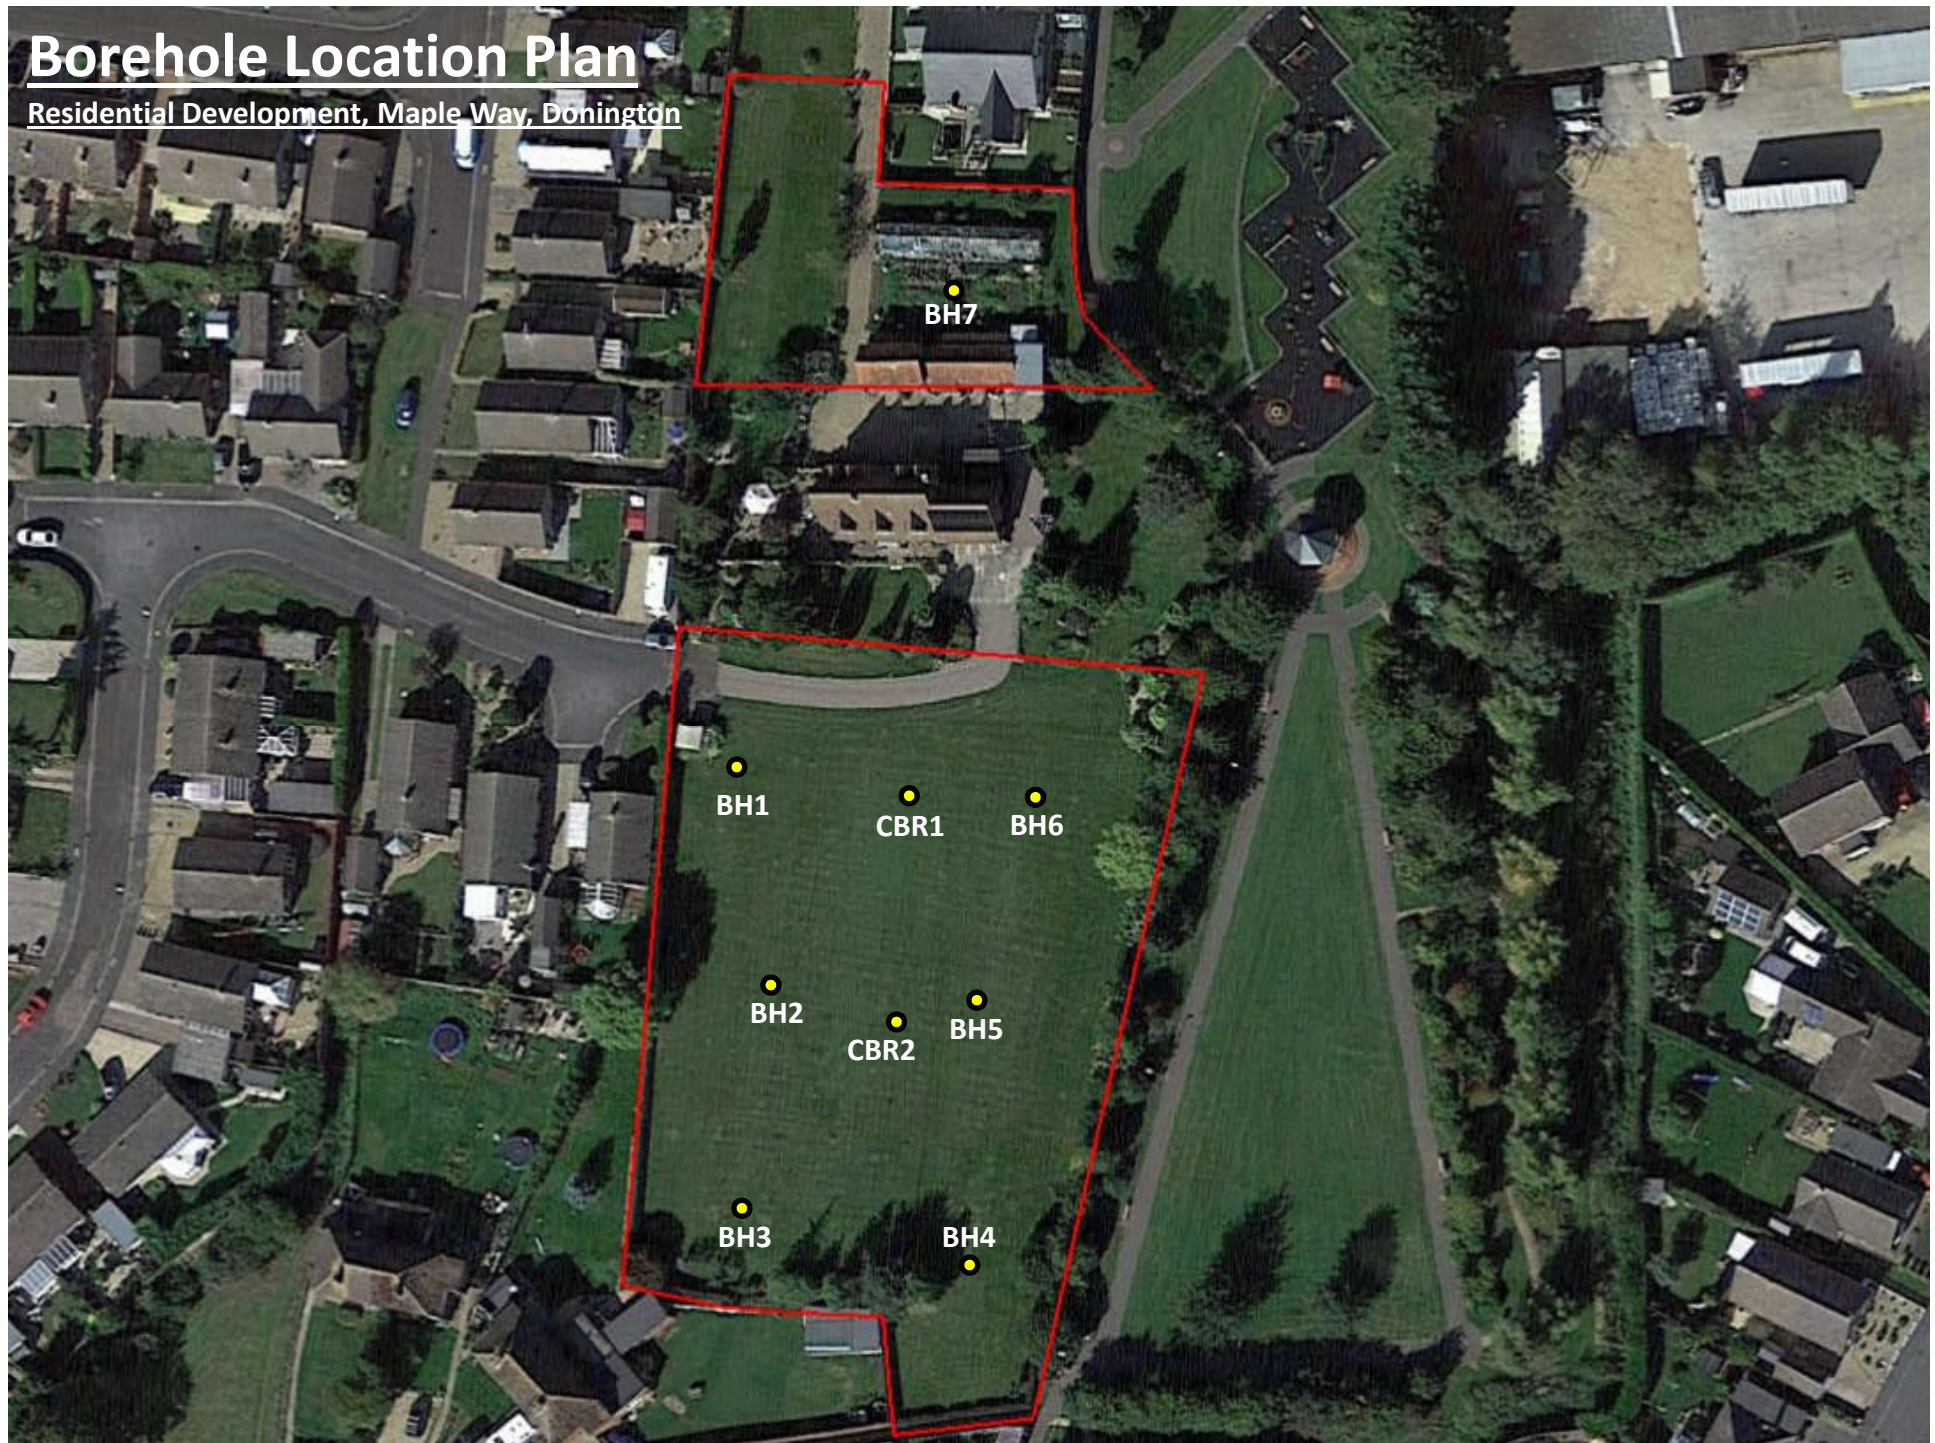
# Borehole Location Plan

The boreholes were located in order to provide an overview of the ground conditions prevailing beneath the site whilst ensuring a number of the borings were located within the areas of the site where private gardens and areas of soft landscaping are envisaged. These landscaped /garden areas are considered to be the most sensitive areas of the development where future users of the site could come into contact with potentially contaminated soils. The locations of the borings have been indicated on the enclosed site layout drawing / aerial photograph and details of the strata encountered have been provided on the enclosed borehole record sheets.
