## CONTAMINATION INVESTIGATION REPORT

DAVE COOK ENGINEERING LIMITED  
QUADRING ROAD  
DONINGTON  
LINCOLNSHIRE

Report Reference C14984

**February 2020**

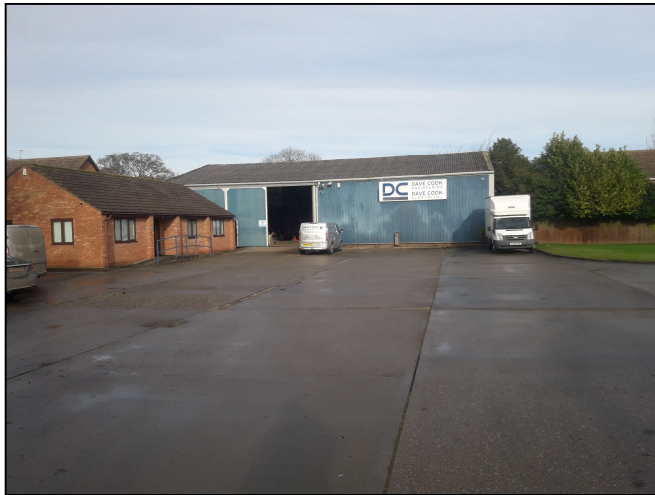
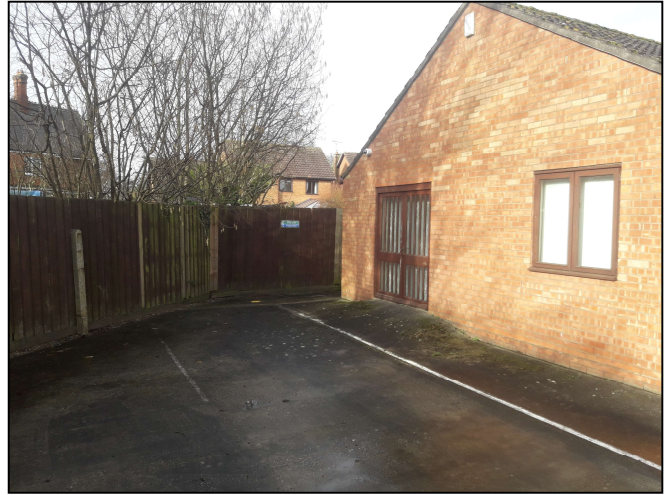
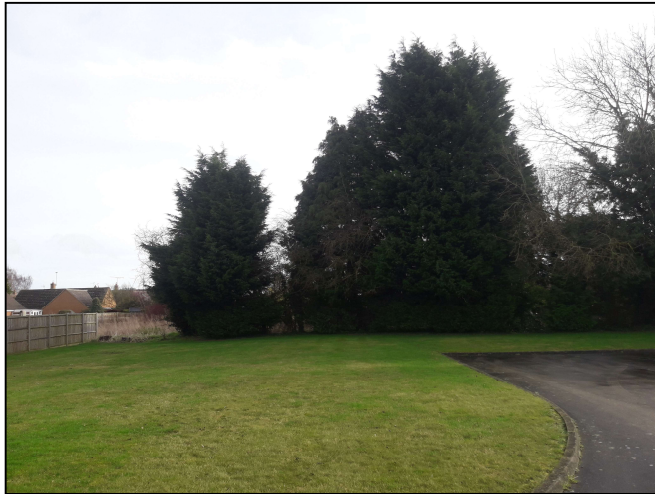
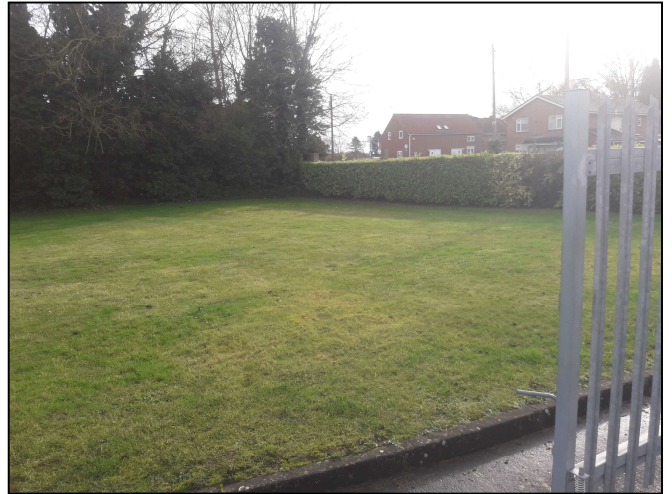
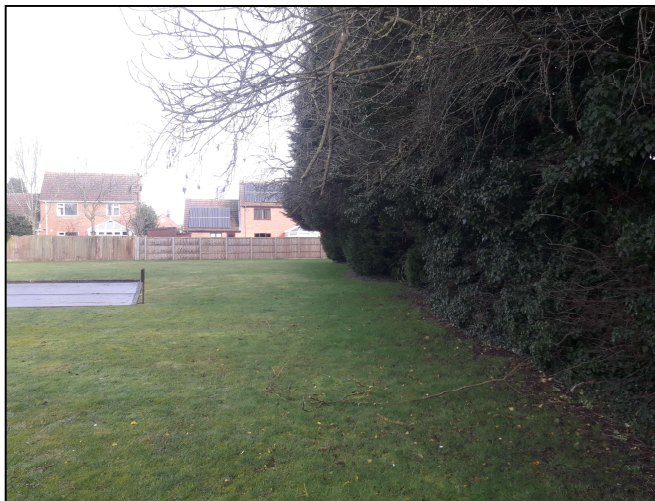
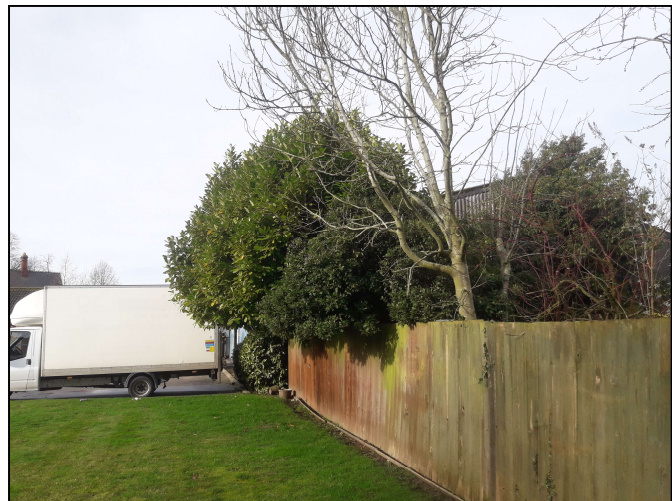
## Site Photographs

At the time of the investigation in January 2020, the site contained the operational offices and yard of Dave Cook Engineering Limited. A large warehouse occupied the northern part of the site, with a single-storey office building in the west, a large concrete surfaced yard centrally on the site, and grassed area to the east. Cement bound asbestos corrugated panels were present along the sides and roof of the warehouse building, as well as cement bound asbestos downpipes.

Trees were present along the eastern boundary of the site, and trees were also present in neighbouring gardens which overhung the site boundary. A row of coniferous trees was present along the eastern boundary, and trees close by off-site included Silver Birch, Sycamore, Laurel and Copper Beech amongst others. The site was bounded by Quadring Road to the south, a pumping station to the east, housing fronting Crosslands to the north, and more housing to the west. The site had gated access from Quadring Road to the south. Photographs from a site walkover on 27<sup>th</sup> January 2020 are presented following the plans.
