## Phase II Environmental Assessment

**4 Goxhill Avenue, Donington**

Delta-Simons Project No. 19-0346.01

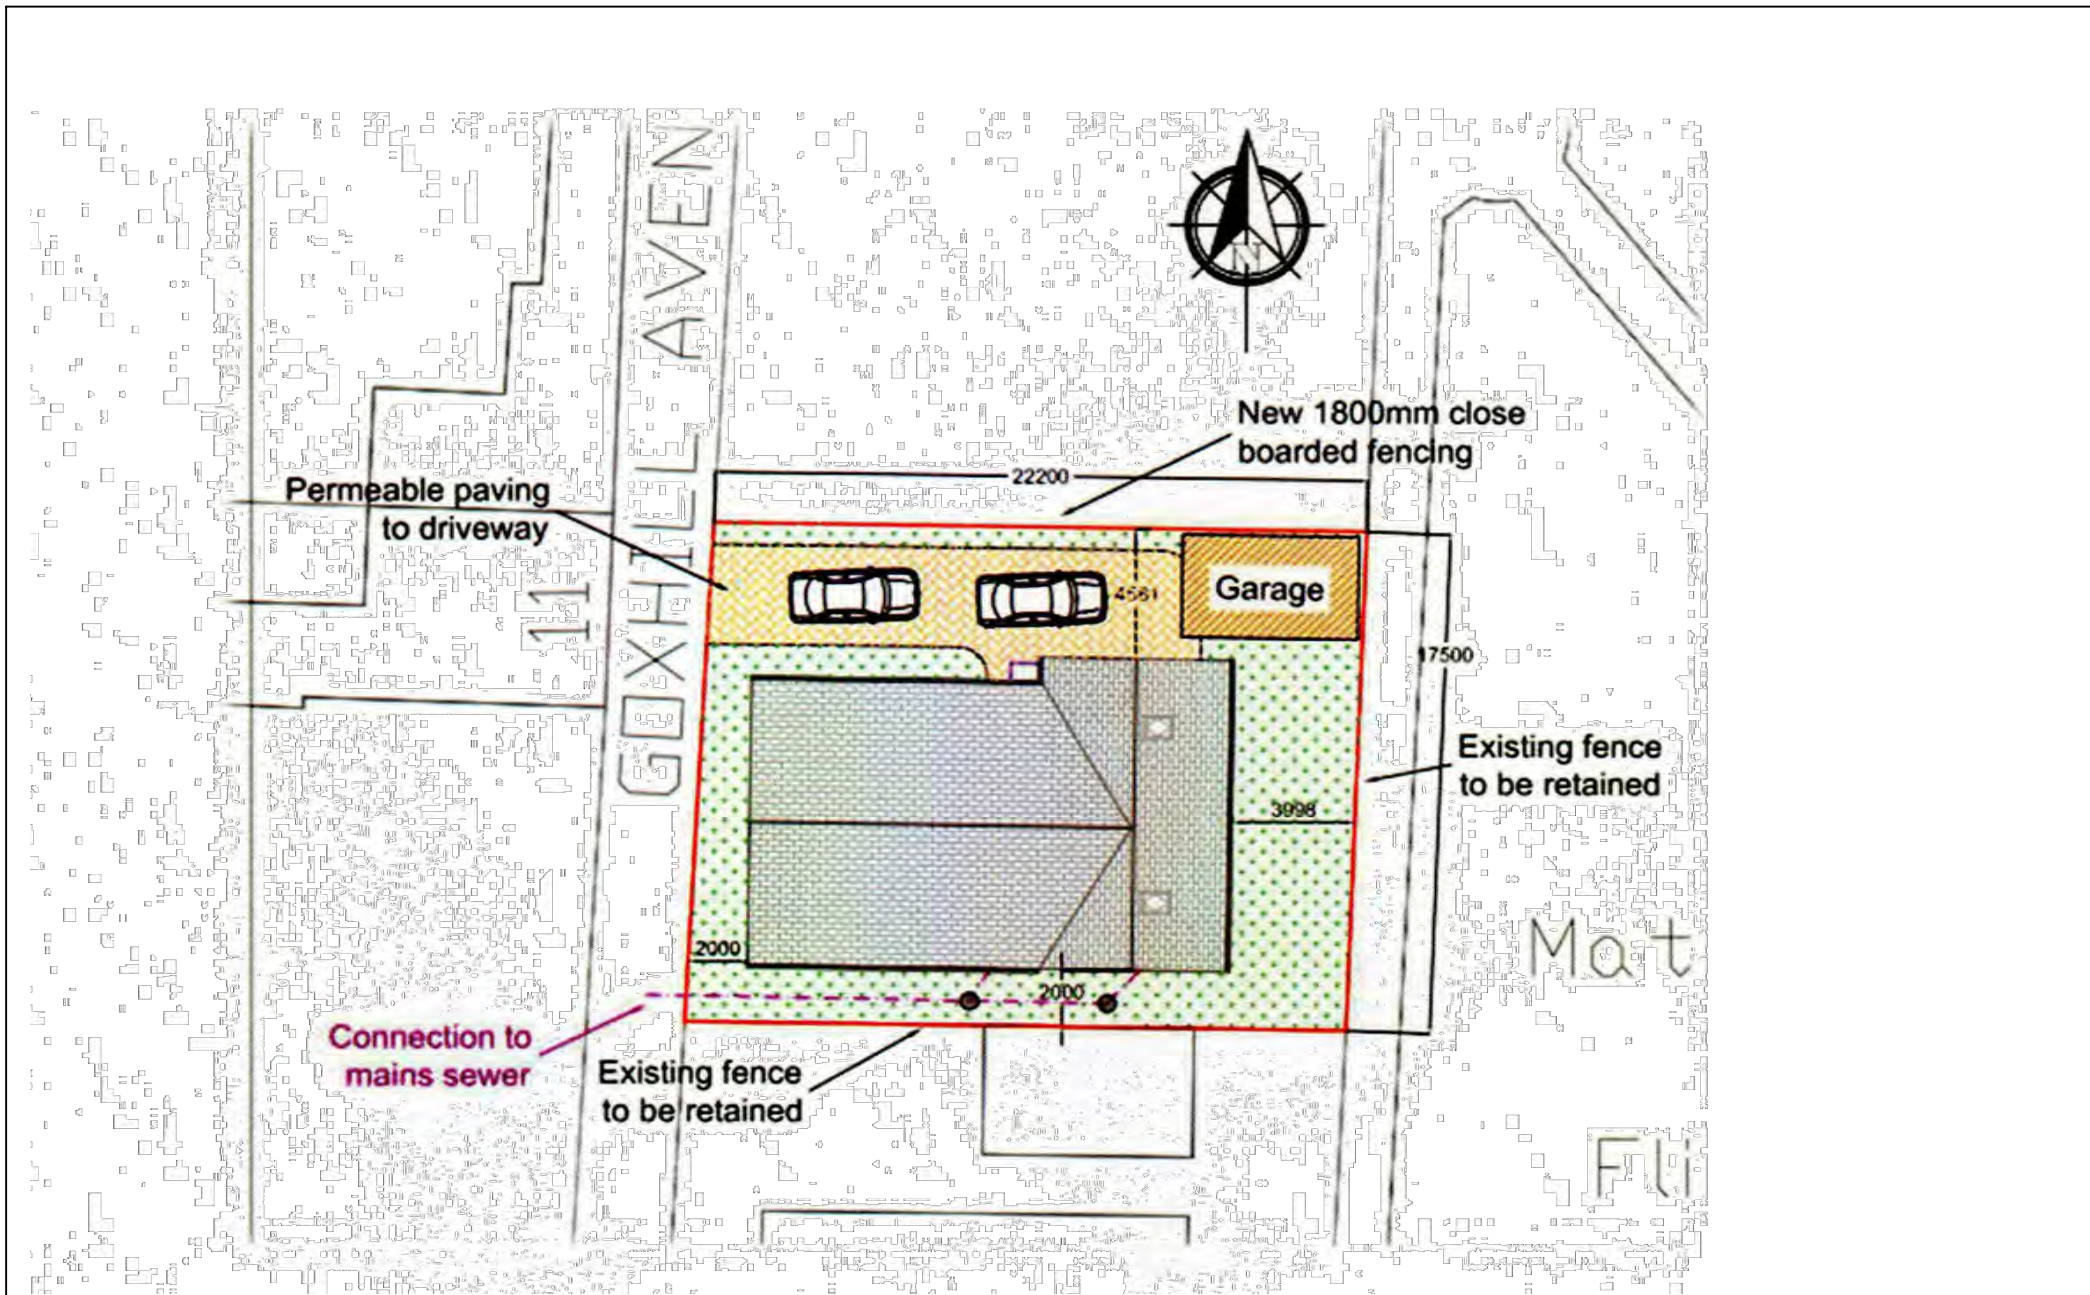
## Figure 2 – Proposed Development Plan

It is understood that the development proposals comprise the erection of a new detached bungalow and garage, with associated areas of soft landscaping. A Proposed Development Plan is presented as Figure 2.

Site Plan Provided by Client

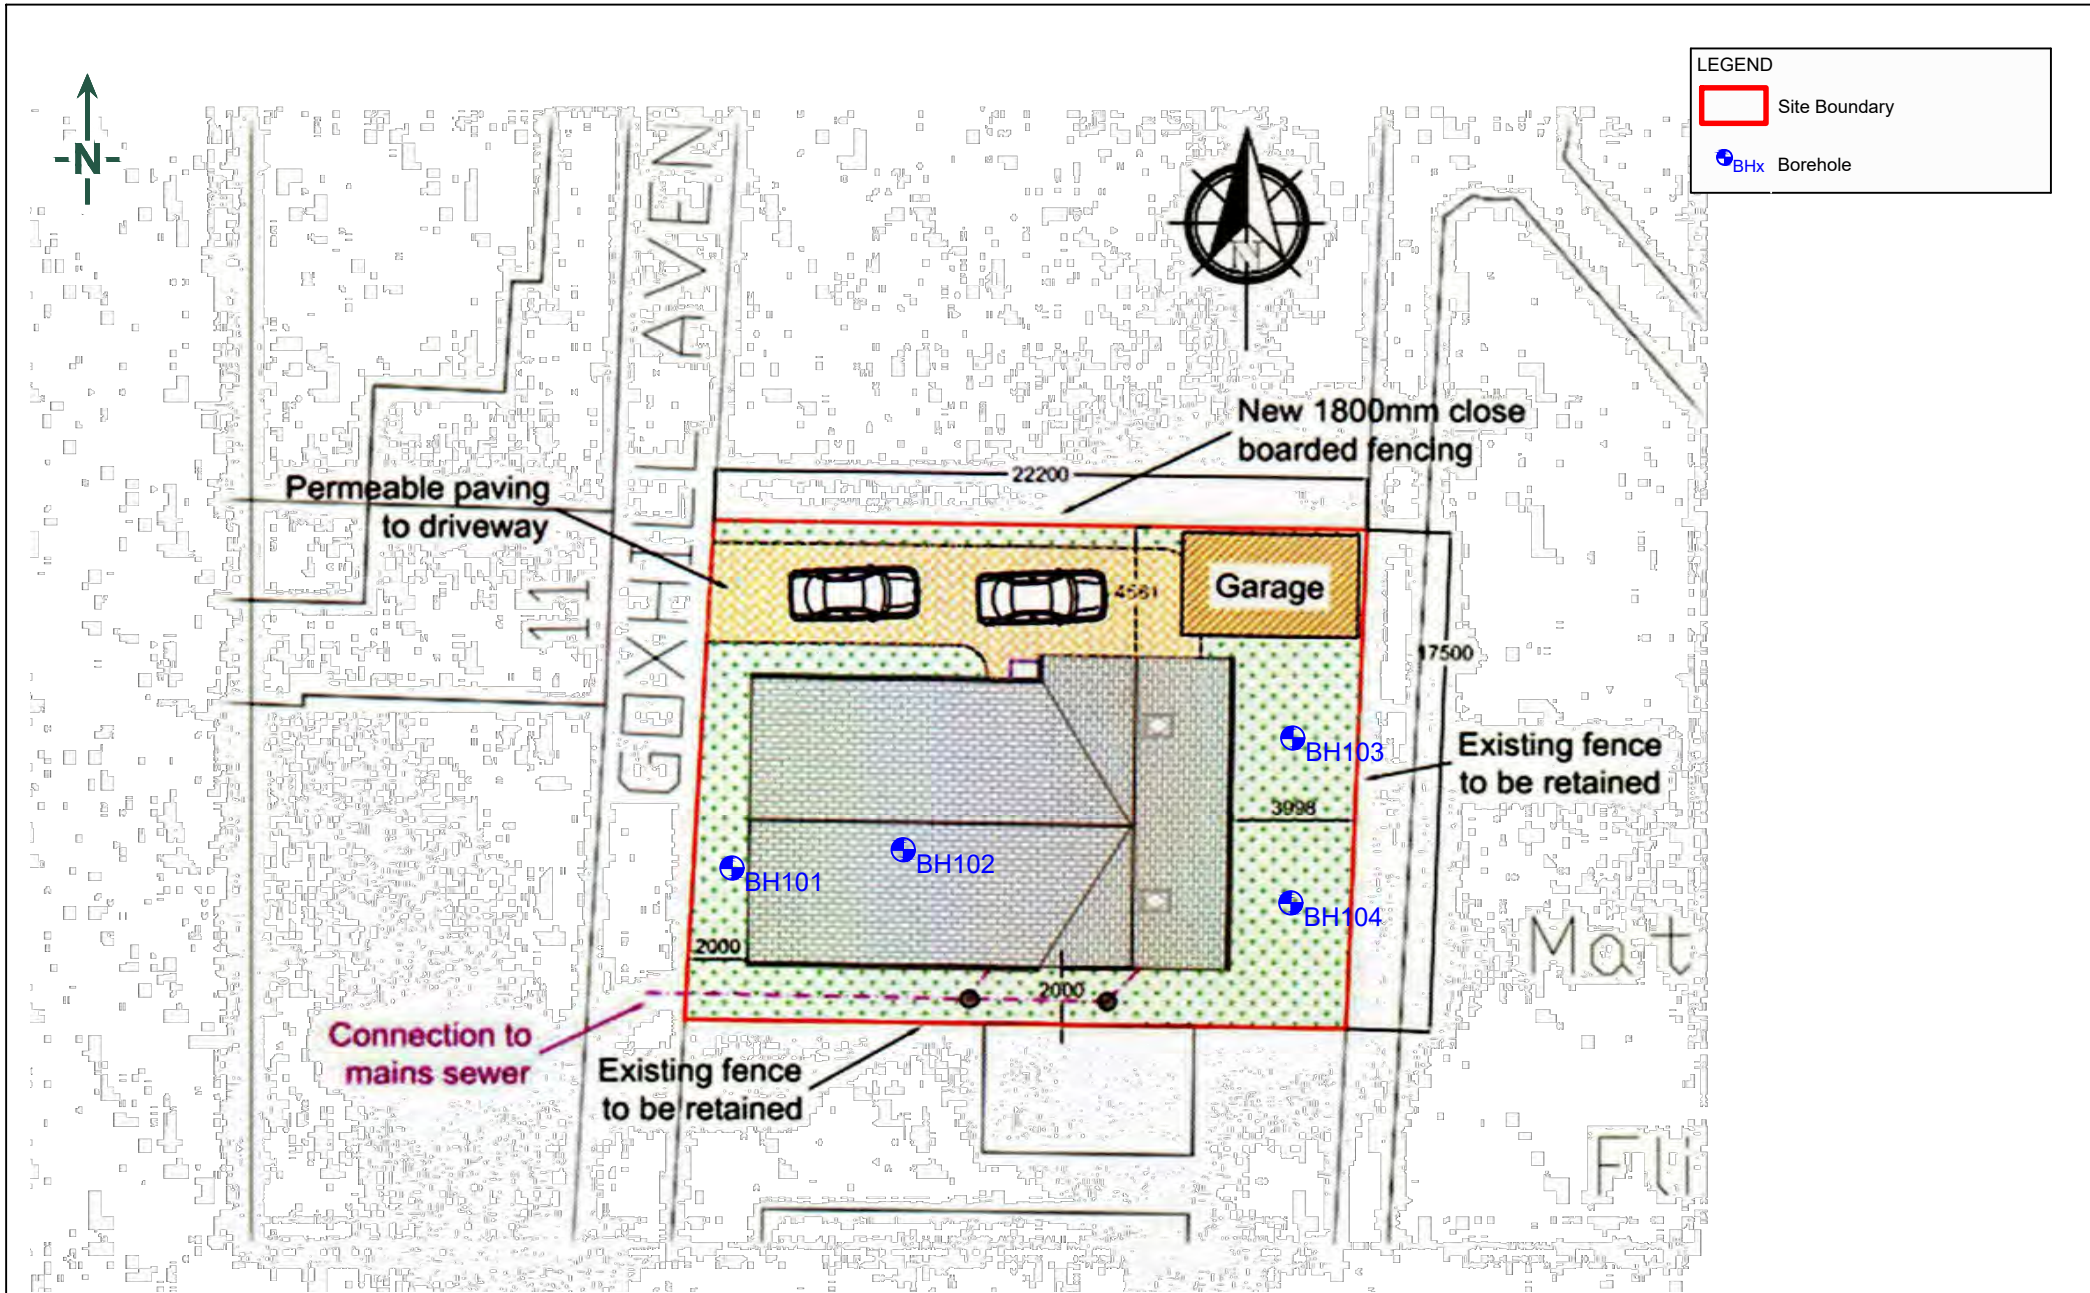
## Figure 3 – Exploratory Hole Location Plan

Site Plan Provided by Client
