## **SITE INVESTIGATION REPORT**

**NEW HOUSING DEVELOPMENT**  
**LAND OFF PARK LANE**  
**DONINGTON**  
**LINCOLNSHIRE**

**Report Reference C13751A**

**April 2016**

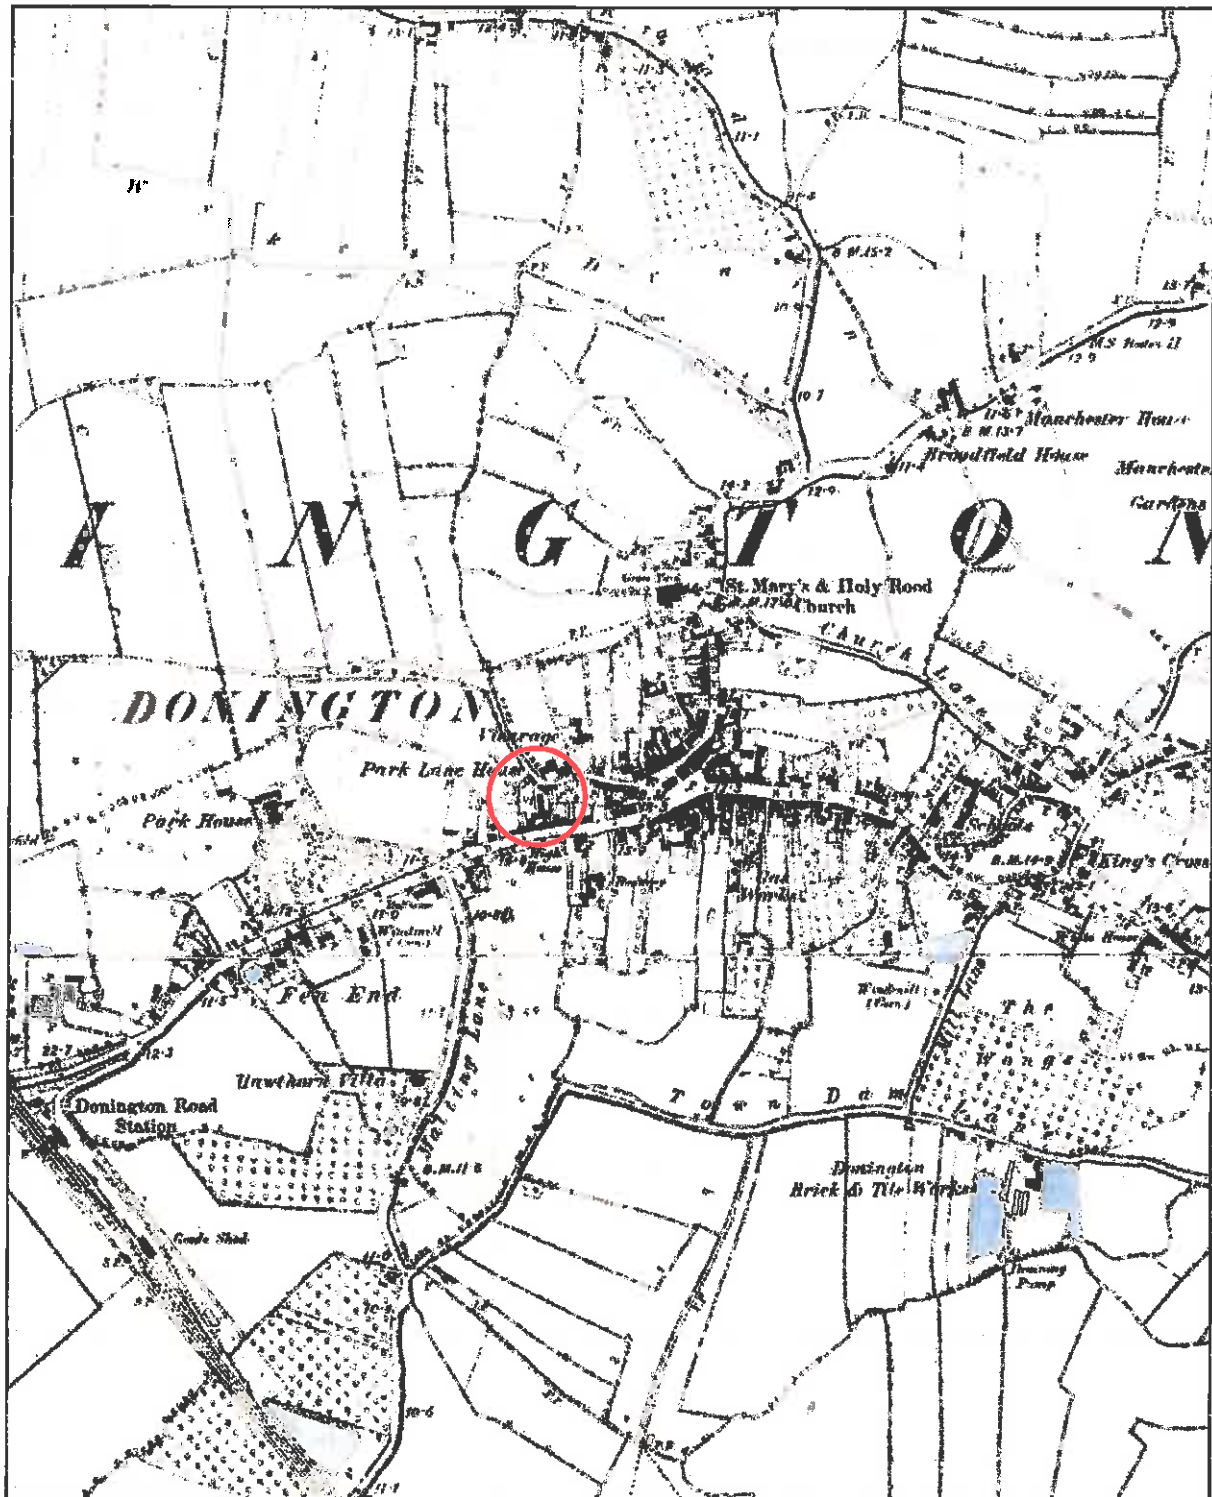
Figure A

Reproduced from the 1887 edition Ordnance Survey sheets Lincolnshire 116SE & 125NE at 1:10,560 scale with the permission of the Controller of Her Majesty's Stationery Office, © Crown Copyright. All rights reserved. Licence number AL100005523

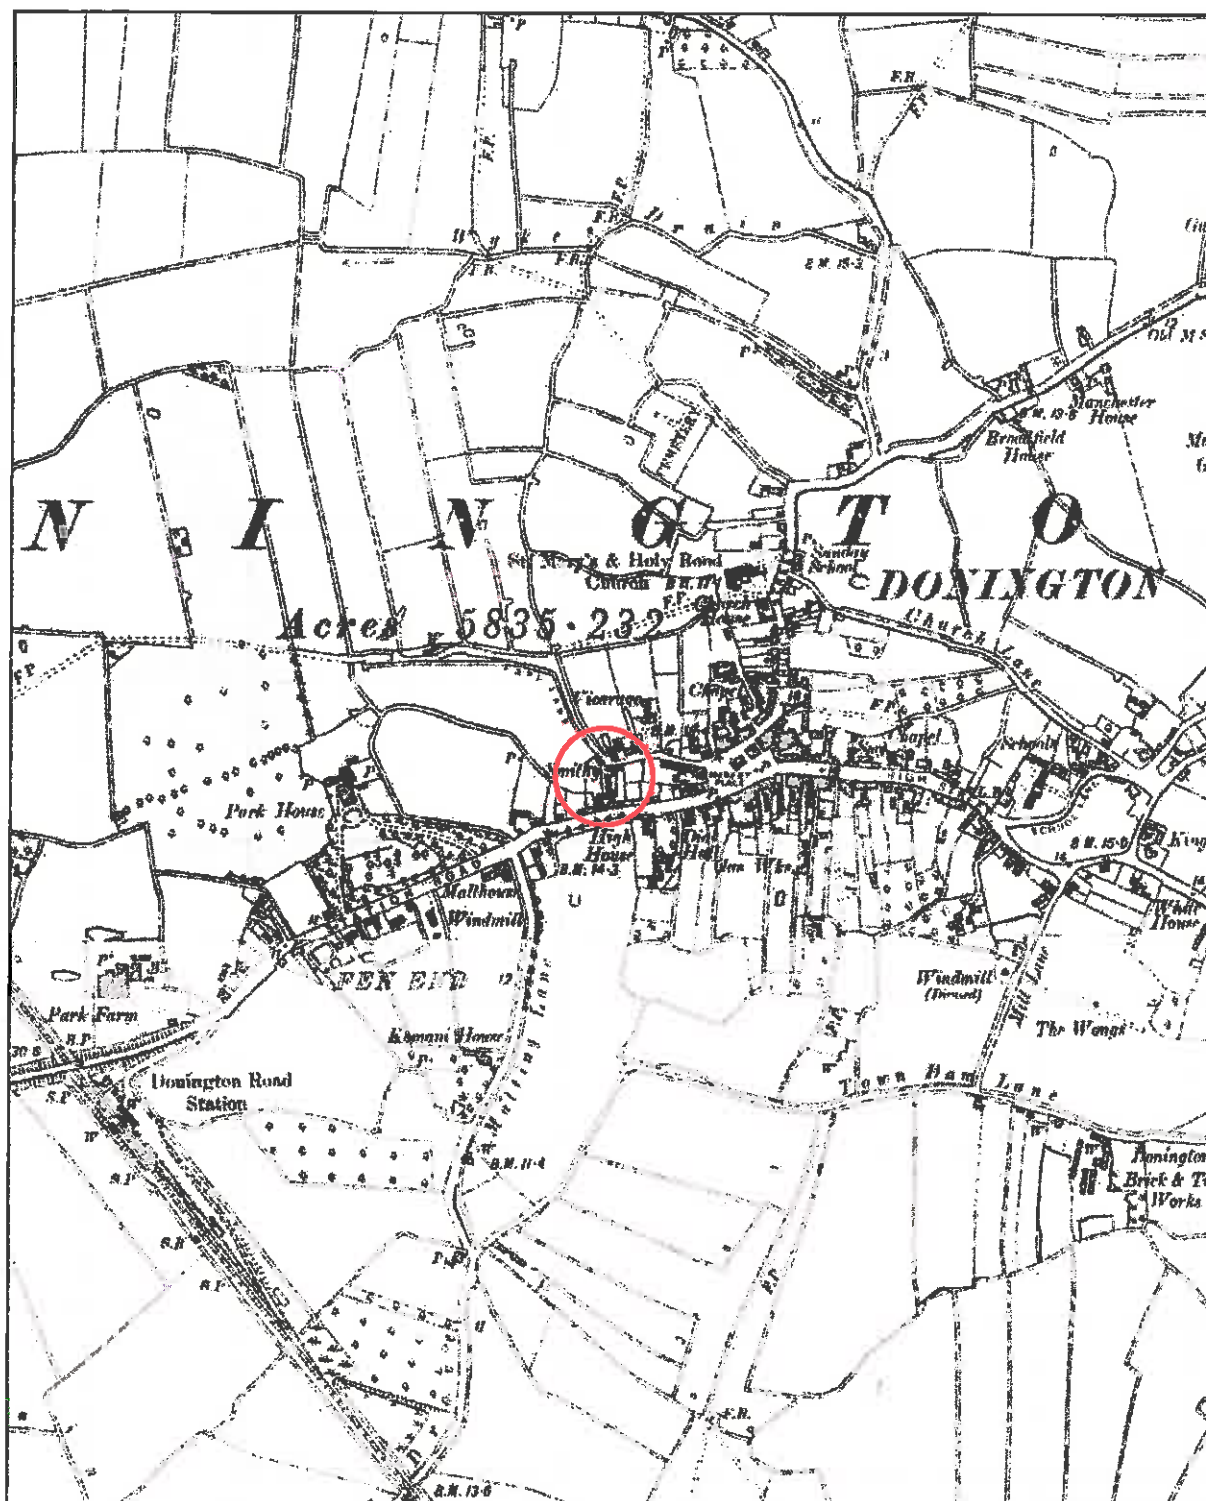
Figure C

Reproduced from the 1903 edition Ordnance Survey sheets Lincolnshire 116SE & 125NE at 1:10,560 scale with the permission of the Controller of Her Majesty's Stationery Office, © Crown Copyright. All rights reserved. Licence number AL100005523

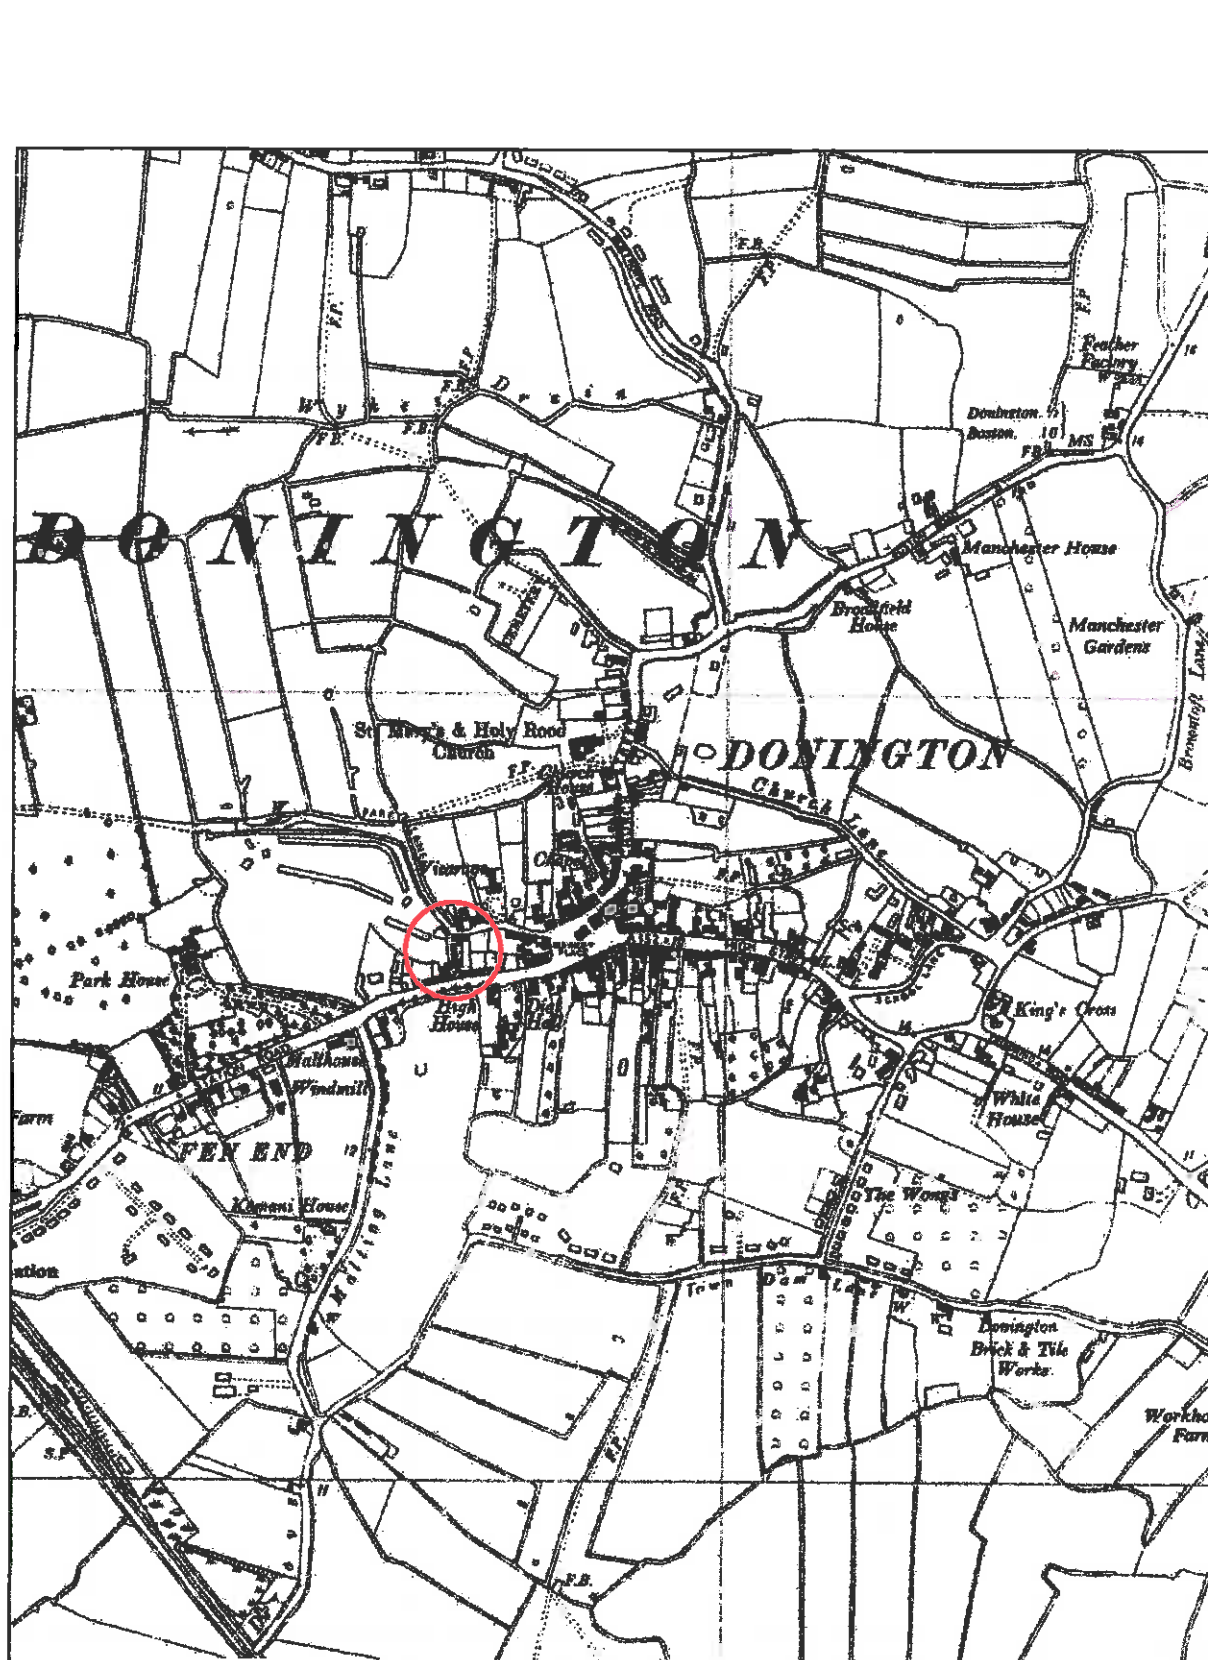
Figure F

Reproduced from the 1956 edition Ordnance Survey sheets TF23NW & TF23SW at 1:10,560 scale with the permission of the Controller of Her Majesty's Stationery Office, © Crown Copyright. All rights reserved. Licence number AL100005523

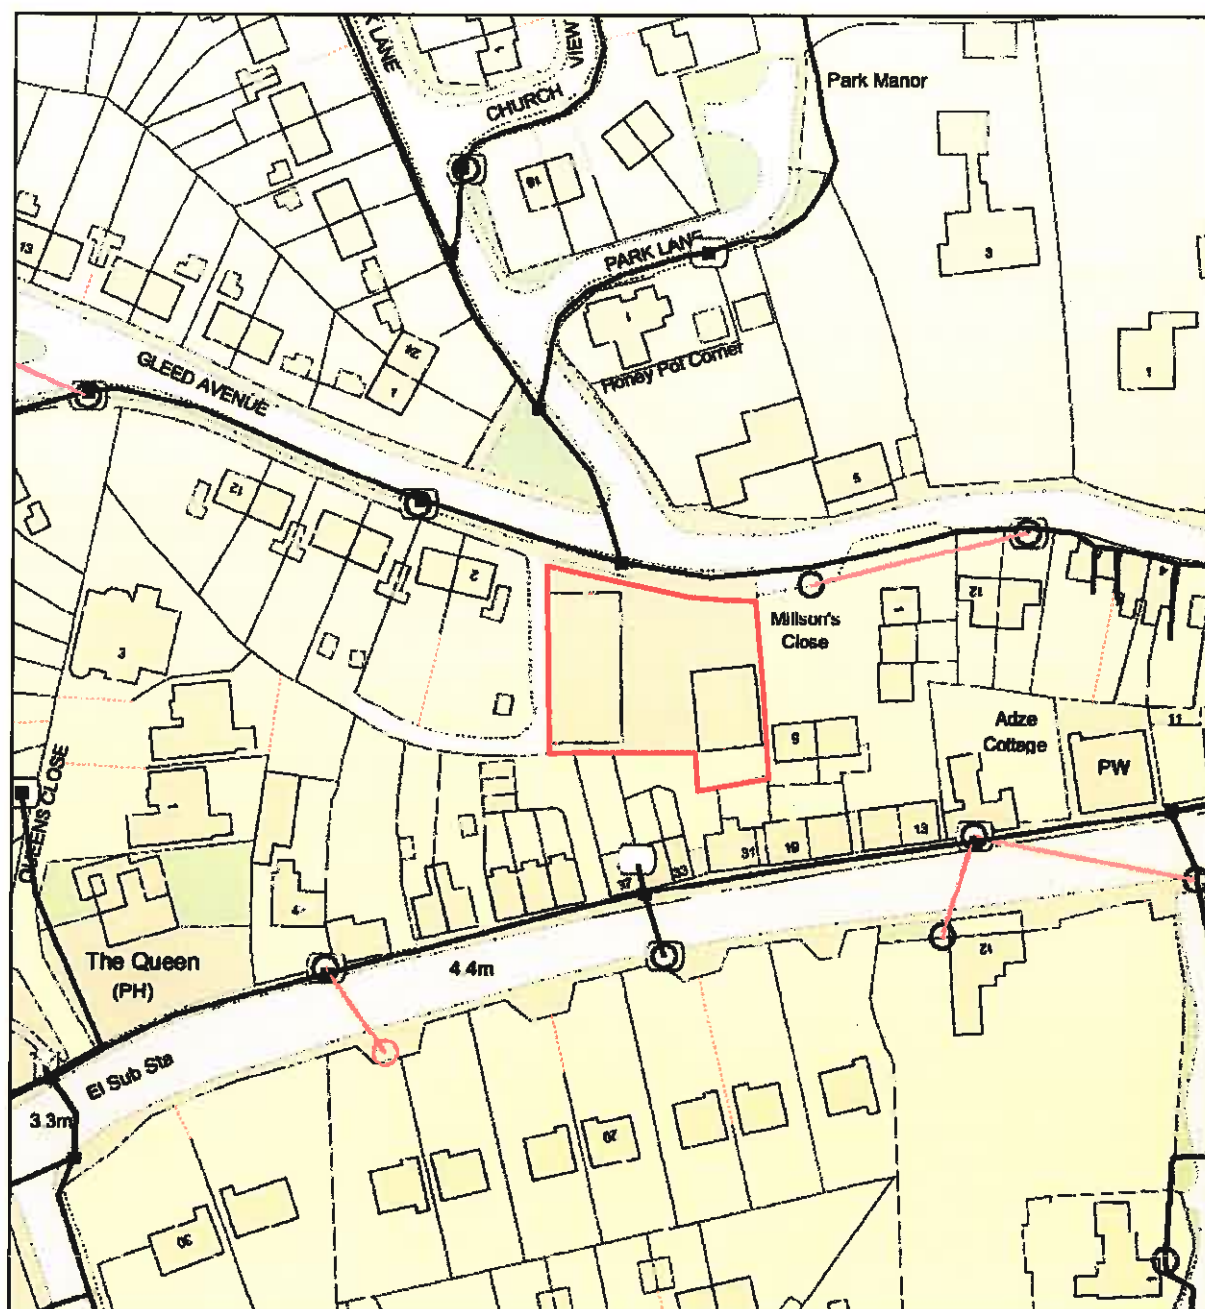
Figure P

Reproduced from the 2016 edition Ordnance Survey TF2035 (BT Plan) Not to scale with the permission of the Controller of Her Majesty's Stationary Office, © Crown Copyright. All rights reserved. Licence number AL100005523

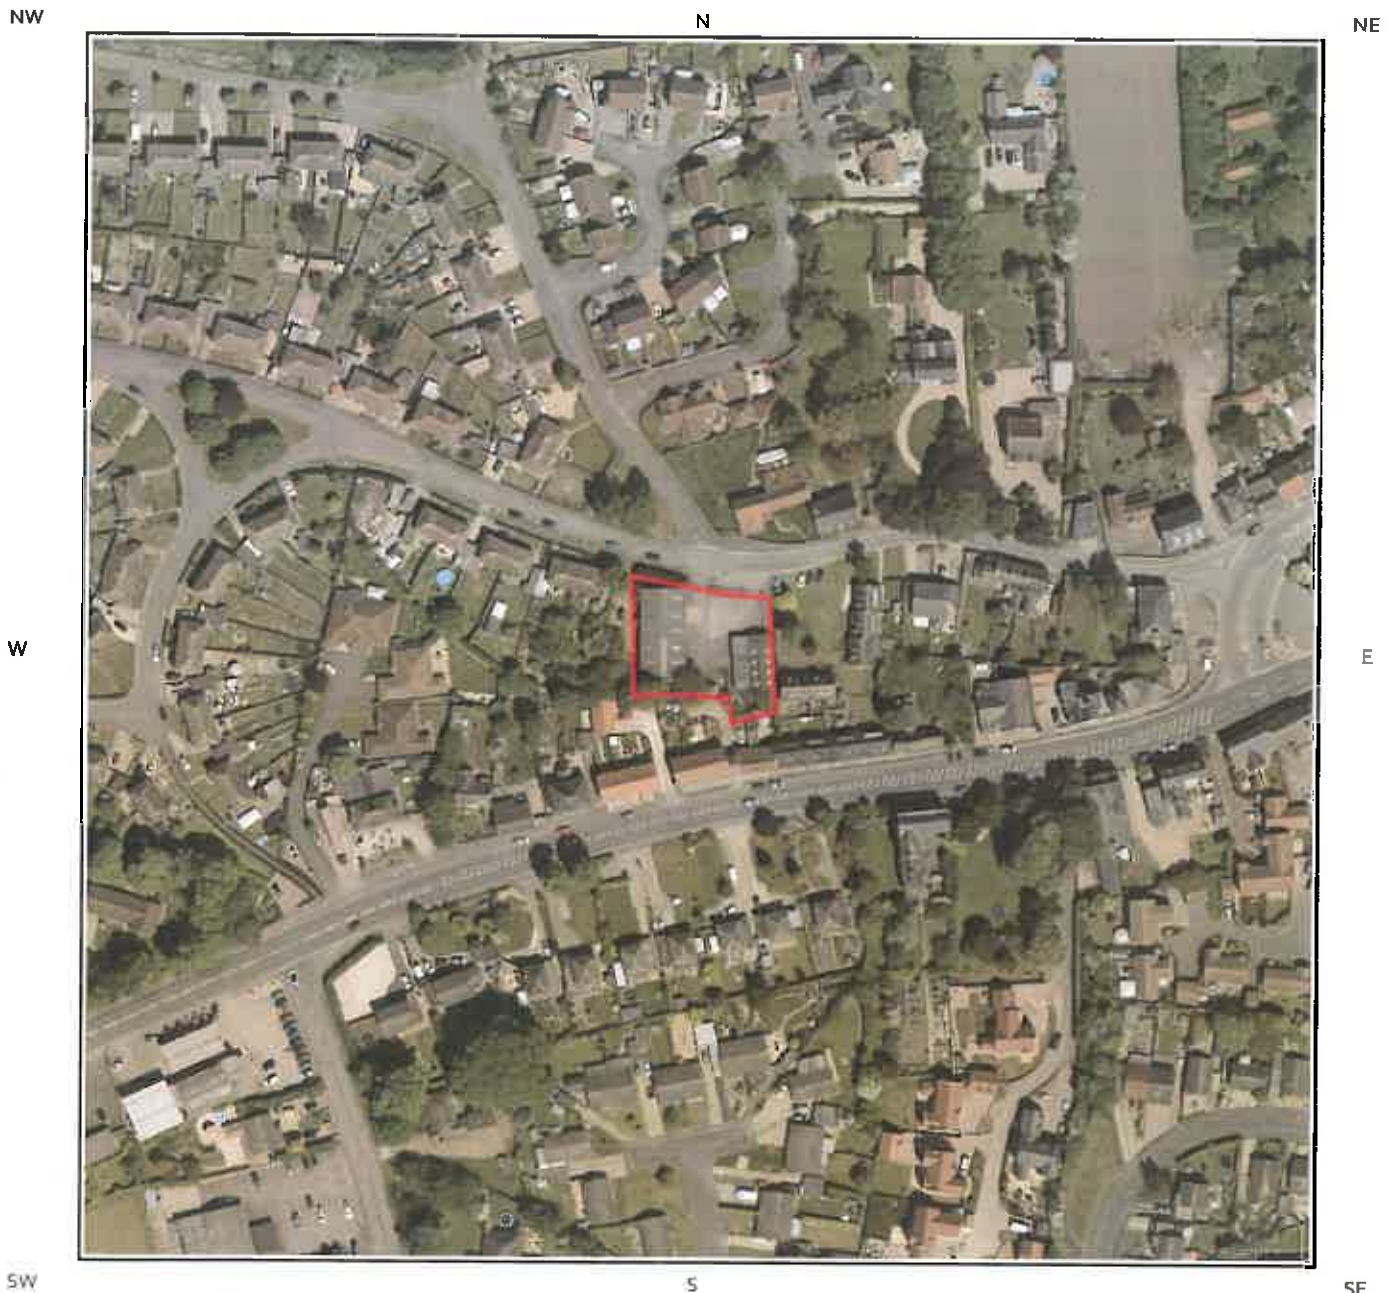
**Aerial Photograph Capture date:** 23-May-2010  
**Grid Reference:** 520650,335684  
**Site Size:** 0.12ha
