| Report type | Phase 1 Preliminary Risk Assessment |
| Date | 9 February 2022 |
| Site address | Poplar Farm, Moor Gate, Holbeach, Spalding, PE12 8QW |

The client's proposed project involves the conversion, partial demolition and extension of barn into a new dwelling at Poplar Farm, Moor Gate, Holbeach, Spalding, PE12 8QW. A preliminary risk assessment (desk study) has been requested by South Holland District Council, through attachment of conditions on planning application H05-1038-21. Oakshire Environmental have carried out a Phase 1 Preliminary Risk Assessment, as described below.

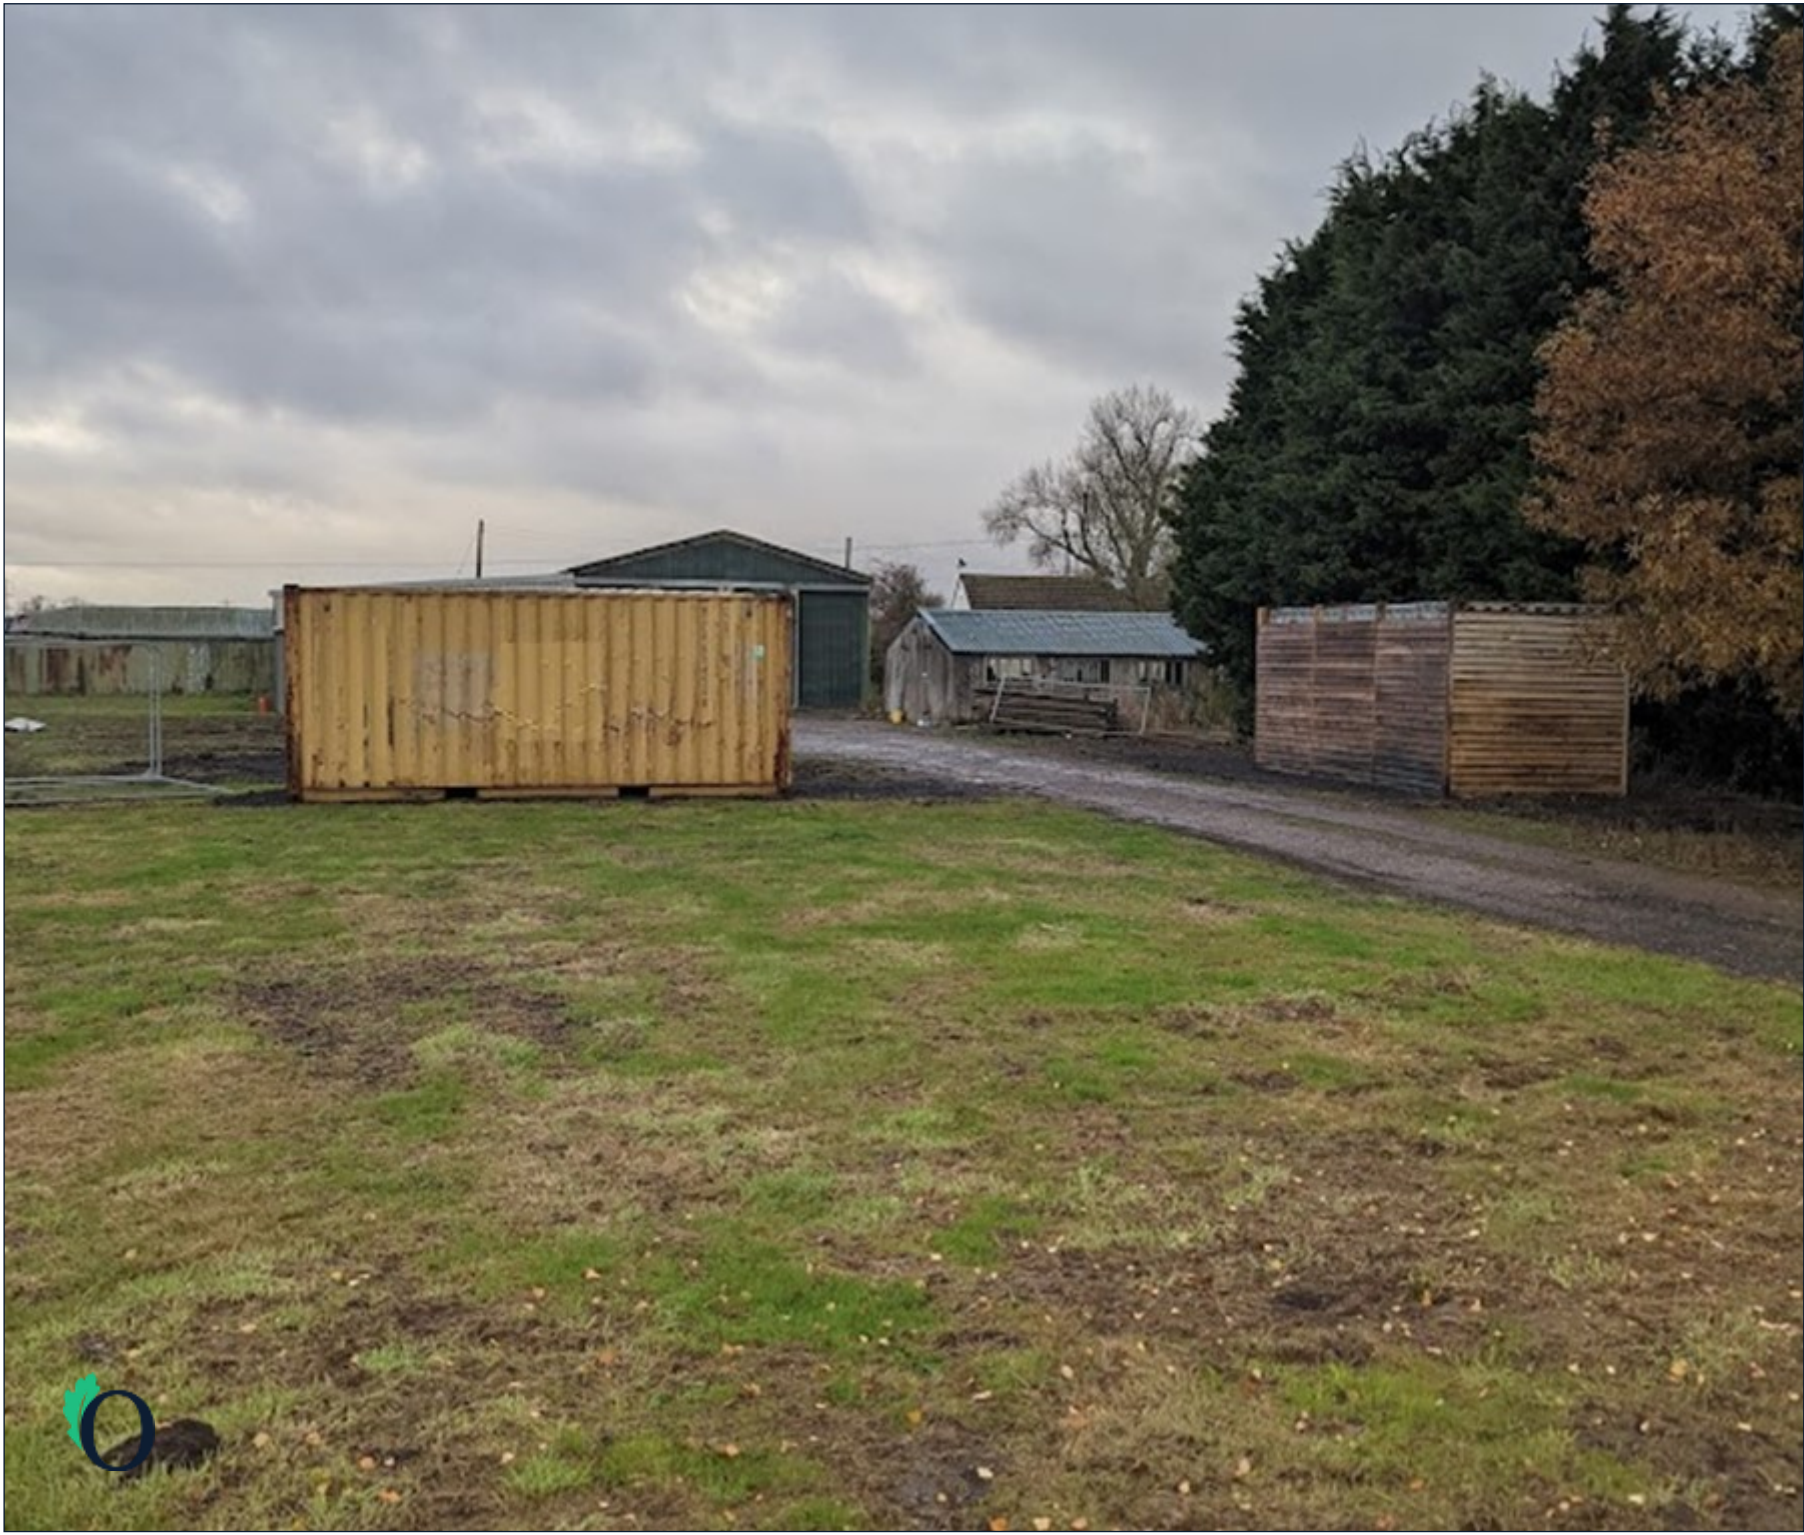
| Appendix A - Site Maps & Plans | |
|---|---|
| Name | Figure 1 |

Photo of the site from the east, facing west, showing storage containers

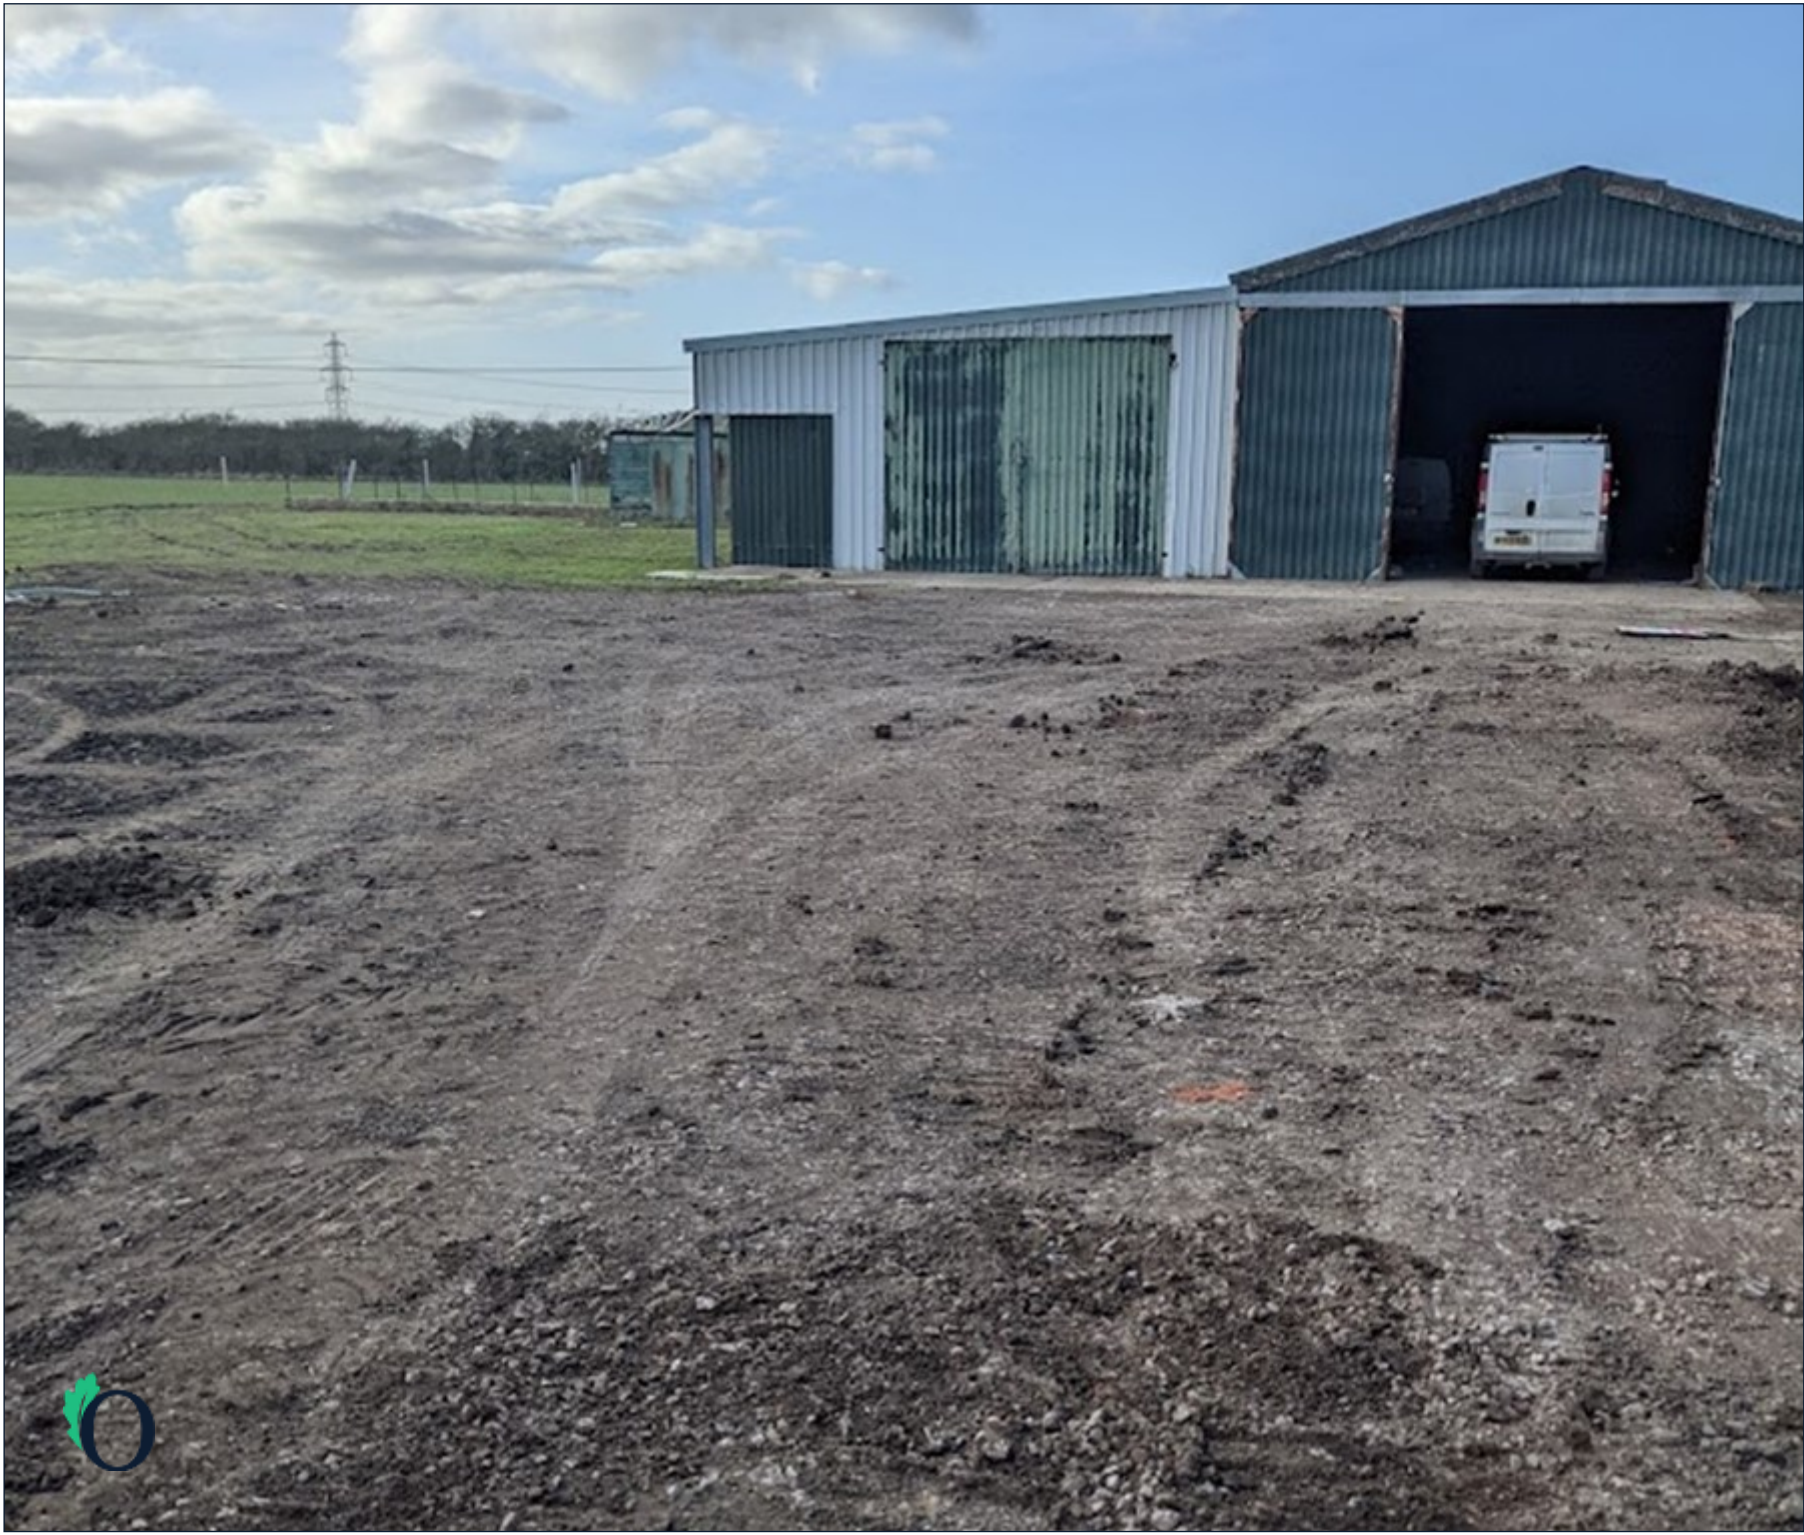
Figure 4

Photo of gravel yard area and existing barn at the north west of the site, facing west

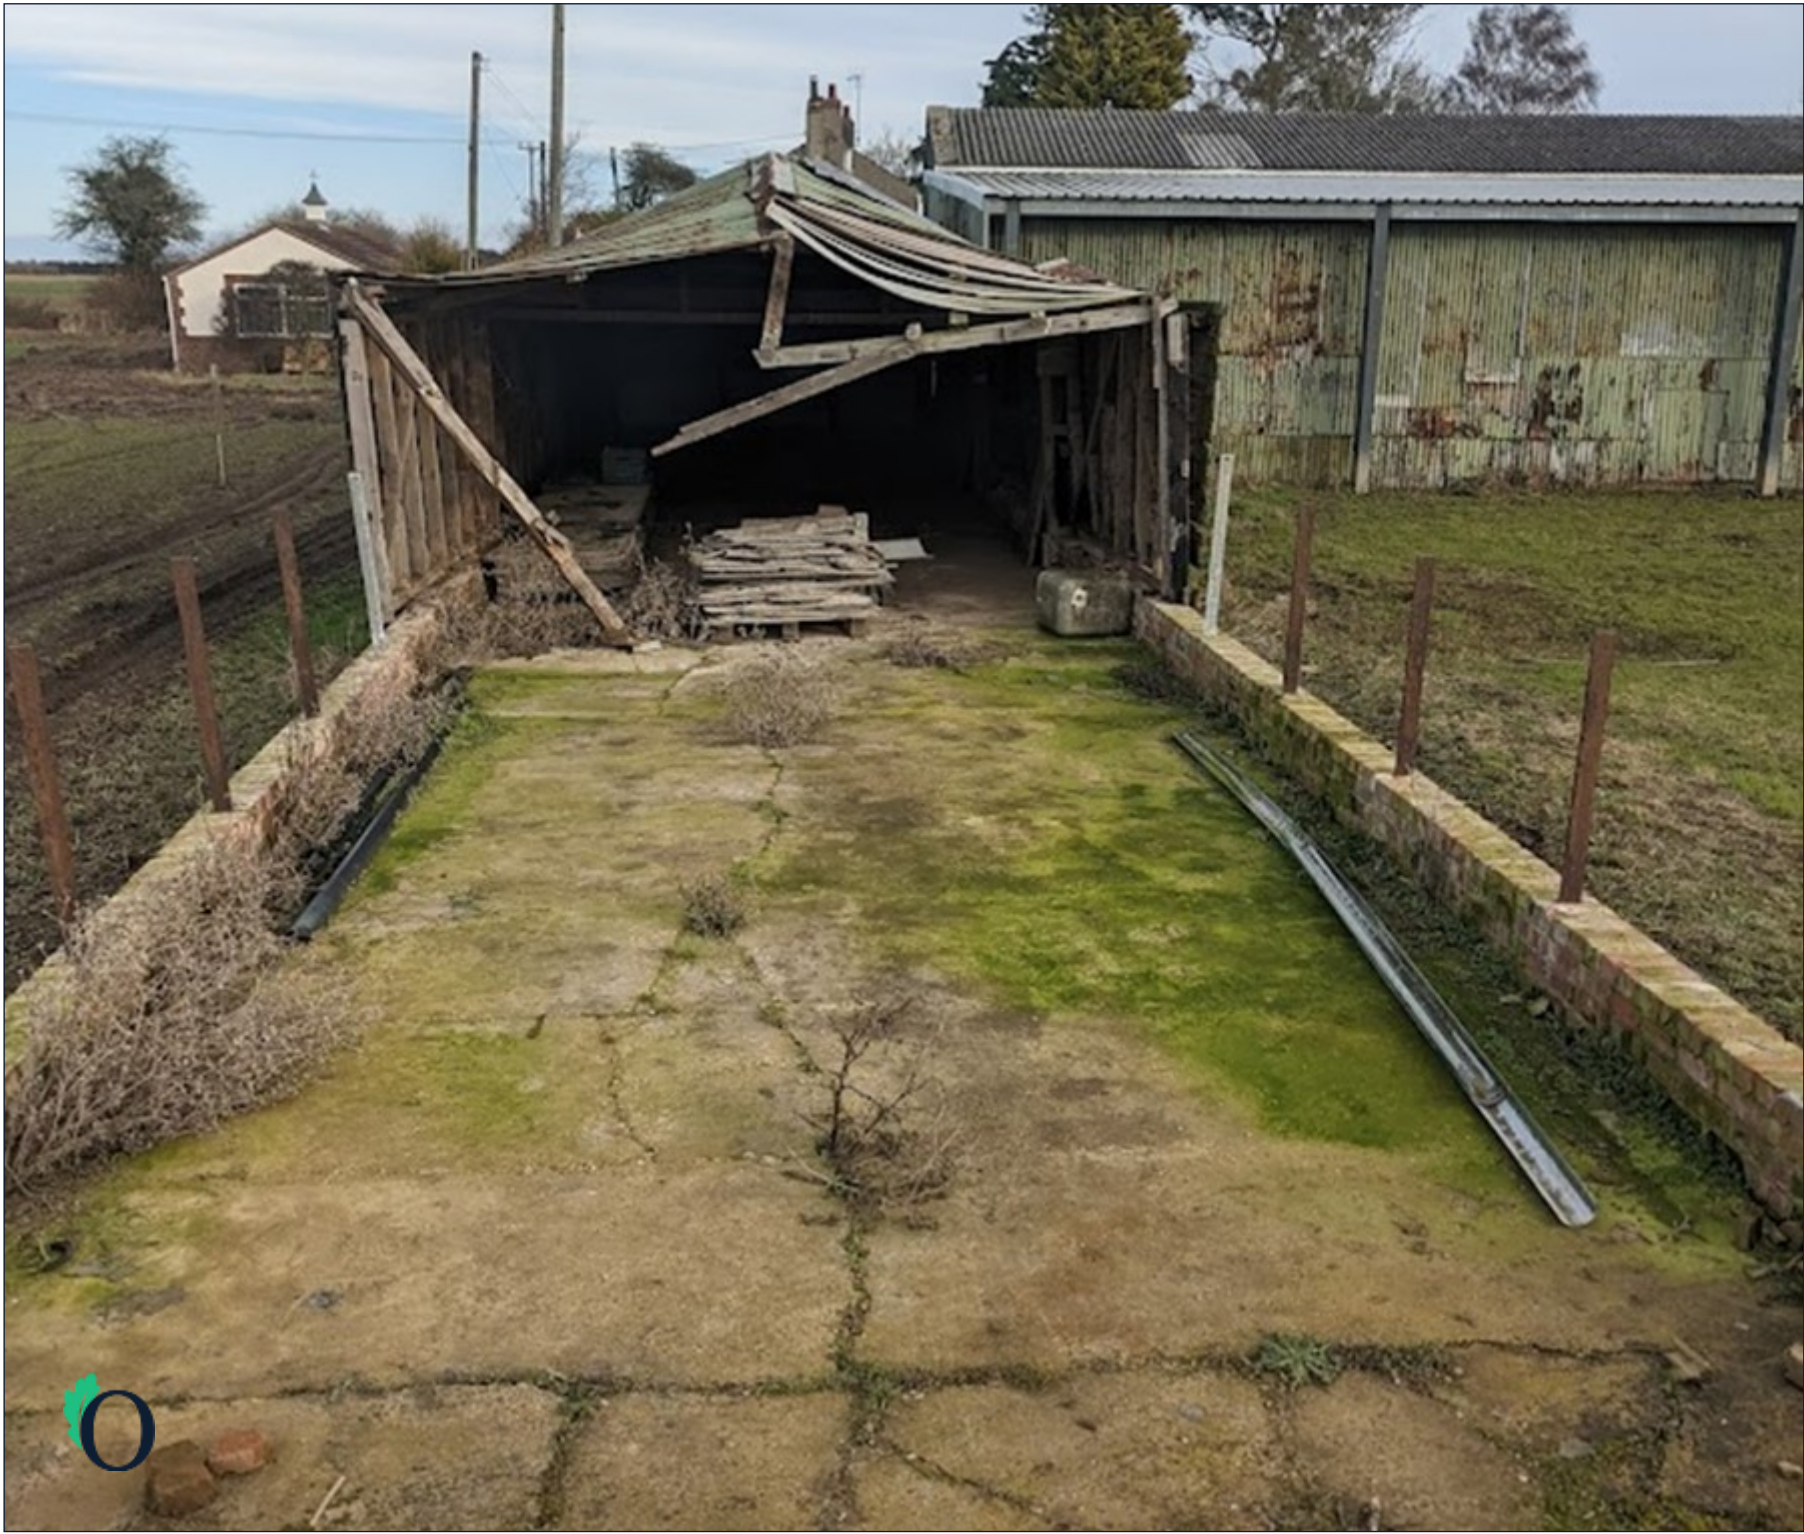
Figure 7

Photo of existing building at the west of the site to be demolished, facing north

There is likely to be made ground on the site, particularly at the west, where buildings have been demolished, in addition to, in the yard and access road. Made ground may contain elevated concentrations of heavy metals and PAHs. It should be noted that made ground is not likely to be widespread or present at significant depths, due to the lack of historical development on the site, and made ground contamination is likely to be localised.

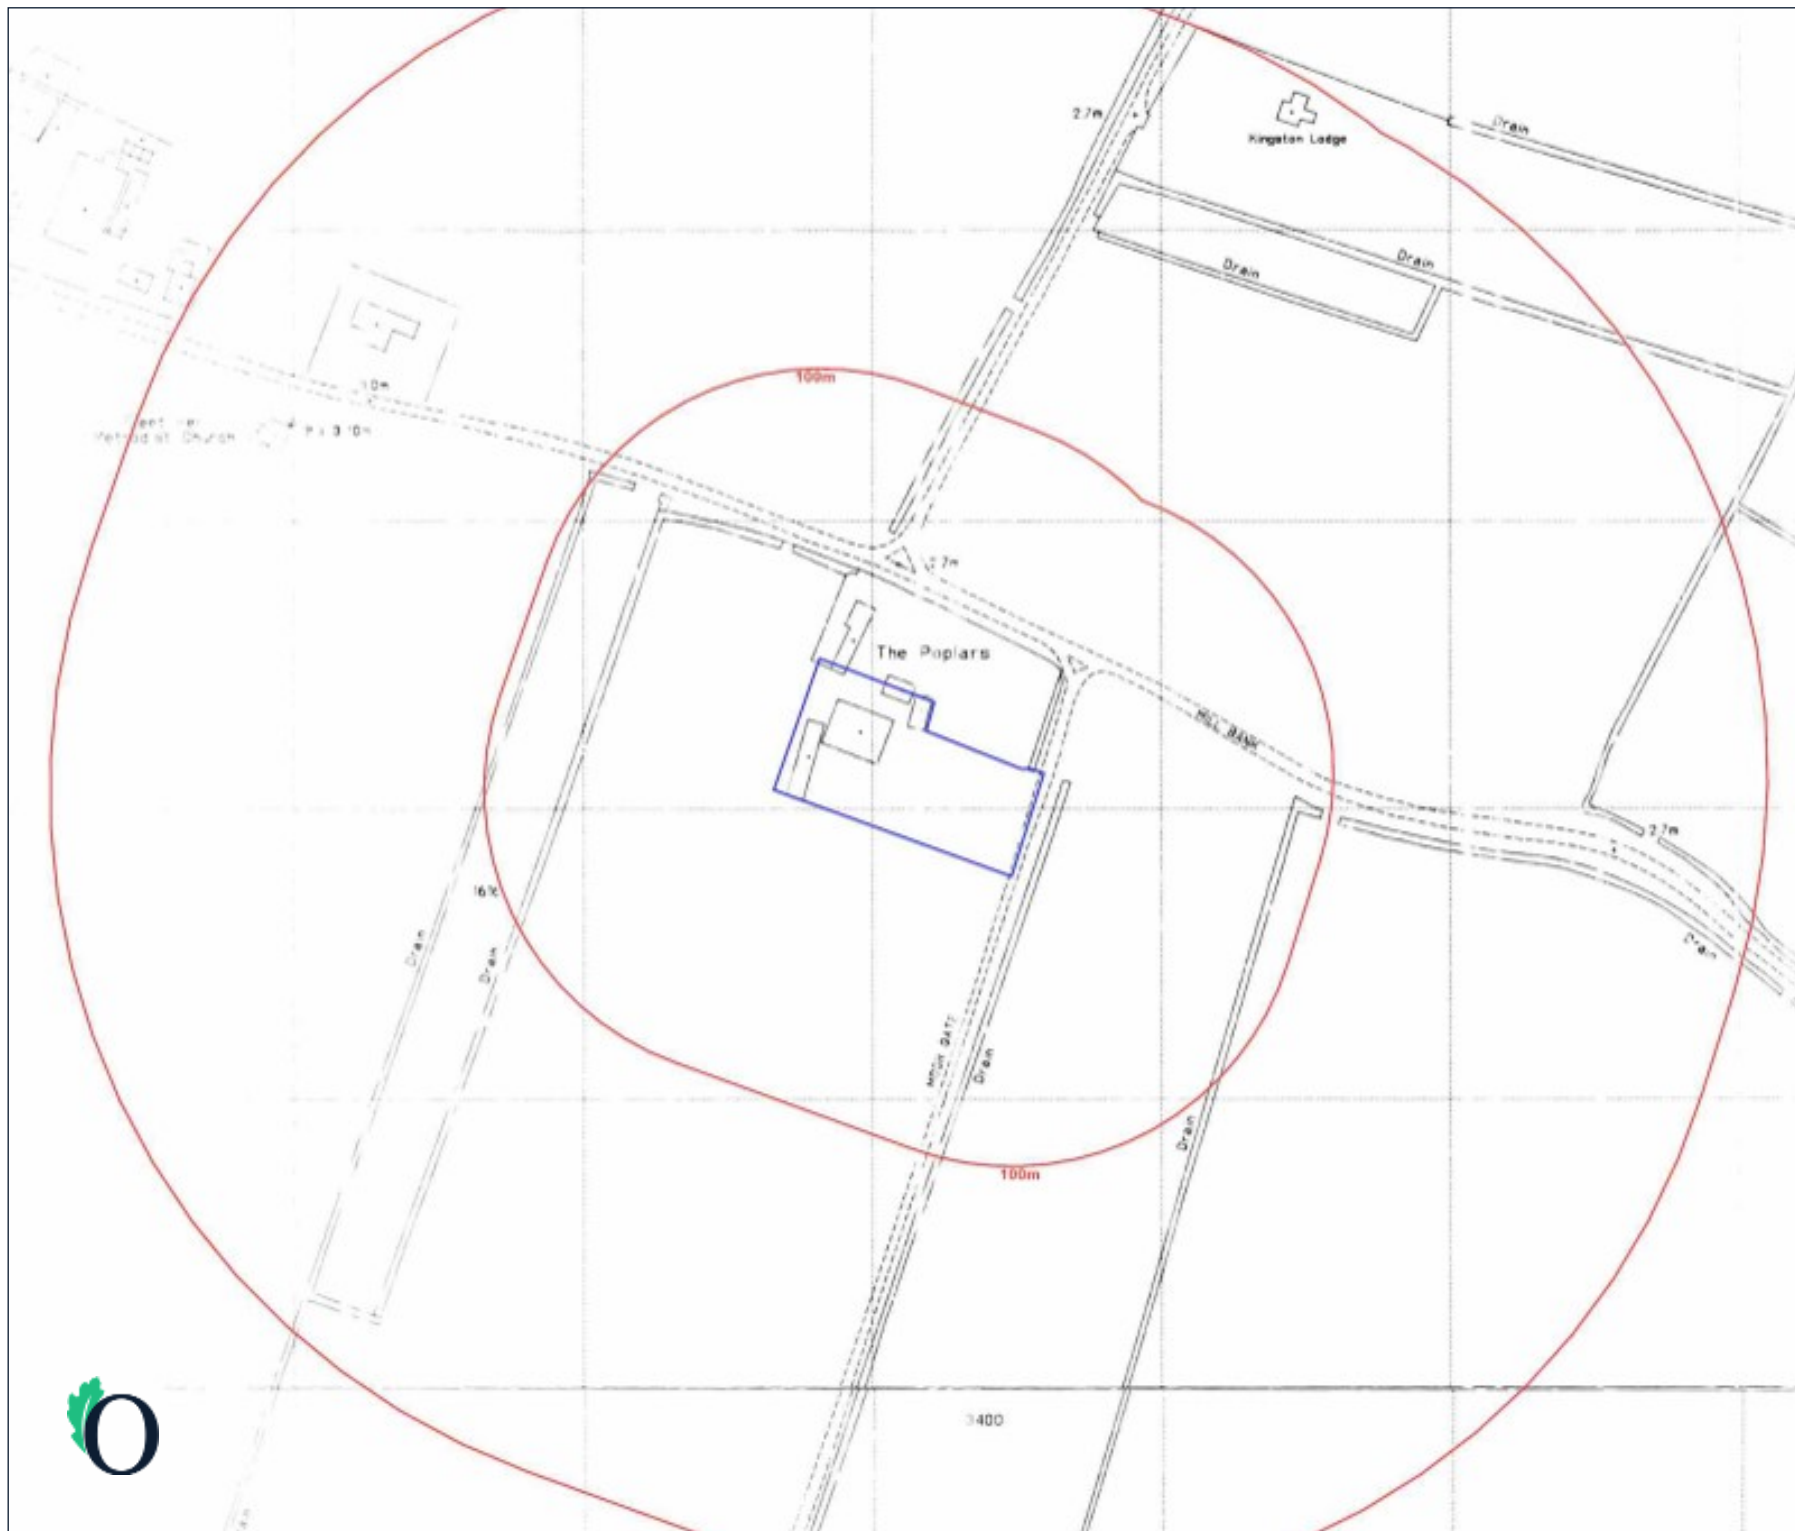
Figure 16

Historical map dated 1991 - 1995

| Year | Site Description | Surrounding Area |
|---|---|---|
| 1991 - 1995 | | Pond to the north no longer shown<br>Small unlabelled building to the north east removed |

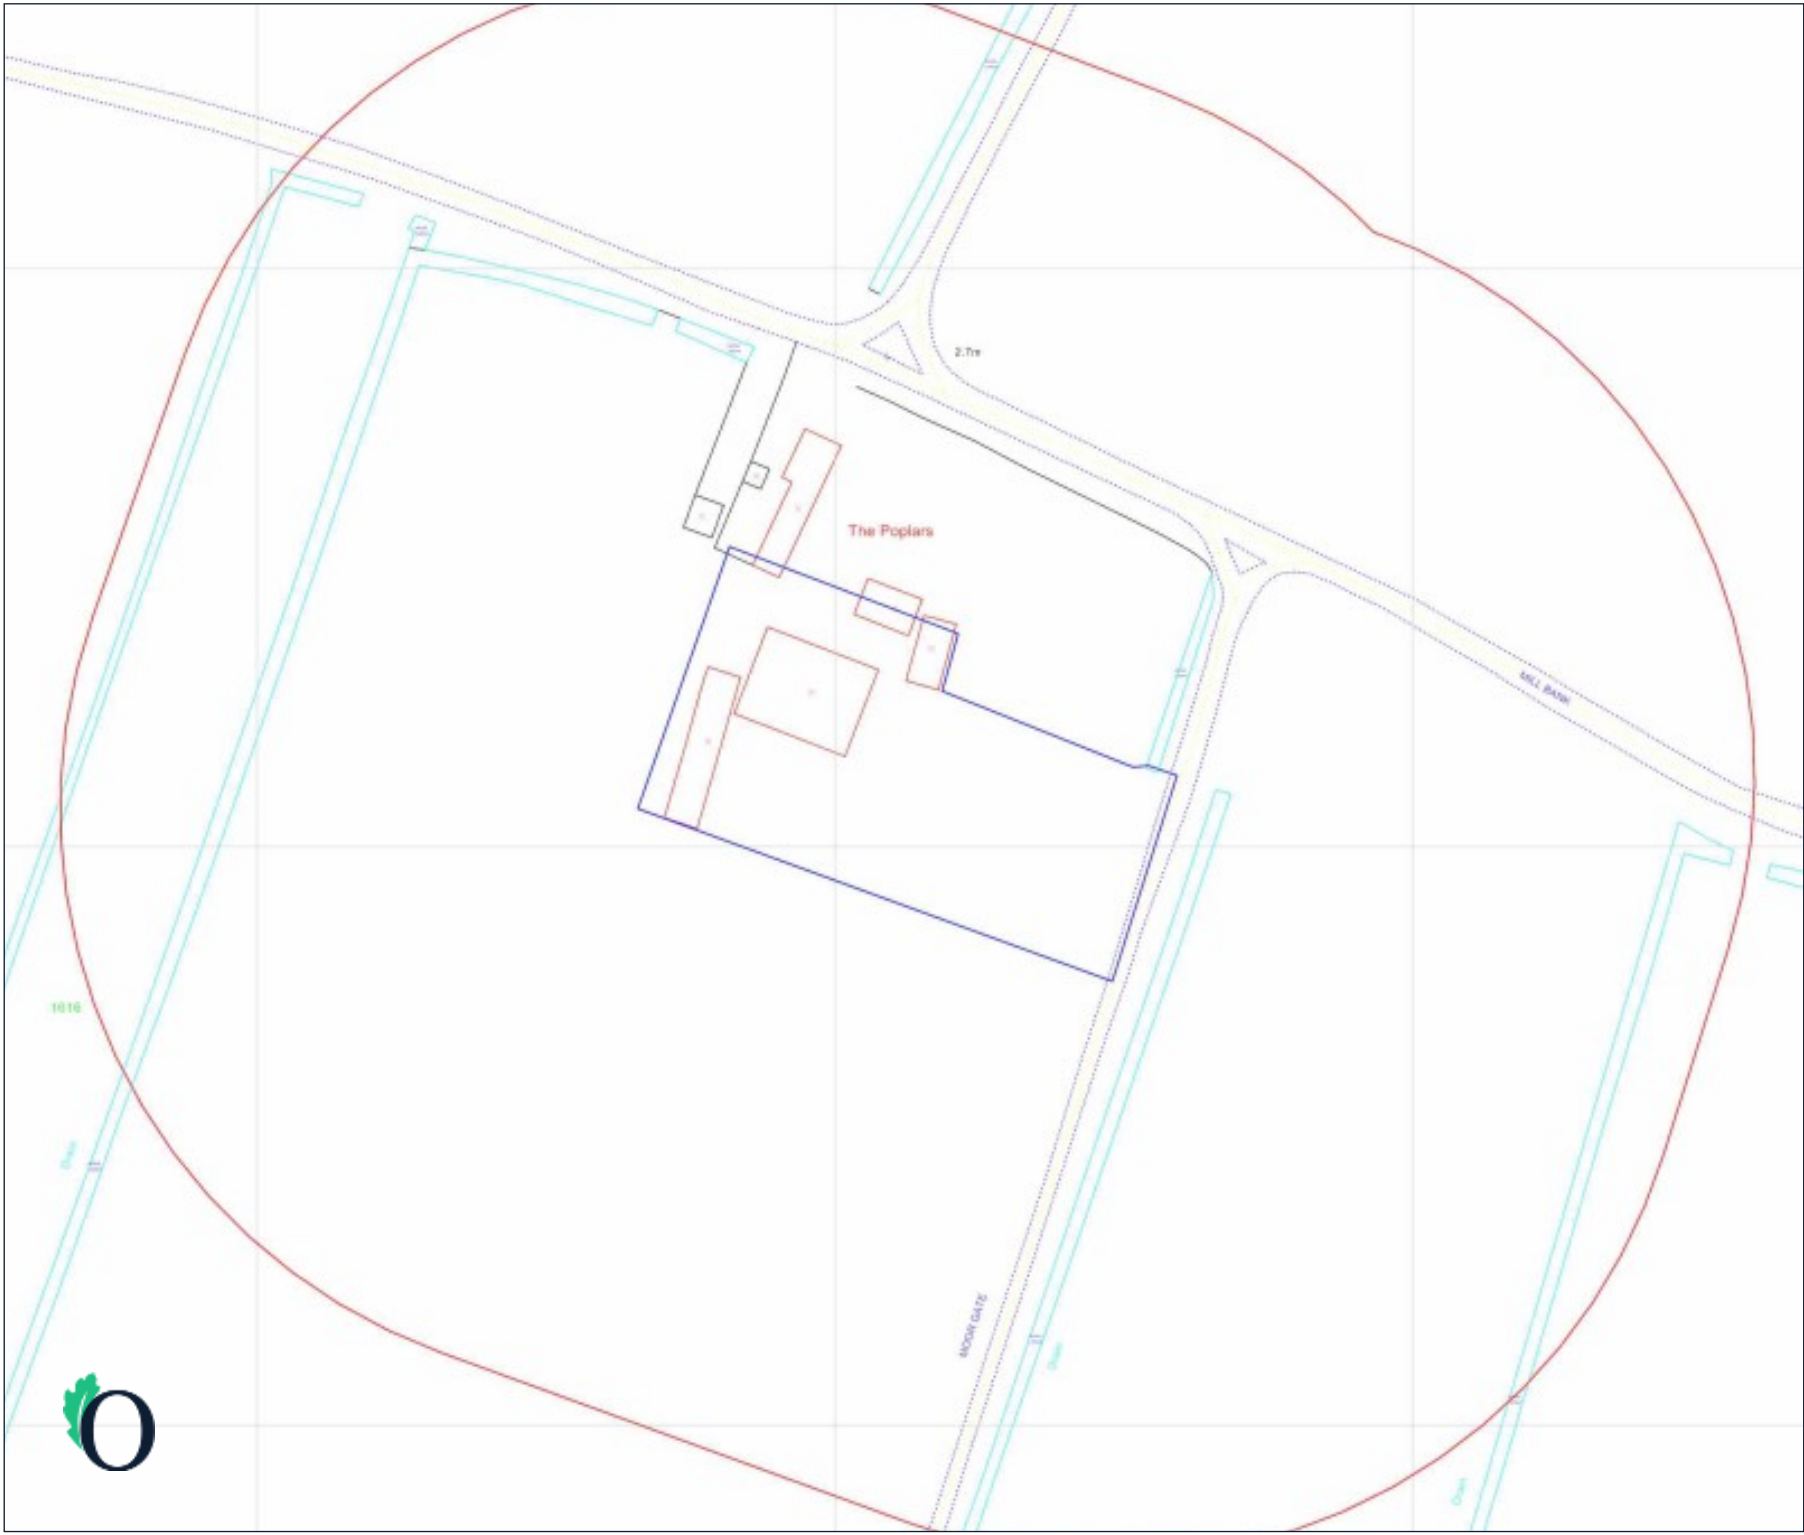
Figure 17

Historical map dated 2003

| Year | Site Description | Surrounding Area |
|---|---|---|
| 2003 | Drain along west boundary no longer shown | Unchanged |

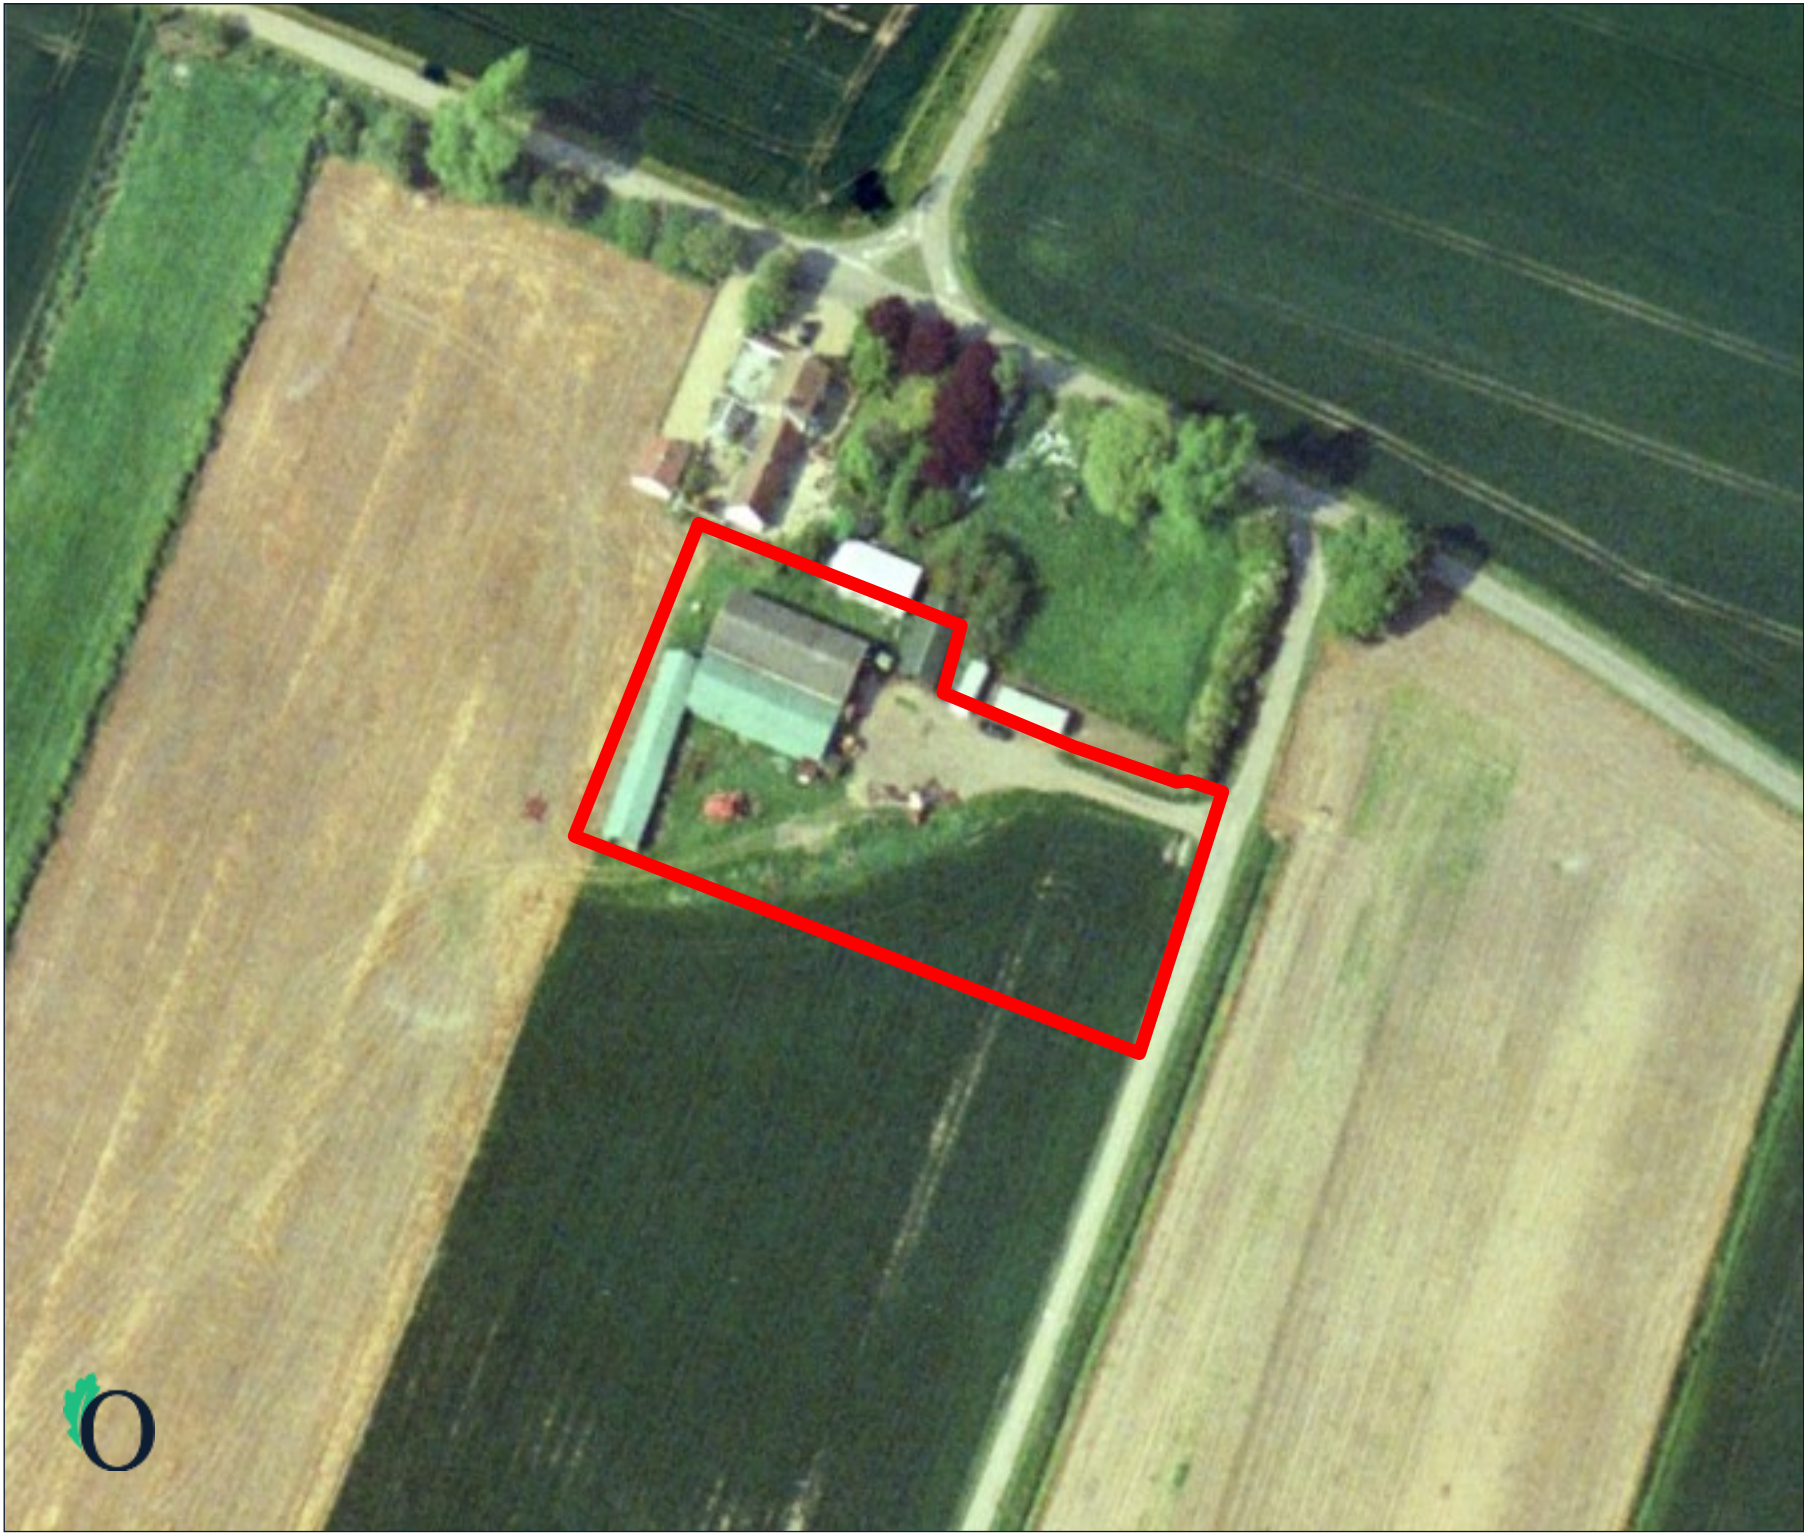
| Appendix C - Historical Maps | |
|---|---|
| Name | Figure 18 |

| Appendix C - Historical Maps | |
|---|---|
| Aerial photograph dated 1999 | |

| Year | Site Description | Surrounding Area |
|---|---|---|
| 1999 | Two buildings removed and one new barn building constructed at the north west | Unchanged |
