**NEVILLE HALL  
FREELANCE ARCHAEOLOGIST & CONSULTANT**

INTERIM REPORT ON THE RESULTS OF  
ARCHAEOLOGICAL MONITORING AND RECORDING ON  
LAND ADJACENT TO 'THE CHESTNUTS',  
HALLGATE,  
FLEET, LINCOLNSHIRE.

**National Grid Reference: TF 3885 2358**  
**Site Code: HGFL21**  
**Accession No: LCNCC: 2021.198**  
**Planning Reference: H05-0659-21**

March 2022

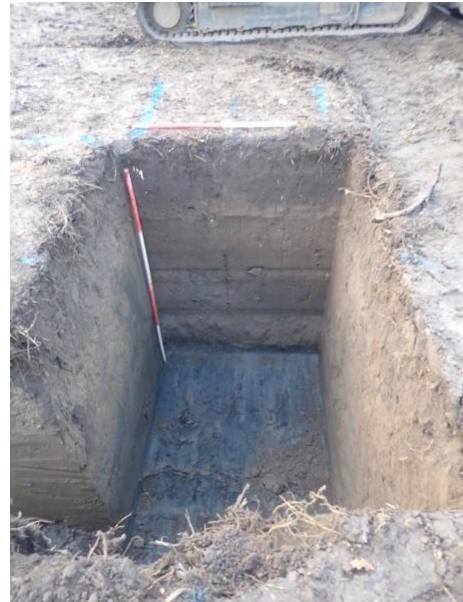
**Plate 116 :**Representative Section 13, from the north

foundation trench excavations here were stepped to reflect these greater depths. These excavations also revealed that this relict watercourse had a wide profile with an irregular approximately north-south orientated line and irregular depths. The full width of this former watercourse was not reached with its eastern side being situated beyond this new build area and further to the west. It was also established that this former watercourse was cut into a further alluvial horizon (006). The deposit sequence within this western portion of the new build area was recorded within **Representative Sections 8, 10 and 15 [Plates 56-57, 69-70 and 132]**. Where these foundation excavations attained their greatest depths at the western edge of the new build area, a further fill of this former medieval relict water course (007) was identified. This was below the upper fill (005) and appeared to have a dark and high organic content with the appearance of a former waterlogged horizon. The deposit sequence of this former medieval relict watercourse showing the basal fill (007) was recorded at depth within **Representative Section 13 [Plate 116]**. The basal fill (007) did not yield any finds.
