**Subject:** H05-0459-20 Land off Old Main Road Fleet Hargate Spalding

**Re: Supplementary Soil Sampling – Old Main Road, Fleet Hargate**

**Plan Showing Approximate Location of Monitoring Wells  
(Figure No. D37124/G1)**

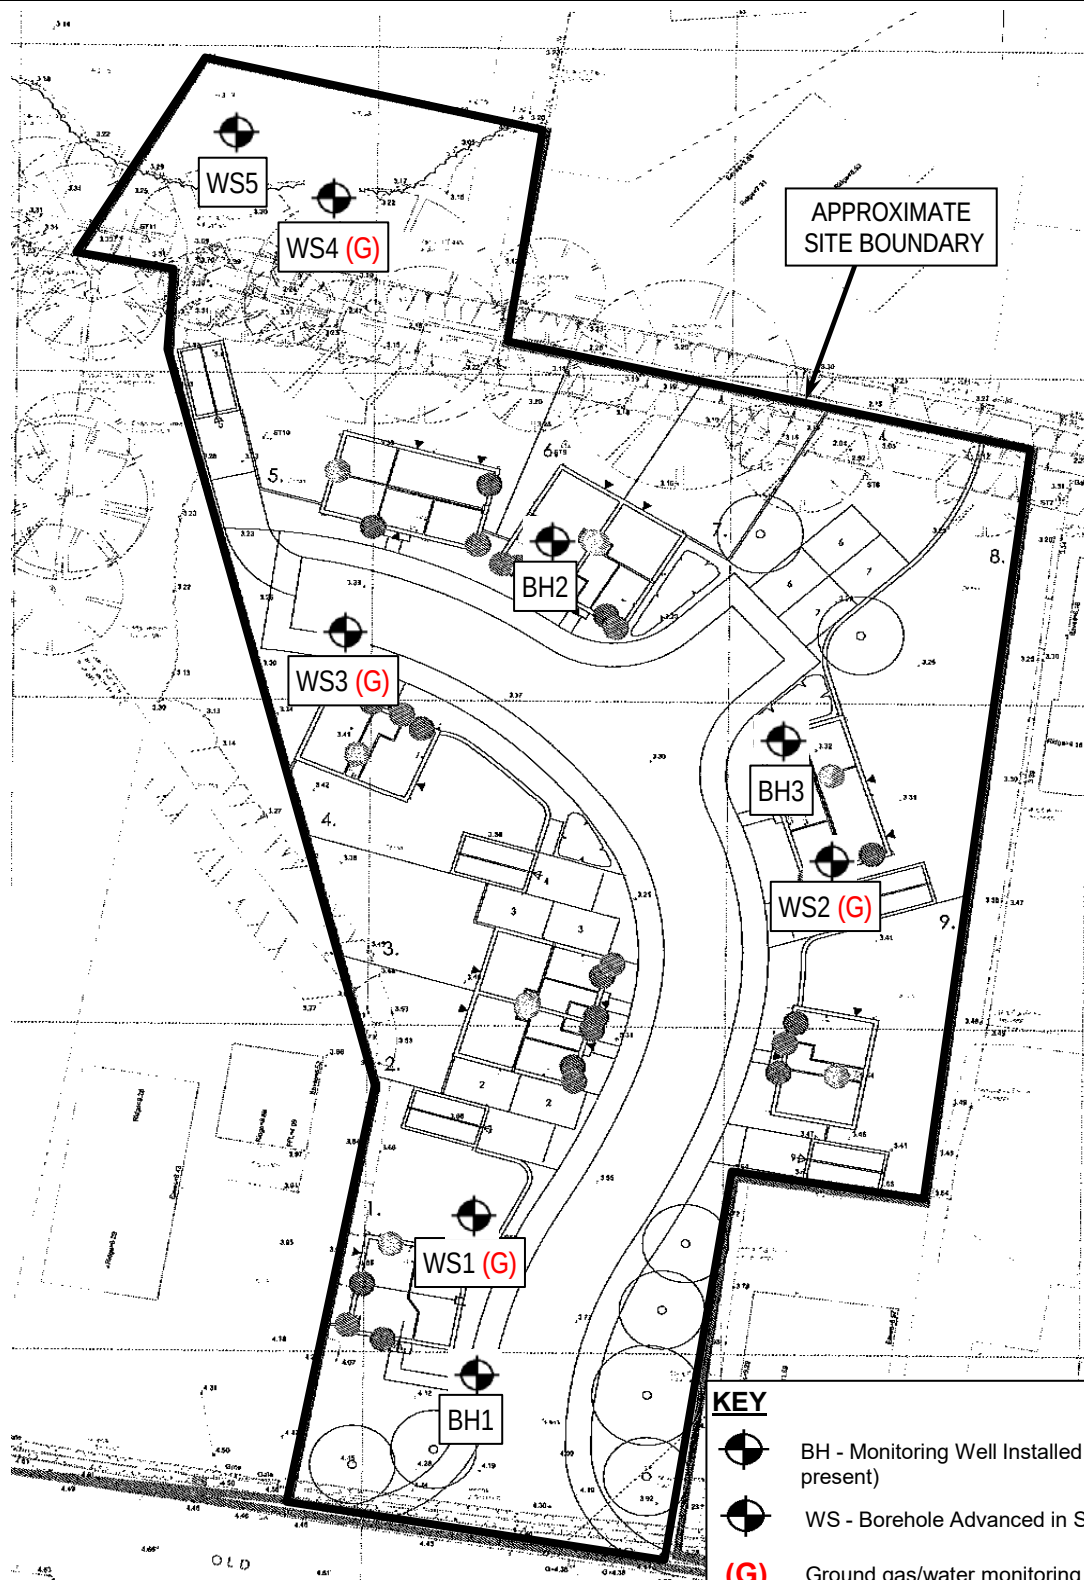
Boreholes WS4 and WS5 were advanced in the northern extremity of the site (within the proposed rear garden area to Plot 5) in an attempt to target the former location of the historical pond. A plan showing the approximate locations of the boreholes is presented in Appendix II of this report (Figure No. D37124/G1).

REPRODUCED FROM THE DRAWING ENTITLED 'CONSTRUCTION SITE LAYOUT'. PRODUCED BY STUDIO 11 ARCHITECTS, DRAWING NO. 356.CSL.01, DATED 30.01.2019. USED EDITED AND REPRODUCED WITH THE PERMISSION OF THE CLIENT.
