**Re:H06-0372-21 & H06-0772-19: Erection of Dwelling In Association With Existing Plant Hire Business: Contaminated Land – Supplemental Ground Gas Risk Assessment.**

**Location: Tilsons Yard, Black Barn, Gedney Drove End.**

**0665-L1 Comments [SHDC Planning Portal] SHDC Environmental Health Tilsons Yard, Black Barn, Gedney Drove End PE12 9PA for Mr & Mrs Parnell.**

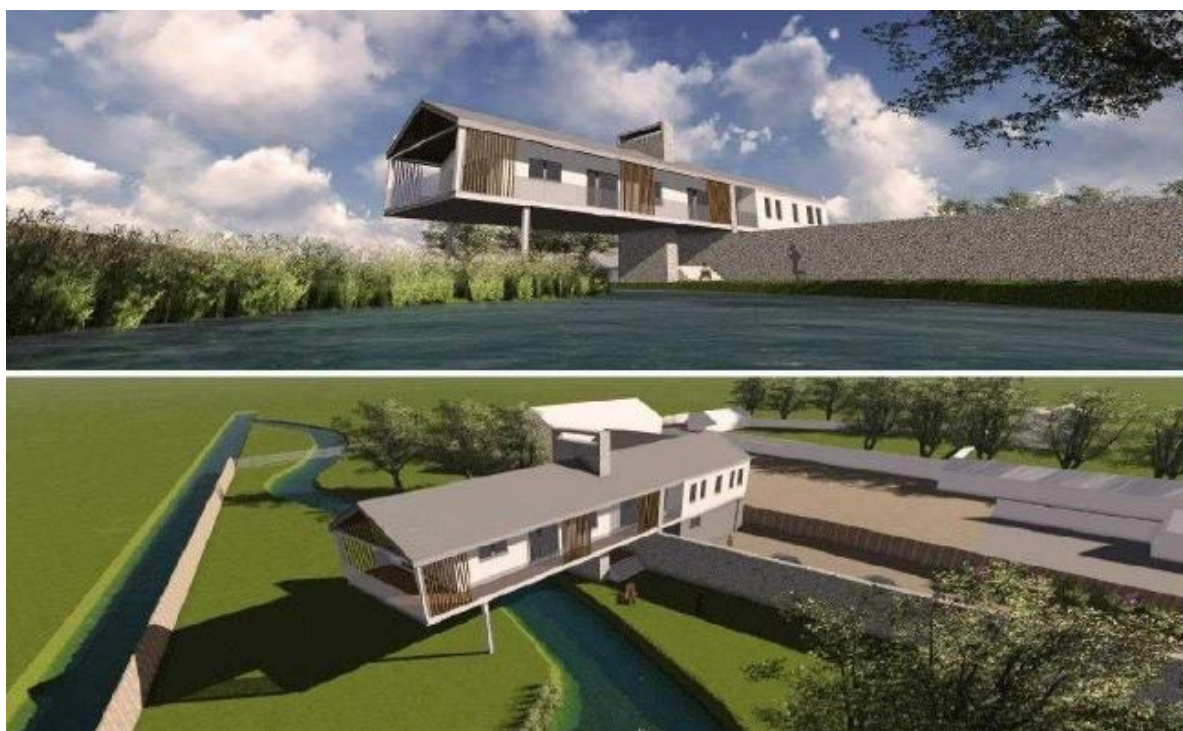
The proposed residential development comprises a single dwelling, which, due to flood risk matters will have minimal ground floor accommodation i.e. predominantly first floor living with bedrooms and living areas **raised** to first floor level [anecdotally] understood to be by 'a least a metre'. The significance of this is that much of the footprint of the dwelling will not be in contact with the [potentially] ground gas bearing soils. Discussion with the Architect suggested that this **raised area will comprise approximately 75%** of the building footprint **leaving only [approximately] 25% in contact with the ground**, and this 25% will have minimal occupancy. The following [Third Party] images have been taken from the Design & Access Statement obtained from the SHDC Planning Portal to illustrate this aspect of the proposed development.

1. Only approximately 25% of the building footprint will be 'ground bearing' thus in contact with soils at the site.
2. This part of the building will be as Utility Room and Garage and therefore the use of these areas may be considered 'minimal occupancy' compared to the bedrooms and living space the latter of which are raised off the ground by approximately 1metre [ventilated] as shown in the elevation above.

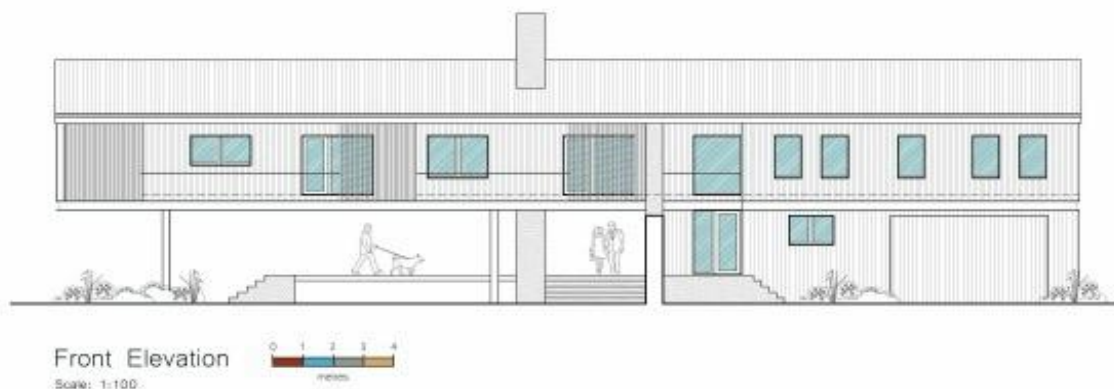
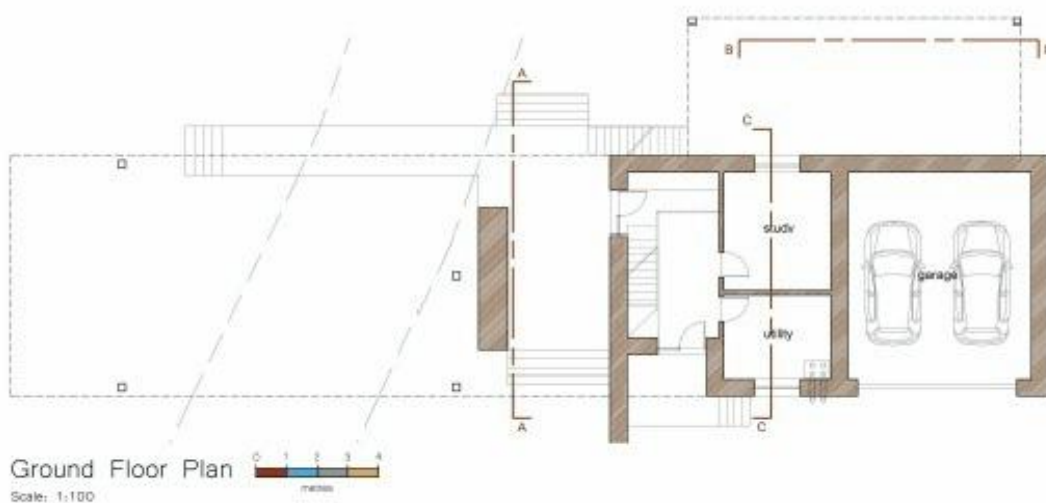
The following two images have been included to assist the Reader and illustrate more clearly the 'ground contact' area of the proposed building. It is understood that the ground contact area of the dwelling will accommodate a Utility Room and a Garage.

It is reasonably anticipated that the proposed ground gas protection measures for the new dwelling which comprise a ventilated subfloor void supporting the 25% of the footprint which is in contact with the ground and a membrane [datasheet and installers

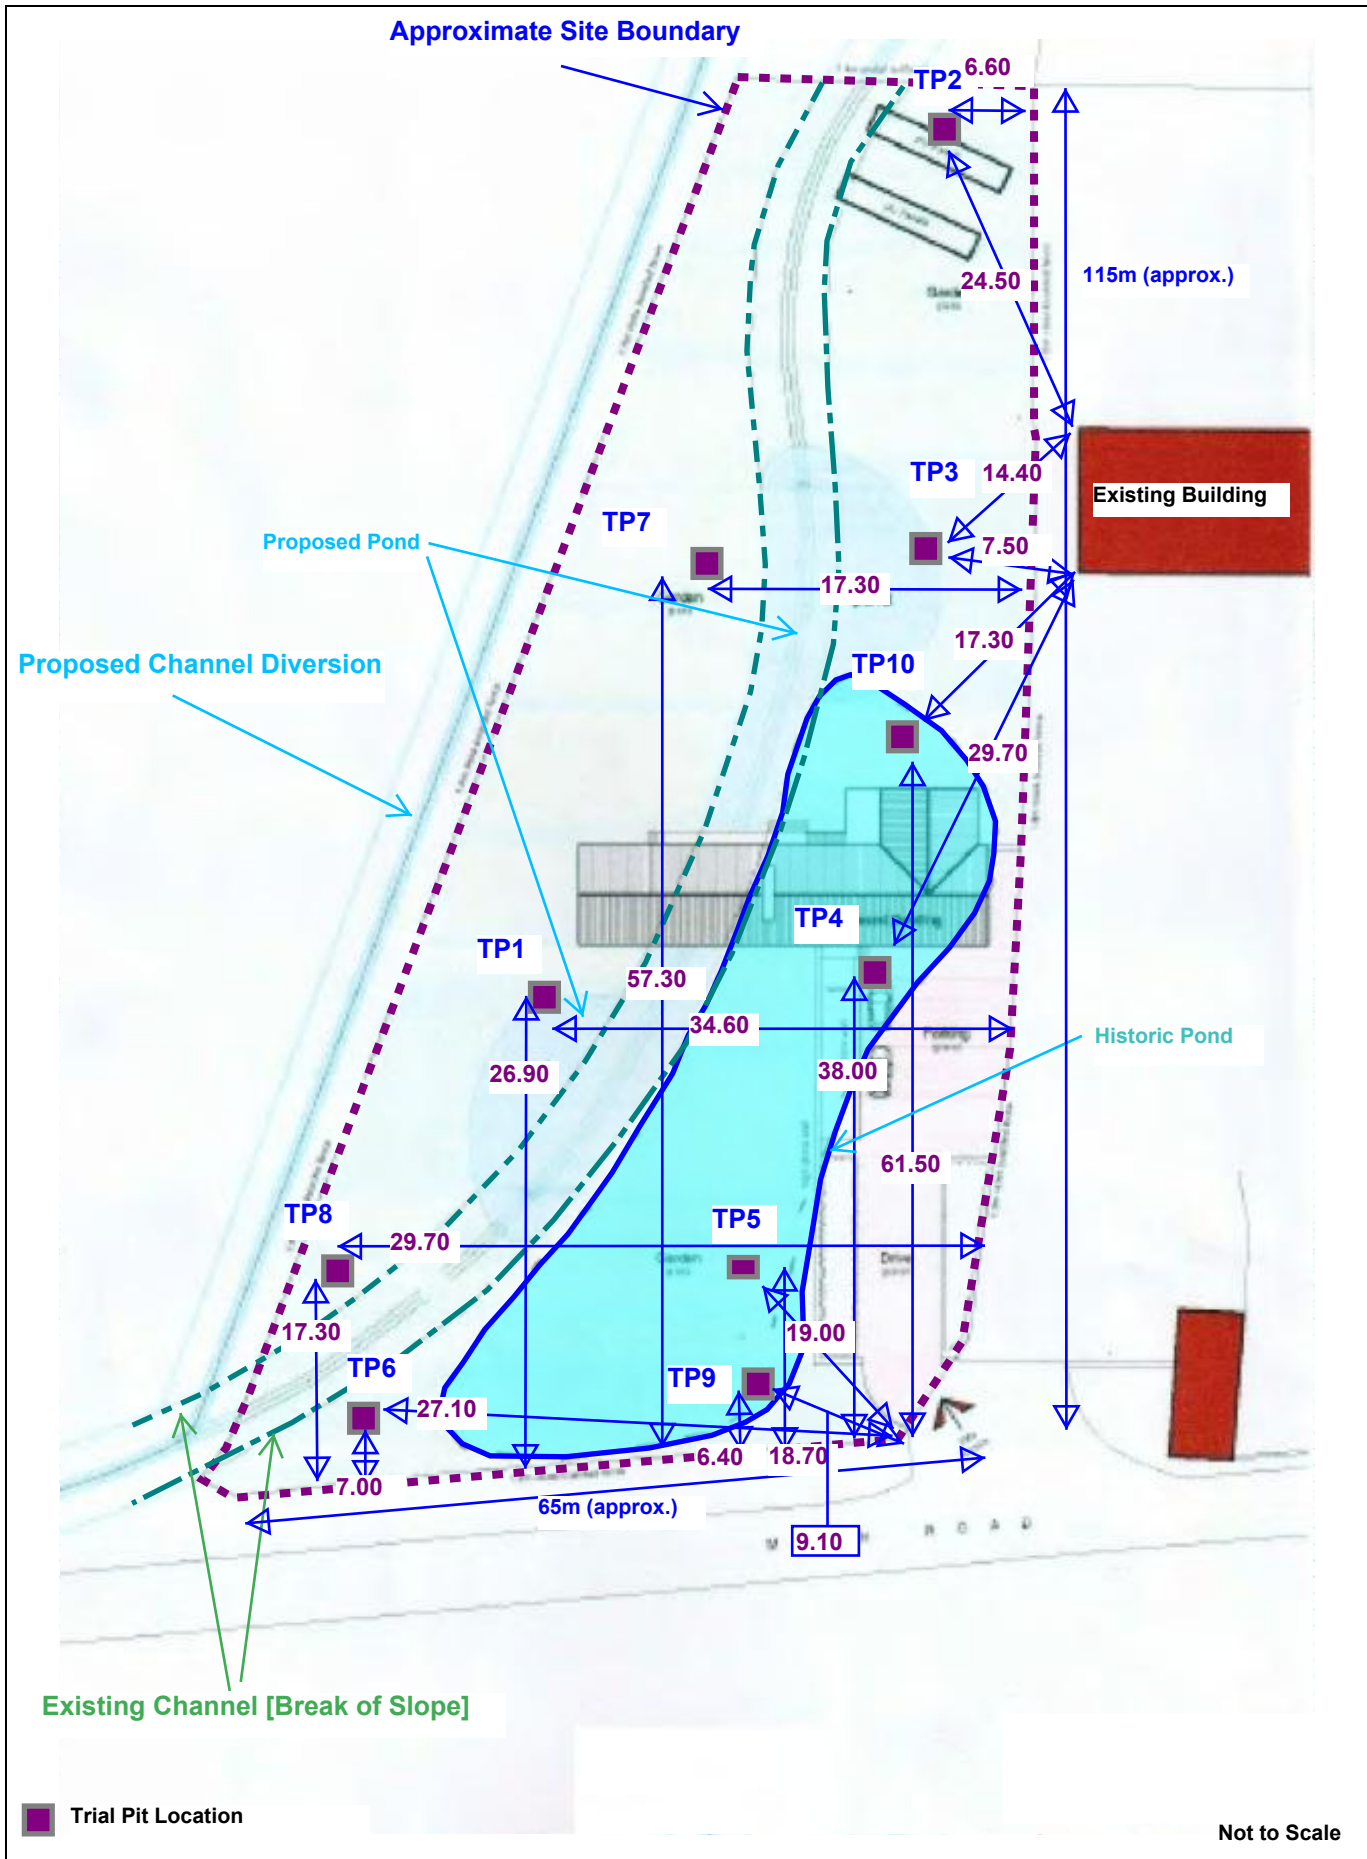
**Figure 2**

**Exploratory Location Plan  
(Over Proposed Layout)**

In this instance the referred images have been provided in Appendix 1, which accompanies this letter report. For the convenience of the Reader, the trial pit location plan from the Phase 2 Report has also been included to allow easy reference of the trial pit locations within the Application area.

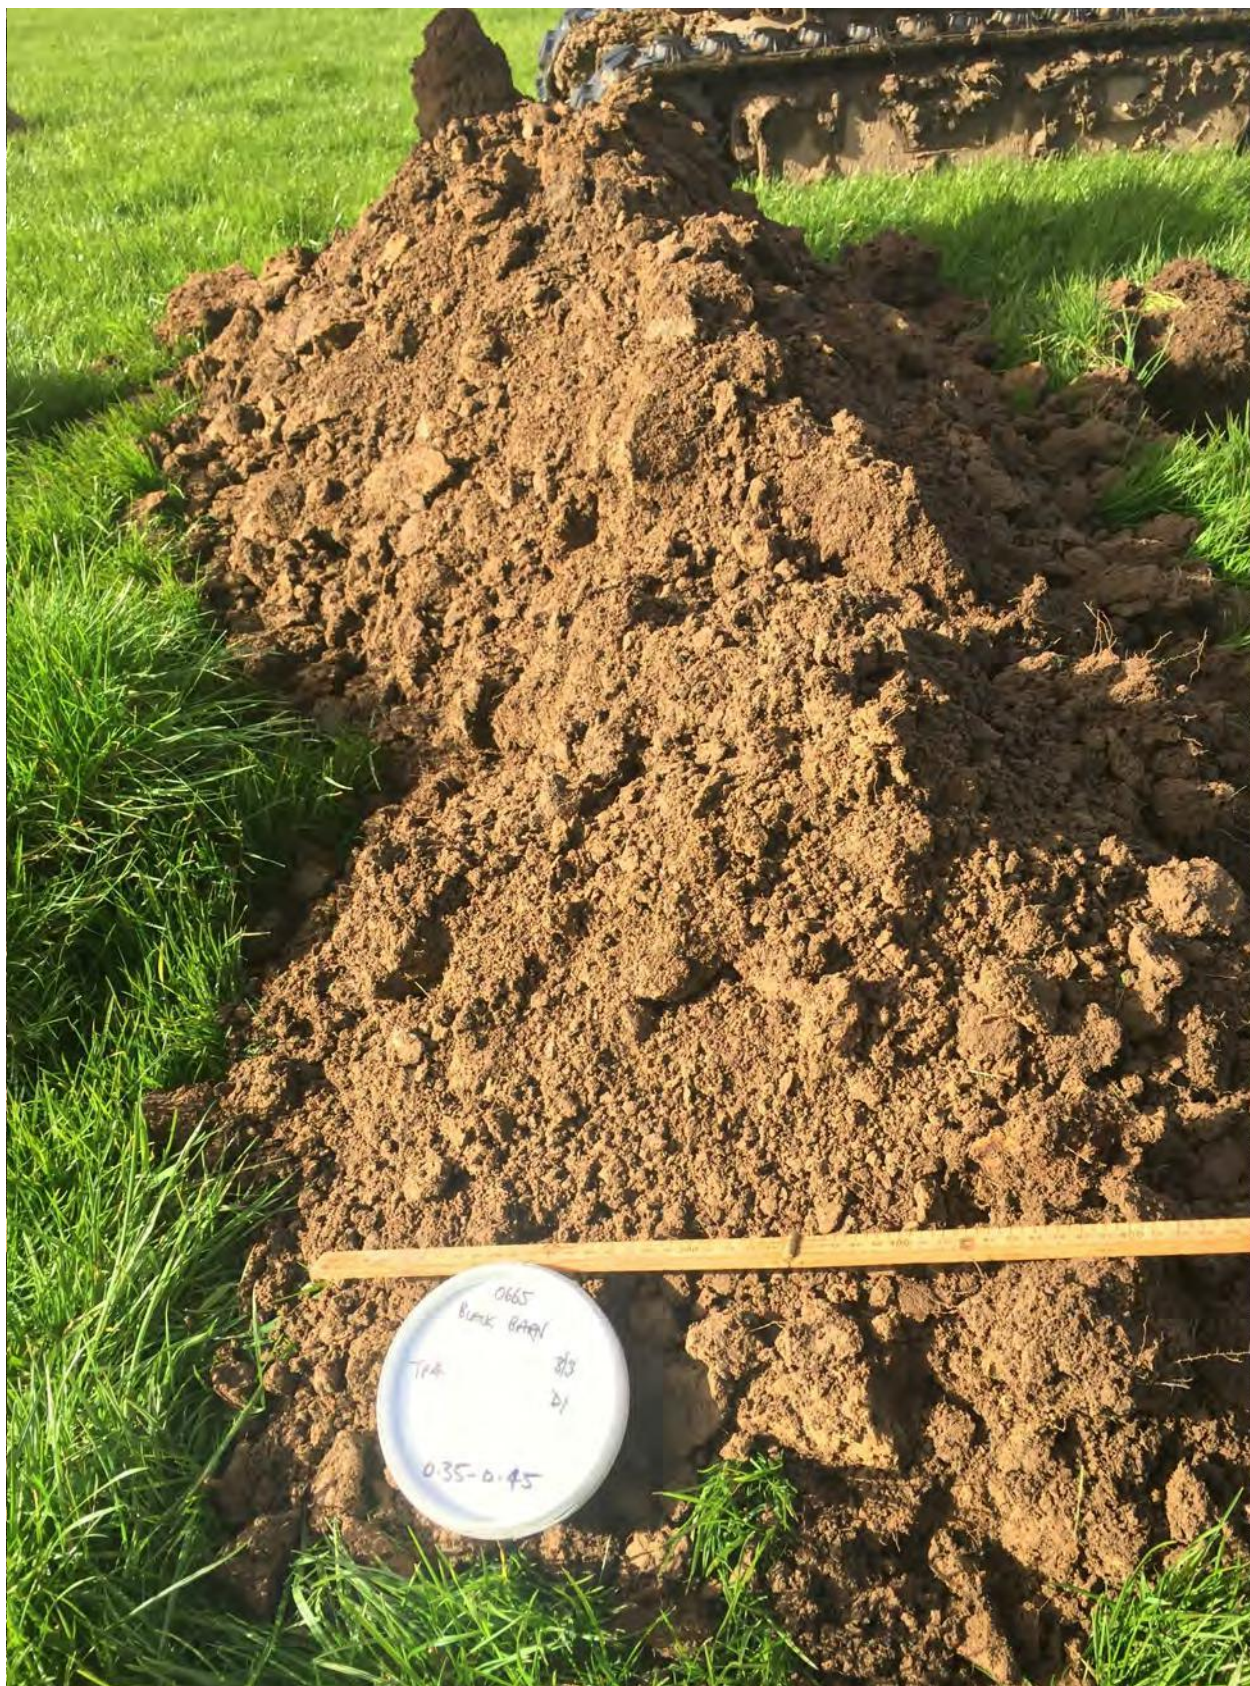
Plate 4ii

| Depth | Description | Sampling depth (m) | Remarks |
|---|---|---|---|
| 0.01 | Loose dark brown slightly sandy slightly clayey Silt | D1 = 0.35-0.45 | Horizon not fully penetrated |

1. Groundwater not encountered.
2. No apparent indicators of contamination [inc. Made Ground].
3. Location terminated at 850mm.

Trial Pit 4

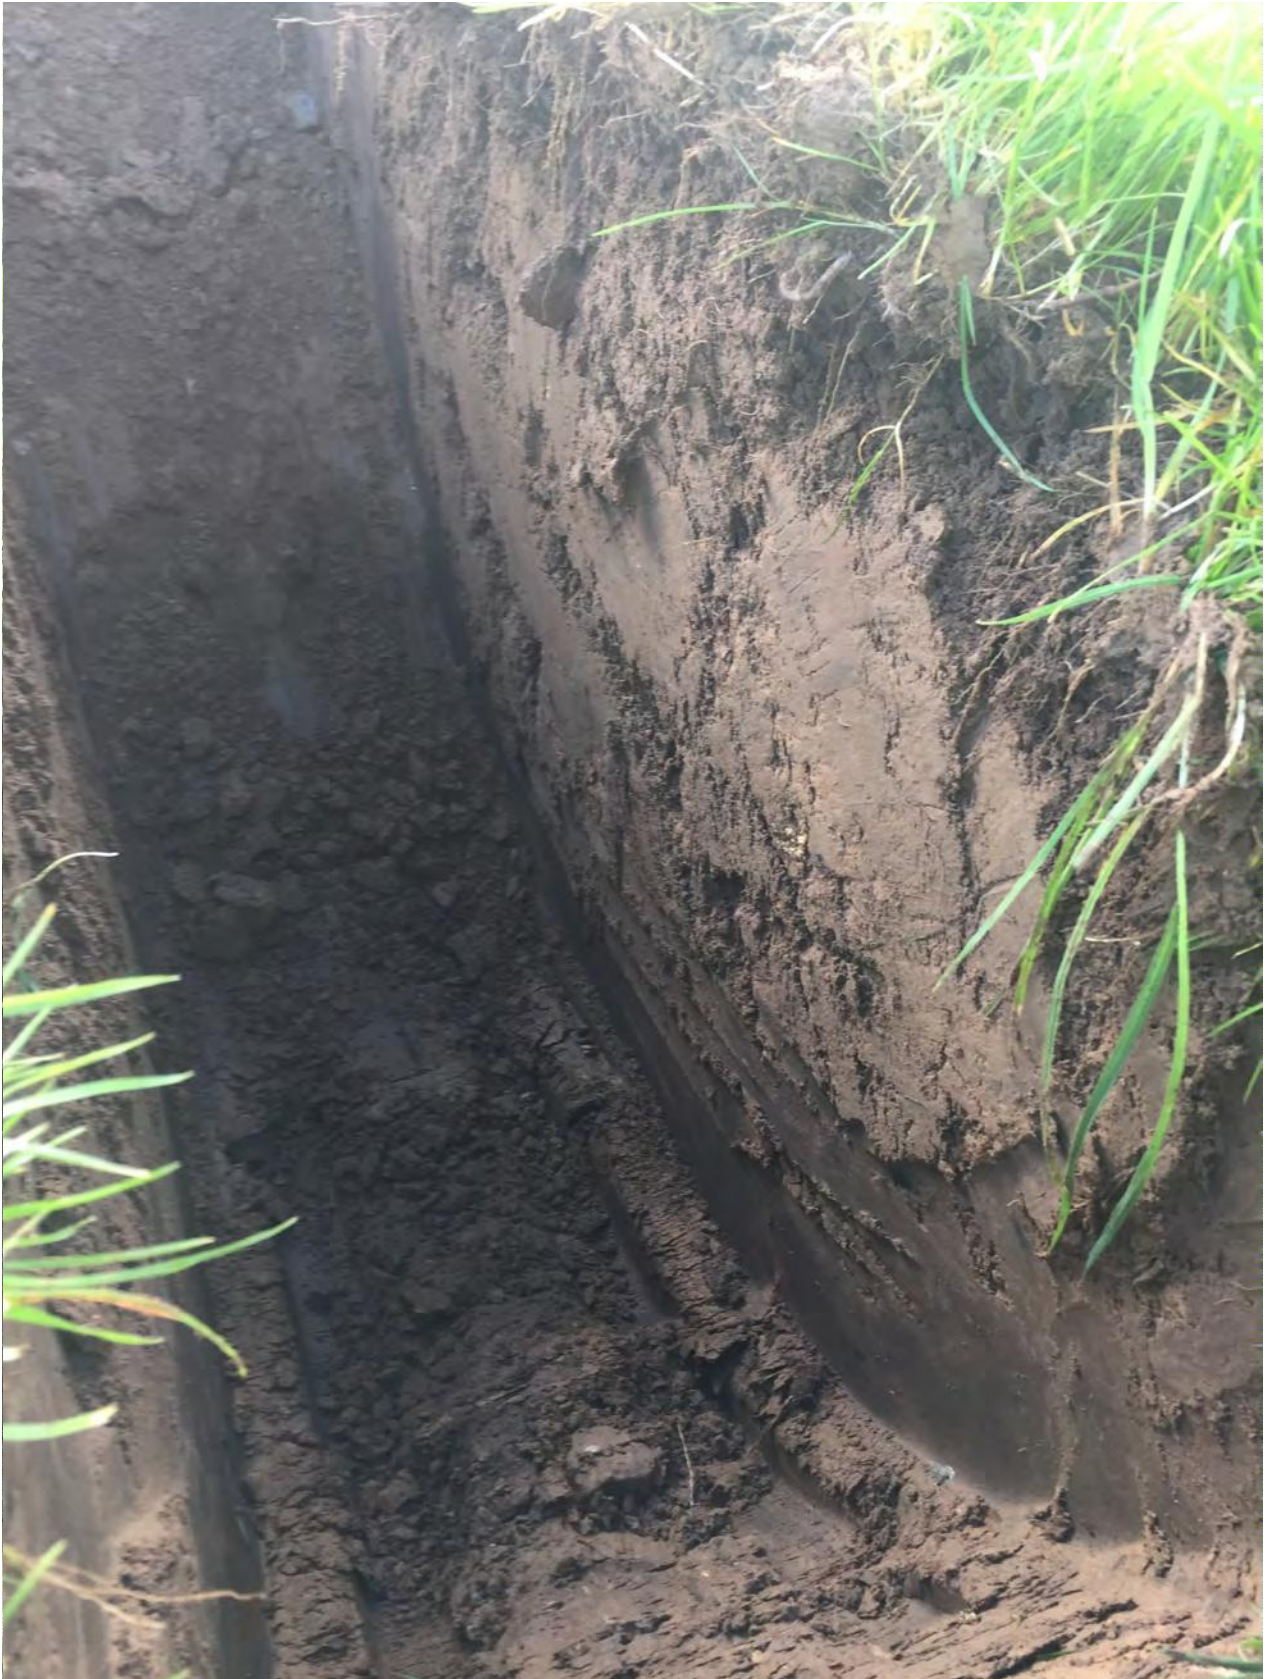
**Plate 6i**

| Depth | Description | Sampling depth (m) | Remarks |
|---|---|---|---|
| 0.01 | Loose dark brown slightly sandy slightly clayey Silt | D1 = 0.20-0.30 | Horizon not fully penetrated |

1. Groundwater not encountered.
2. No apparent indicators of contamination [inc. Made Ground].
3. Location terminated at 750mm.

**Trial Pit 6**

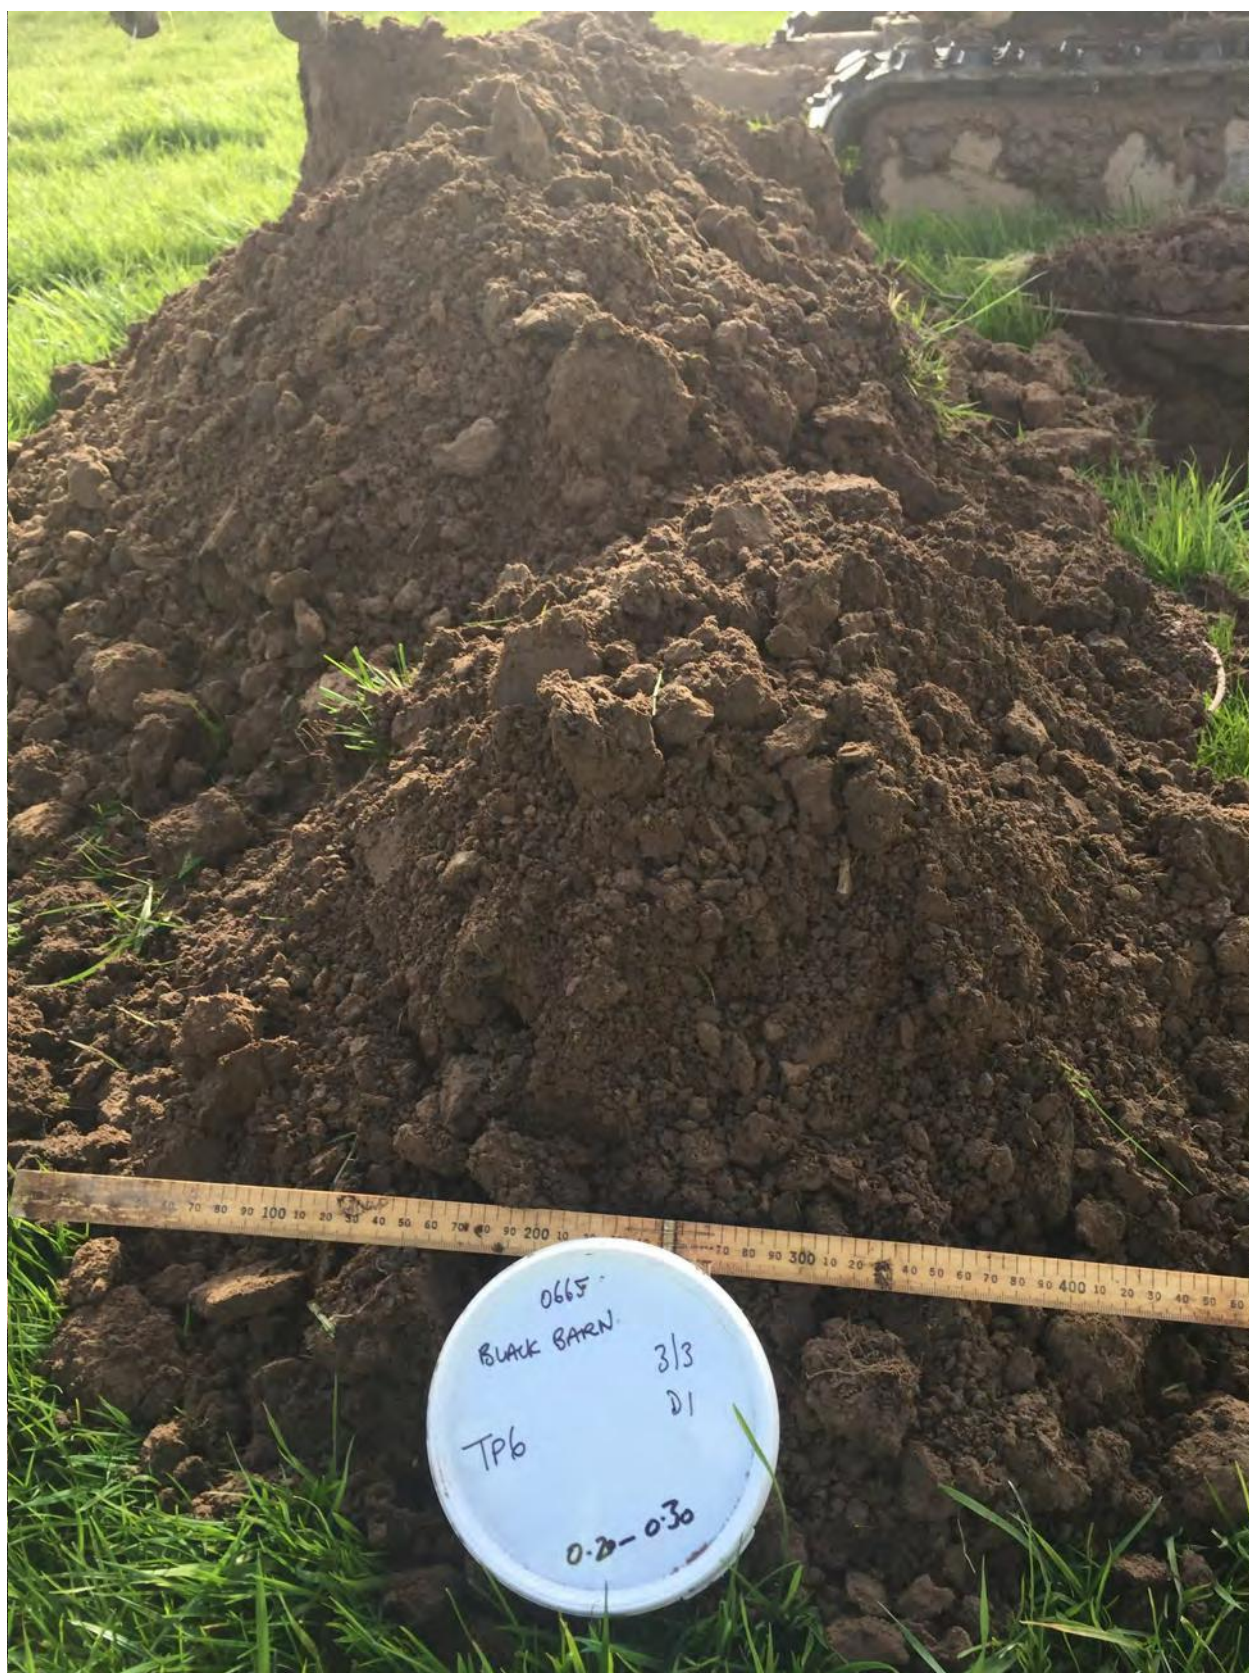
Plate 6ii

Trial Pit 6

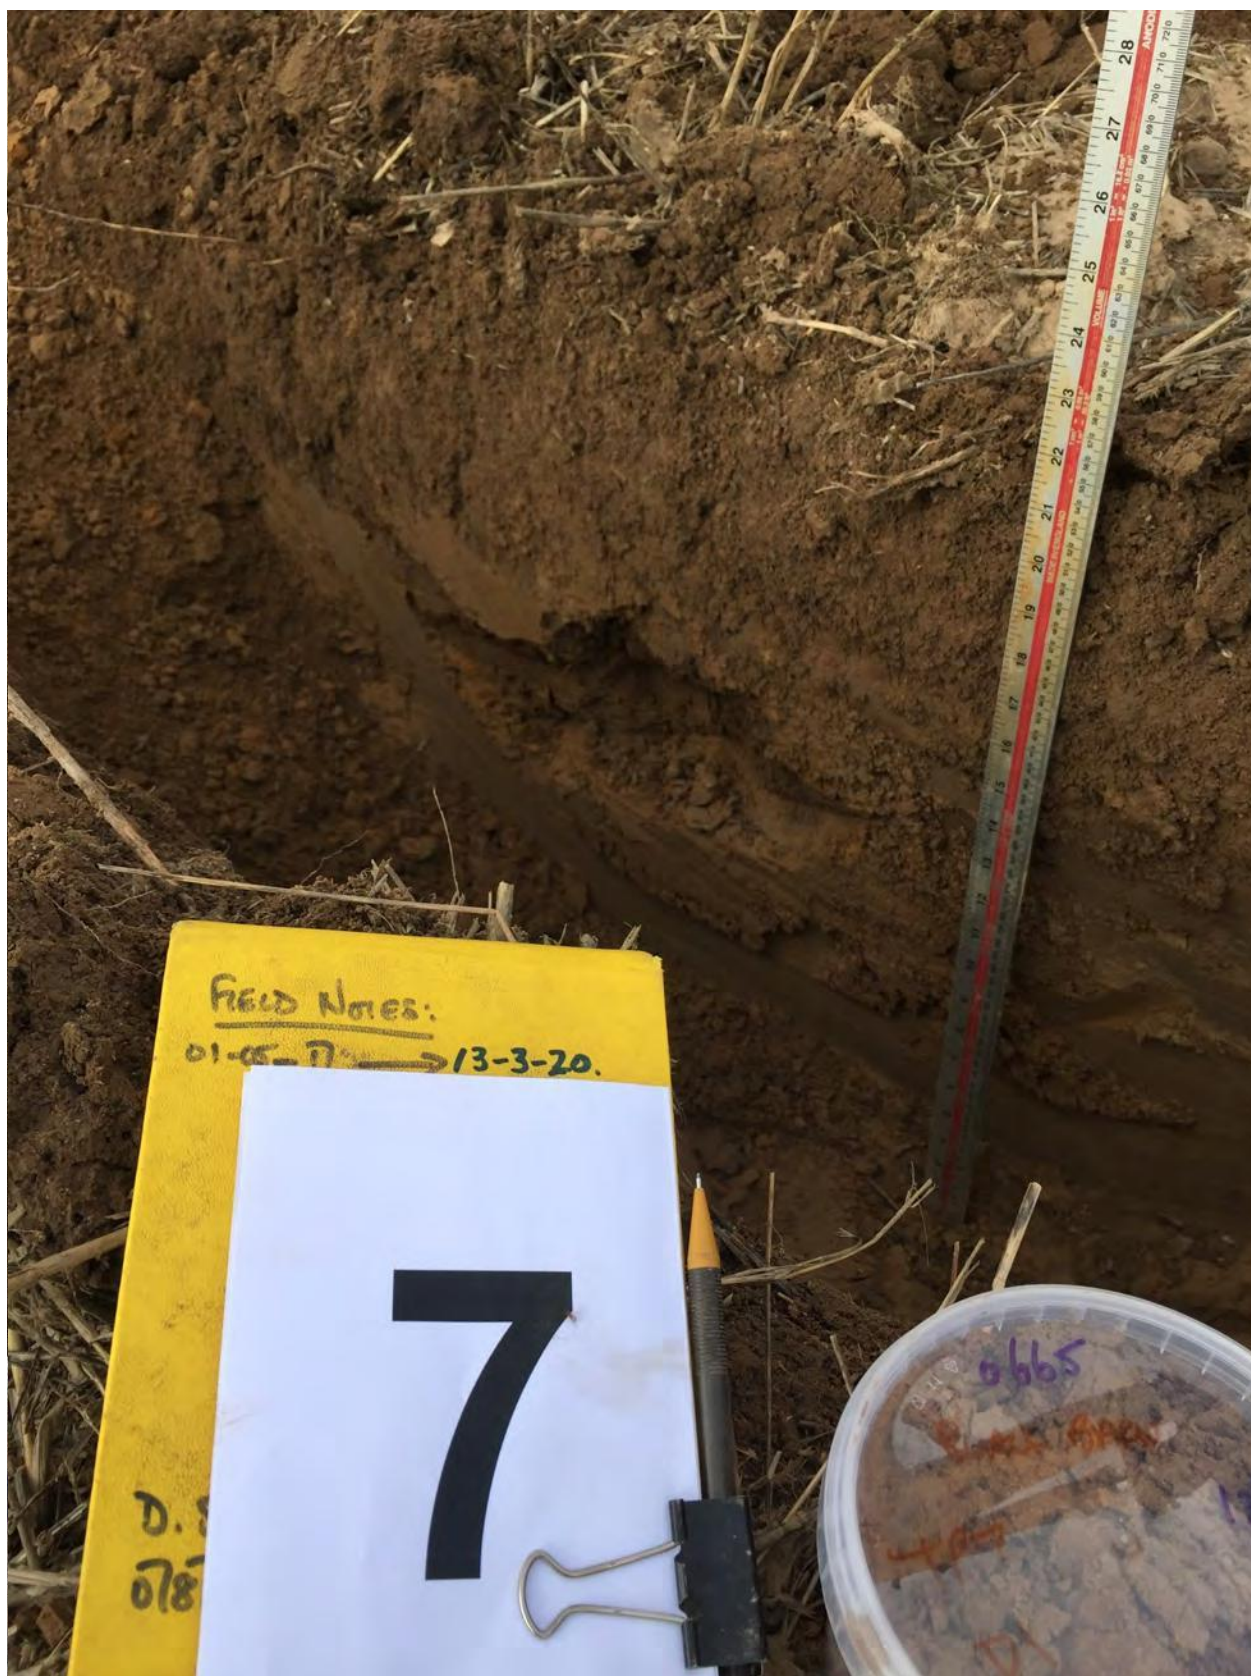
Plate 7i

| Depth | Description | Sampling depth (m) | Remarks |
|---|---|---|---|
| 0.01 | Loose dark brown slightly sandy slightly clayey Silt | D1 = 0.30-0.40 | Horizon not fully penetrated |

1. Groundwater not encountered.
2. No apparent indicators of contamination [inc. Made Ground].
3. Location terminated at 600mm.

Trial Pit 7

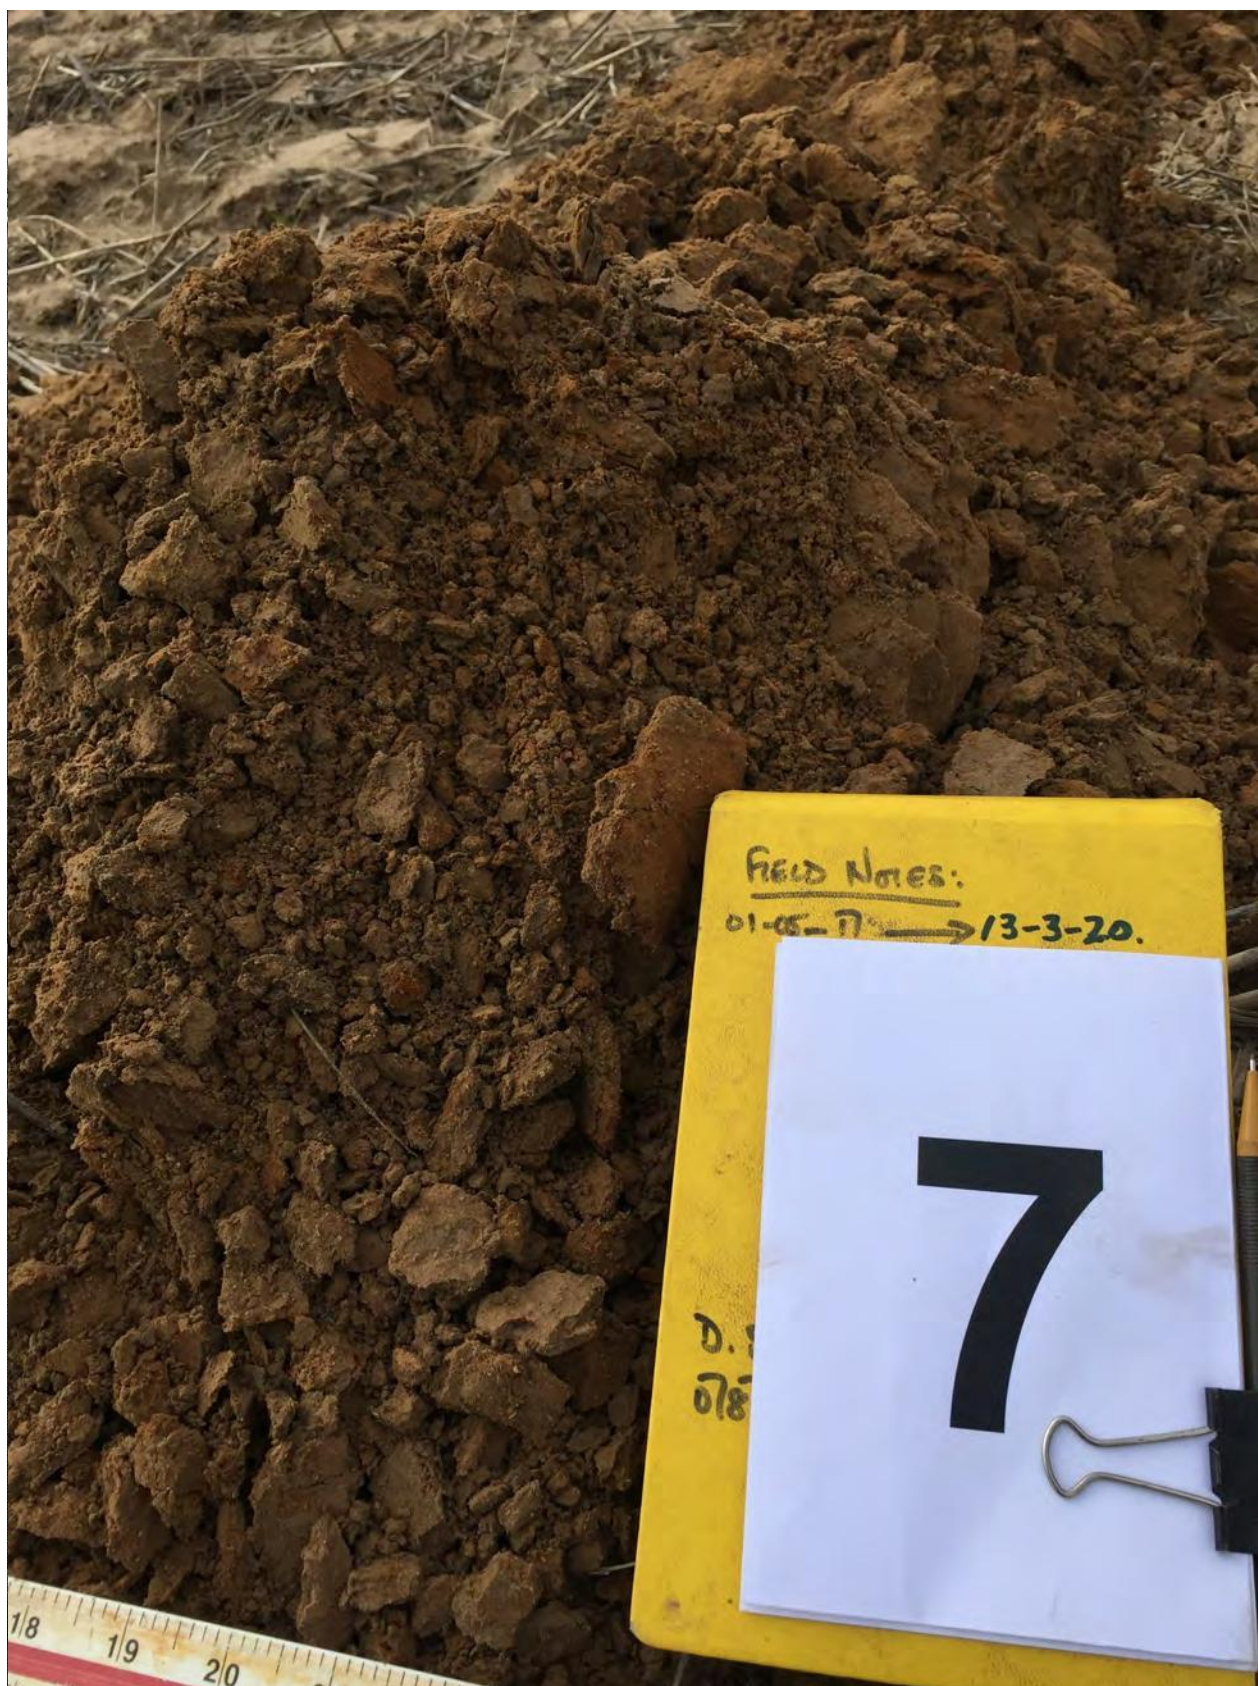
Plate 7ii

Trial Pit 7

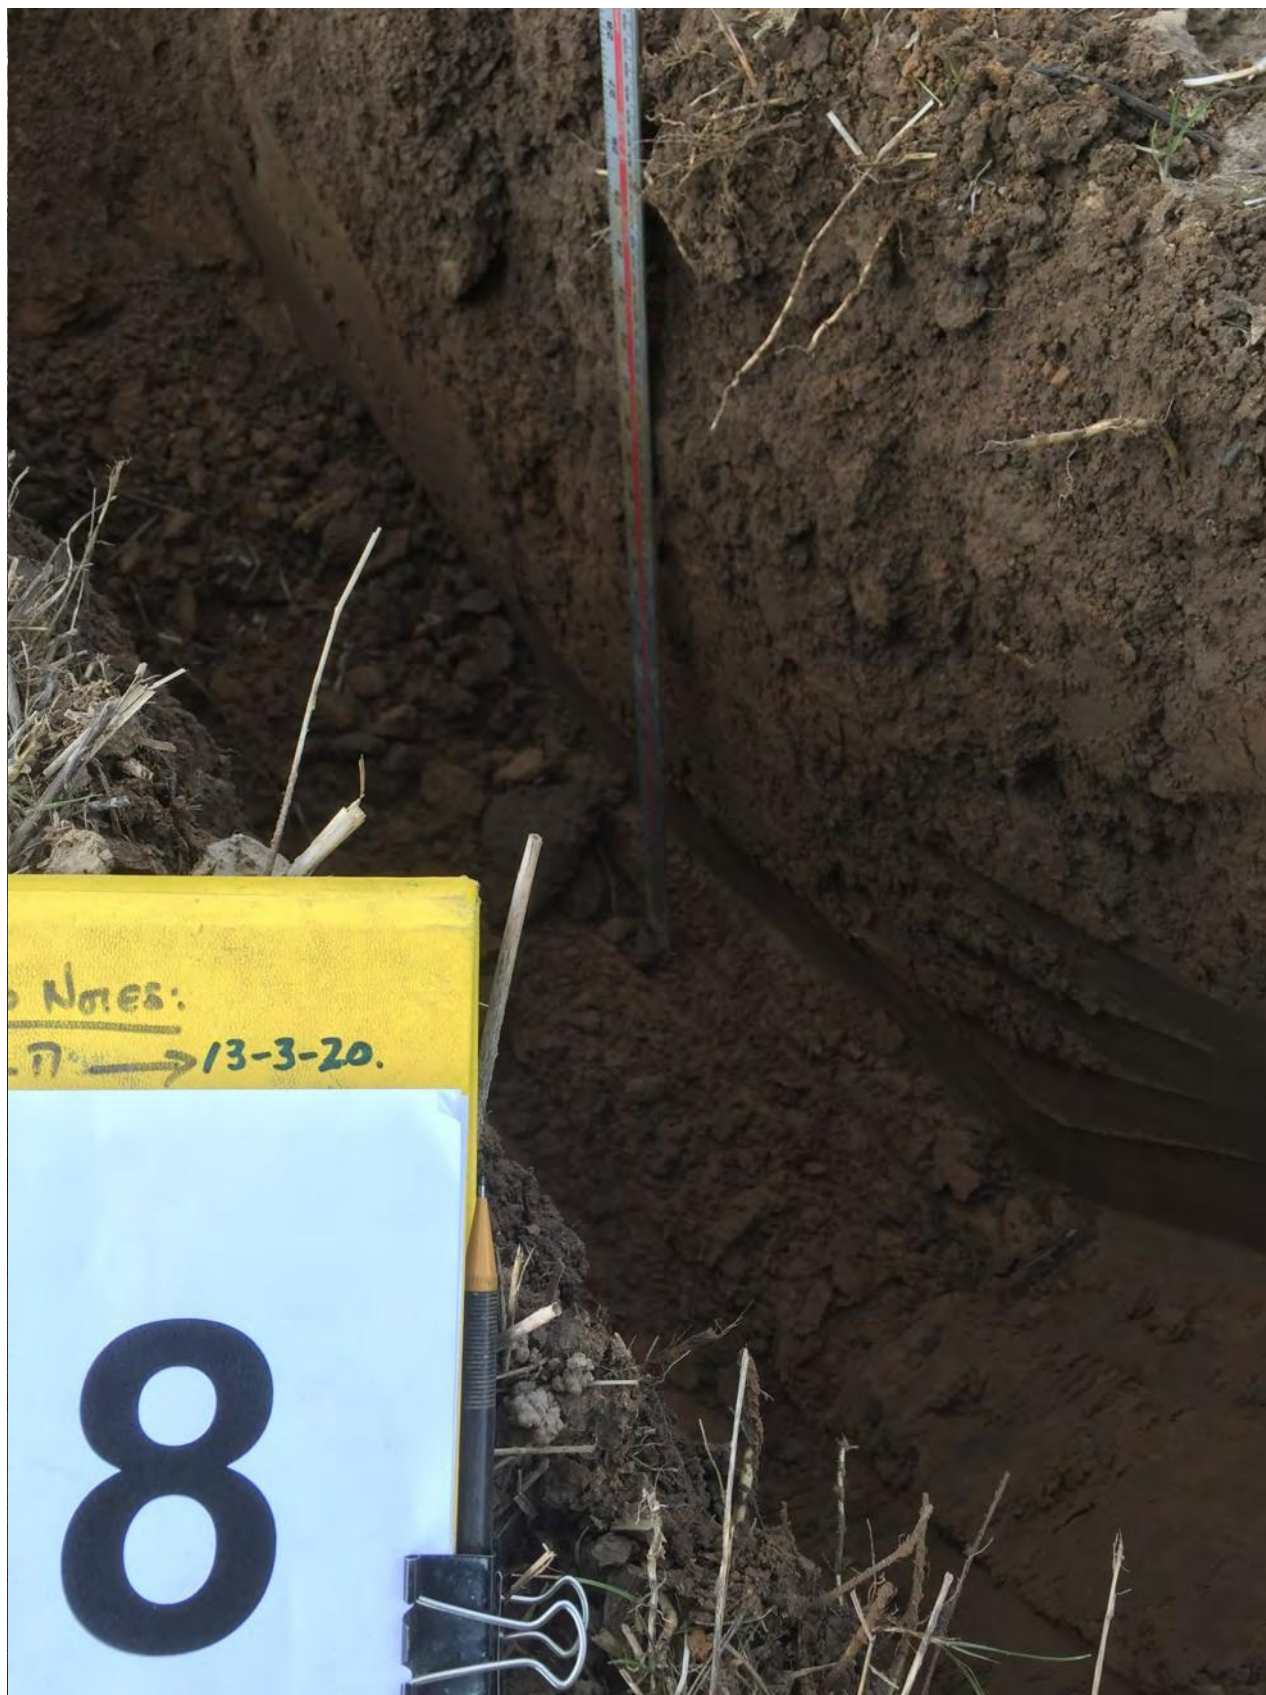
Plate 8i

| Depth | Description | Sampling depth (m) | Remarks |
|---|---|---|---|
| 0.01 | Loose dark brown slightly sandy slightly clayey Silt | D1 = 0.40-0.50 | Horizon not fully penetrated |

1. Groundwater not encountered.
2. No apparent indicators of contamination [inc. Made Ground].
3. Location terminated at 750mm.

Trial Pit 8

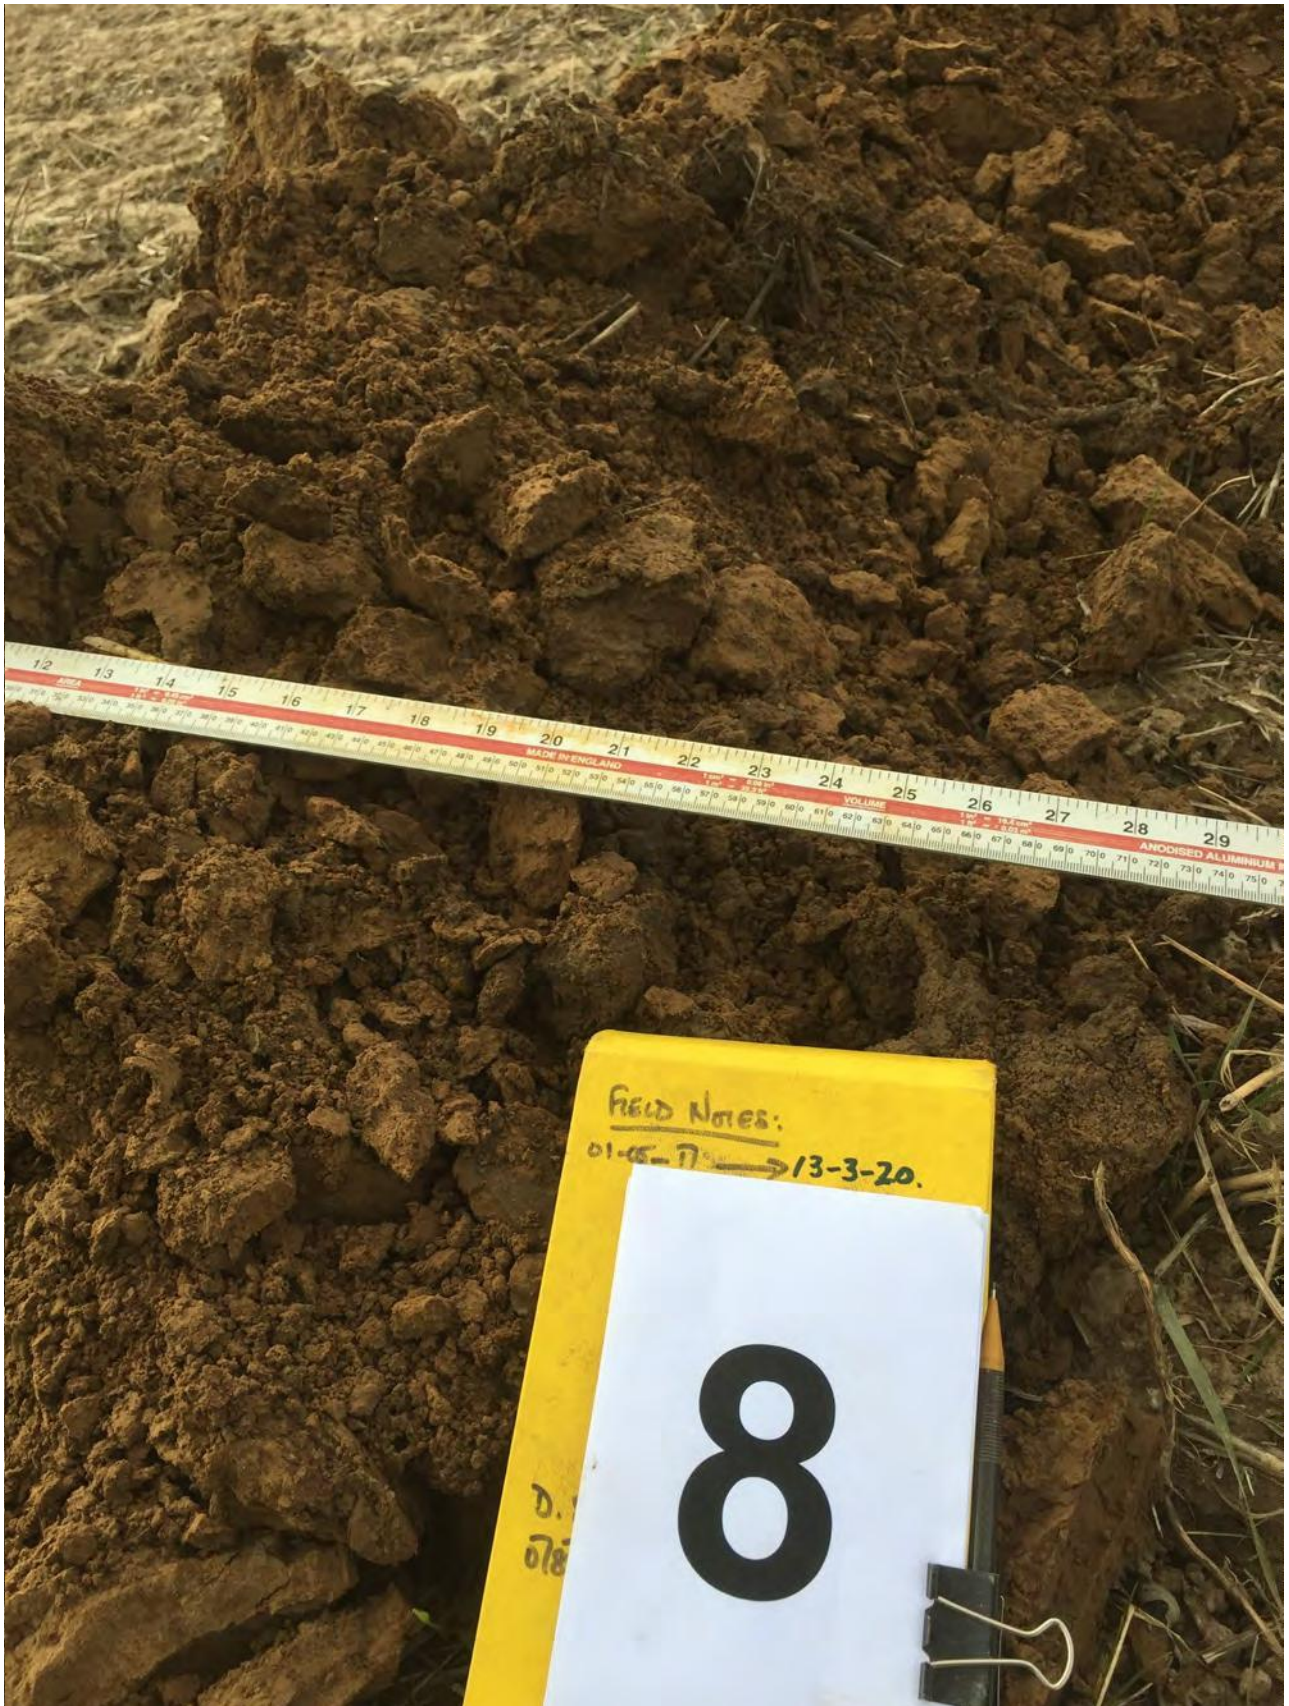
Plate 8ii

Trial Pit 8

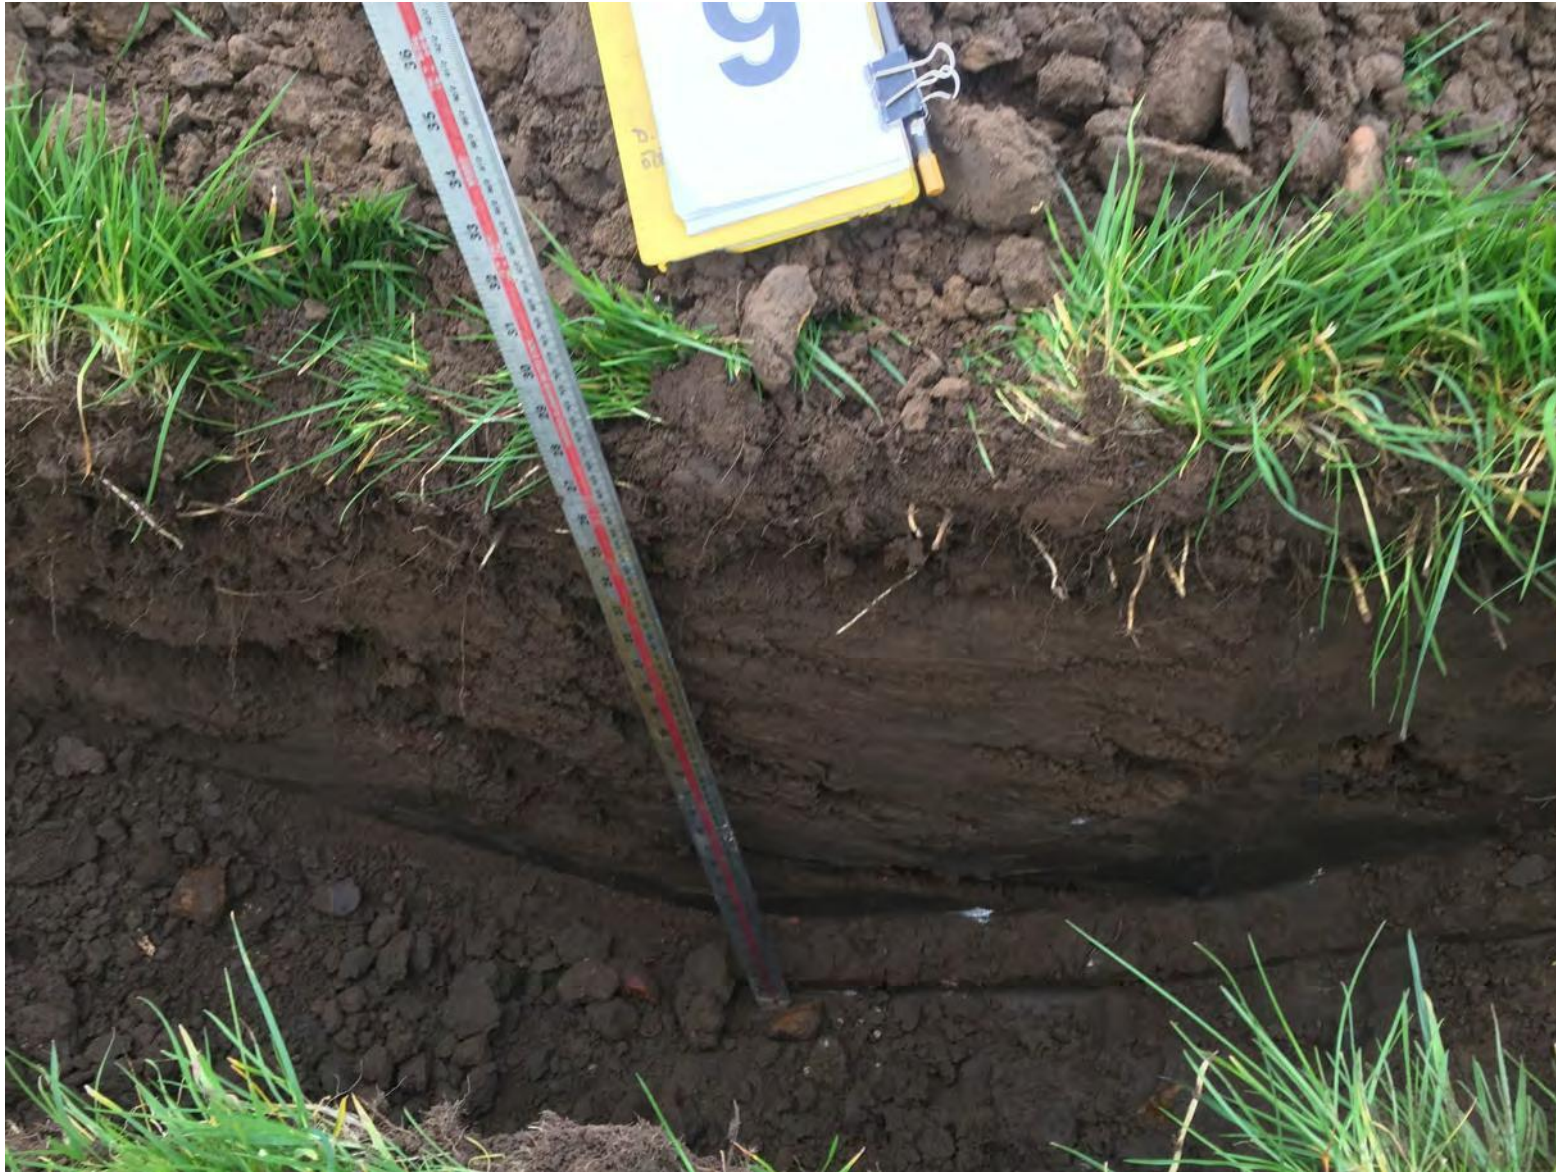
Plate 9i

| Depth | Description | Sampling depth (m) | Remarks |
|---|---|---|---|
| 0.01 | Loose dark brown slightly sandy slightly clayey Silt | D1 = 0.15-0.25 | Horizon not fully penetrated |

1. Groundwater not encountered.
2. No apparent indicators of contamination [inc. Made Ground].
3. Location terminated at 780mm.

Trial Pit 9
