**Re:H06-0372-21 & H06-0772-19: Erection of Dwelling In Association With Existing Plant Hire Business: Contaminated Land – Supplemental Ground Gas Risk Assessment.**

**Location: Tilsons Yard, Black Barn, Gedney Drove End.**

**0665-L1 Comments [SHDC Planning Portal] SHDC Environmental Health Tilsons Yard, Black Barn, Gedney Drove End PE12 9PA for Mr & Mrs Parnell.**

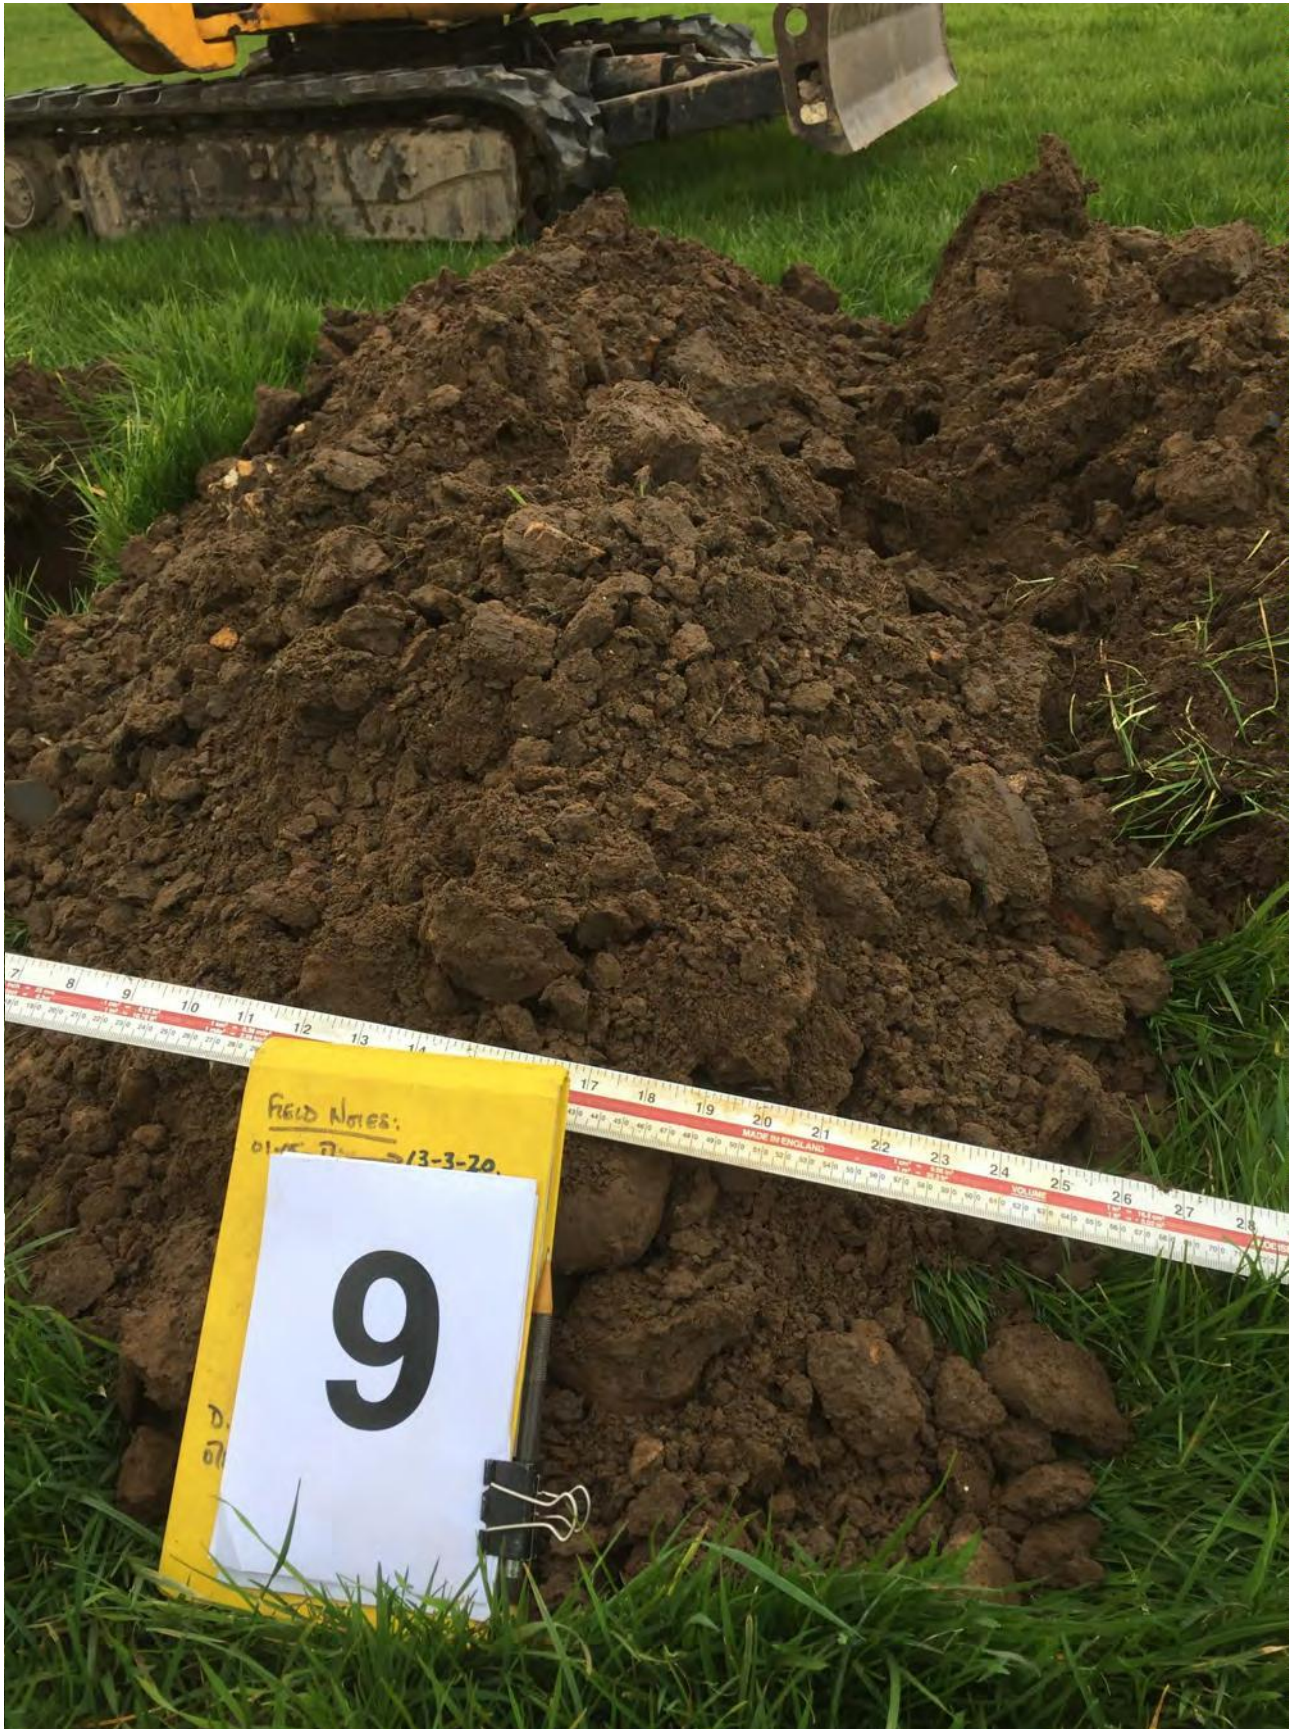
Plate 9ii

| Depth | Description | Sampling depth (m) | Remarks |
|---|---|---|---|
| 0.01 | Loose dark brown slightly sandy slightly clayey Silt | D1 = 0.15-0.25 | Horizon not fully penetrated |

1. Groundwater not encountered.
2. No apparent indicators of contamination [inc. Made Ground].
3. Location terminated at 780mm.

Trial Pit 9

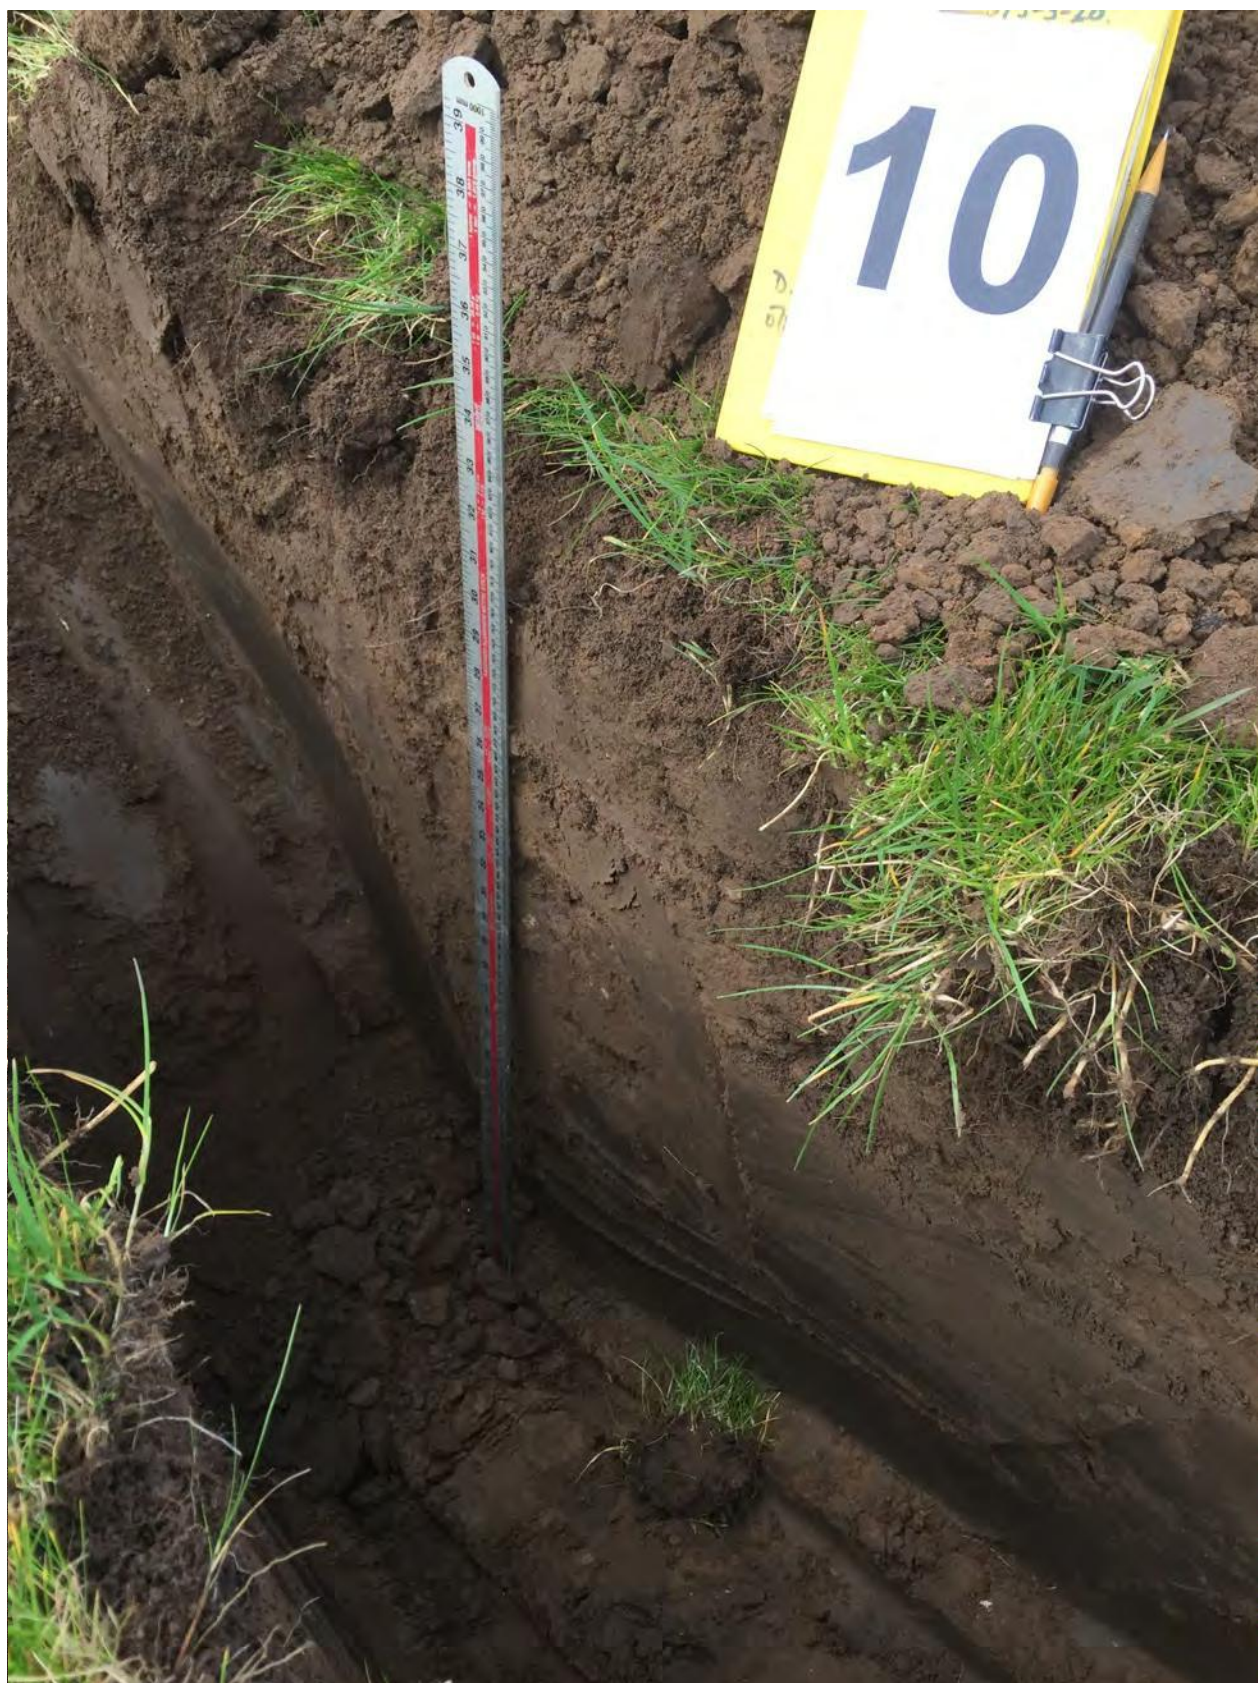
**Plate 10i**

| Depth | Description | Sampling depth (m) | Remarks |
|---|---|---|---|
| 0.01 | Loose dark brown slightly sandy slightly clayey Silt | D1 = 0.35-0.45 | Horizon not fully penetrated |

1. Groundwater not encountered.
2. No apparent indicators of contamination [inc. Made Ground].
3. Location terminated at 900mm.

**Trial Pit 10**

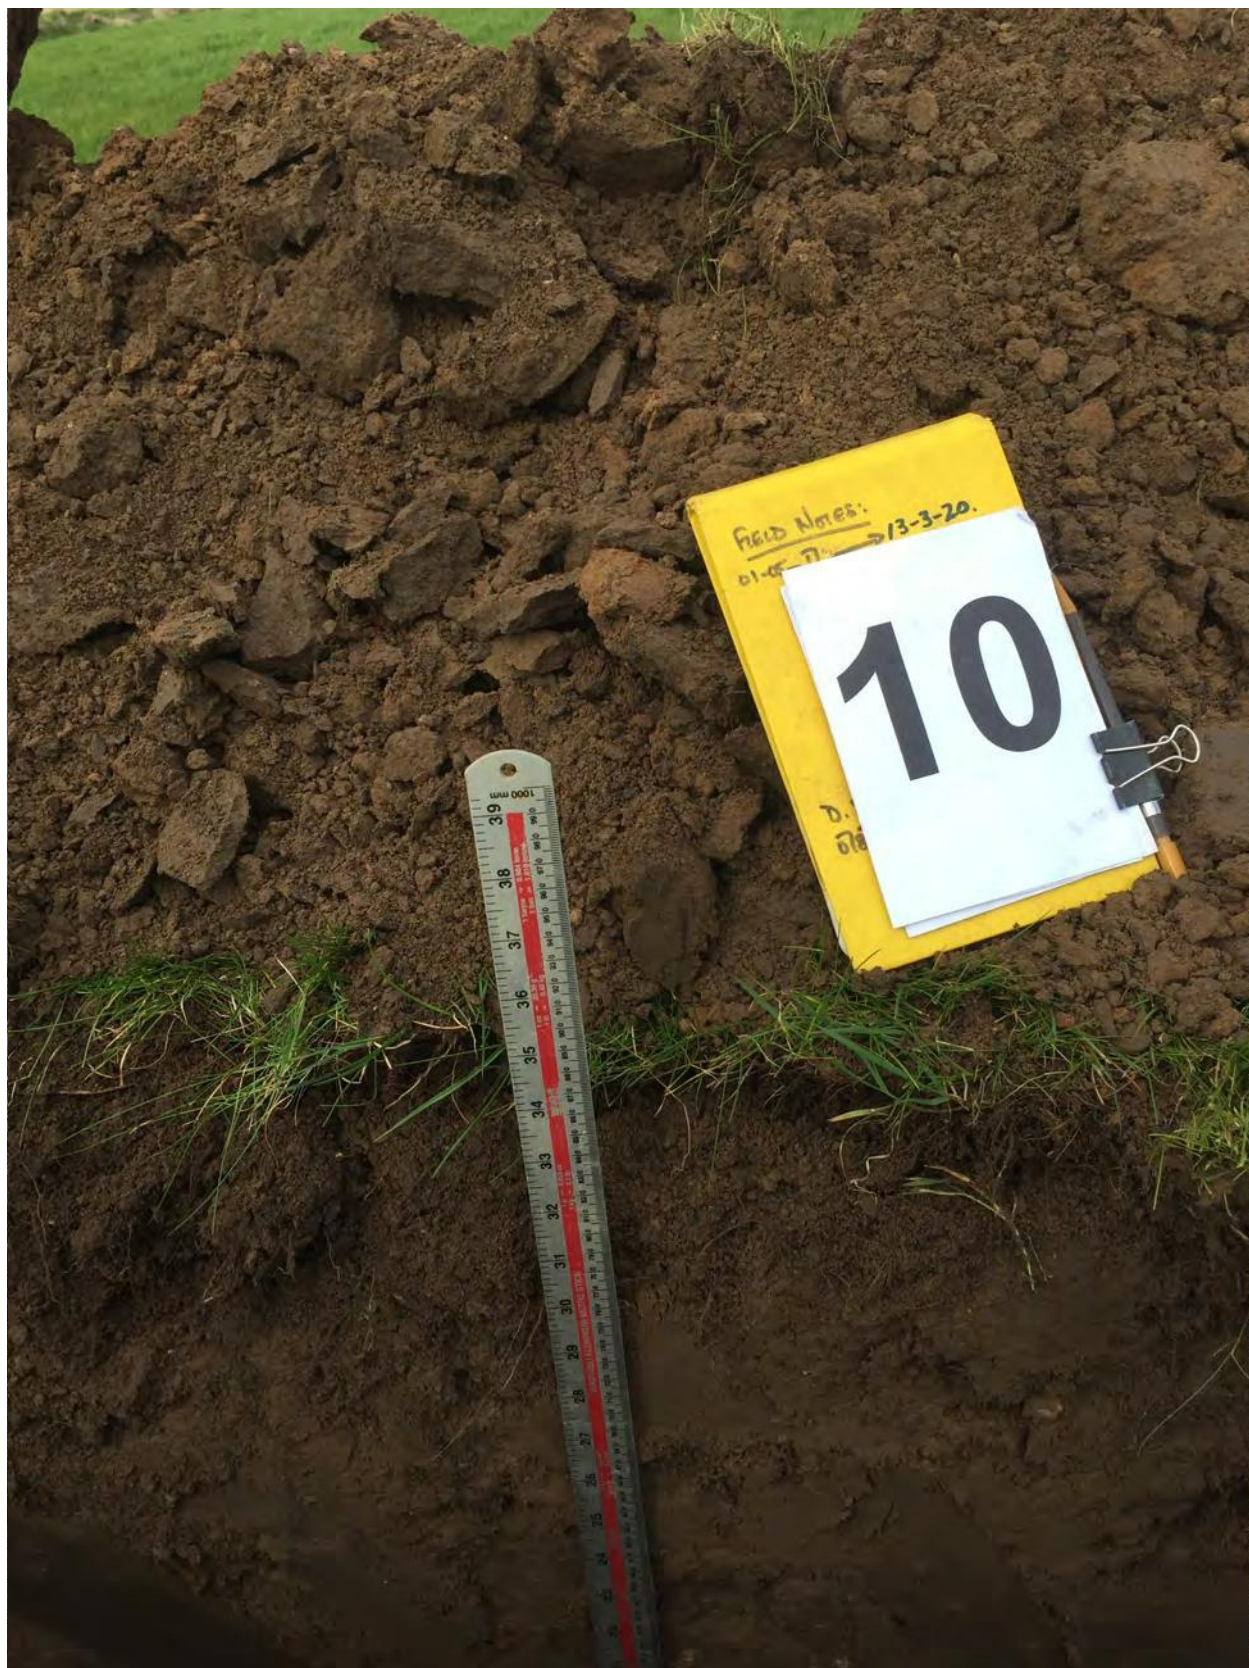
Plate 10ii

Trial Pit 10
