| Report type | Intrusive Site Investigation |
| Date | 11 May 2022 |
| Site address | Station House, Station Road, Gedney, Spalding, PE12 0DD |

The following document is a Intrusive Site Investigation carried out by Oakshire Environmental, commissioned by Mark Godfrey, and includes details of the site, sampling methodology, ground conditions, an evaluation of risk and an assessment of further investigations.

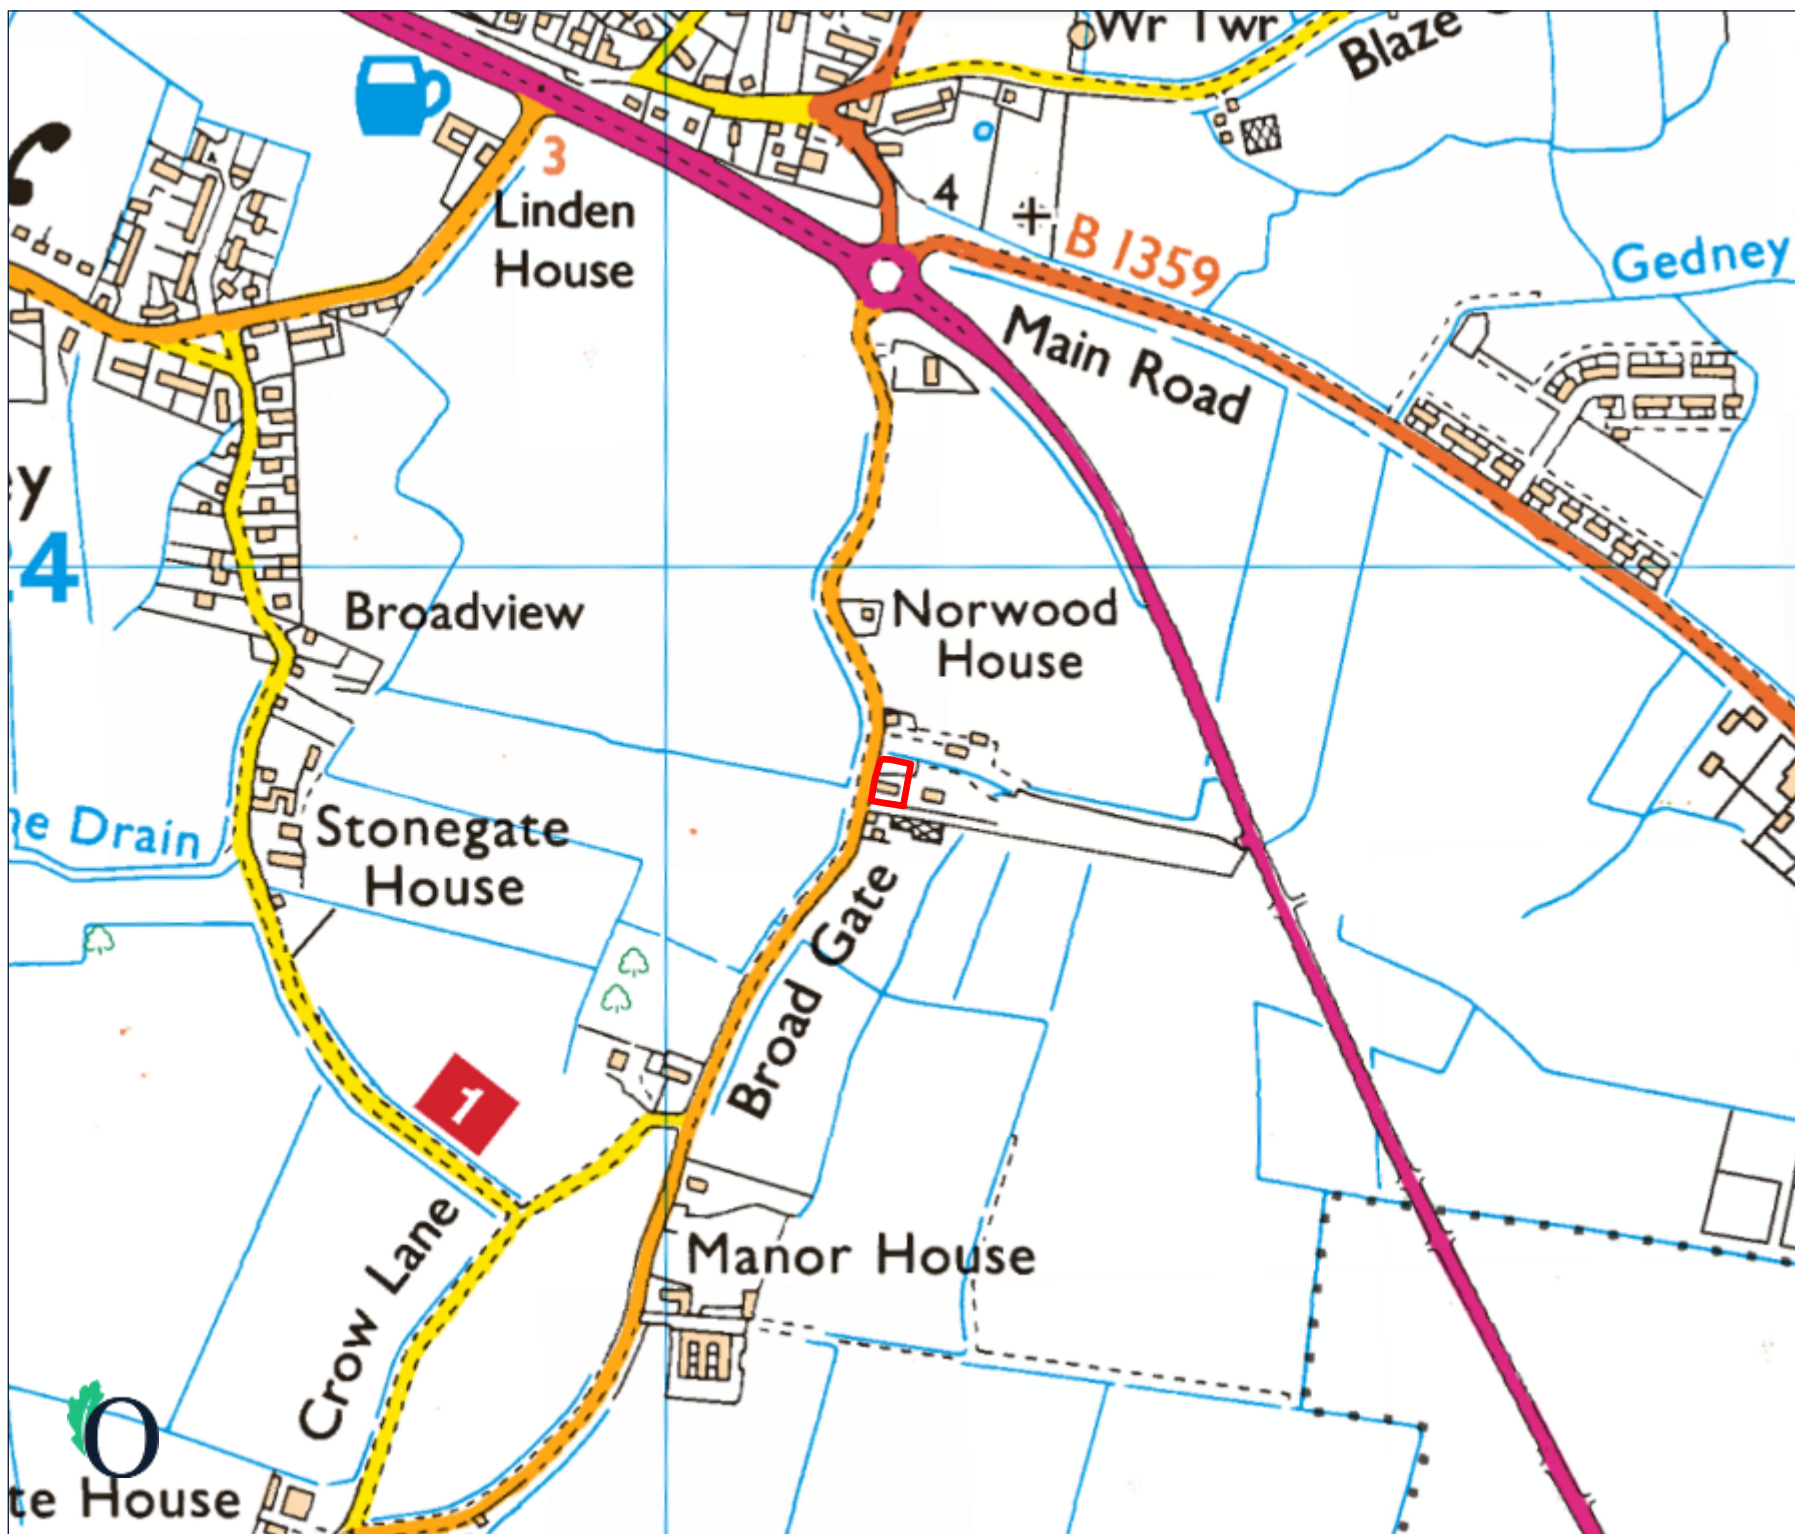
Figure 1

Boreholes were dug at the locations shown on plans in the appendix. It should be noted that, while the attached plan shows samples BH02 and BH03 to be in gravel areas, these are actually areas of soft landscaping, in addition, the attached proposed plan does not show the timber structures at the north of the site.
