**PRELIMINARY GROUND INVESTIGATION REPORT**

**RESIDENTIAL DEVELOPMENT PLOT 2**

**HIGHSTOCK LANE**

**DOCUMENT REF: 46318-GI-01**

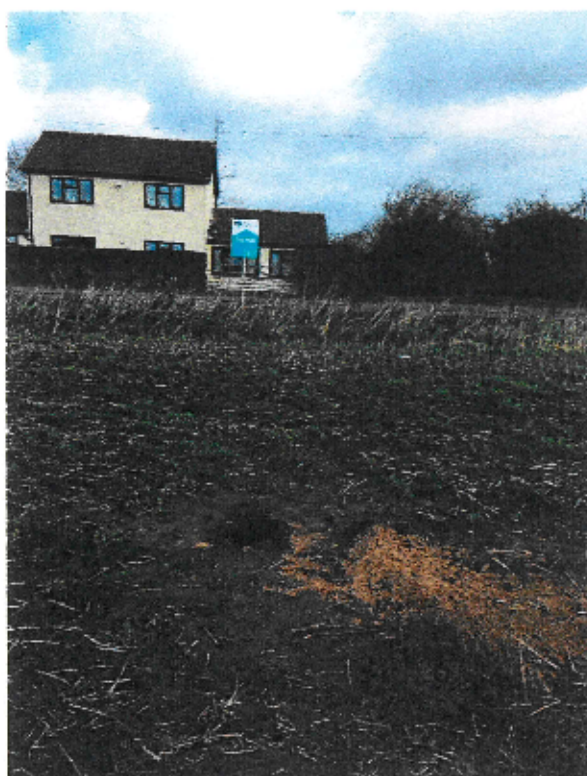
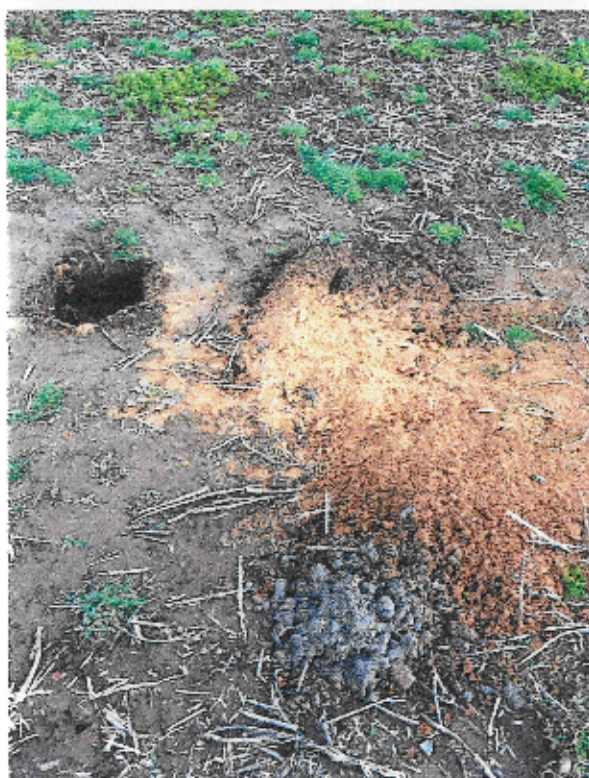
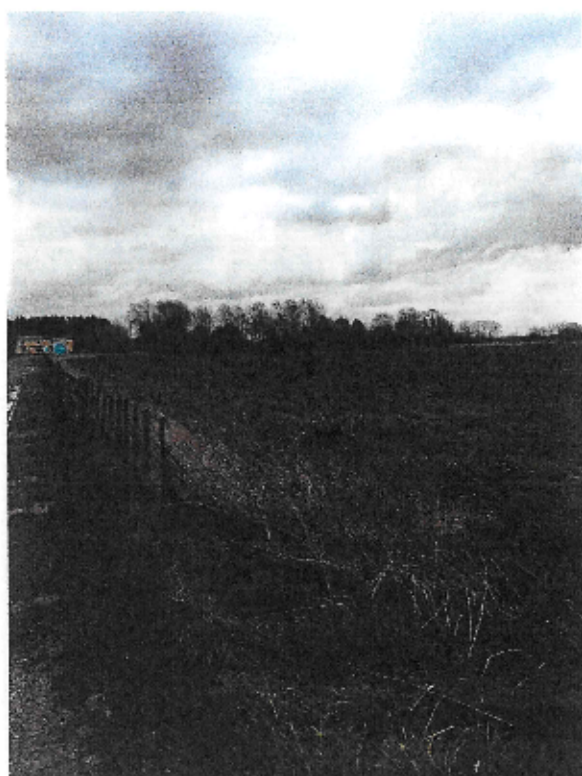
APPENDIX D  
Photographic Record

The strata encountered in all explorations were very similar, and typical of that to be found in the fenland area.

Once the dry topsoil material was penetrated the strata became a mid-dense slightly silty sand which extended to depths of 3m until a wet grey sandy silt was encountered.

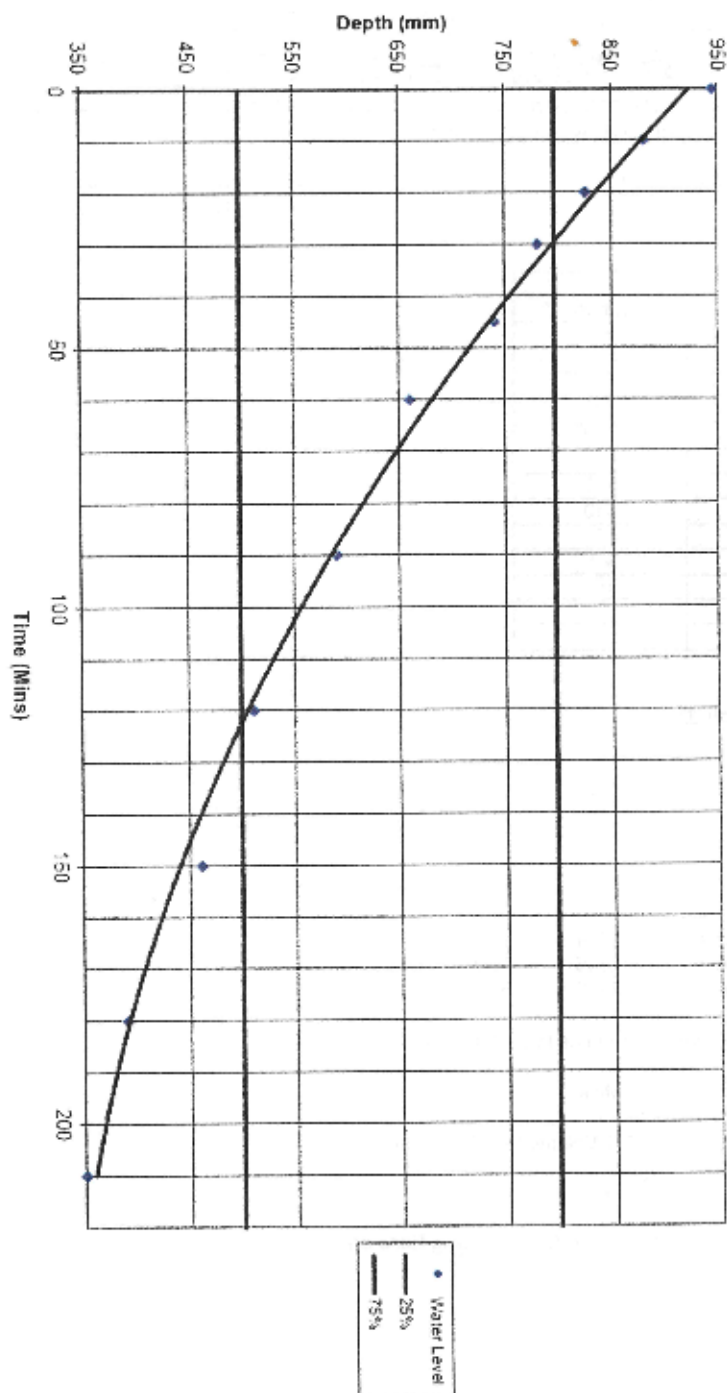
Highstock Lane, Gedney Hill  
 Job No. 46318  
 Plot showing water level against time for SA01

An infiltration test was undertaken in adjacent plot 5, the water drained well through the granular strata. Although the test was undertaken on an adjacent plot, the results are still valid for the purposes of this site, as the explorations on both plots indicate them to be underlain by the same strata. The test results and calculation are contained within APPENDIX E, the calculated infiltration rate is  $2.3 \times 10^{-5}$  m/s.

Soil Infiltration rate, f

2.30425E-05 m/s

The infiltration test drained well, and the site is well suited to the use of soakaway surface water drainage and a drainage field outfall from a treatment plant for foul water. The calculated infiltration rate is contained with the results in APPENDIX E.
