**PRELIMINARY GROUND INVESTIGATION REPORT**

**RESIDENTIAL DEVELOPMENT PLOT 1**

**HIGHSTOCK LANE**

**DOCUMENT REF: 16721-GI-01**

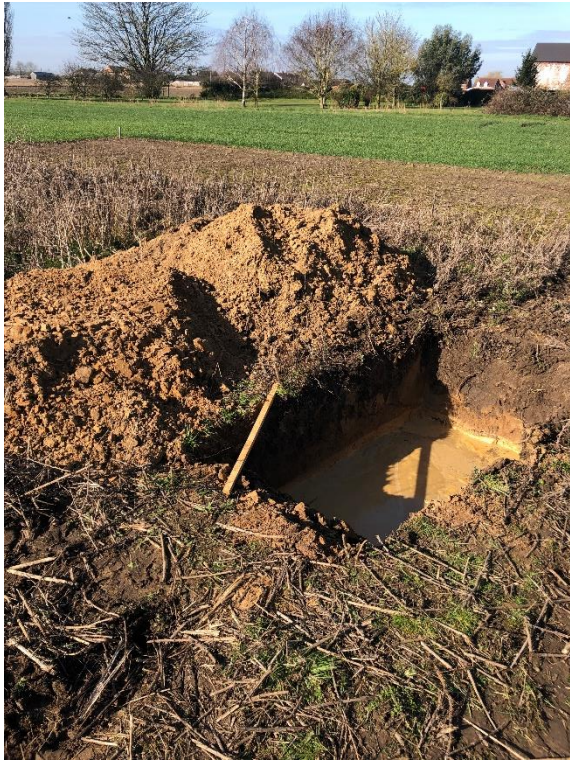
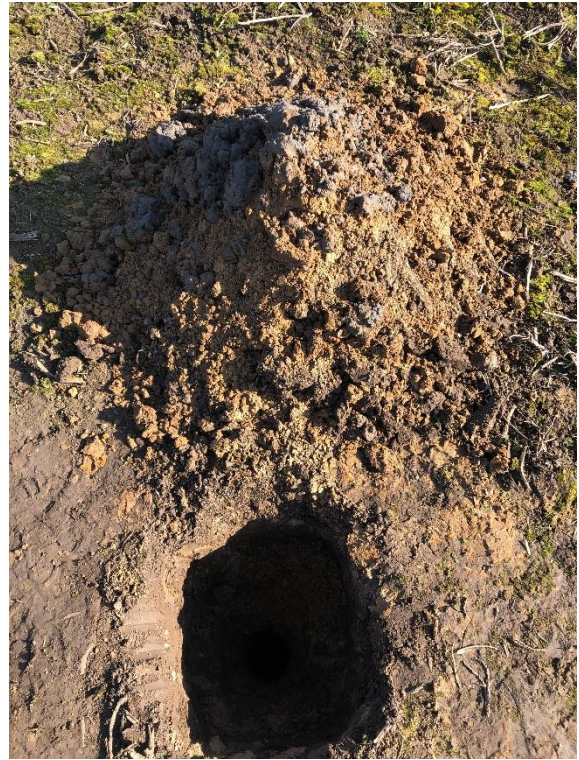
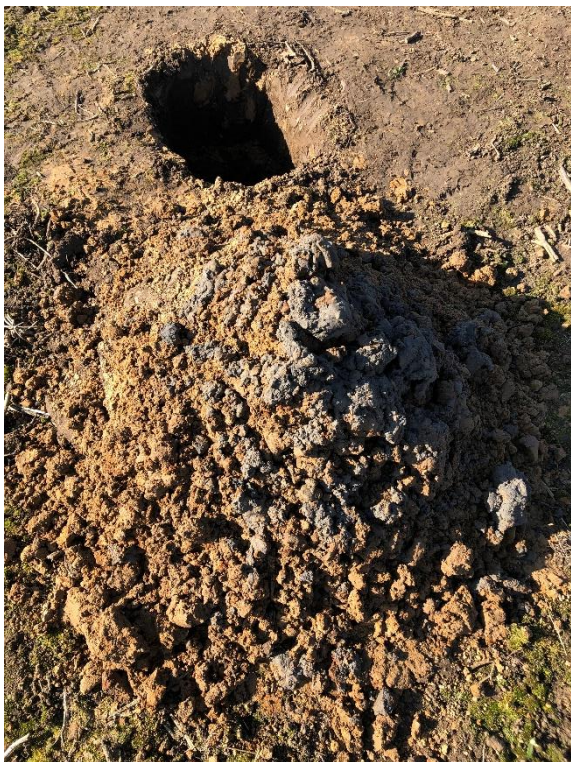
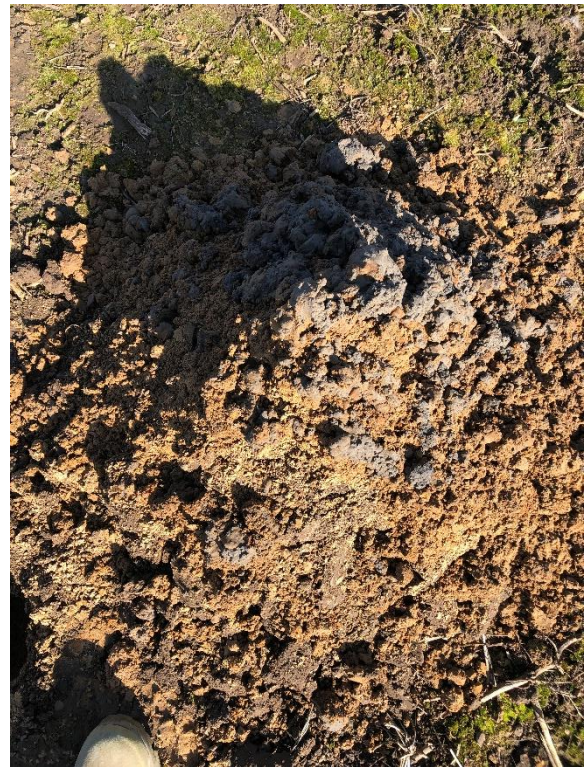
### Photographic Record

A photographic record is contained within APPENDIX D.

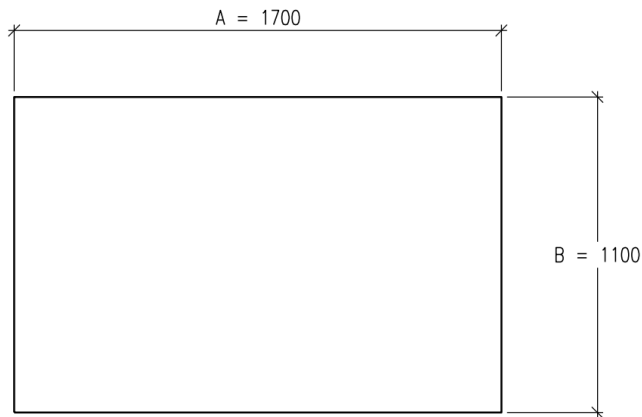
Plan On SA01

Title  
Infiltration Soak Away Sketch

A = 1.7 m  
B = 1.1 m  
C = 1 m

An infiltration test was undertaken to the rear of the plot, the water drained well through the granular strata. The test results and calculation are contained within APPENDIX E, the calculated infiltration rate is  $1.07 \times 10^{-5}$  m/s.

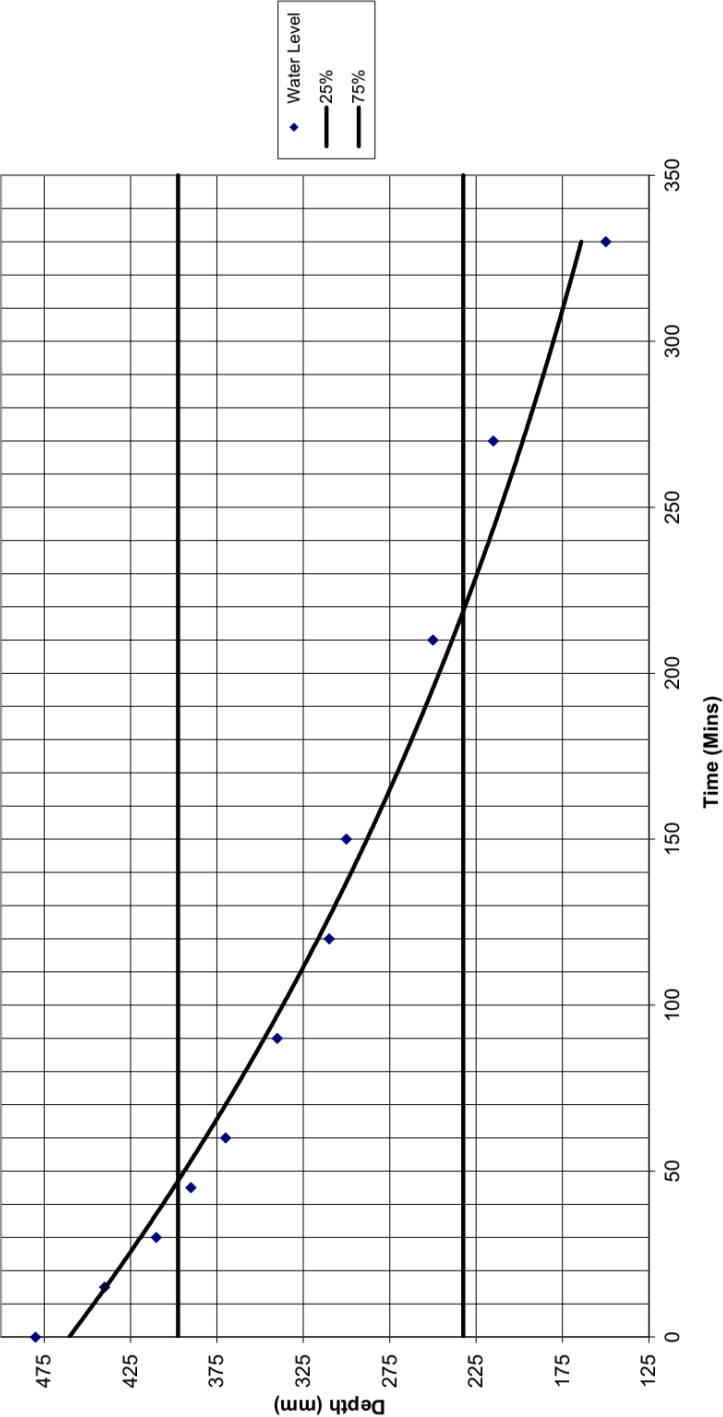
1.07009E-05 m/s

Proposed Dwelling, Plot 1, Highstock Lane, Gedney Hill, Spalding, Lincs.  
Job No. 16721 09/03/2021  
Plot showing water level against time for SA01

The infiltration test drained well, and the site is well suited to the use of soakaway surface water drainage and a drainage field outfall from a treatment plant for foul water. The calculated infiltration rate is contained with the results in APPENDIX E.
