## **Stage One Environmental Desk Study of land opposite 11 Highstock Lane, Gedney Hill Spalding, Lincolnshire, PE12 0QG**

**REPORT NUMBER 19-09-01**

**Planning Application No. H07-1178-18**

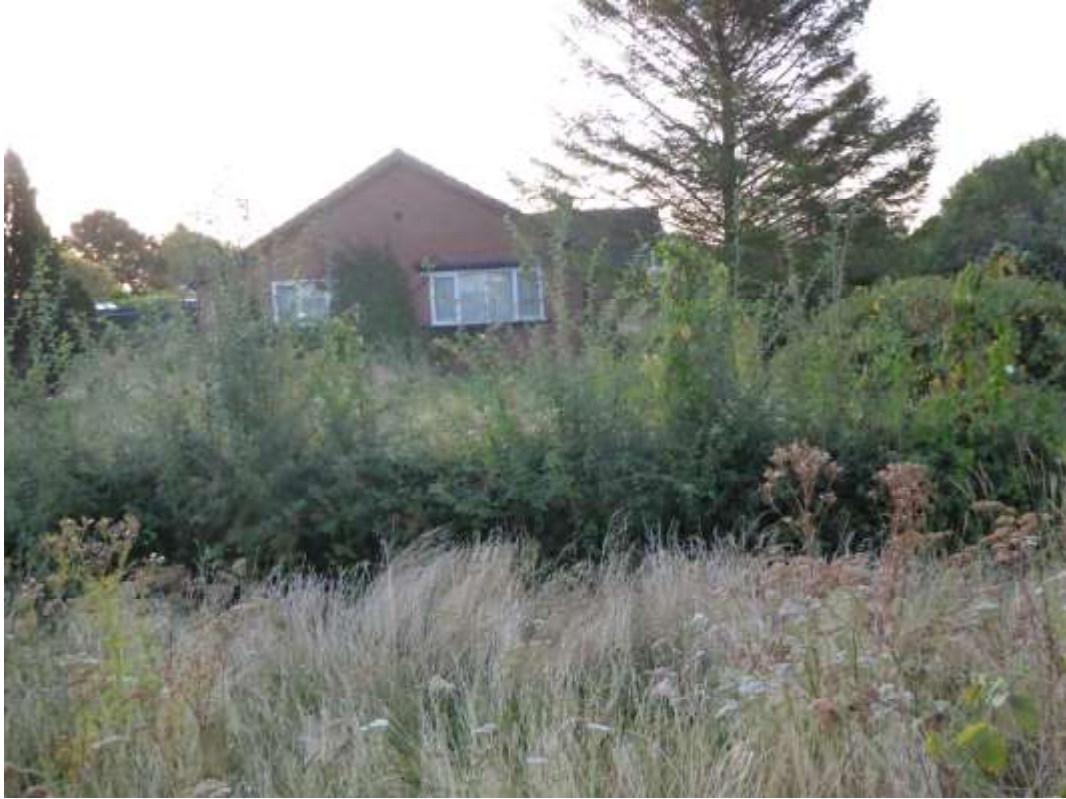
3.2 The road haulage services marked on the Sitecheck data report was just a residential building (photo 5) on the corner of Highstock Lane and Station Road with no other buildings or hard standing for haulage vehicles. This could just be the registered address of the business with no actual vehicles on site. A walk to where the garage services were marked near to Hubert's Close in the Sitecheck Data report did not find any trace of such a business. On further investigation, it was found located at the southern end of the village on Station Road more than 250 m from the site.

Photo 5 House on site of road haulage services from Station Road

5.2 The haulage services does not exist as an operation as there is only a residential property at that point and no hard standing, whilst the garage services are not at the location in the Sitecheck Data report but rather at the outskirts of the village, a very long way from the development site. The infilled ground is not identifiable as it is now farmed for crops, as well as being some distance from this site. An examination of the fields and the surrounding residential buildings did not identify any other sources of potential contamination. The underlying geology is impermeable formations and the superficial soils are only very slightly permeable.
