HISTORIC BUILDING RECORDING AT THE  
FORMER DUKE OF YORK PUBLIC HOUSE,  
106, RISEGATE ROAD,  
GOSBERTON RISEGATE, LINCOLNSHIRE

**National Grid Reference: TF 2186 3004**  
**Planning Reference: H08-0964-21**  
**Site Code: RRGR22**  
**Accession Number: LCNCC: 2022.147**

PREPARED FOR MRS. S. GOODENOUGH

January 2023

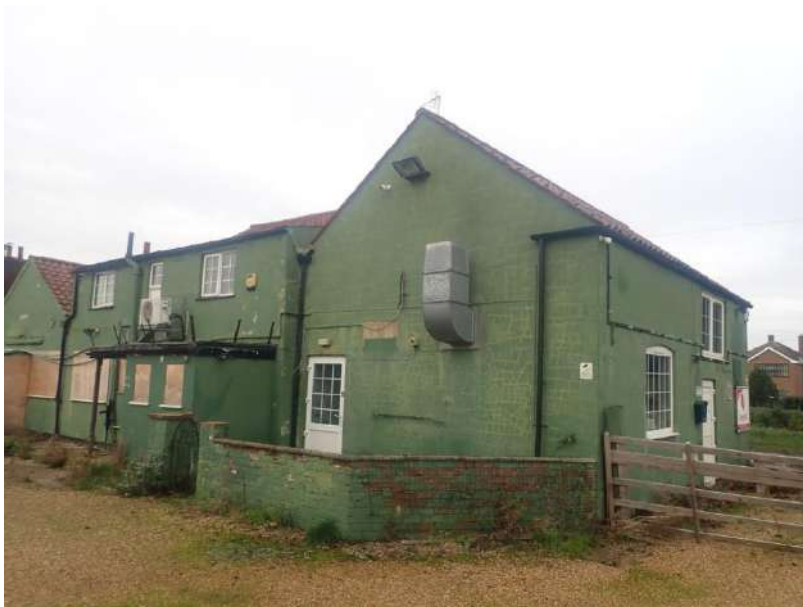
**Plate 5: General view of the Duke of York public house complex, from the south-east**

**Plate 5** presents a general view of the eastern end of this former public house complex with the two storey **Building 1** in the foreground with the two storey **Building 2** with its rear outshut and the two storey **Building 3** in the background.

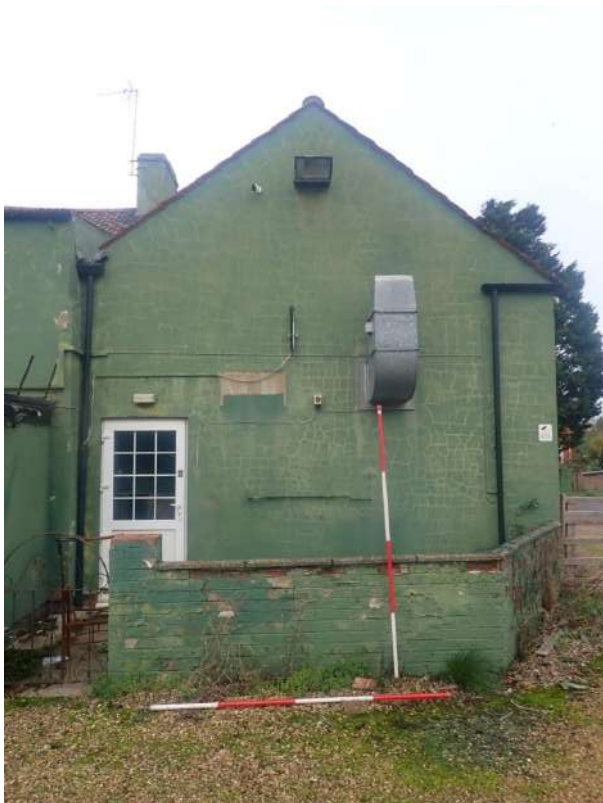
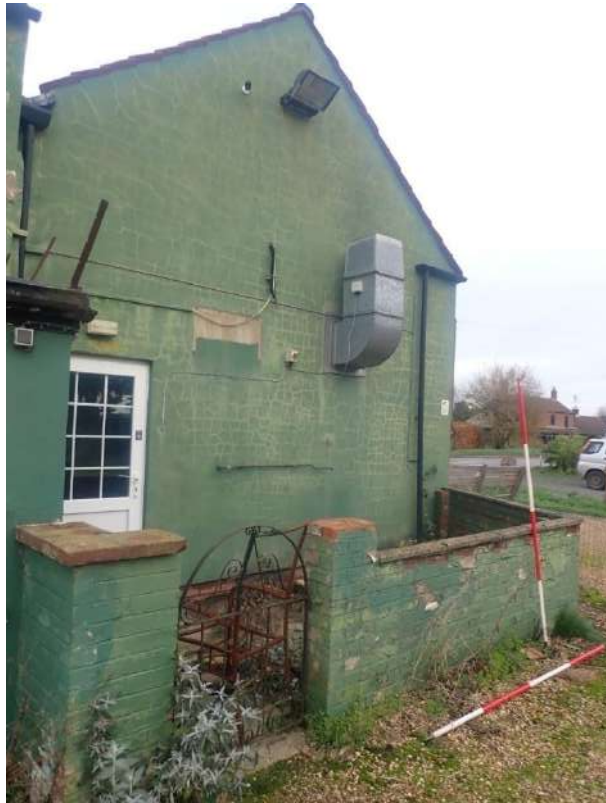
**Plate 11: View of the South Elevation of Building 1, from the south-east**

**Plates 11 and 12** feature the South Elevation of **Building 1**. The entire Elevation appears to have been rendered over with modern cement. No first or ground floor former window openings are apparent. At either ends of this Elevation are two modern vertical Upvc downpipes. Also featured is the outer face of a south facing modern entrance opening. This is occupied by a modern glazed Upvc door. Also shown is the exterior metal flue of an interior kitchen extractor fan.

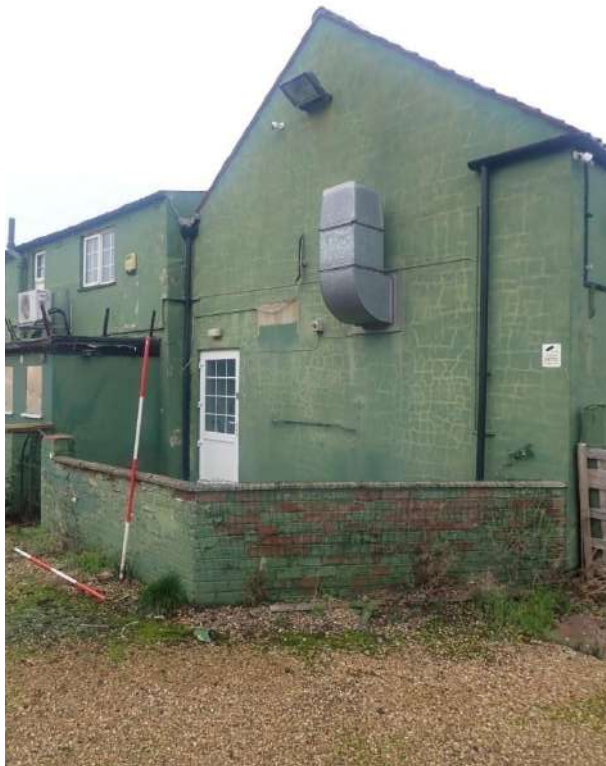
**Plate 13: View of the South Elevation of Building 1, from the south-east**

**Plate 13** provides a further view of the South Elevation of **Building 1**. At the rear of this Elevation is a small enclosed rear yard with a modern concrete surface. The yard is enclosed within a low wall, which is composed of courses of brick stretchers in Stretcher Bond. Atop the brickwork is a series of modern concrete coping stones. A modern metal gateway is also shown within the low wall, providing an access to the rear of **Building 1**. **Plates 14 and 15** provide further detailed views of this low modern enclosing wall and rear yard from differing positions.

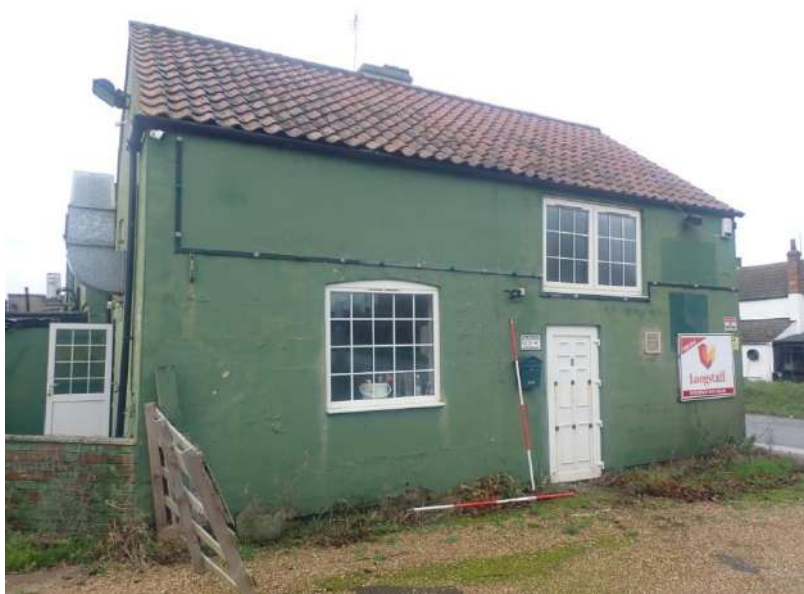
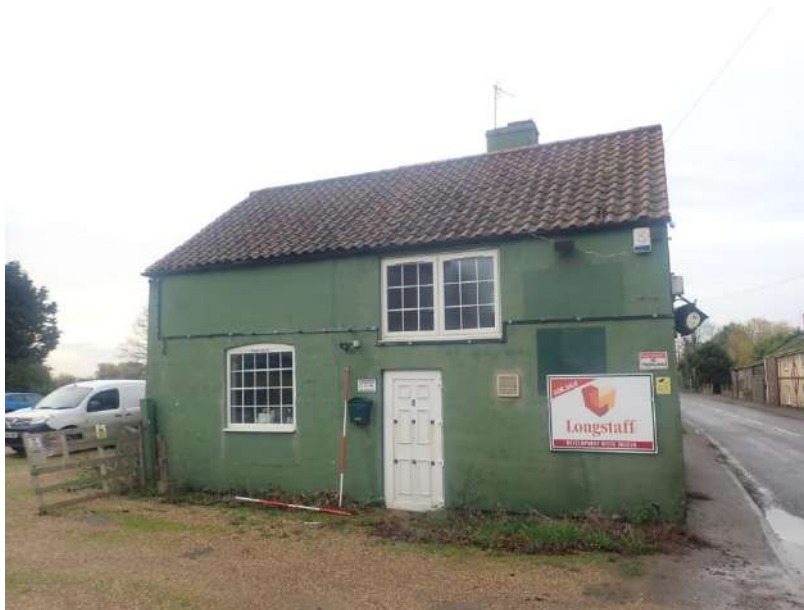
**Plate 16: View of the East Elevation of Building 1, from the north-east**

**Plates 16 and 17** provide detailed views of the East Elevation of **Building 1**. Here also, the entire external area of this East Elevation has been covered over with a modern cement rendering. At just below roof levels is modern horizontal Upvc guttering. At the ground floor level is an east facing window opening, which may be original. This is occupied by a modern glazed Upvc casement window. To the right (north), of this is an east facing ground floor entrance opening, within which is a modern Upvc panelled door. This opening may also be an original feature. At first floor levels is a further east facing window opening. This may also be original and is occupied by a second modern glazed Upvc casement window.

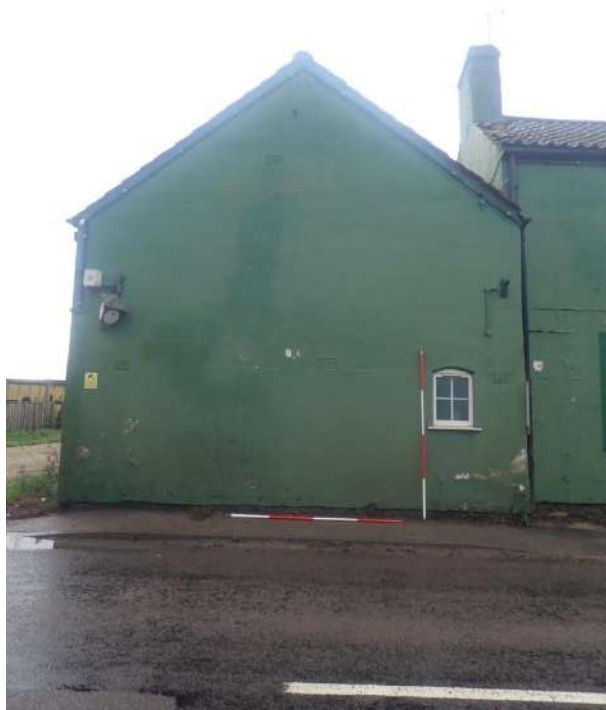
Plate 18: View of the North Elevation of Building 1, from the north-west

**Plate 18** furnishes a detailed image of the North Elevation of **Building 1**. Here also, the entire external area of this North Elevation has been covered over with a modern cement rendering. This Elevation is also mostly absent of further window openings with the exception of a small north facing ground floor window opening, which is occupied by a modern Upvc casement window. This may also be an original opening.

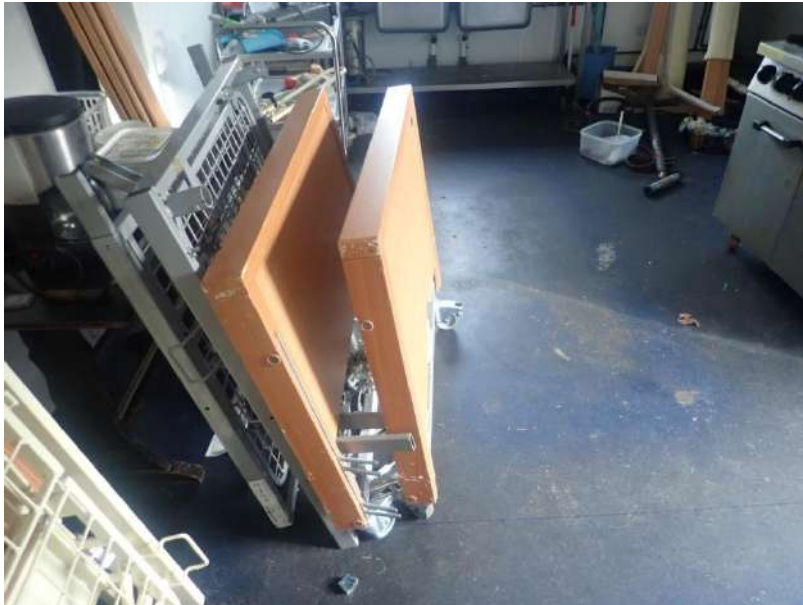
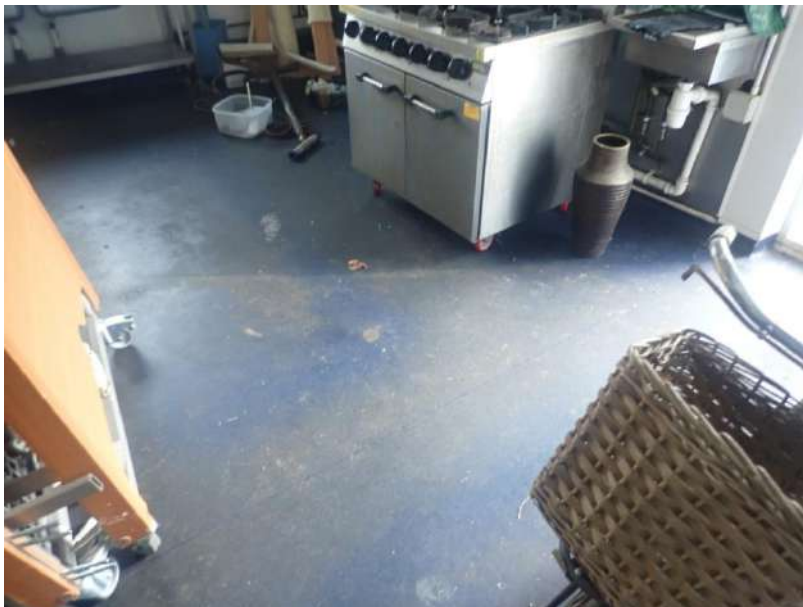
**Plate 21: View of the flooring of Cell 1, from the south-west**

**Plates 21 and 22** feature the nature of the flooring of **Cell 1**, which is of modern concrete.

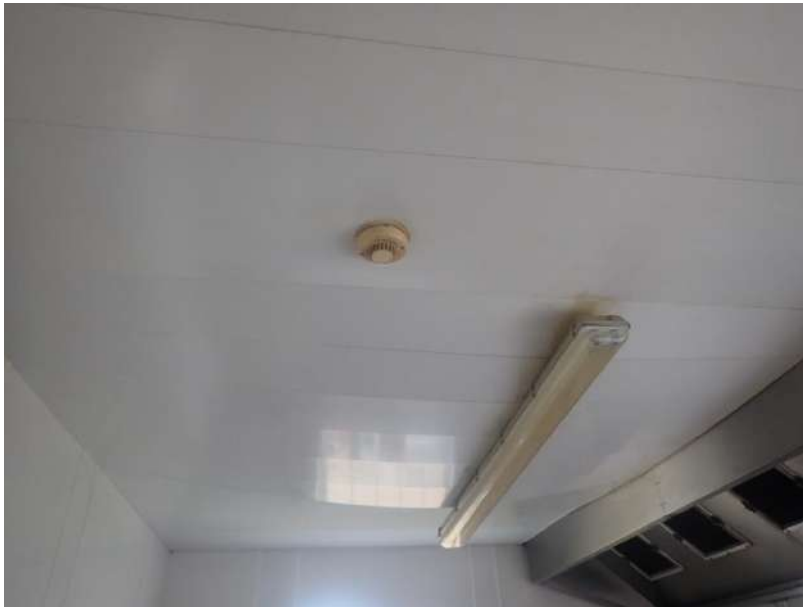
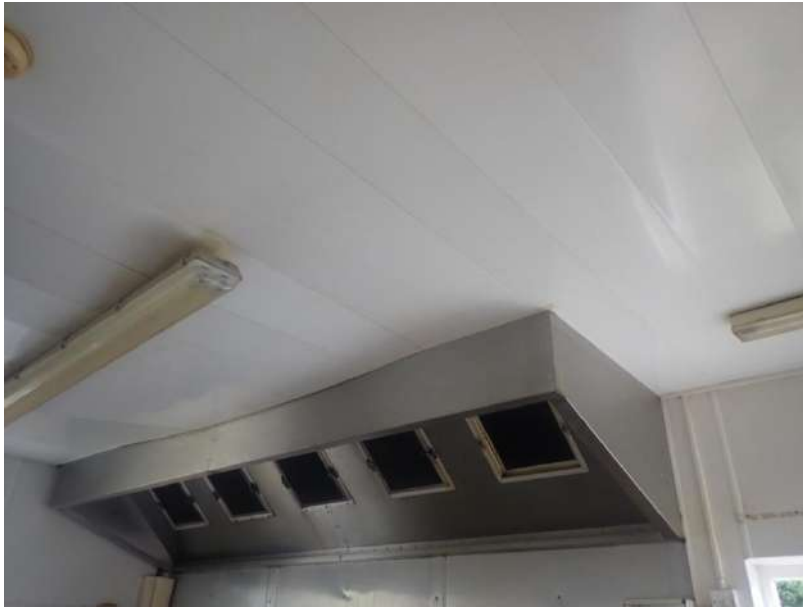
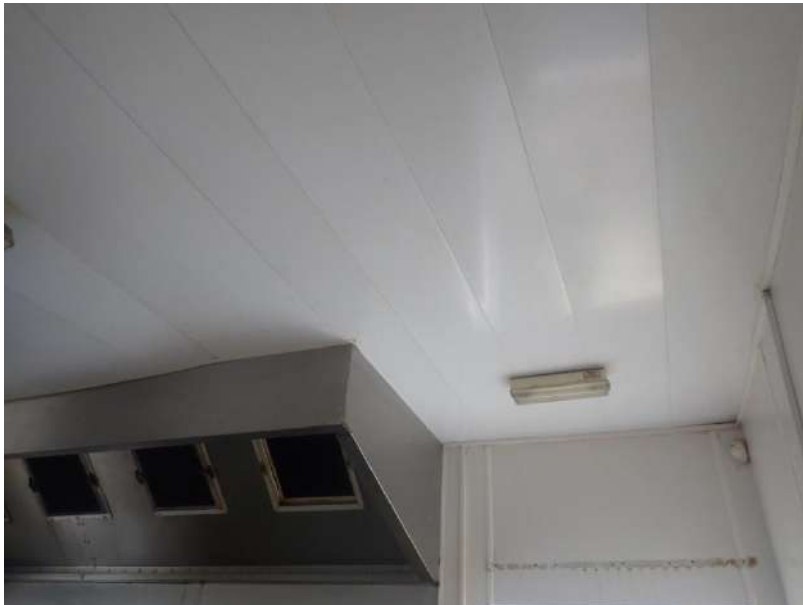
**Plate 26: View of the ceiling of Cell 1, from the south-west**

**Plates 26-28** furnish several images of the nature of the modern suspended ceiling of **Cell 1**, which is of modern Upvc.

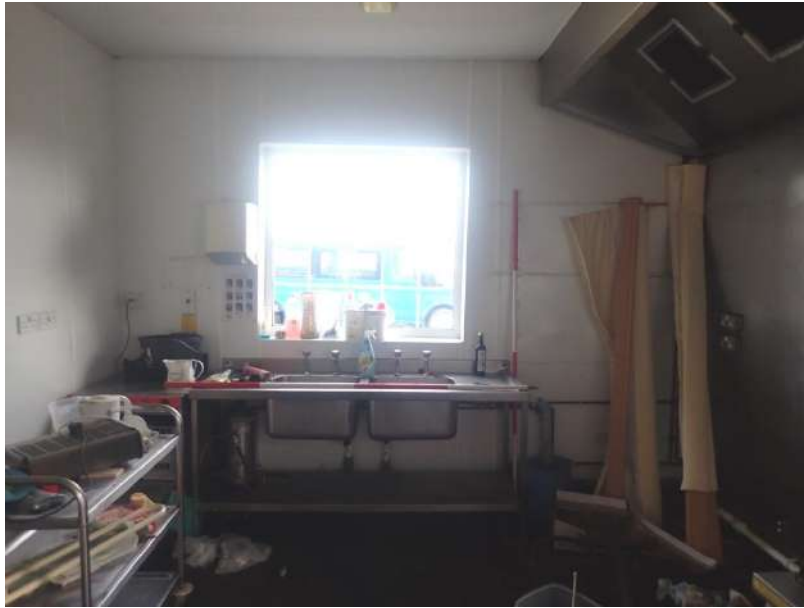
**Plate 29: View of the east wall of Cell 1, from the south-west**

**Plate 29** provides a detailed view of the east wall of **Cell 1**, including that of the inner face of the slightly recessed ground floor east facing window opening that was recorded externally at the East Elevation of this building. This entire east wall has been covered over with modern Upvc sheeting.

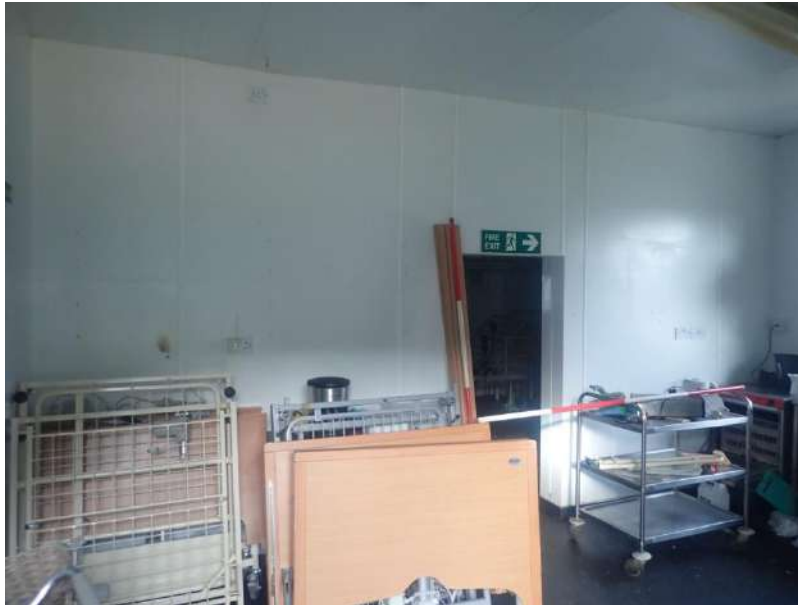
**Plate 31: View of the north wall of Cell 1, from the south-west**

**Plate 31** presents a detailed view of the north wall of **Cell 1**, which is also the internal dividing wall with the adjoining **Cell 2**, to the north. Here also, this entire north wall has been covered over with modern Upvc sheeting. Also shown is the north facing entrance opening that leads onto the adjoining **Cell 2** to the north. Both a door frame and a door were absent from this opening, which is of modern Upvc.

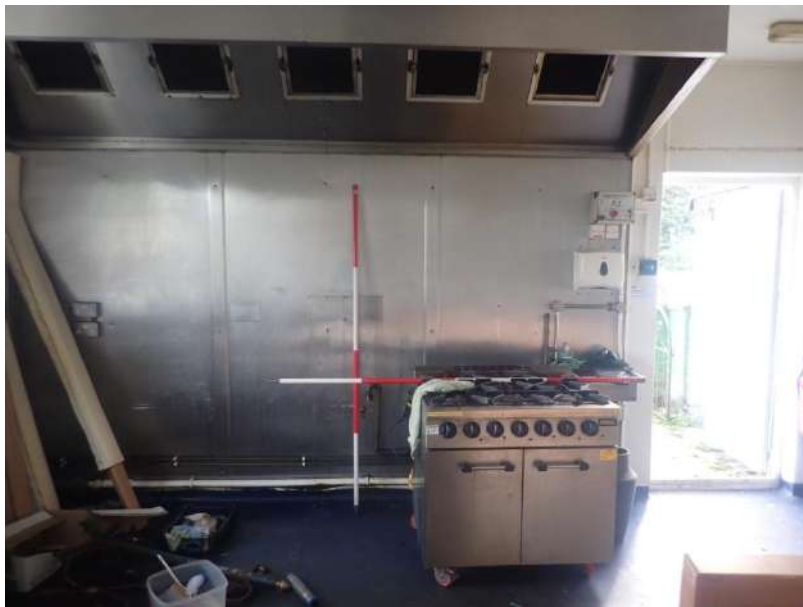
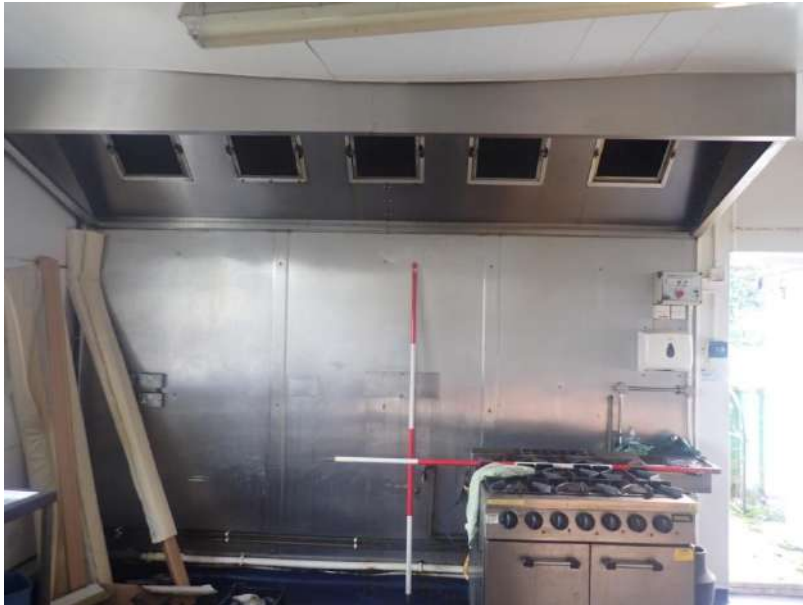
**Plate 32: View of the south wall of Cell 1, from the north-west**

**Plates 32-34** show the south wall of **Cell 1**, most of which is occupied by a modern stainless steel backing with extractor fans above this. To the right (west), is the inner face of the ground floor south facing entrance opening that was recorded externally at the South Elevation of this building. This slightly recessed opening is occupied by a modern Upvc frame with modern Upvc wall sheeting covering the wall above the opening.

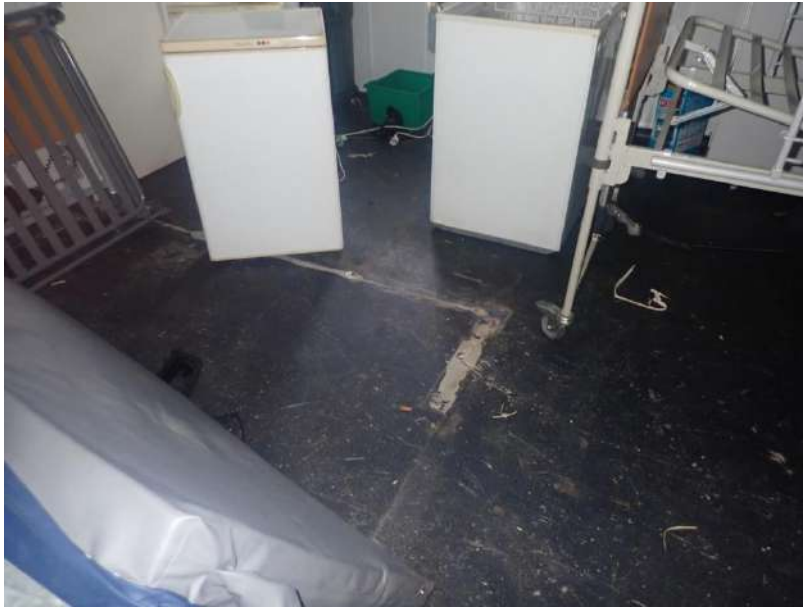
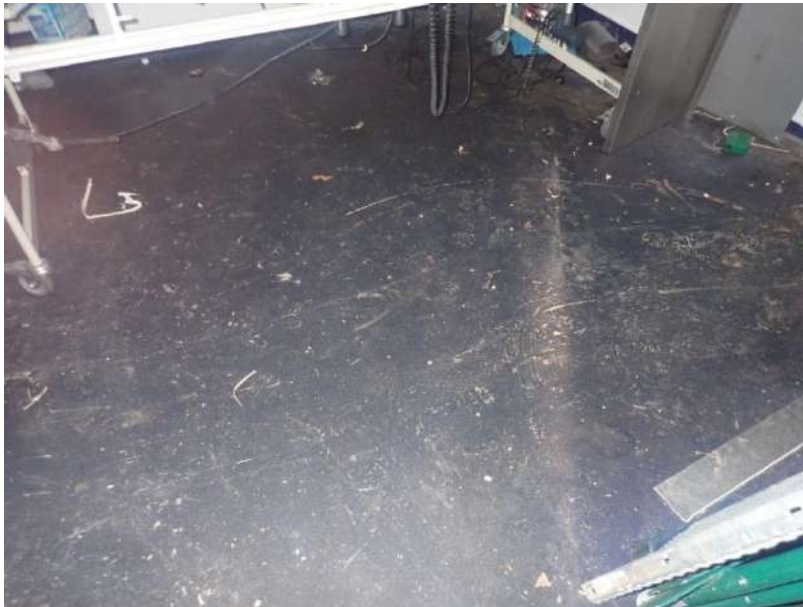
**Plate 35: View of the flooring of Cell 1, from the south-east**

**Plates 35 and 36** feature the nature of the flooring of **Cell 2**, which is of modern concrete.

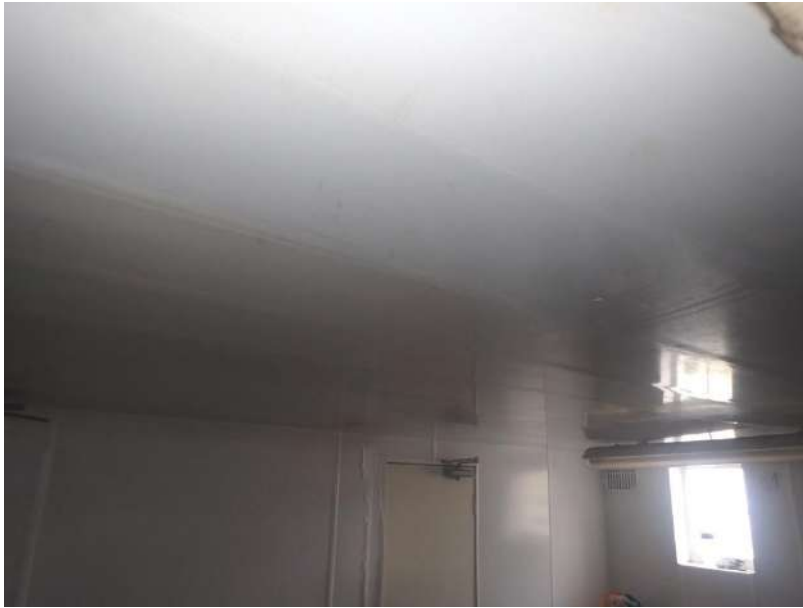
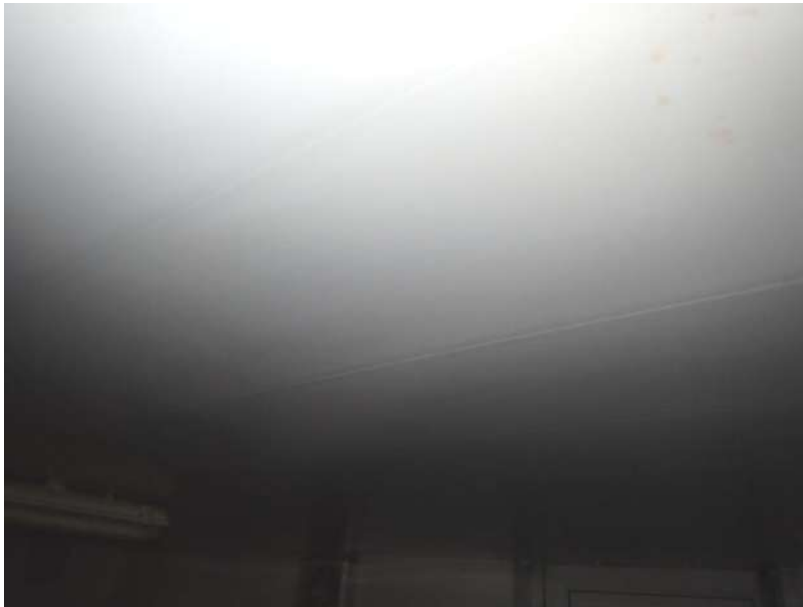
**Plate 39: View of the ceiling of Cell 2, from the south-east**

**Plates 39 and 40 feature the modern suspended Upvc ceiling of Cell 2.**

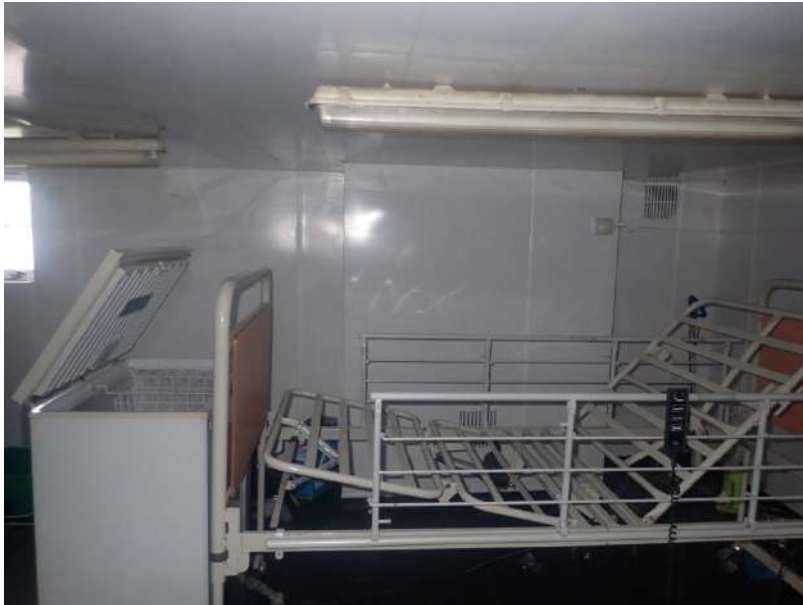
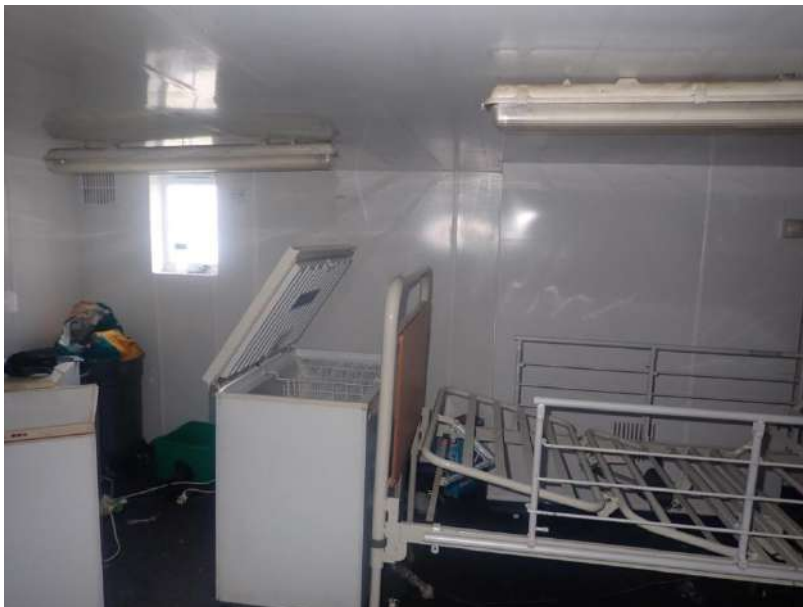
**Plate 41: View of the north wall of Cell 2, from the south**

**Plates 41 and 42** show the north wall of **Cell 2**. Here also, the whole area of this north wall has been covered over with modern Upvc sheeting. To the left (west), is the inner face of the slightly recessed north facing ground floor window opening that was recorded externally at the North Elevation of this building.

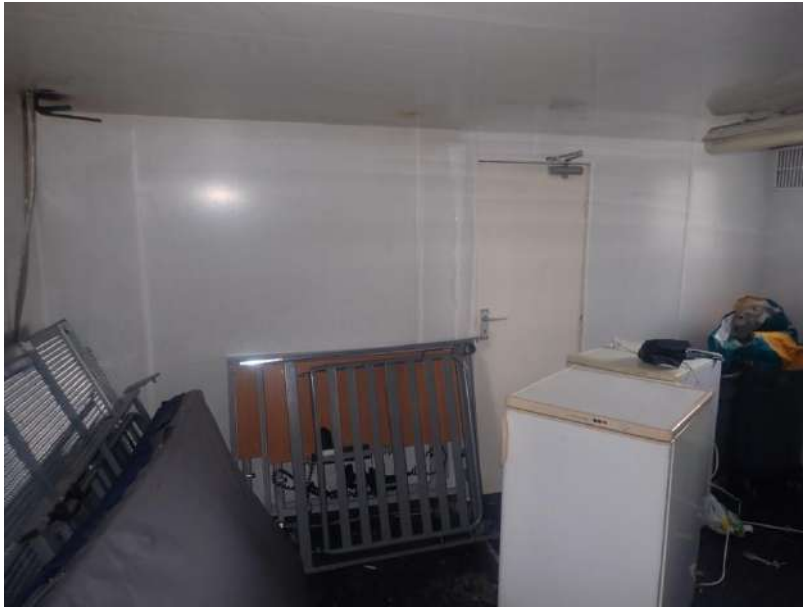
**Plate 43: View of the west wall of Cell 2, from the east**

**Plate 43** presents a detailed view of the west wall of **Cell 2**. Here also, the area of this west wall has been covered over with modern Upvc sheeting. This is also the internal dividing wall with the adjacent **Cell 8 of Building 2** to the west. To the right (north), is a west facing entrance opening that is occupied by a modern timber frame of a head and surrounds and a probable timber door that has been covered over with modern hardboard sheeting. This originally led on into the interior of **Building 2**, but has been blocked off.

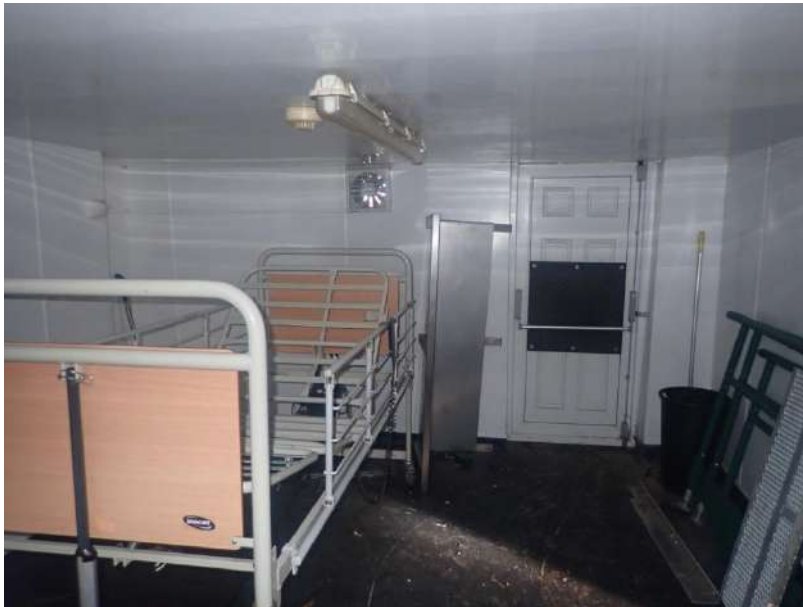
**Plate 44: View of the east wall of Cell 2, from the south-west**

**Plate 44** features the east wall of **Cell 2**. Here also, the area of this east wall has been covered over with modern Upvc sheeting. To the right (south), is the inner face of the east facing entrance opening that was recorded externally at the East Elevation of this building.

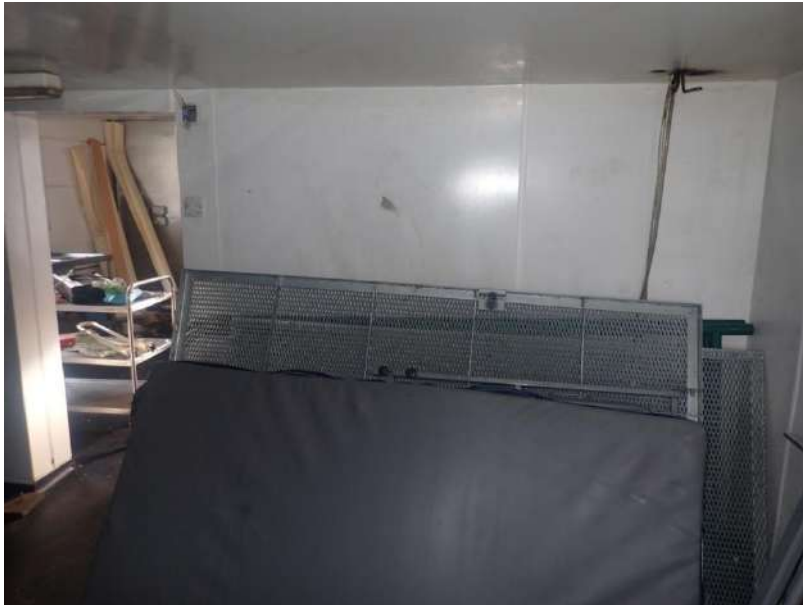
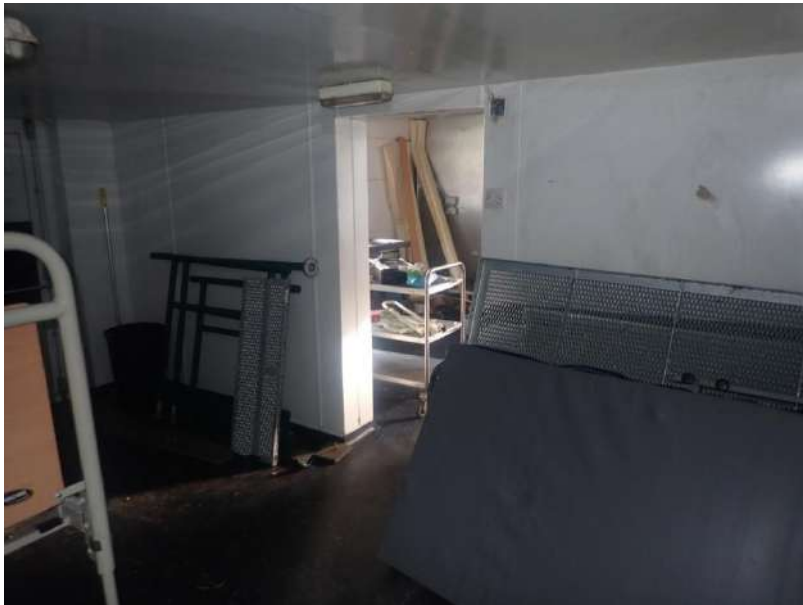
**Plates 45 and 46** present images of the south wall of **Cell 2**, which is also the internal dividing wall with the adjoining **Cell 1** to the south. Here also, the area of this south wall has been covered over with modern Upvc sheeting. To the left (east), is the inner face of the south facing entrance reopening that extends onto **Cell 1**. Both a door frame and a door are absent.

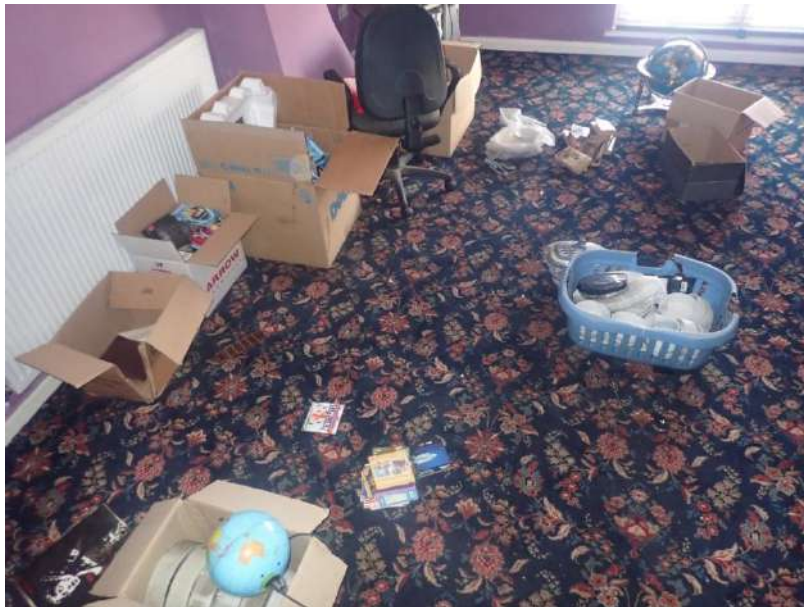
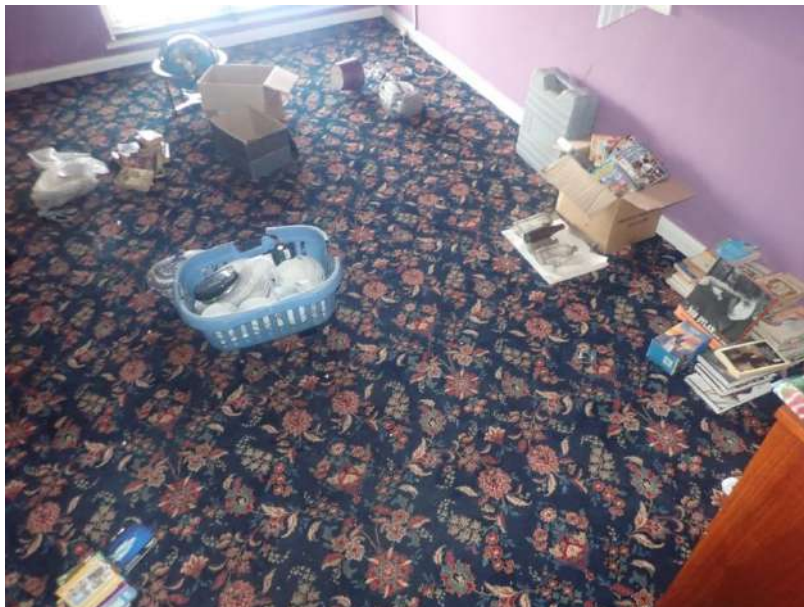
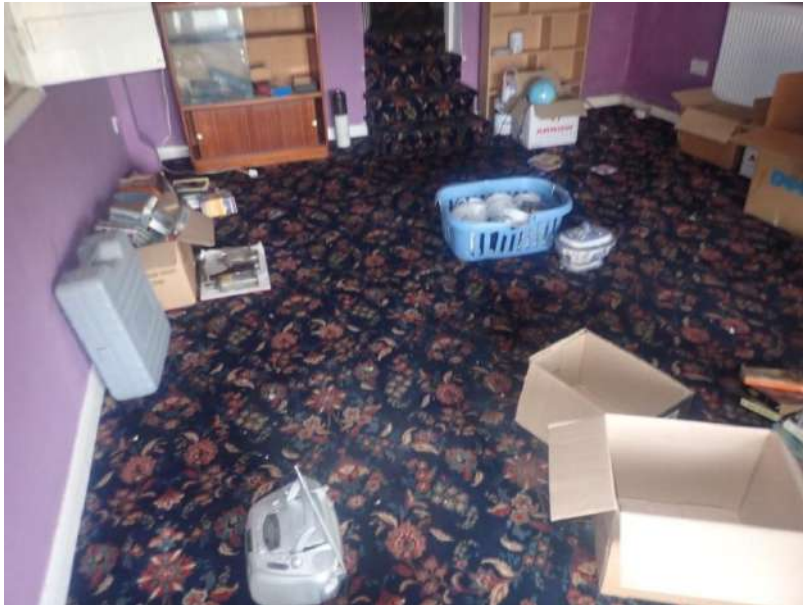
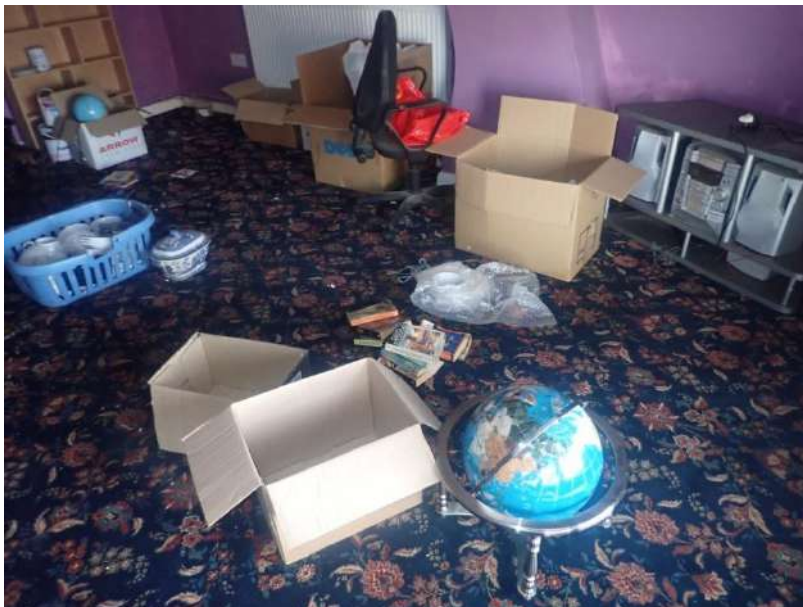
**Plates 47-50** present a number of views from different vantage points of the flooring of **Cell 3**, which is covered with modern carpeting.

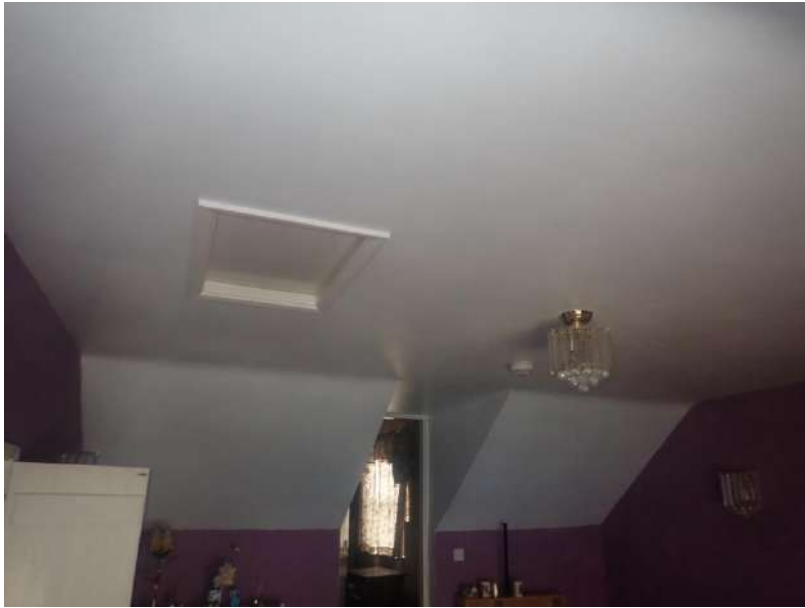
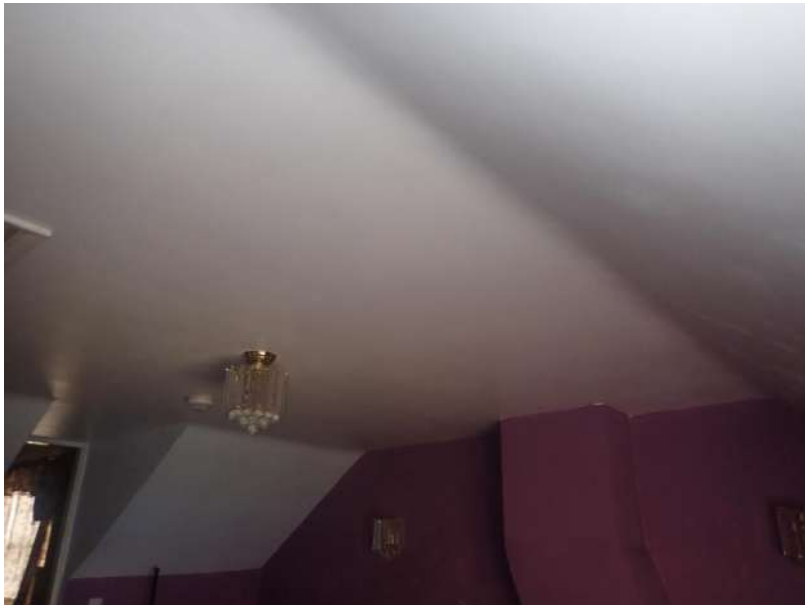
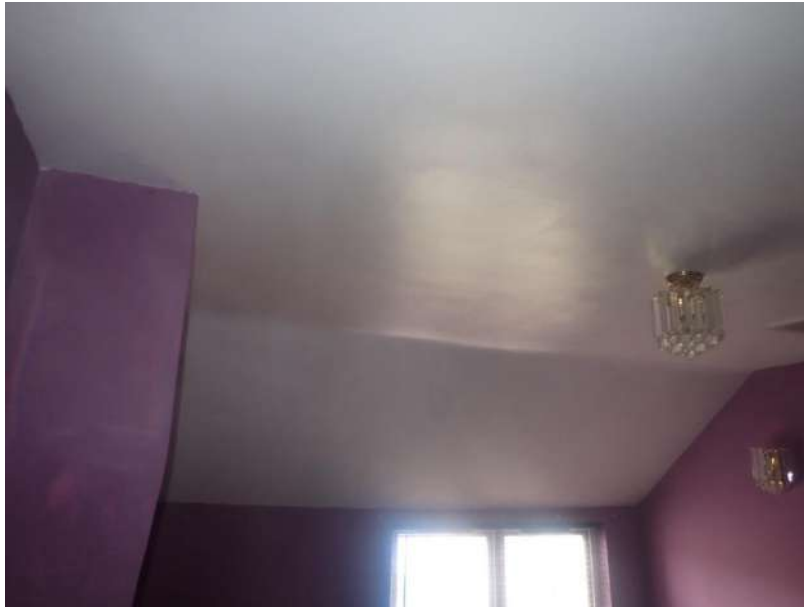
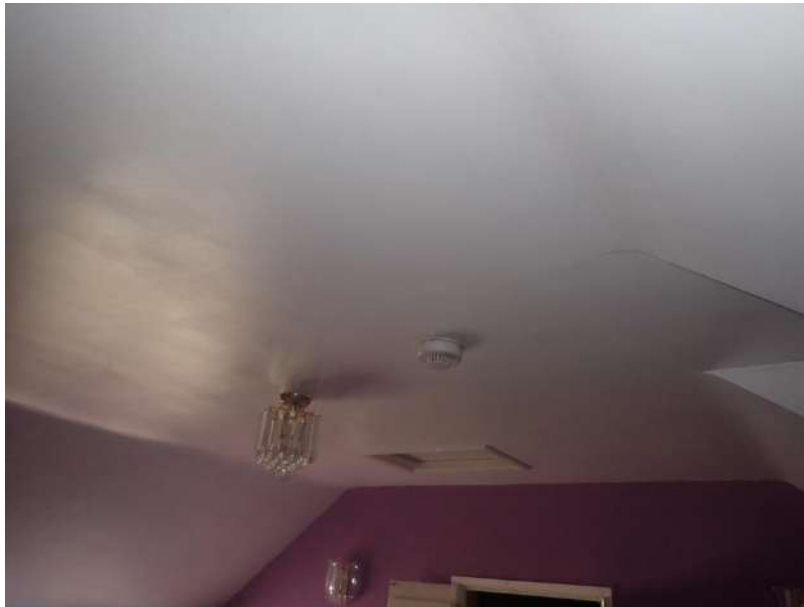
**Plates 53-56** provide a number of views from different vantage points of the nature of the ceiling of **Cell 3**, which has been rendered over with modern plasterwork. **Cell 3** occupies much of the internal roof space of the northern portion of **Building 1**.

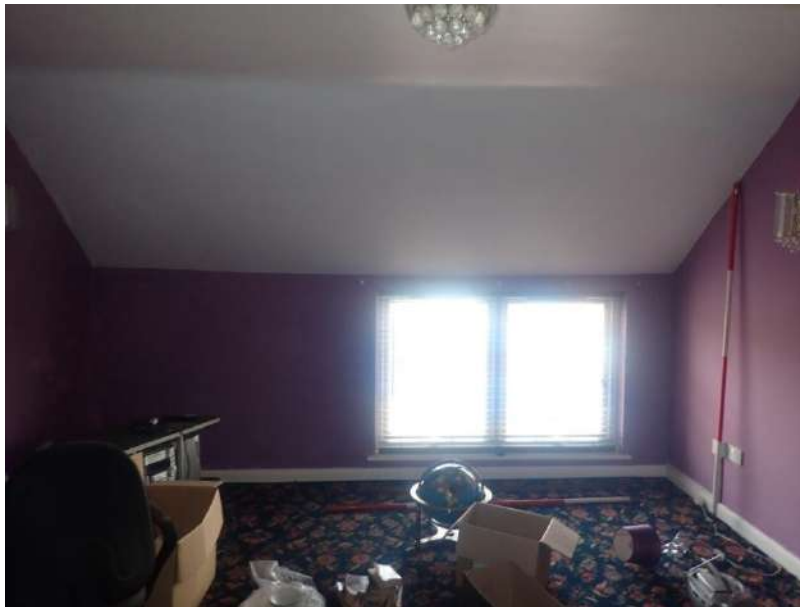
**Plate 57: View of the east wall of Cell 3, from the south-west**

**Plate 57** furnishes a view of the low east wall of **Cell 3**, which has been rendered over with modern plasterwork. Modern horizontal timber skirting boards occur along its base. The central feature is the inner face of the east facing first floor window opening that was recorded externally at the East Elevation of this building. It may also be observed that the mid and lower levels of the angled line of the gabled roof of **Building 1** occur at the upper levels above this low east wall.

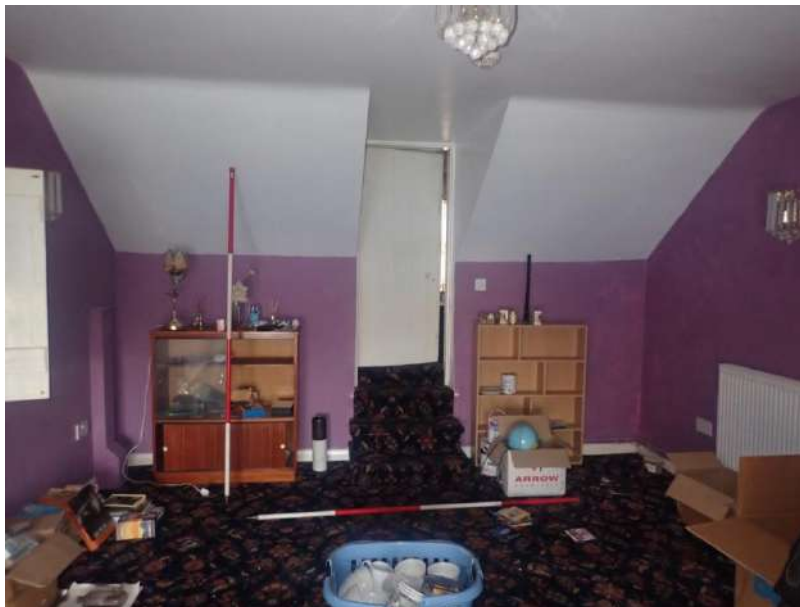
**Plate 58: View of the west wall of Cell 3, from the south-east**

**Plate 58** presents a detailed view of the west wall of **Cell 3**, which has been rendered over with modern plasterwork. Modern horizontal timber skirting boards occur along its base. This is also the internal dividing wall with the adjacent **Cell 13 of Building 2** to the west. The central feature of this west wall is the inner face of a first floor west facing entrance opening that extends onto the adjoining **Building 2** to the west. Several timber steps extend upwards to this entrance opening, emphasising the difference in first floor levels between this **Building 1** and the adjoining **Building 2**. This entrance opening is occupied by a modern timber frame of a head and surrounds and by a timber door that has been covered over with modern hardboard. It may also be observed that the mid and lower levels of the angled line of the gabled roof of **Building 1** occur at the upper levels above this west wall.

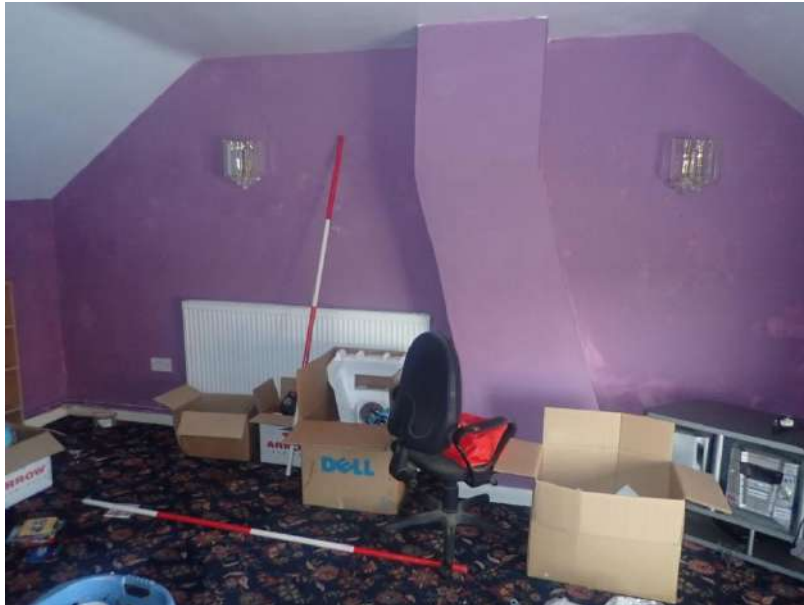
**Plate 59: View of the north wall of Cell 3, from the south-east**

**Plate 59** features the north wall of **Cell 3**, which has been rendered over with modern plasterwork. Modern horizontal timber skirting boards occur along its base. The central feature of this north wall is the winding internal chimney breast. This is worthy of note as an accompanying external chimney stack is no longer present. It is clear that this is also an original feature. The lines of the angled gabled roof of **Building 1** flank either side of this north wall.

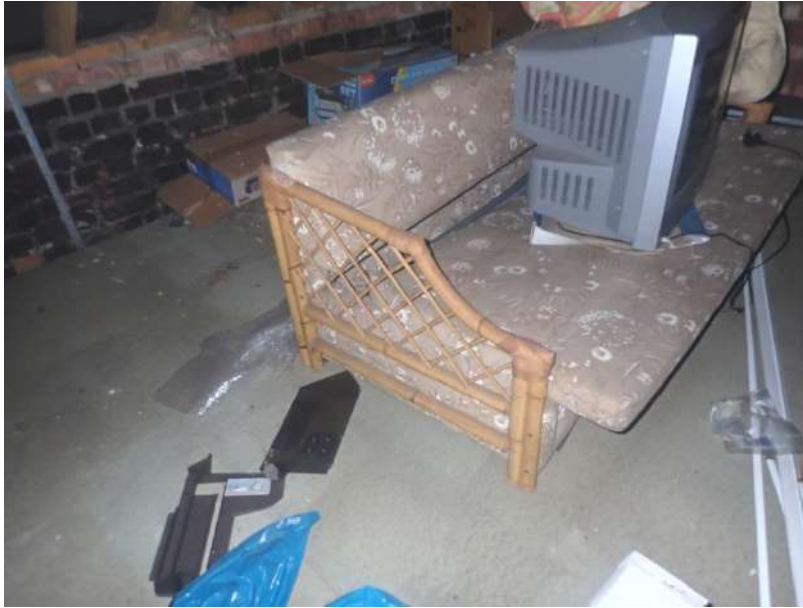
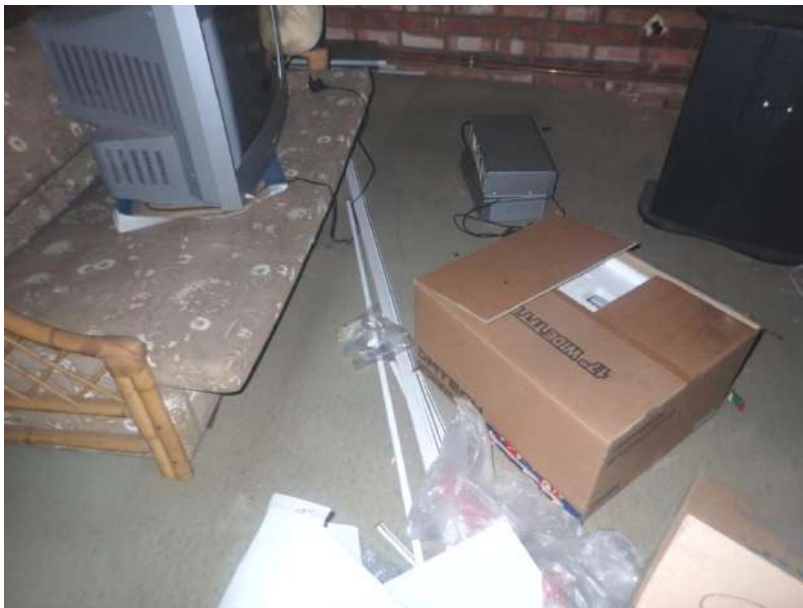
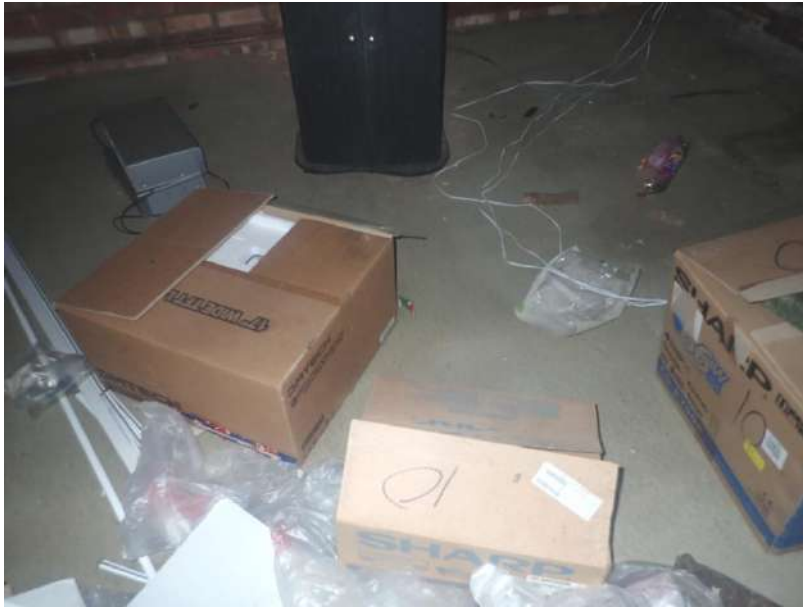
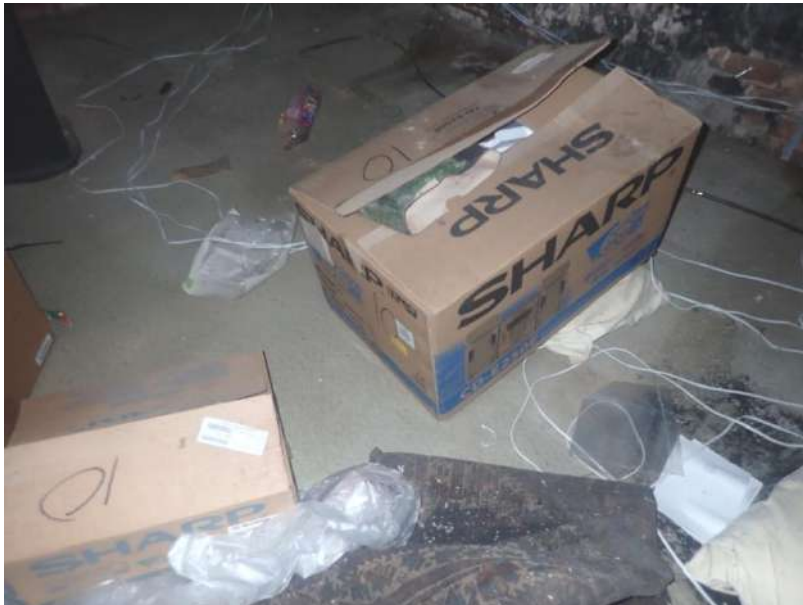
**Plates 61-64** present a number of views of the nature of the flooring of **Cell 4**, which is of modern hardboard.

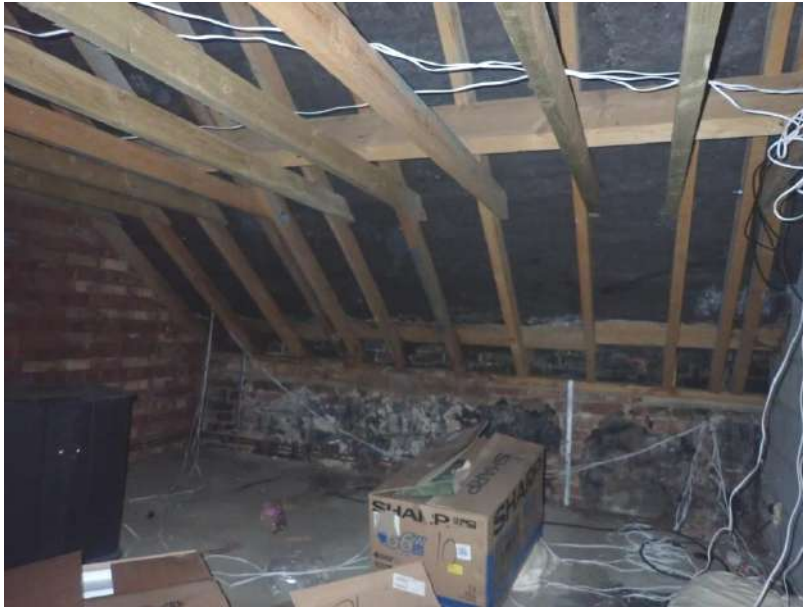
**Plate 65: View of the west wall of Cell 4, from the north-east**

**Plate 65** furnishes a detailed view of the low west wall of **Cell 4**. The nature of the brickwork wall fabric here has become obscured by being covered over with painted plasterwork rendering. An horizontal timber wallplate may be seen to extend along the top of this low west wall.
