HISTORIC BUILDING RECORDING AT THE  
FORMER DUKE OF YORK PUBLIC HOUSE,  
106, RISEGATE ROAD,  
GOSBERTON RISEGATE, LINCOLNSHIRE

**National Grid Reference: TF 2186 3004**  
**Planning Reference: H08-0964-21**  
**Site Code: RRGR22**  
**Accession Number: LCNCC: 2022.147**

PREPARED FOR MRS. S. GOODENOUGH

January 2023

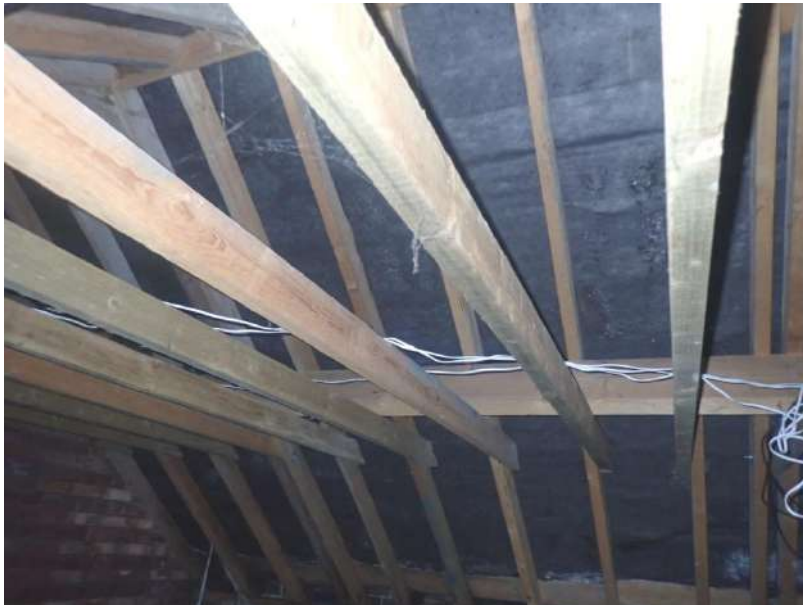
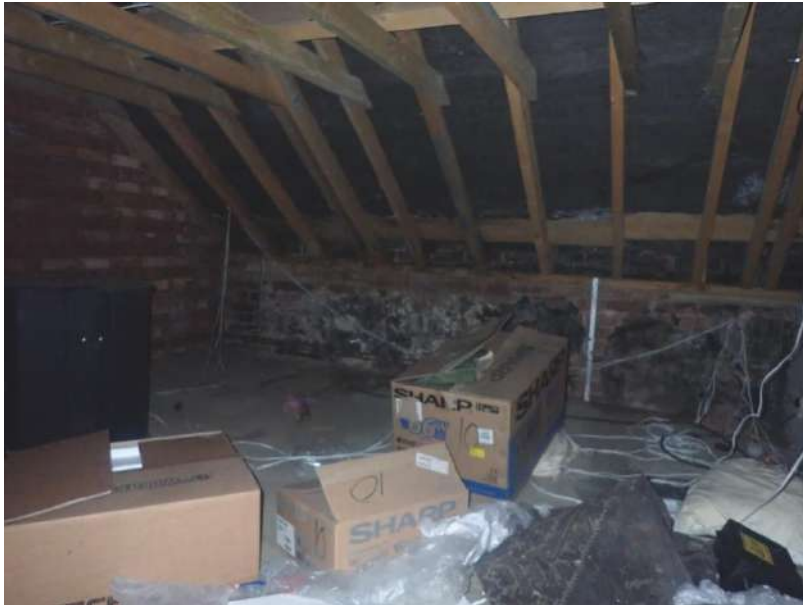
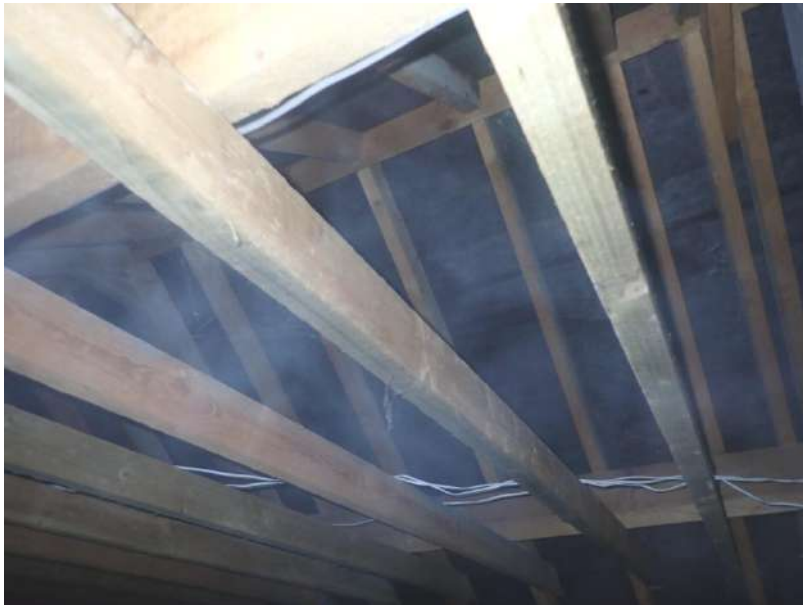
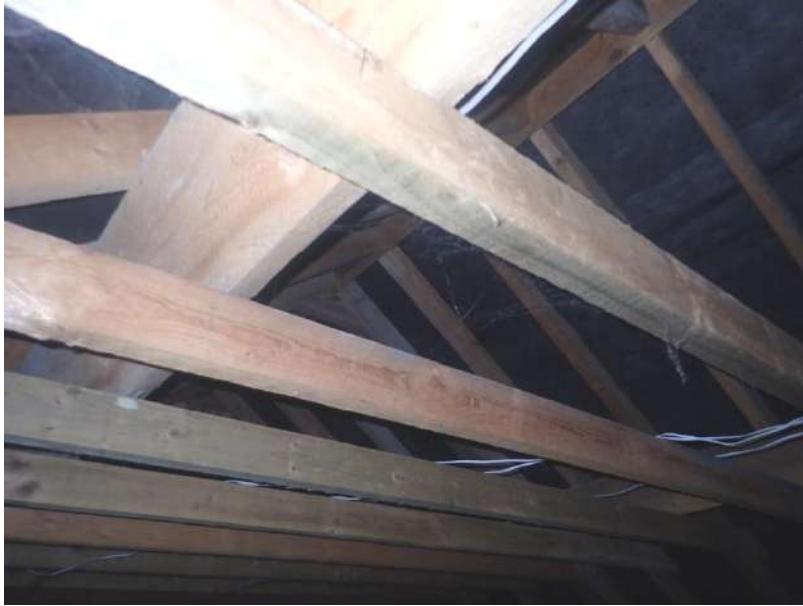
**Plates 66-69** present views of the nature of the roof supporting structure of **Cell 4** and hence of **Building 1**. This is a modern addition and a relatively simple structure. This consists of a framework of timber rafters and a series of horizontal timber purlins that extend along both sides of this structure and also at the roof apex. The basal ends of the timber rafters are attached to the horizontal timber wallplates that run along the top of the low east and west walls, whilst their upper ends are affixed to the horizontal timber purlins at the roof apex. At the mid levels are a series of further horizontal timber tie beams, the ends of which are attached to the timber rafters.

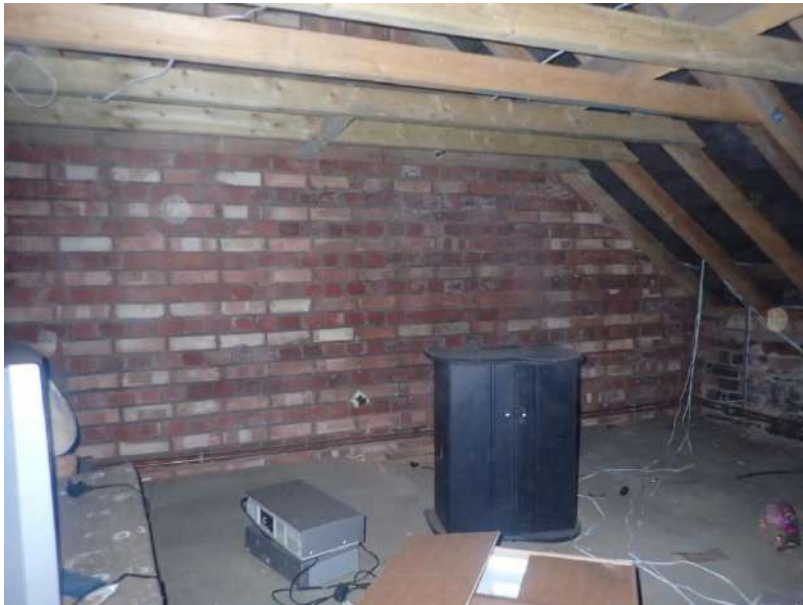
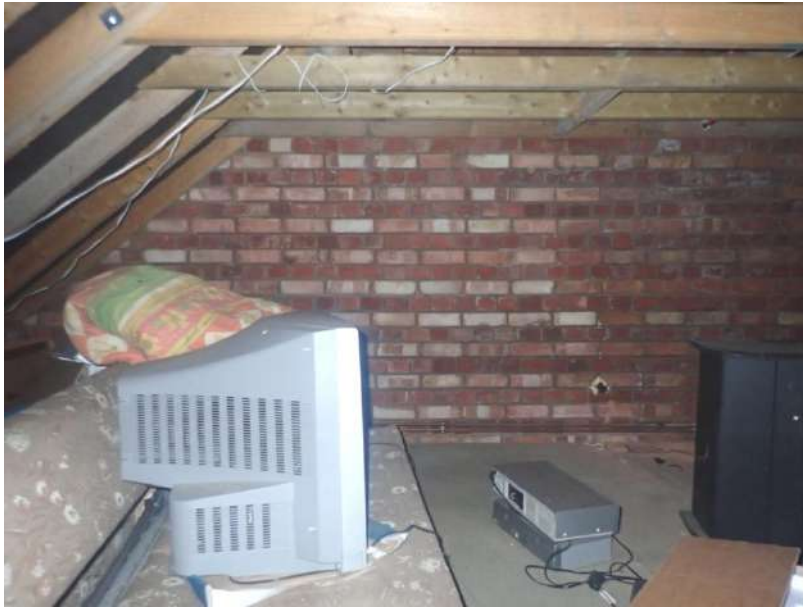
**Plates 70 and 71** furnish detailed views of the lower levels of the south wall of **Cell 4**. The brickwork wall fabric here is composed of courses of brick stretchers that alternate with courses of brick headers in English Bond.

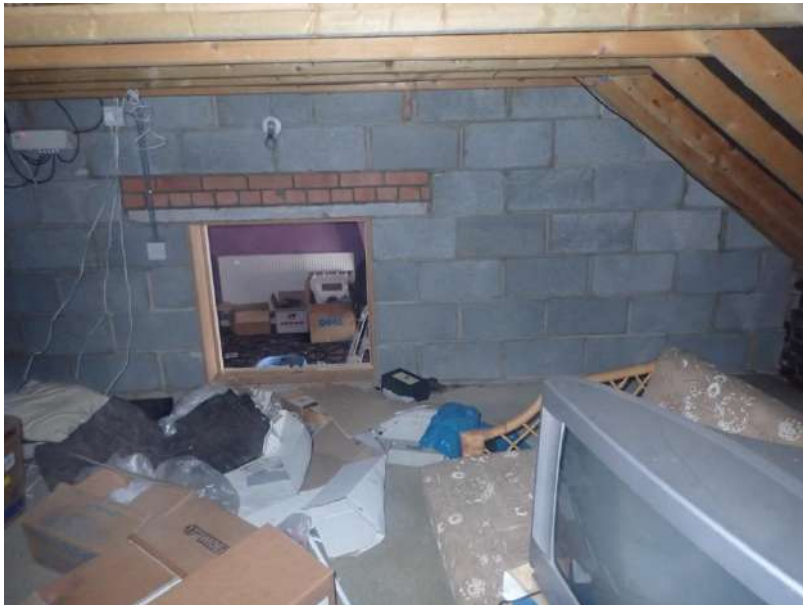
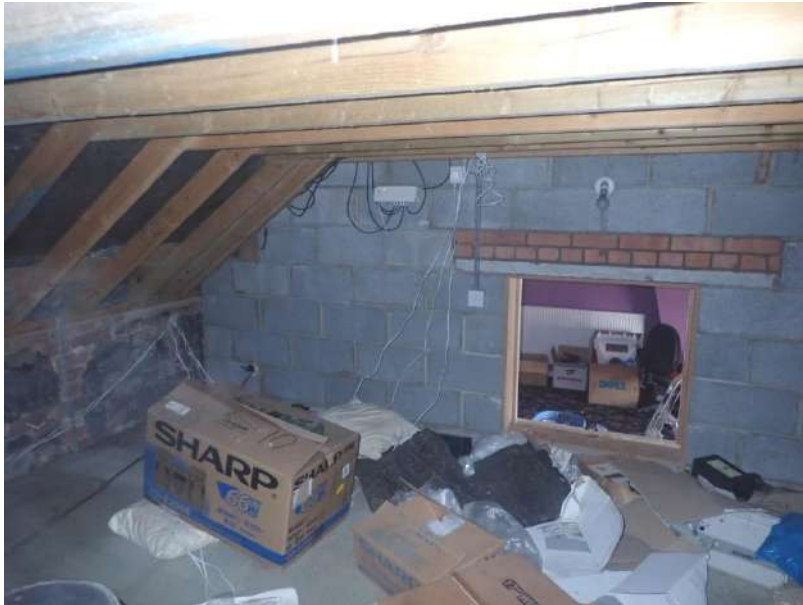
**Plates 72 and 73** feature the north wall of **Cell 4**, which is also the internal dividing wall with the adjoining **Cell 3** to the north. The wall fabric here is composed of courses of modern breeze blockwork and so this is clearly a modern addition. Inserted into this wall fabric is the north facing opening that extends onto the adjoining **Cell 3**. The inner face of this is shown with a timber frame of a head and surrounds.

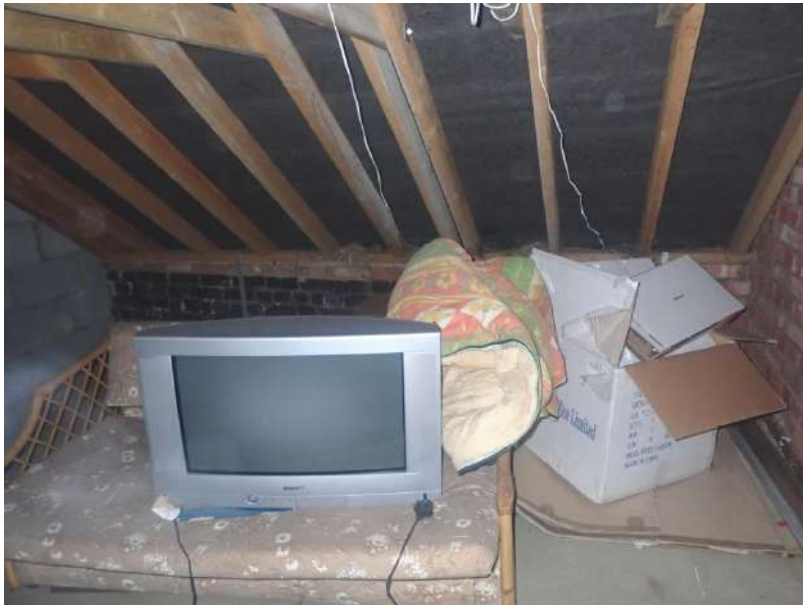
**Plate 74:** View of the east wall of Cell 4, from the south-west

**Plate 74** presents a view of the low east wall of **Cell 4**. The brickwork wall fabric here is composed of courses of brick stretchers that alternate with courses of brick headers in English Bond. An horizontal timber wallplate may be seen to extend along the top of this low east wall.

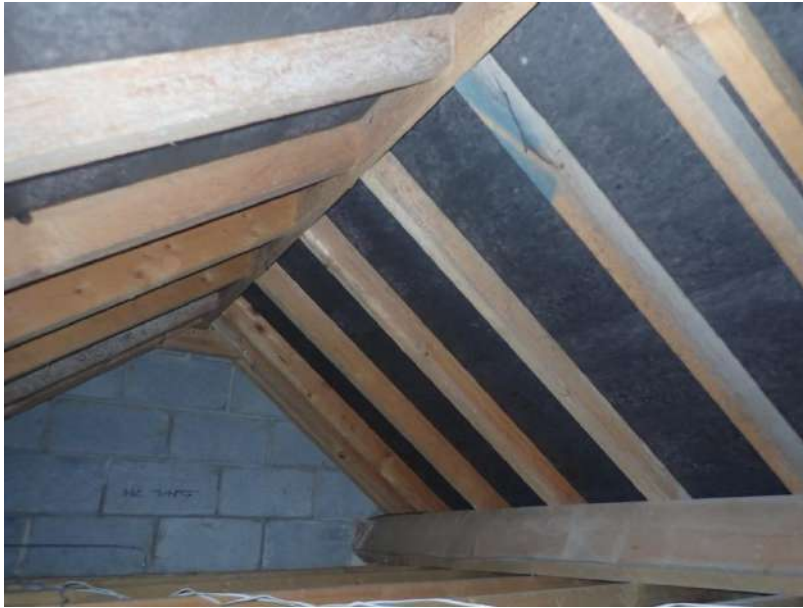
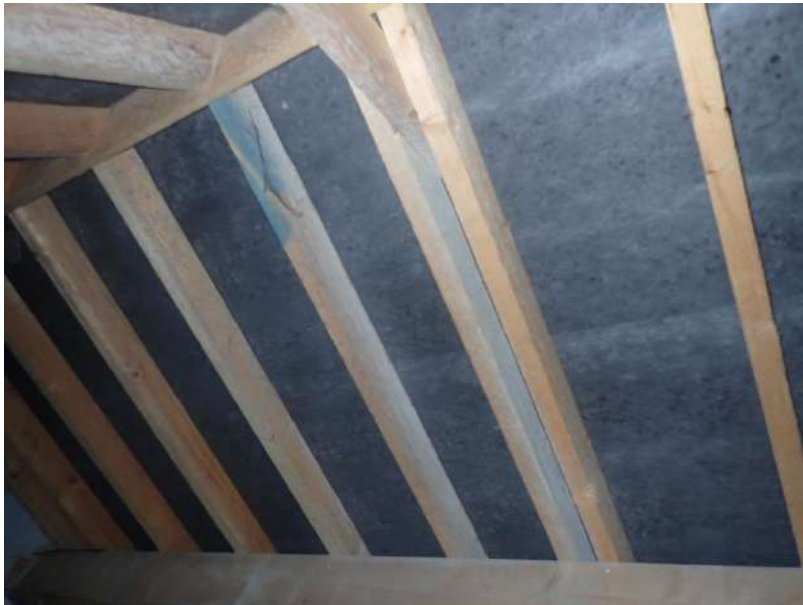
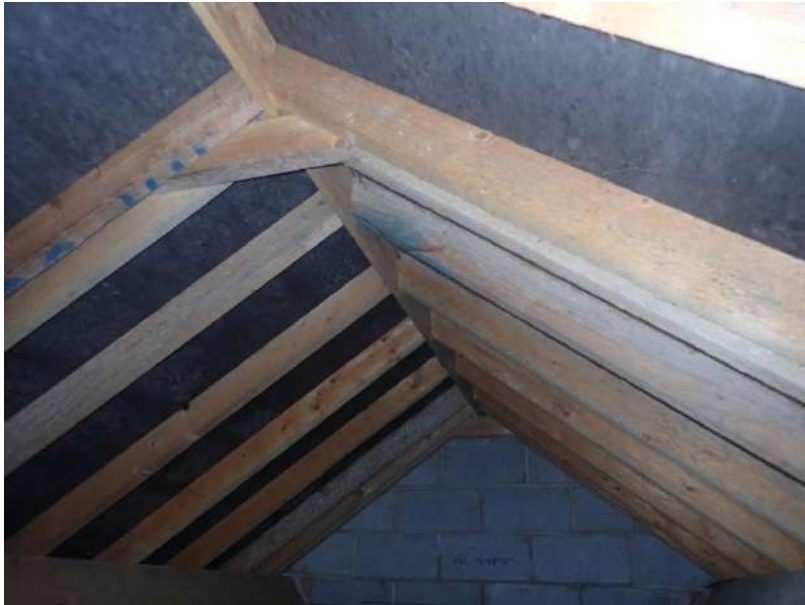
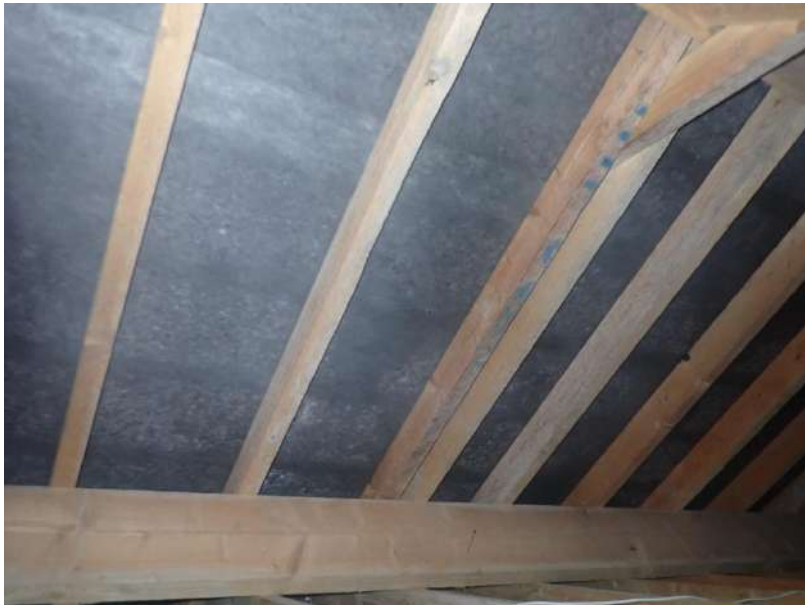
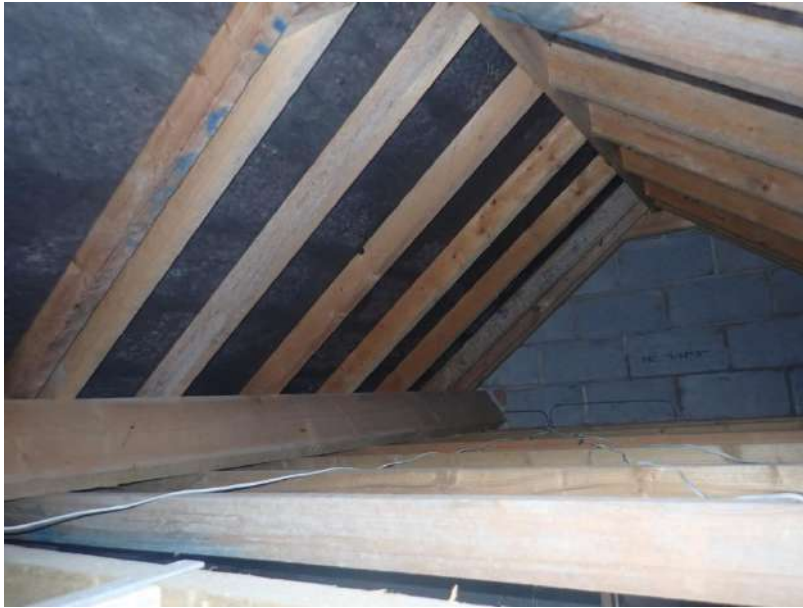
**Plates 75-79** present further views from differing positions of the nature of the roof supporting structure of **Cell 4** and hence of **Building 1**. **Plates 75 and 79** show the upper levels of the north wall of **Cell 4**, which is composed of courses of modern breeze blockwork.

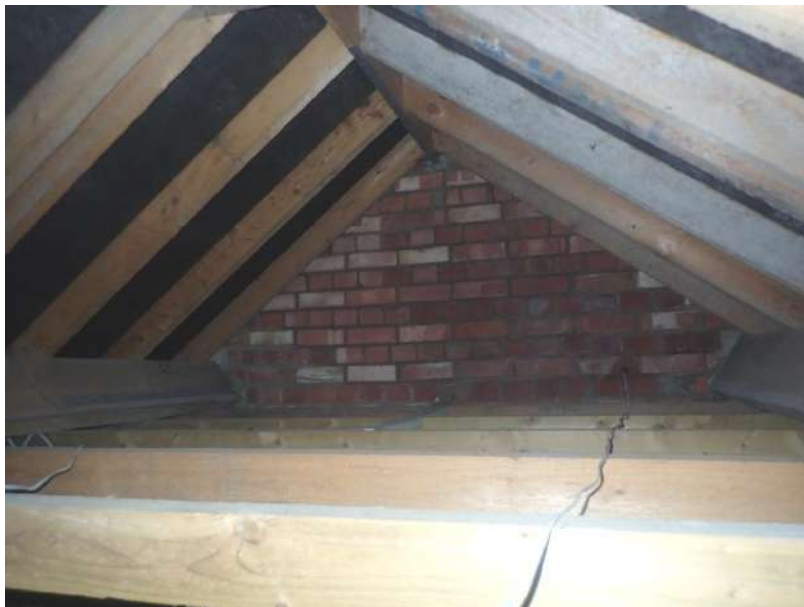
**Plate 84: View of the roof supporting structure of Cell 4, from the north-west**

**Plates 84-88** present further views from differing positions of the nature of the roof supporting structure of **Cell 4** and hence of **Building 1**. **Plates 84 and 87** also feature the upper levels of the south wall of **Cell 4**, where the brickwork here is of English Bond.

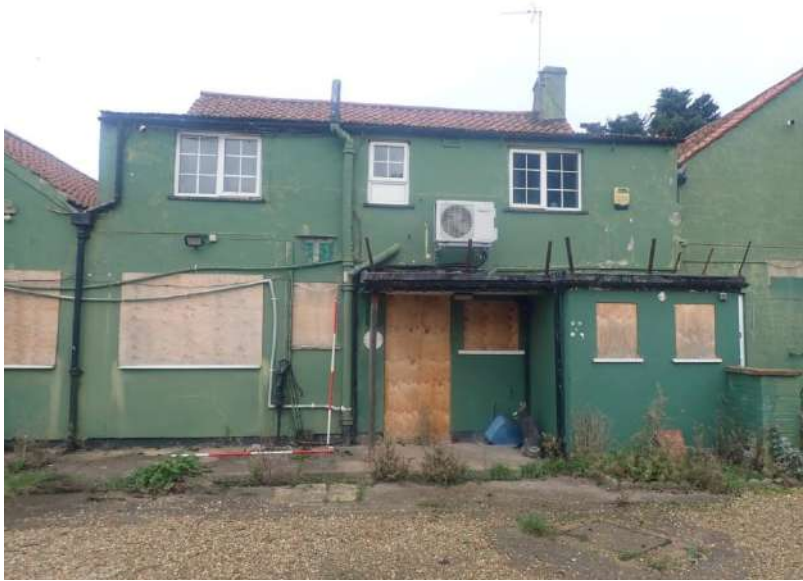
**Plate 89: View of the South Elevation of Building 2, from the south-west**

**Plates 89-92** present a number of detailed views of the South Elevation of **Building 2**, which is in effect the South Elevation of the later rear outshut of the main body of the public house. It may be observed that the entirety of the wall fabric of this South Elevation has been covered over with modern cement rendering. At just below roof levels is modern horizontal Upvc guttering that extends onto a winding vertical modern Upvc downpipe at the western end of this Elevation. Also visible is an off centre vertical metal soilpipe.

At first floor levels are three south facing modern glazed Upvc casement windows, each with timber sills at the base of each opening.

At ground floor levels and to the left (west) are two ground floor window openings that have been boarded over. To the right (east), is a rear south facing entrance opening into this building, which has also been boarded over. Further to the right (east) of this, is a third south facing ground floor window opening that has similarly been boarded over. To the right (east) of this and bonded to the eastern end of this South Elevation is a single storey modern toilet extension, the wall fabric of which has also been entirely rendered over. This has a flat roof which extends westwards to a modern canopy over the rear ground floor entrance opening. Two further south facing window openings within the modern single storey toilet extension have also been boarded over.

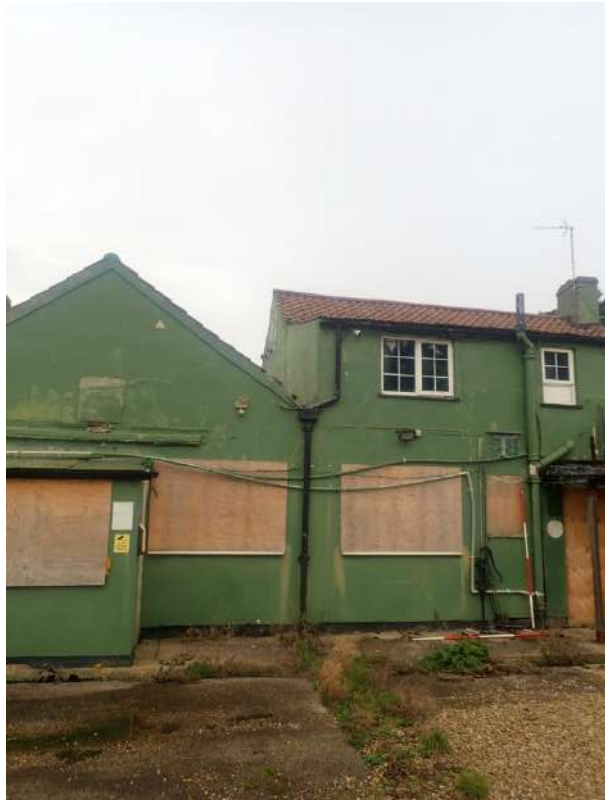
**Plate 93: View of the South Elevation of Building 2, from the south-west**

**Plate 93** provides a view of the upper levels of the West Elevation of the main and original body of the public house along with the upper levels of the West Elevation of the bonded rear outshut. Here also, the entire wall fabric of both Elevations have been covered over with modern cement rendering.

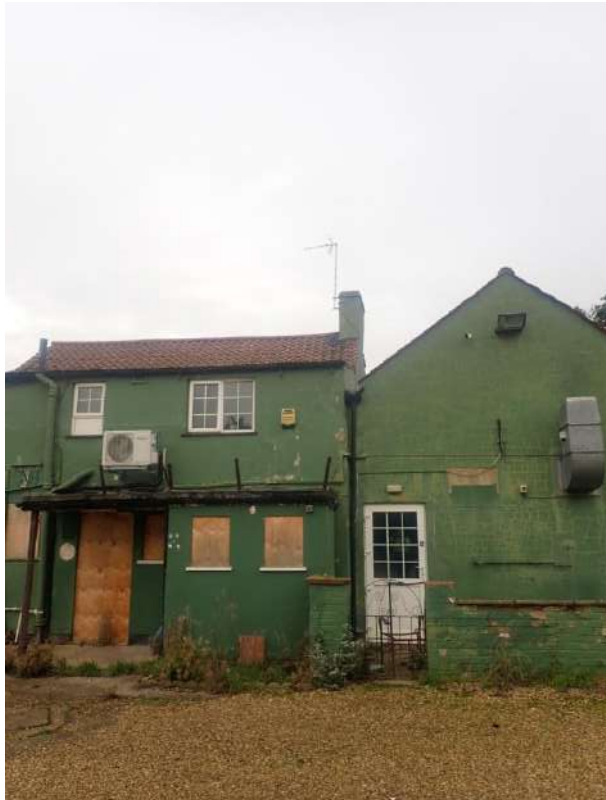
**Plate 94: View of the South Elevation of Building 2, from the south-east**

**Plate 94** also features the upper levels of the East Elevation of the main and original body of the public house along with the upper levels of the East Elevation of the bonded rear outshut. Here also, the entire wall fabric of both Elevations have been covered over with modern cement rendering.

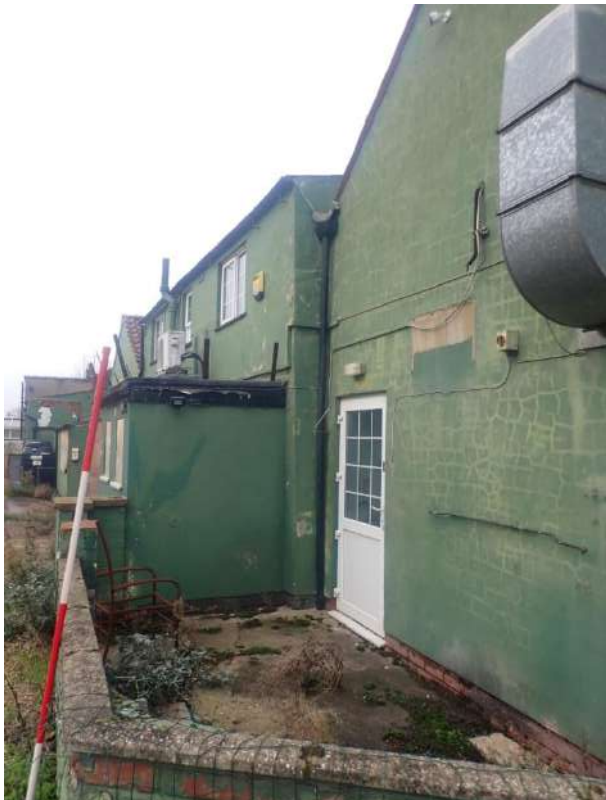
**Plate 95: View of the South Elevation of Building 2, from the north-east**

**Plate 95** presents an image of the East Elevations of the modern single storey toilet extension and also of the lower levels of the rear outshut from a north-eastern vantage point. Here also, the entire wall fabric of both Elevations have been covered over with modern cement rendering.

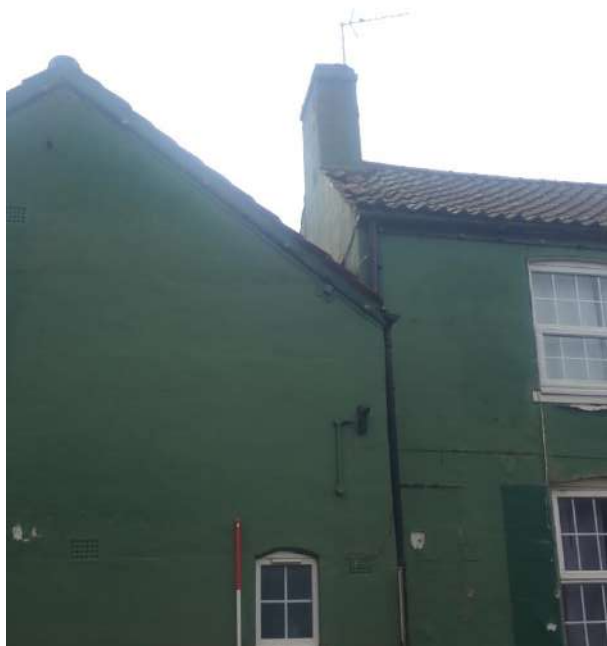
**Plate 96: View of the North Elevation of Building 2, from the north-west**

**Plate 96** provides a view from a different north-western perspective of the upper levels of the East Elevation of the main and original body of the public house, the wall fabric of which has also been entirely covered over with modern cement rendering.

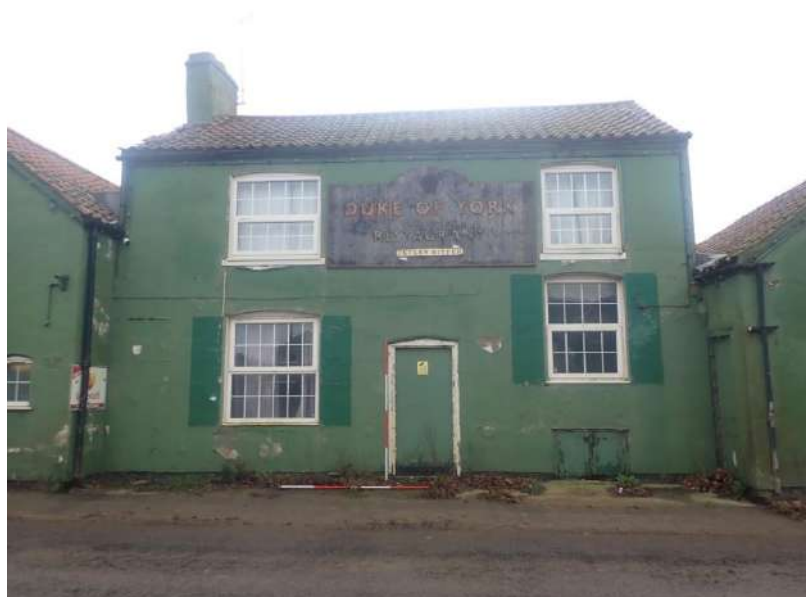
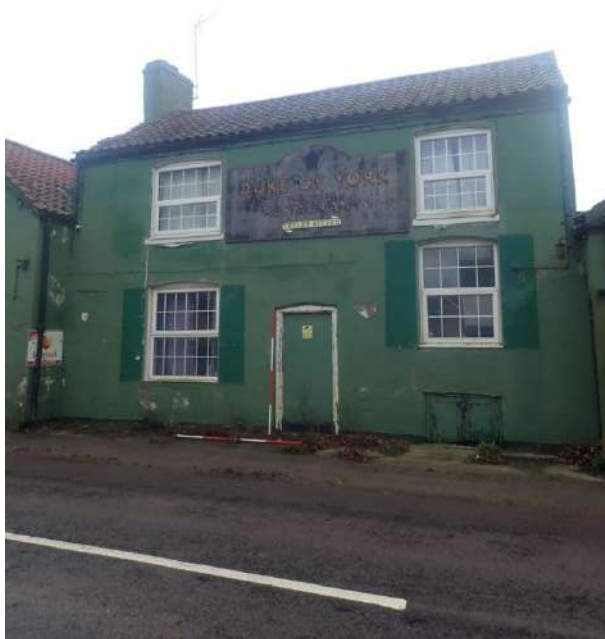
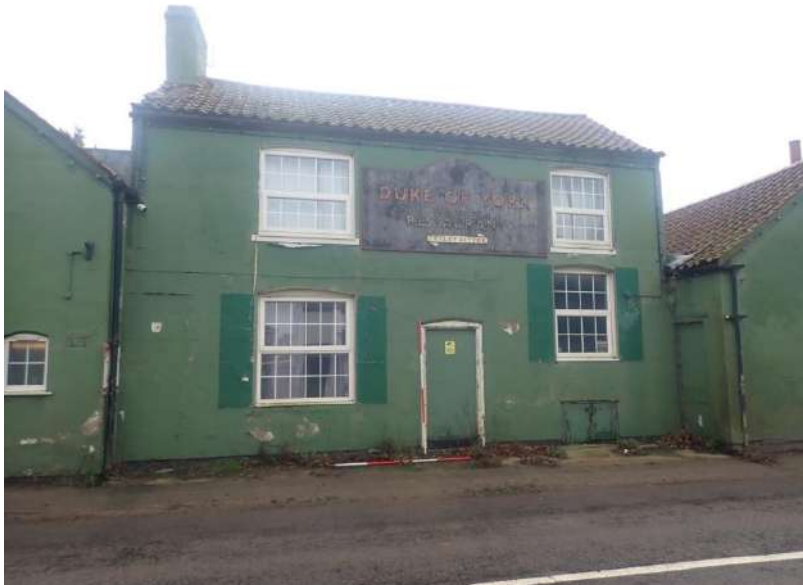
**Plates 97-99** furnish several views of the North Elevation of the original public house building. Here also, the entire wall fabric of this North Elevation has been covered over with modern cement rendering. At just below roof levels is modern horizontal Upvc guttering, which is attached to horizontal timber fascia boards. At first floor levels are two north facing window openings that are both occupied by modern glazed Upvc casement windows. At ground floor levels is the main former access into the building off the Risegate Road street frontage. This north facing entrance opening is occupied by a timber frame of a head and surrounds. The remainder of the opening has been infilled with timber boarding. At ground floor levels are two further north facing window openings.

These north facing ground floor window openings are similarly occupied by two further modern glazed Upvc casement windows. At street levels and to the right (west) is the hatched opening into the basement of the building through which brewery deliveries were made. This opening is occupied by a timber frame and a pair of panelled timber doors.

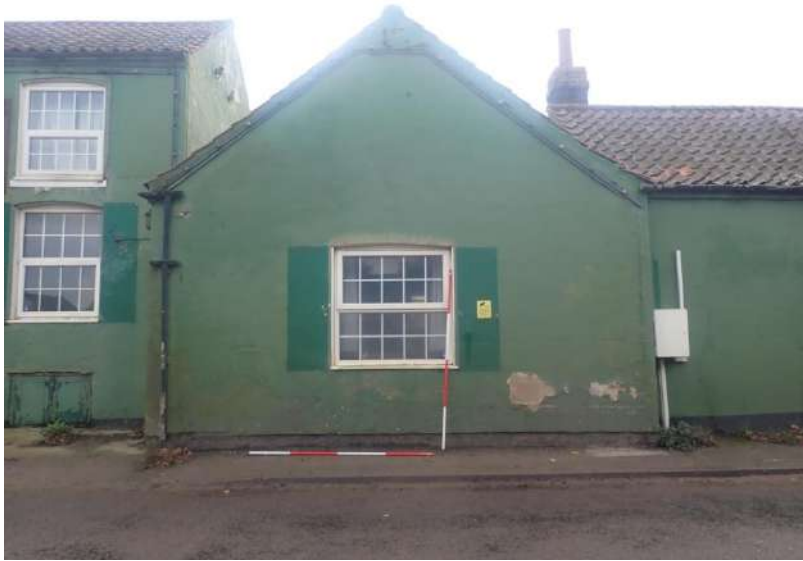
**Plate 100: View of the West Elevation of Building 2, from the north-west**

**Plate 100** provides a view of the upper levels of the West Elevation of the main and original body of the public house, the wall fabric of which has also been entirely covered over with modern cement rendering.

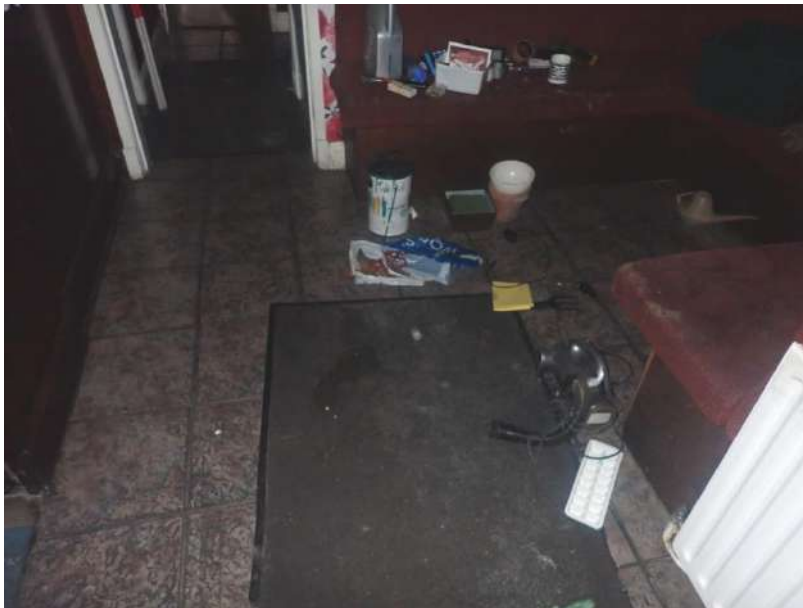
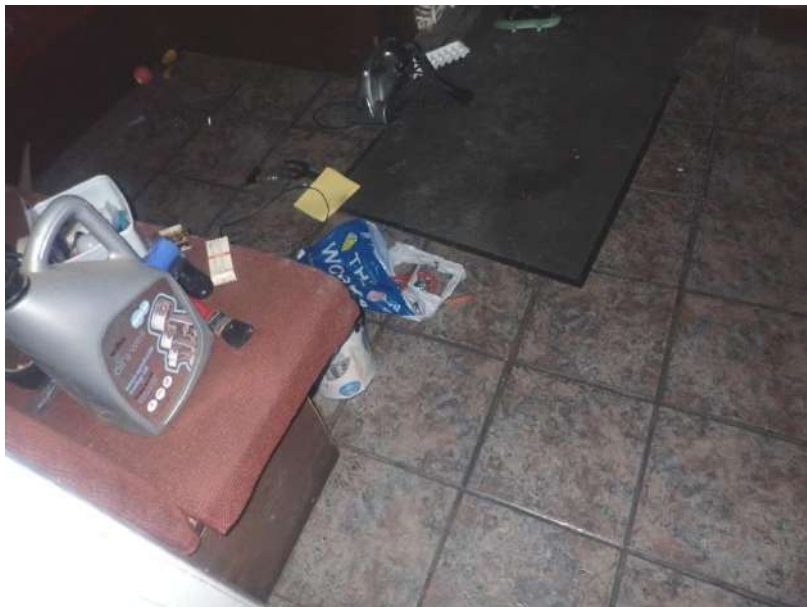
**Plates 101 and 103** furnish views from different perspectives of the nature of the flooring of **Cell 5**, which is of modern ceramic tiling.

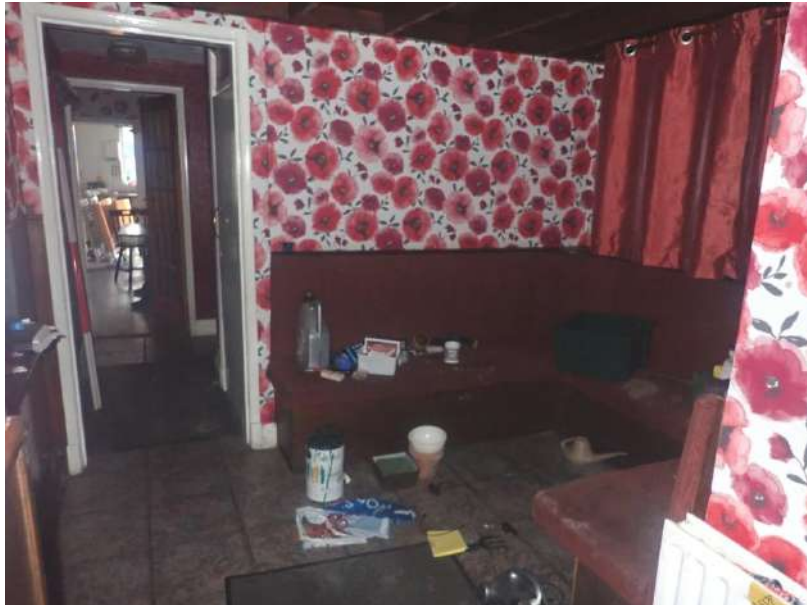
**Plate 102:** General view of the interior of Cell 5, from the south-west

**Plate 102** furnishes a general view of the interior of **Cell 5** from a south-western position.

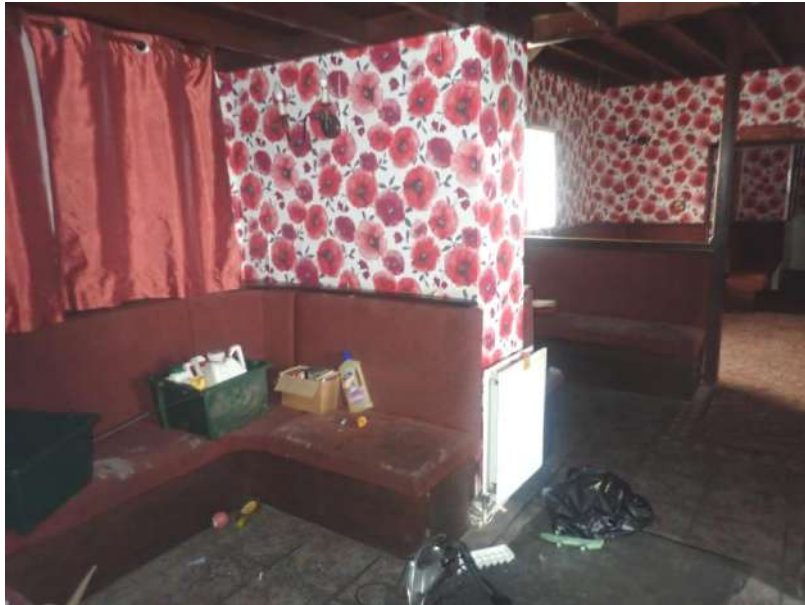
**Plate 104: General view of the interior of Cell 5, from the north-east**

**Plate 104** provides a further general view of the interior of **Cell 5** from a different north-eastern vantage point.

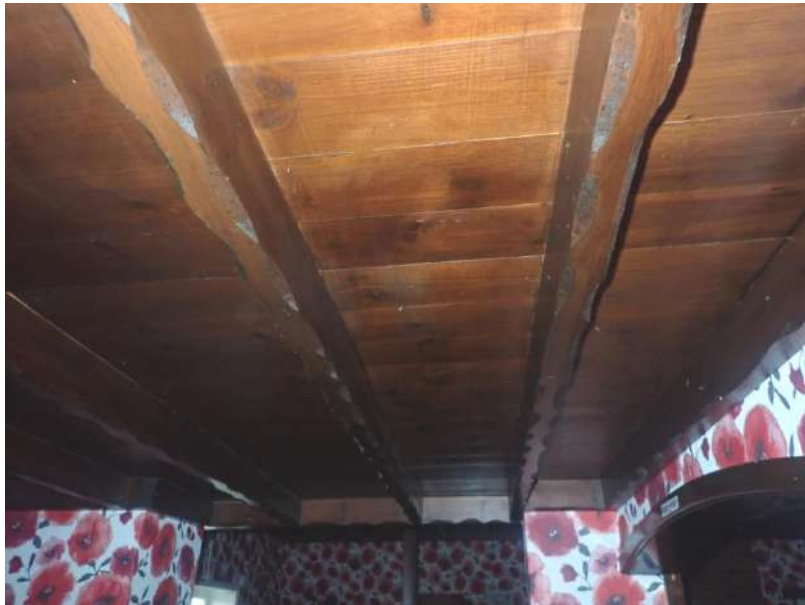
**Plate 105: View of the ceiling of Cell 5, from the north-east**

**Plates 105 and 106** present images of the nature of the modern ceiling structure of **Cell 5** with its east-west orientated horizontal moulded timber joists, which support a first floor flooring above of north-south orientated horizontal timber floor planking.

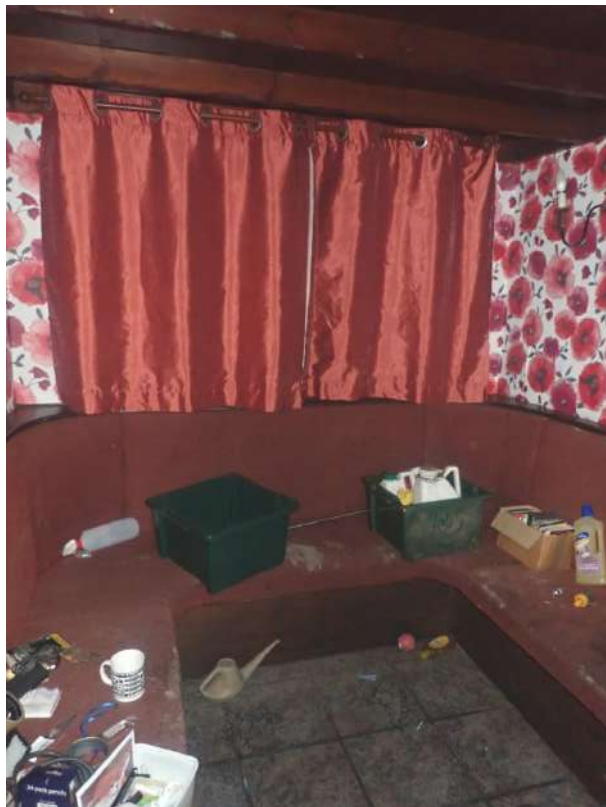
**Plate 107:** View of the south wall of Cell 5, from the north-west

**Plate 107** features the south wall of **Cell 5** and shows the inner face of one of the boarded over south facing window openings that was recorded at the South Elevation of this building. This south wall has a wall covering of modern wallpaper with modern soft furnishings/seating occupying the lower levels of this south wall.

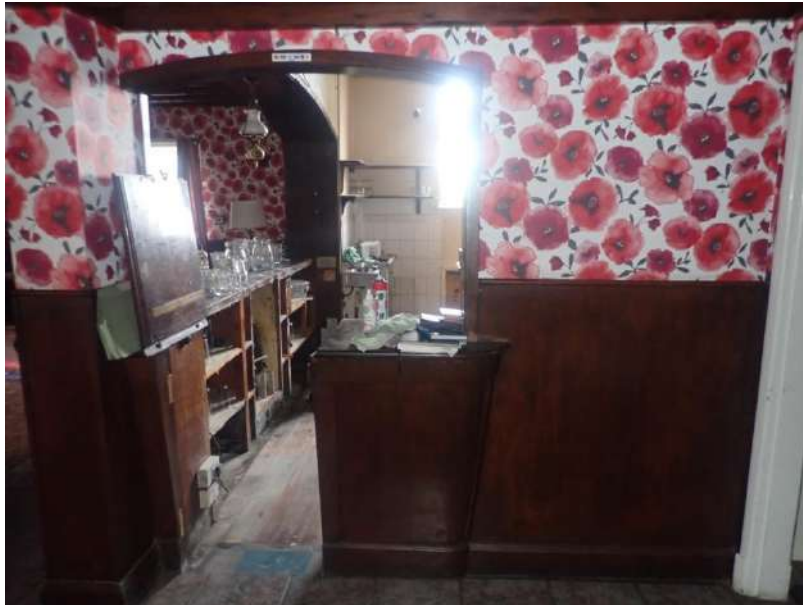
**Plate 108:** View of the north wall of **Cell 5**, from the south-east

**Plate 108** provides a detailed view of the north wall of **Cell 5**. Here also, the wall fabric is covered over with modern wallpaper with modern timber panelling covering the lower levels of this north wall. To the left (west), is the access onto the rear of the public bar via a timber half door and movable counter top. This is also the internal dividing wall with the adjoining **Cell 6** to the north.

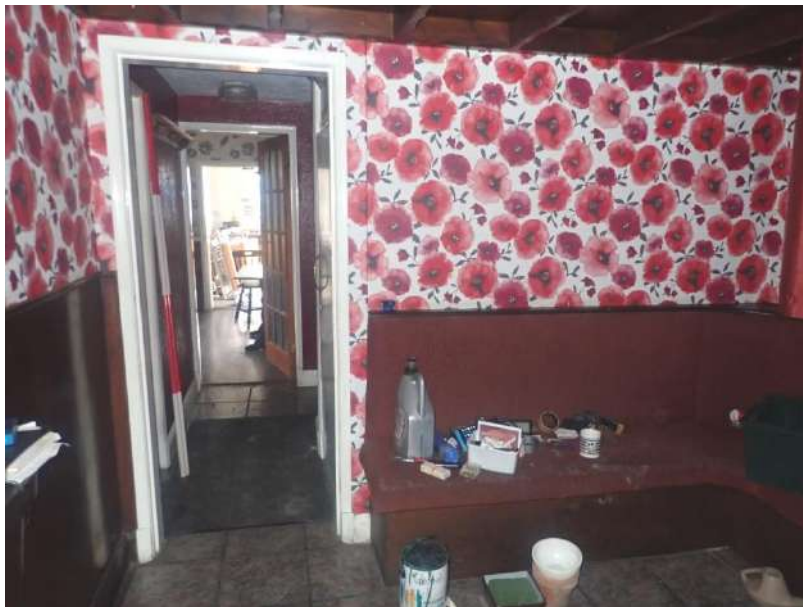
**Plate 109:** View of the east wall of **Cell 5**, from the south-west

**Plate 109** features the east wall of **Cell 5**. Here also, the wall fabric is covered over with modern wallpaper with modern soft furnishings/seating occupying the lower levels of this east wall. This is also the internal dividing wall with the adjoining **Cell 7** to the east. To the left (north), is an east facing entrance opening that extends onto a ground floor lobby (**Cell 7**) with further access to ground floor toilets (**Cell 9**). This entrance opening is occupied by a modern timber frame only. A door is absent.

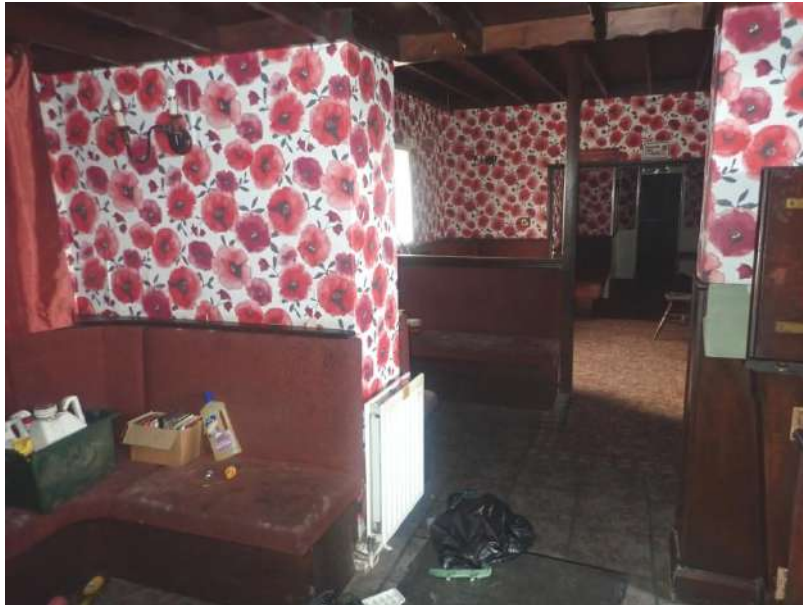
**Plate 110: View of the west wall of Cell 5, from the north-east**

**Plate 110** presents a view of the west wall of **Cell 5** and of its open access into the main part of the public lounge of the public house to the west (**Cell 15**). Here also, the wall fabric is covered over with modern wallpaper with modern soft furnishings/seating occupying the lower levels of this west wall.

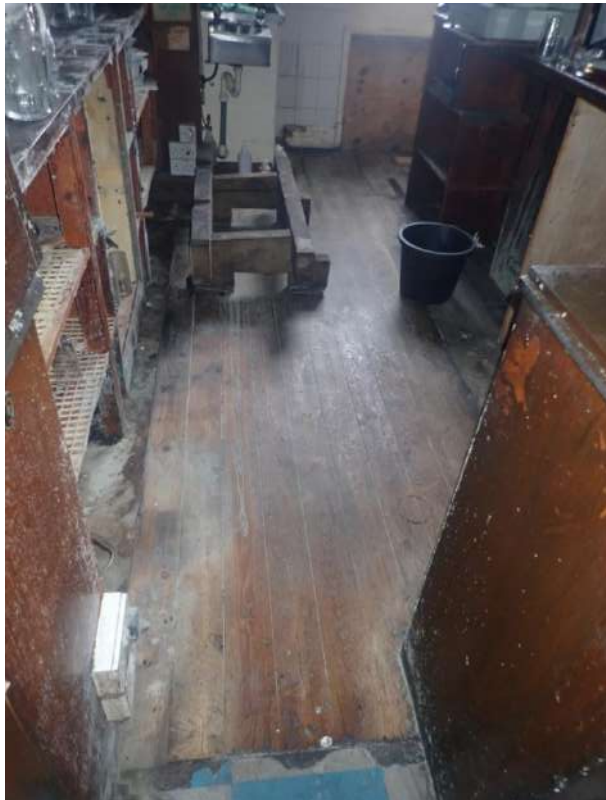
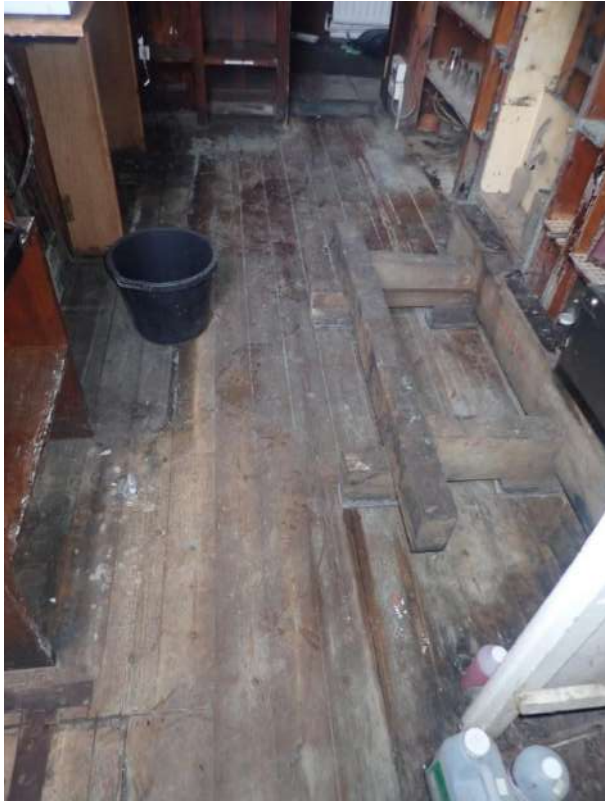
**Plates 111 and 113** provide views of the nature of the flooring of **Cell 6** from different perspectives, which is of horizontal timber planking.

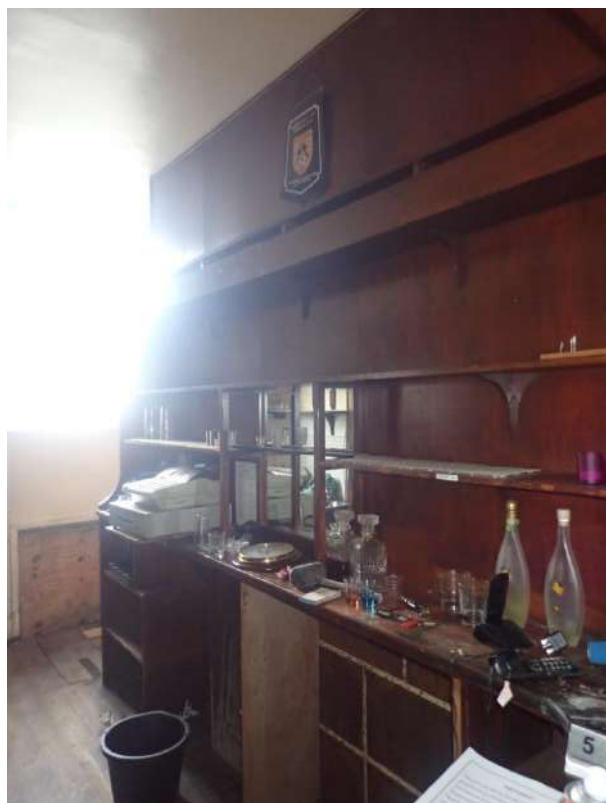
**Plate 112: View of the rear serving area of the public bar, from the south-west**

**Plate 112** presents a view of the rear serving area of the public bar with its mahogany fixtures and fittings.

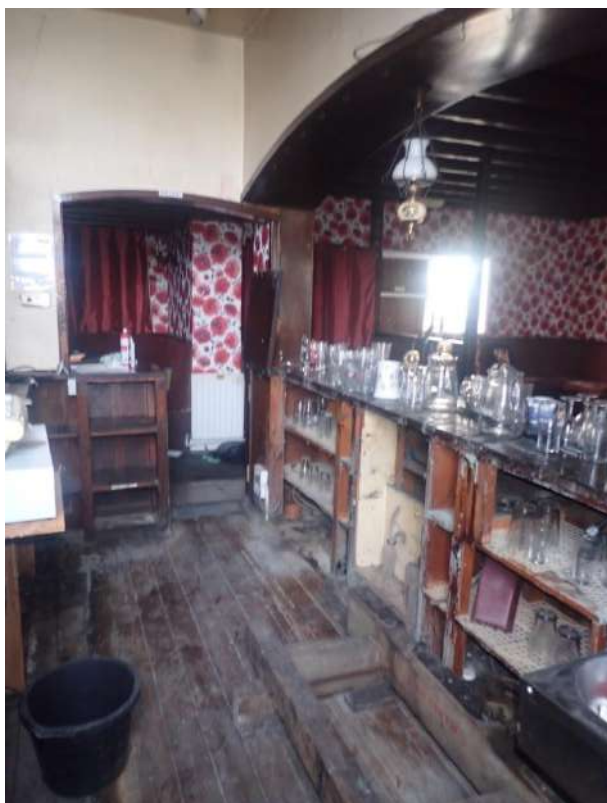
**Plate 115: General view of the interior of Cell 6, from the north-west**

**Plate 115** furnishes a general view of the interior of **Cell 6** from a north-western vantage point.

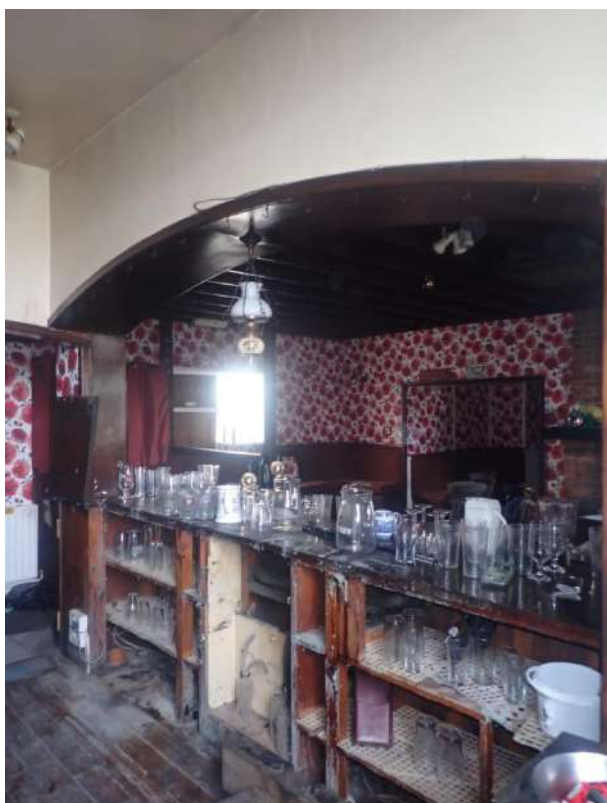
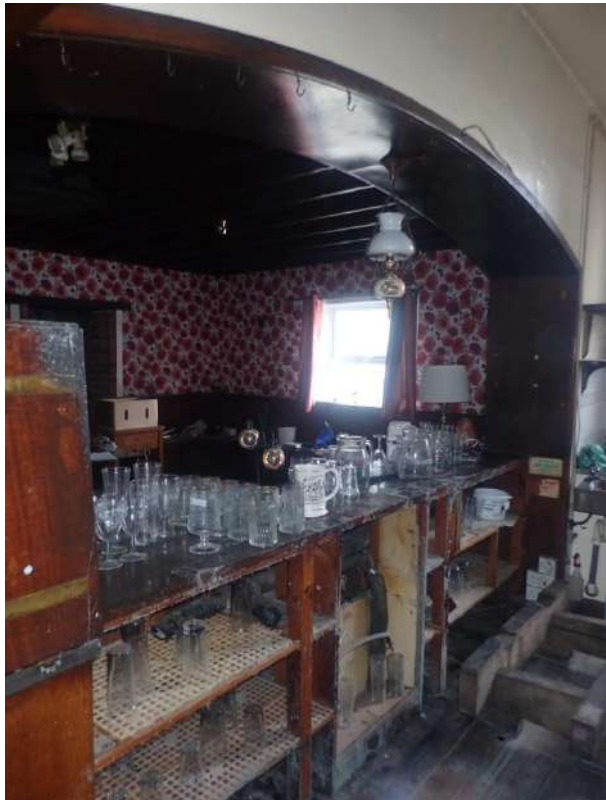
**Plates 116 and 117** provide views from differing perspectives of the rear of the public bar with its fixtures and fittings.
