HISTORIC BUILDING RECORDING AT THE  
FORMER DUKE OF YORK PUBLIC HOUSE,  
106, RISEGATE ROAD,  
GOSBERTON RISEGATE, LINCOLNSHIRE

**National Grid Reference: TF 2186 3004**  
**Planning Reference: H08-0964-21**  
**Site Code: RRGR22**  
**Accession Number: LCNCC: 2022.147**

PREPARED FOR MRS. S. GOODENOUGH

January 2023

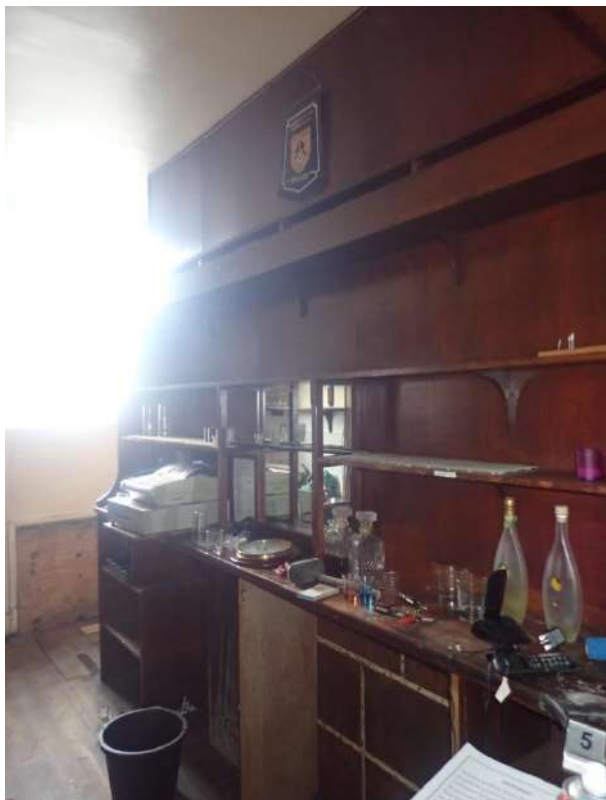
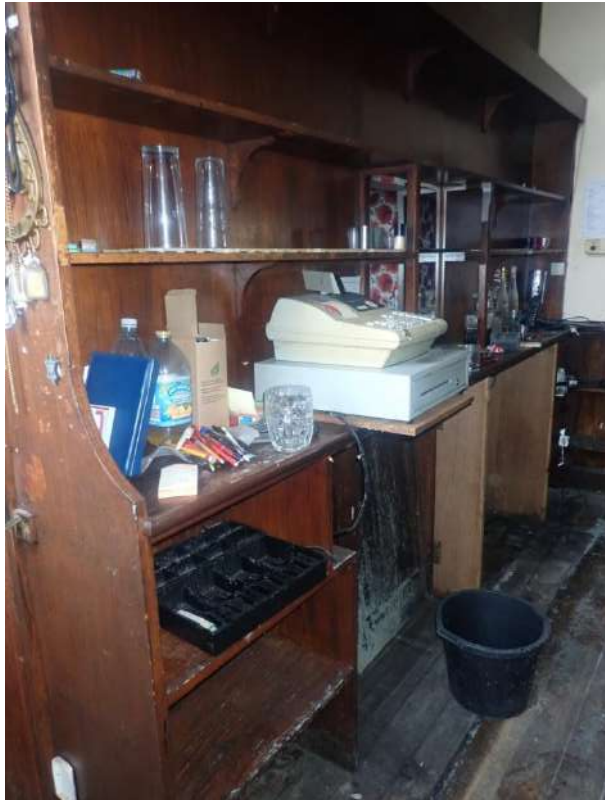
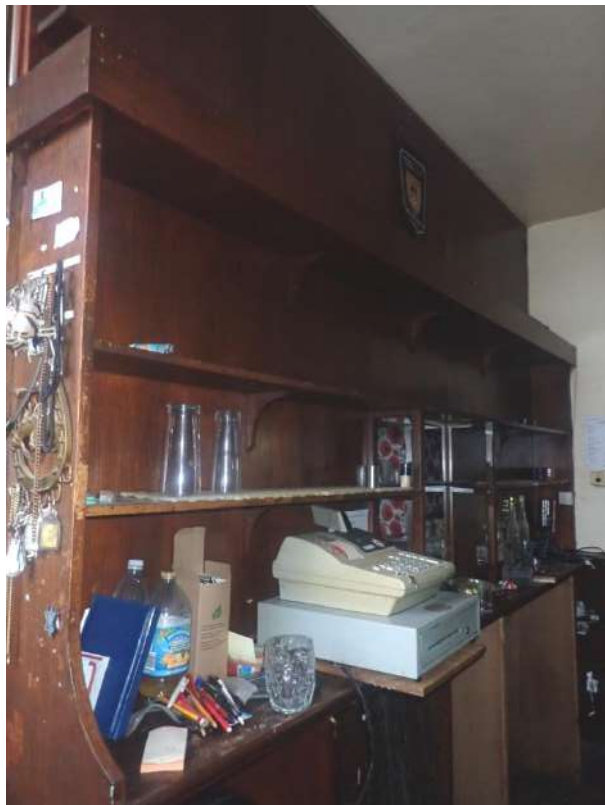
**Plates 118-120** present further views from differing positions of the rear serving area of the public bar with its mahogany fixtures and fittings.

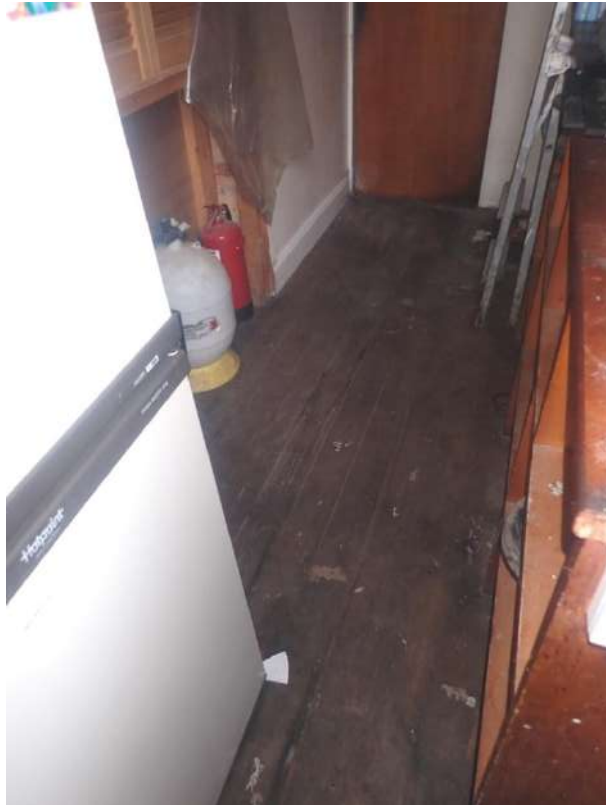
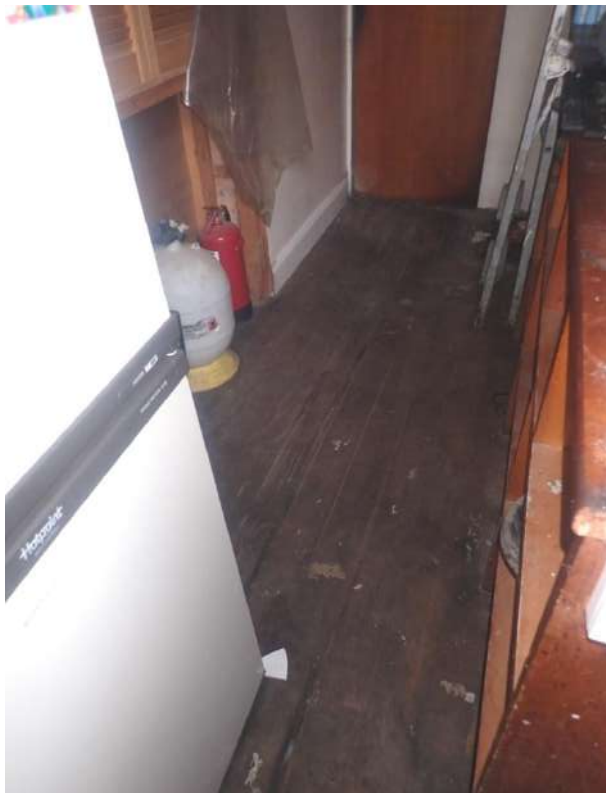
**Plate 122 and 129** provide further views of the nature of the flooring at the rear of **Cell 6**, which is of horizontal timber planking.

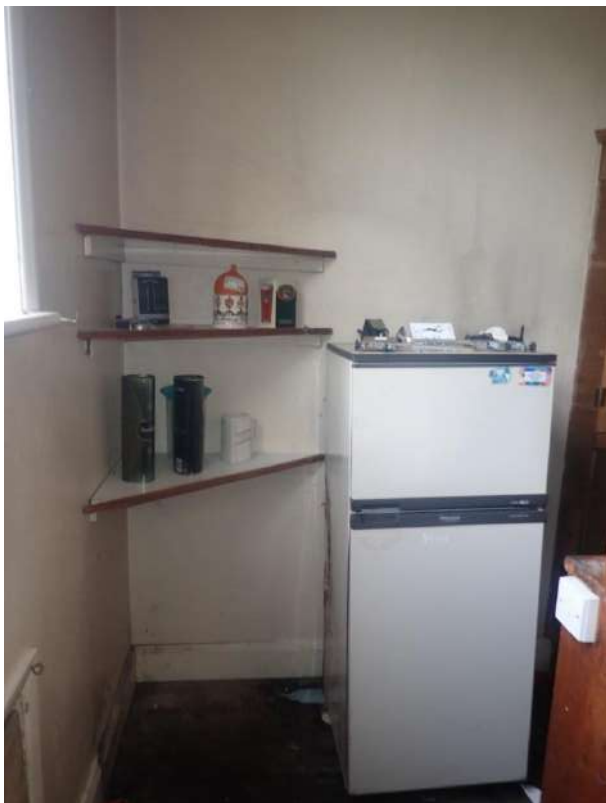
**Plate 123: View of the northern portion of the east wall of Cell 6, from the south-west**

**Plate 123** features the western portion of the east wall of **Cell 6**, which has been rendered over with modern plasterwork. This is also the internal dividing wall with the adjoining **Cell 8** to the east.

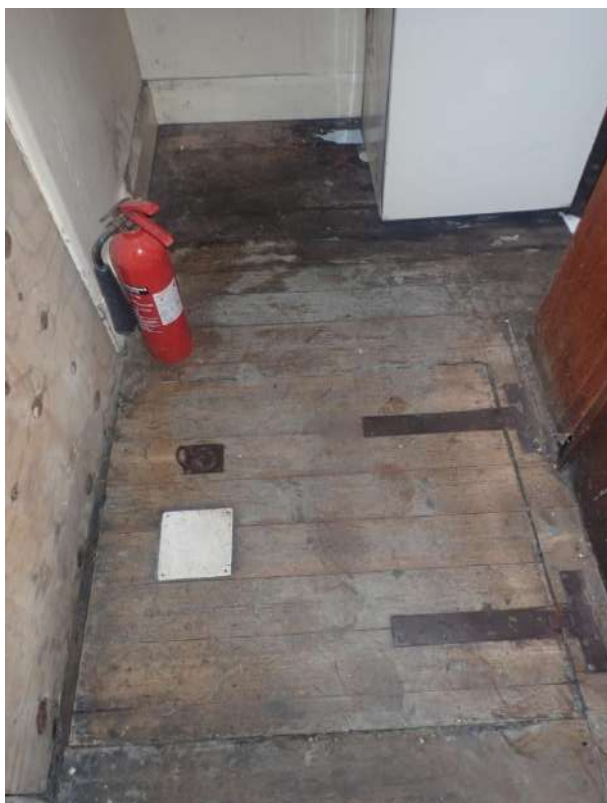
**Plate 124: View of part of the flooring of Cell 6, from the south-west**

**Plate 124** presents a further view of the nature of the flooring at the northern end of **Cell 6**, which is also of horizontal timber planking. Set into this flooring is a timber trap door or hatch which leads onto the public house/bar basement. Unfortunately, this was sealed at the time of this survey, such that the basement below could not be accessed.

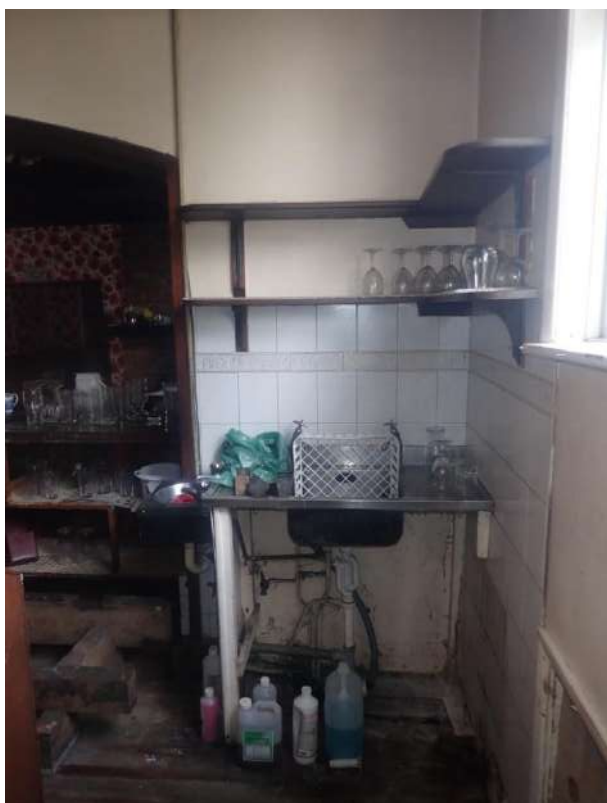
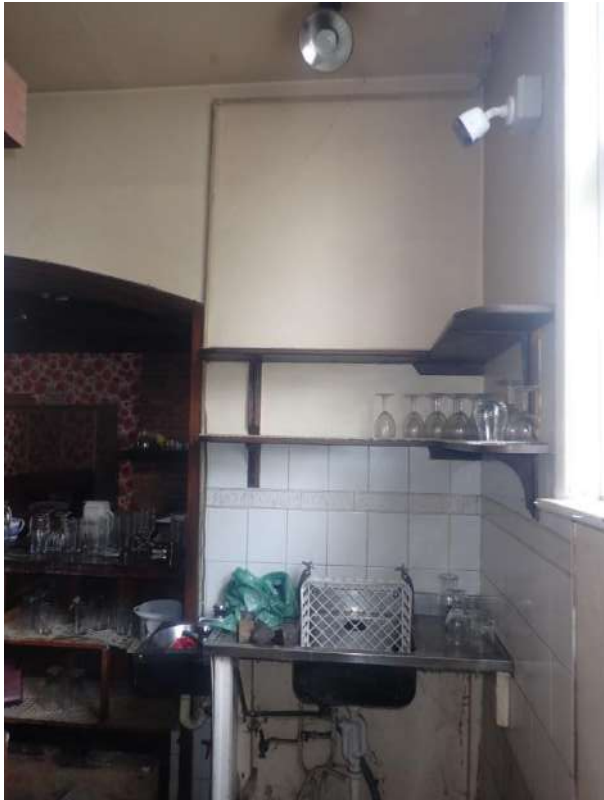
**Plates 125 and 126** show the northern portion of the west wall of **Cell 6**, and beside the rear of the public bar, which has also been rendered over with modern plasterwork. This is also part of an internal dividing wall with the adjacent **Cell 15** to the west.

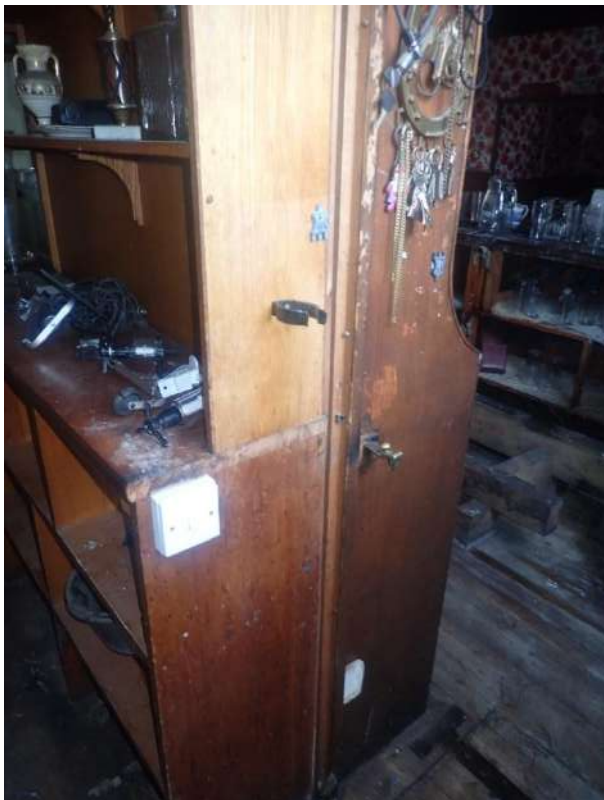
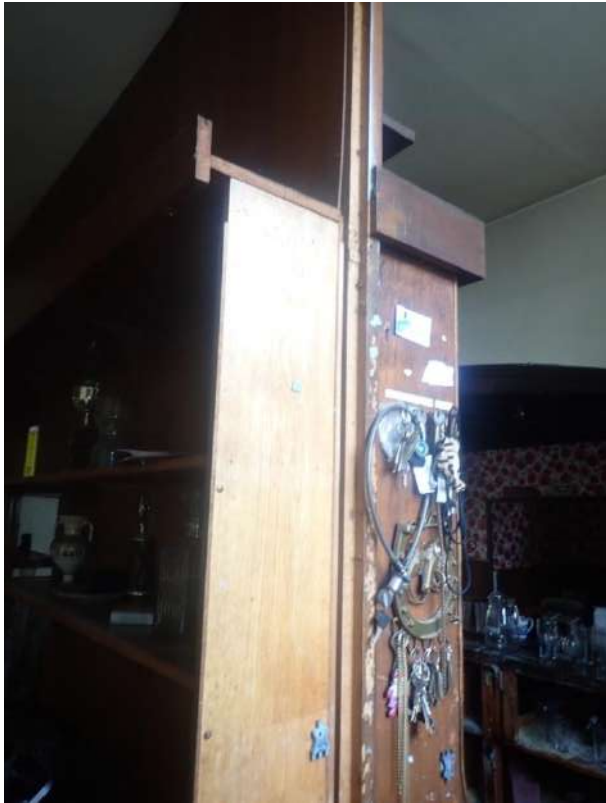
**Plates 127 and 128** provide views of the northern end of the rear wooden storage area of **Cell 6** with its fixtures and fittings.

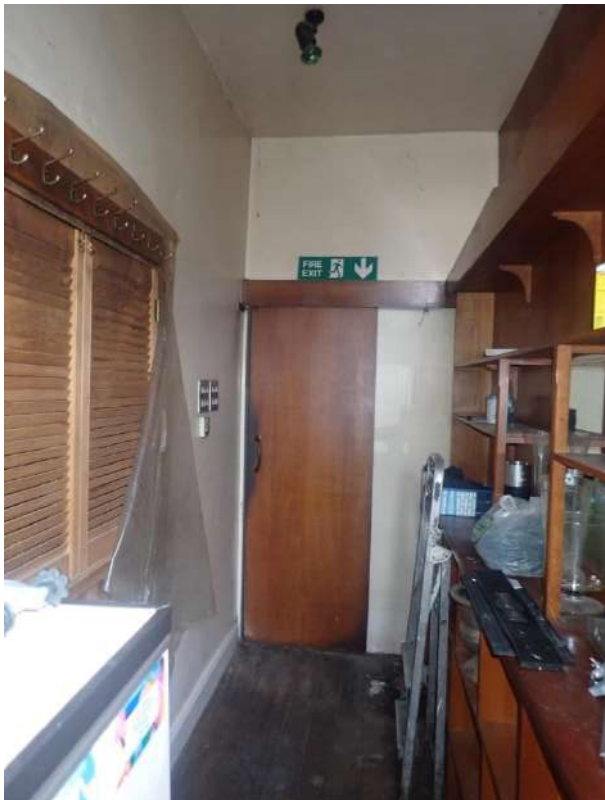
**Plate 130: View of the ceiling of the rear of Cell 6, from the north-west**

**Plate 130** provides a further view of the nature of the ceiling structure at the rear of **Cell 6**, which has been rendered over with modern plasterwork.

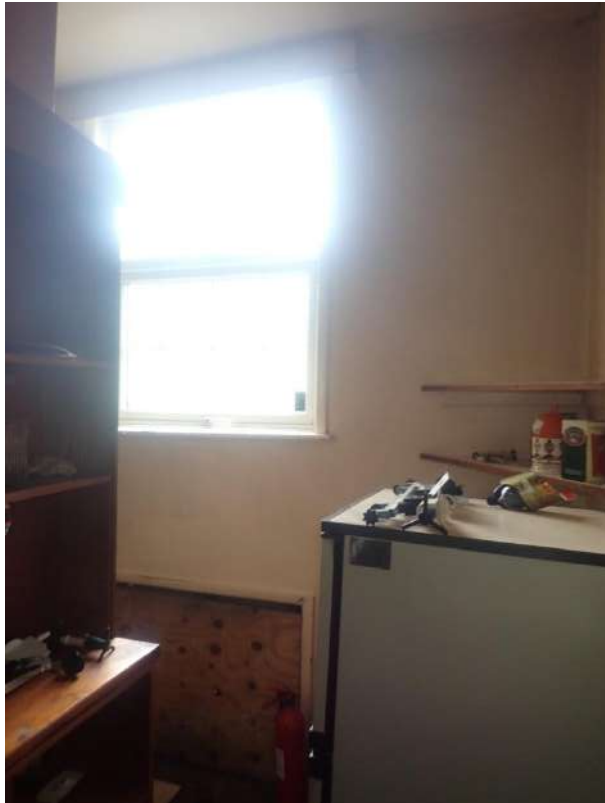
**Plate 131: General view of the interior of the rear of Cell 6, from the north-west**

**Plate 131** furnishes a general view of the interior of the rear of **Cell 6** from a north-eastern vantage point. This also shows the eastern portion of the south wall of **Cell 6**, which has also been rendered over with modern plasterwork. This is also the internal dividing wall with the adjoining **Cell 7** to the south. Inserted into this eastern portion of the south wall is a modern south facing entrance opening, that leads onto **Cell 7**. This opening is occupied by a modern timber door that is attached to a modern sliding mechanism.

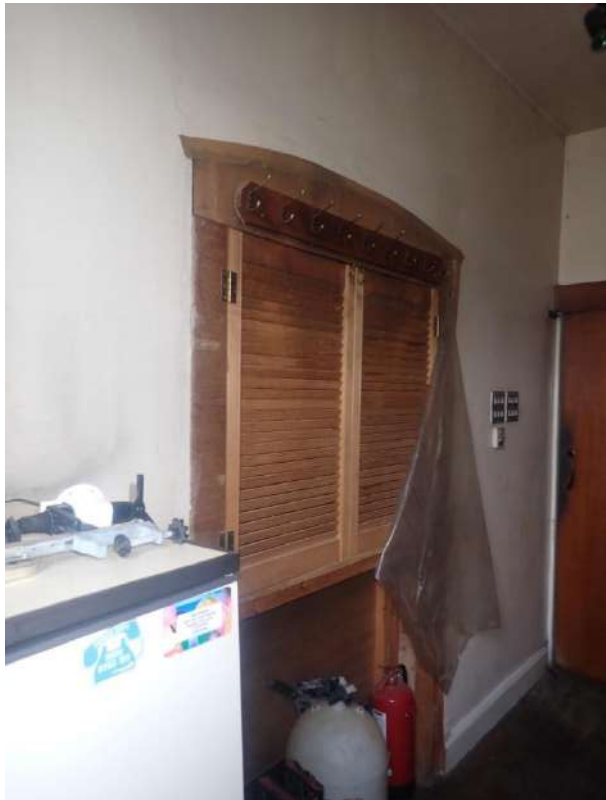
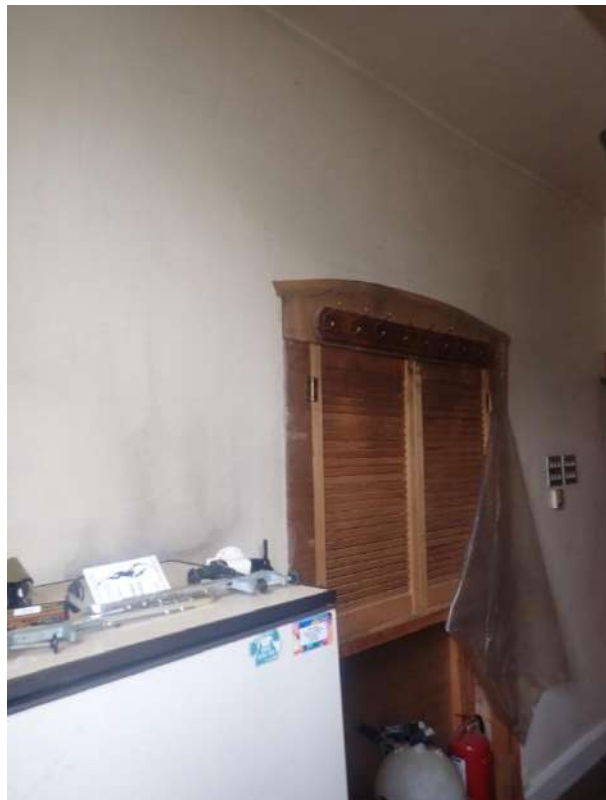
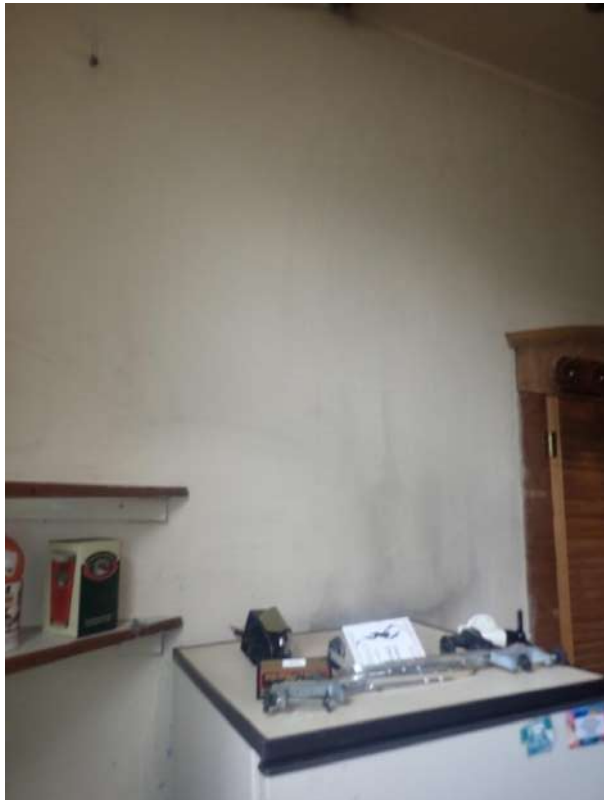
**Plates 133-135** present several further images from differing positions of the east wall of **Cell 6**. This has also been rendered over with modern plasterwork. This is also the internal dividing wall with the adjacent **Cell 8** to the east. Horizontal timber skirting boards occur along its base. Also shown is a modern timber servery hatch, which serviced the ground floor dining room to the east (**Cell 8**).

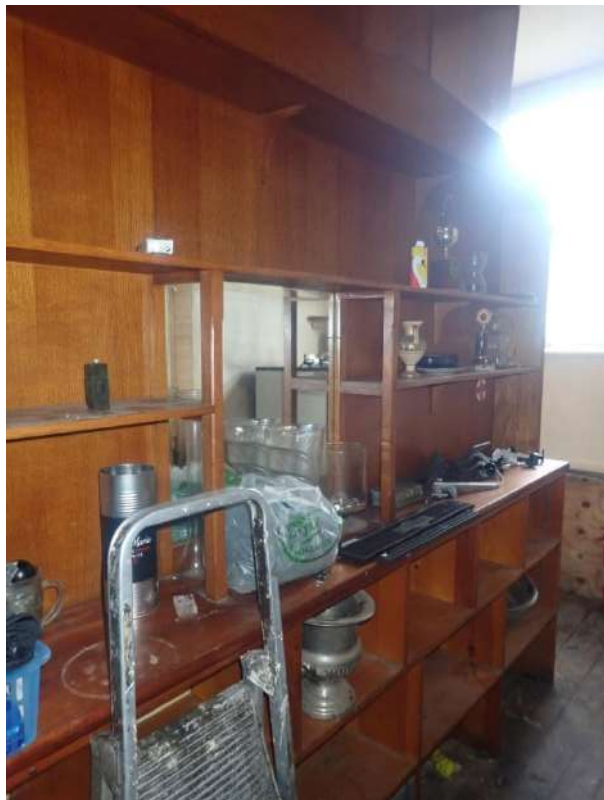
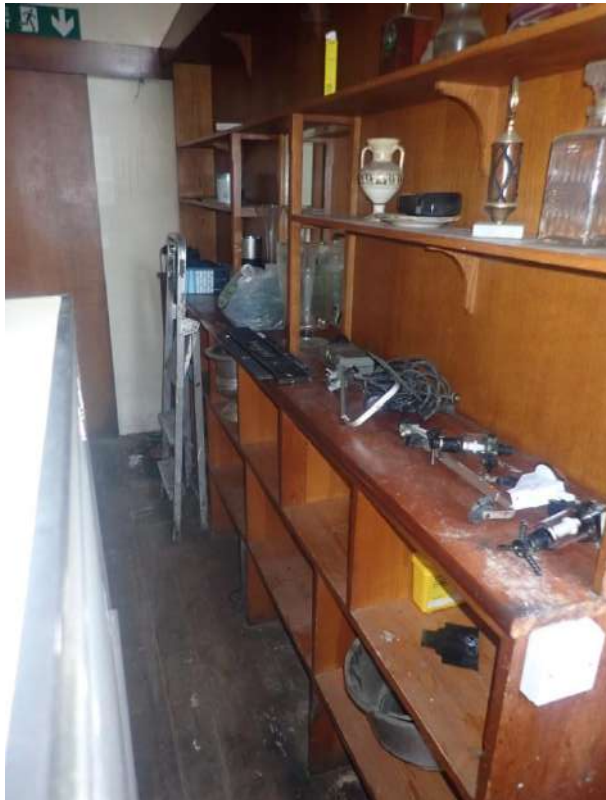
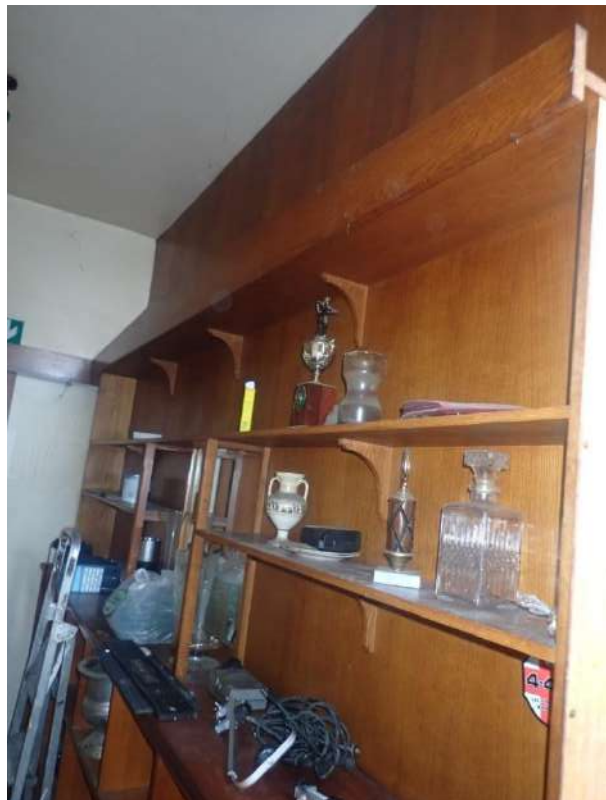
**Plates 136-138** furnish further views of the rear wooden storage area of **Cell 6** with its fixtures and fittings.

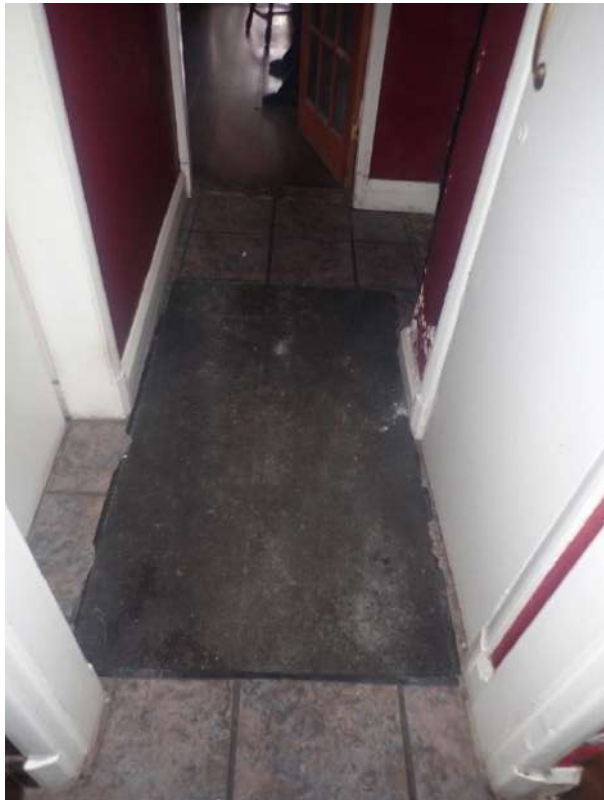
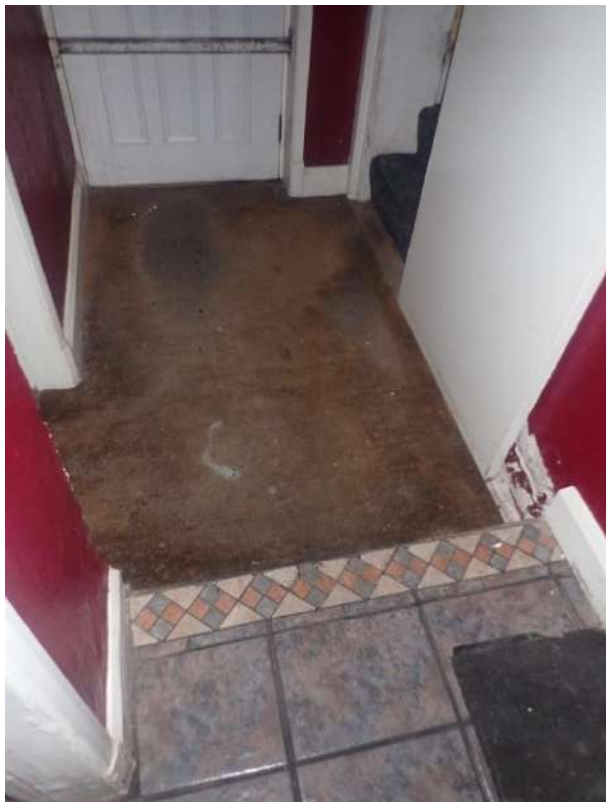
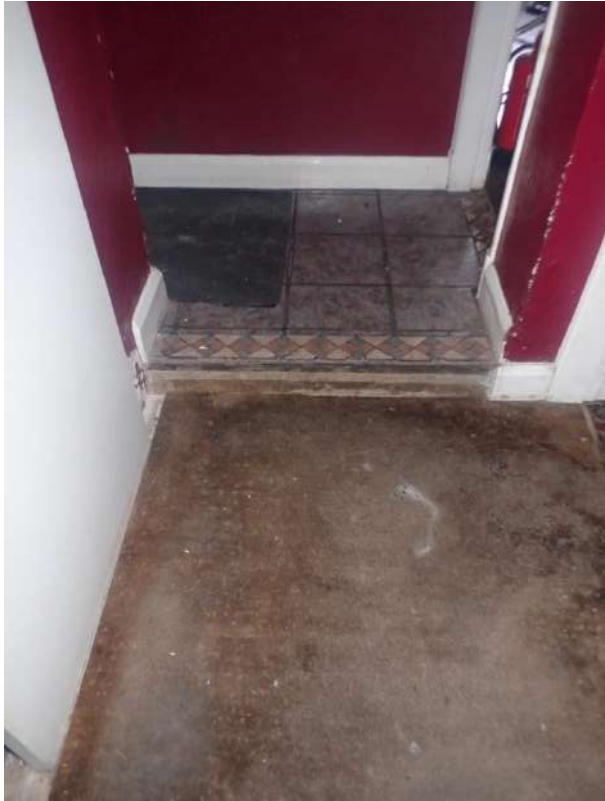
**Plates 139 and 141-142** present a number of views of the nature of the flooring of **Cell 7** from different vantage points. This is of modern ceramic floor tiling with further areas of matting.

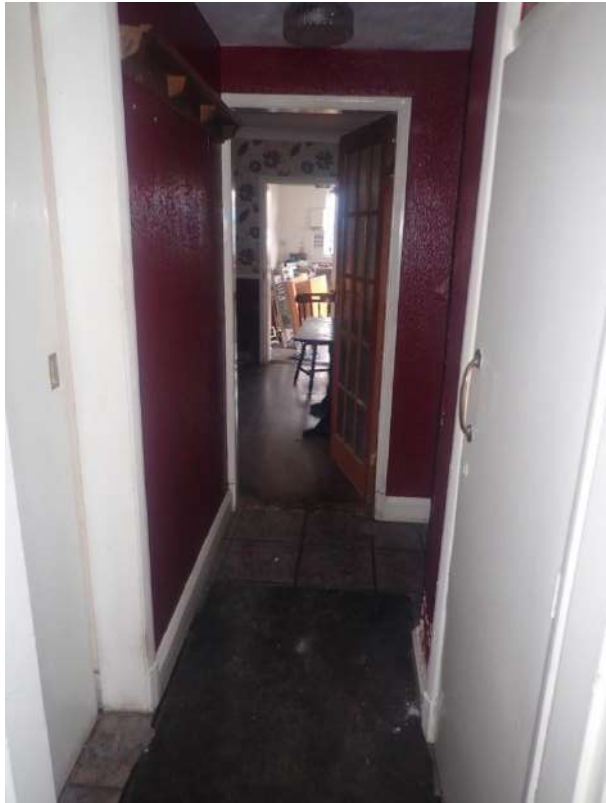
**Plate 140: General view of the interior of Cell 7, from the south-west**

**Plate 140** provides a general view of the interior of **Cell 7** from a south-western position

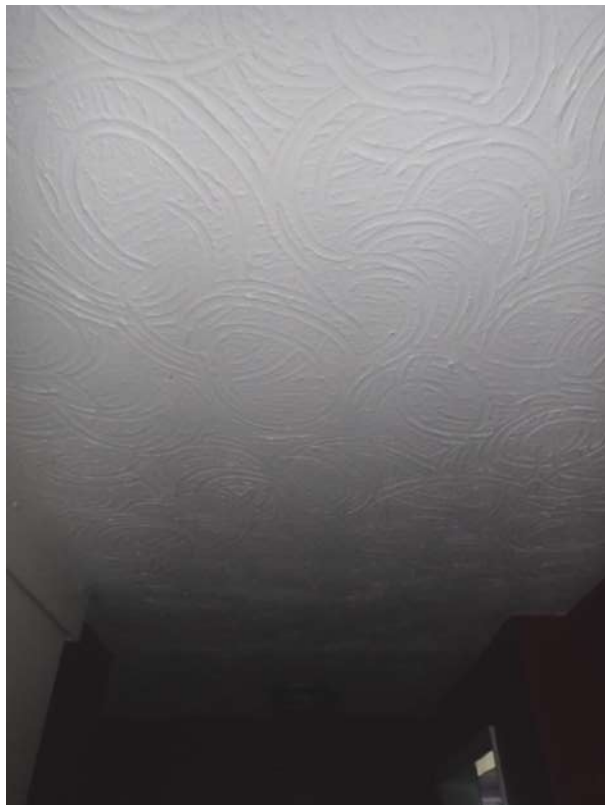
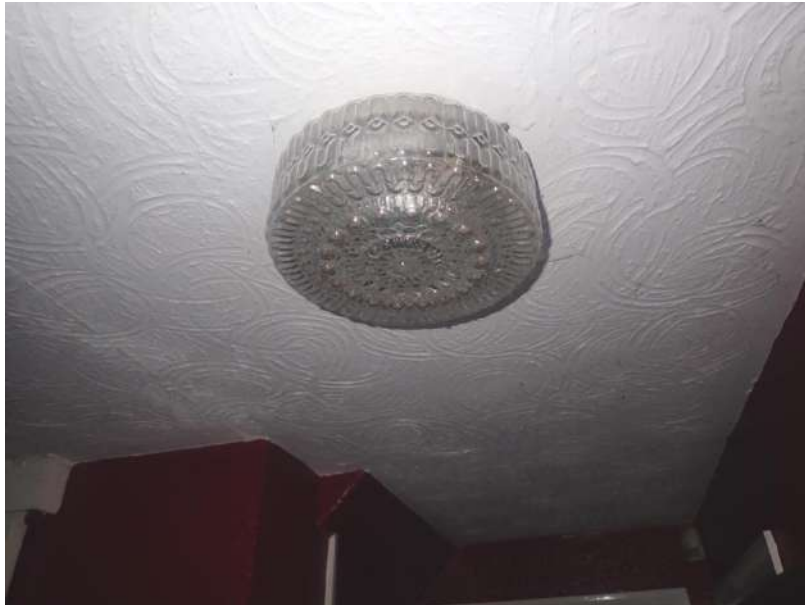
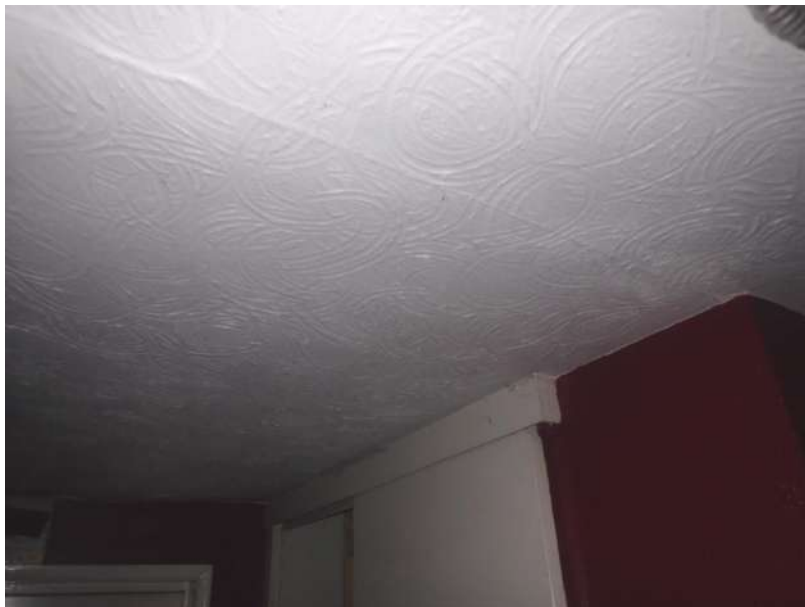
**Plates 143-145** present several images of the nature of the ceiling structure of **Cell 7**, which has been rendered over with modern plasterwork.

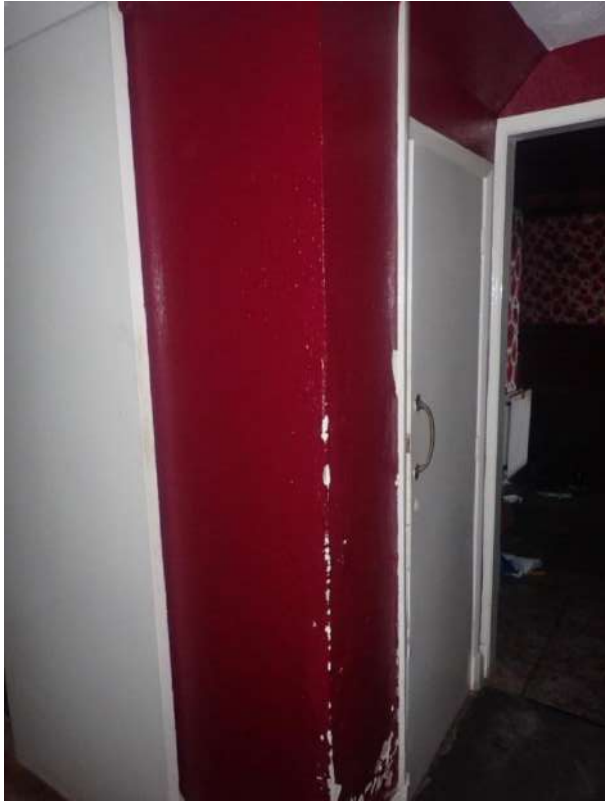
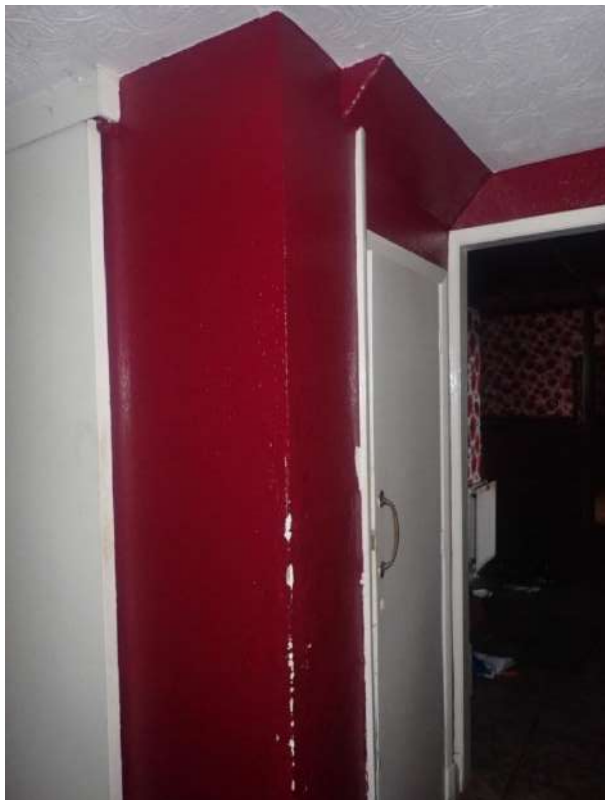
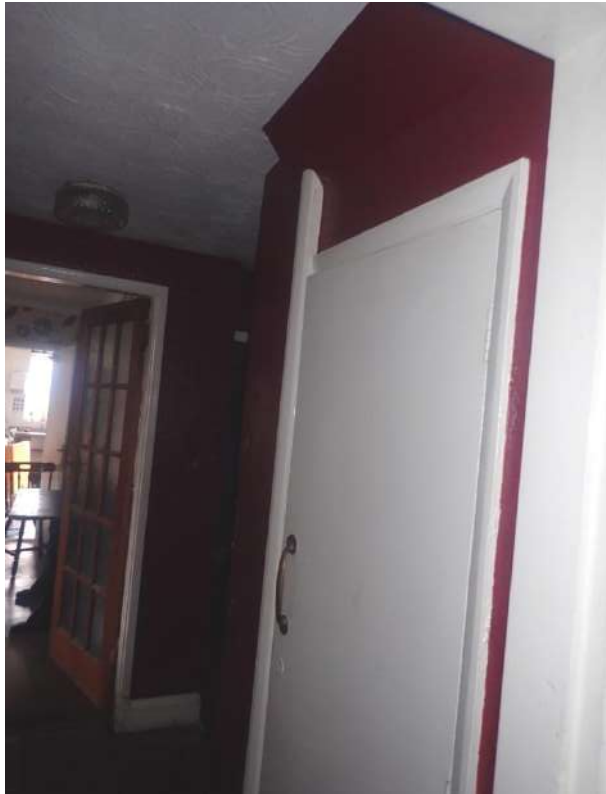
**Plates 146 and 147 and 149-150** show the western portion of the south wall of **Cell 7**, which has also been rendered over with modern plasterwork. Inserted into this wall fabric is an entrance into a storage cupboard comprising a timber door and a door frame of a head and surrounds. At the base of the wall are horizontal timber skirting boards.

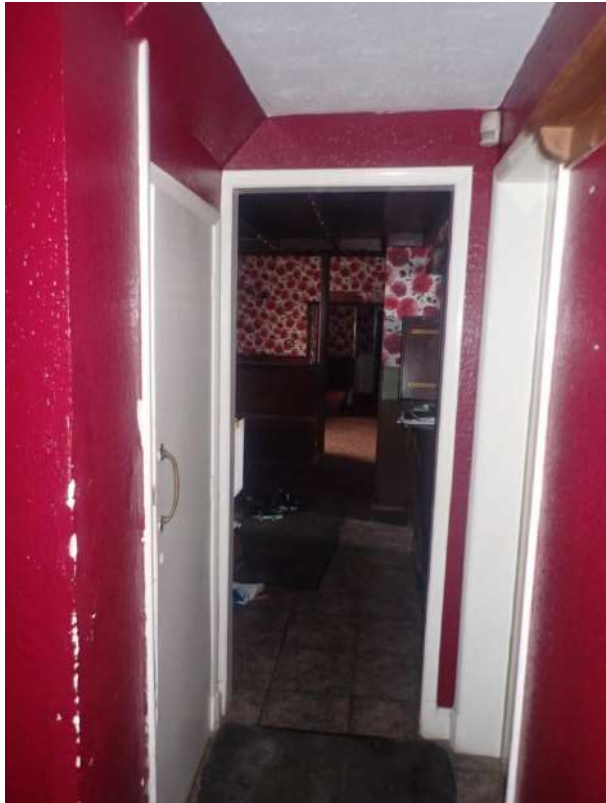
**Plate 148: View of the northern portion of the west wall of Cell 7, from the north-east**

**Plate 148** features the northern portion of the west wall of **Cell 7**, which is also the internal dividing wall with the adjoining **Cell 5** to the west. This wall has also been rendered over with modern plasterwork. Occupying much of this west wall is the west facing entrance opening that extends onto **Cell 5** to the west. This opening is occupied by a timber frame of a head and surrounds only. A small section of horizontal timber skirting board also occurs at its base.

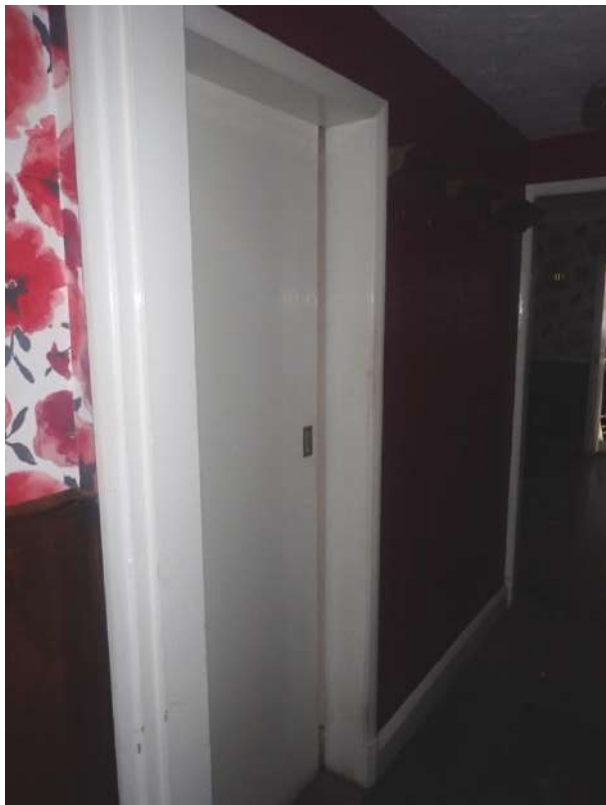
**Plate 151: View of the north wall of Cell 7, from the south-west**

**Plates 151** features the north wall of **Cell 7**, which also been rendered over with modern plasterwork. Horizontal timber skirting boards occur at its base. In the foreground is a north facing entrance opening that extends onto **Cell 6** to the north. This opening is occupied by a timber frame of a head and surrounds and by a modern timber sliding door.

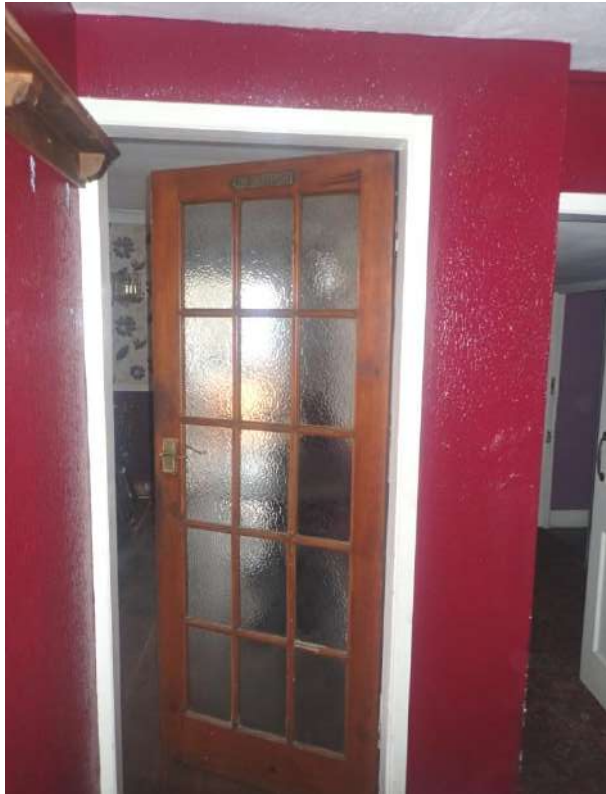
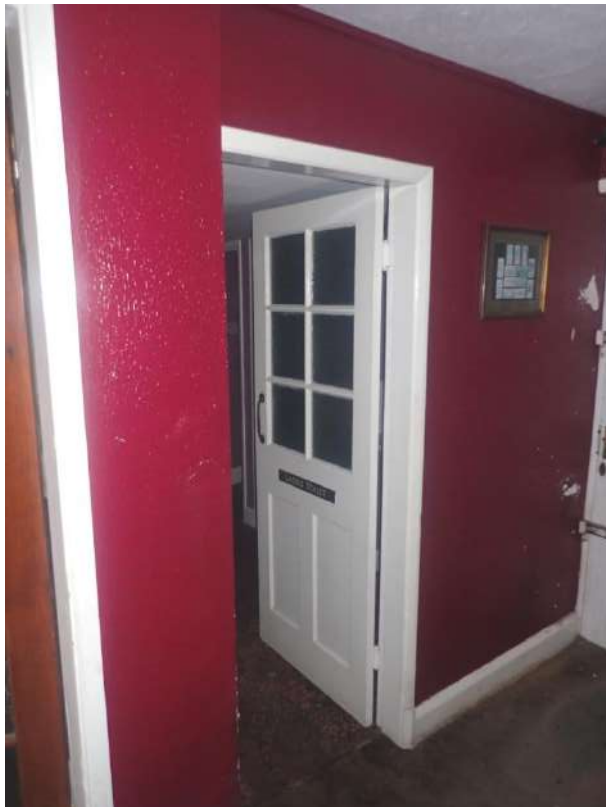
**Plates 152 and 153** show the east wall of **Cell 7**, which also been rendered over with modern plasterwork. Horizontal timber skirting boards occur at its base. To the left (north), is an east facing entrance opening that extends onto **Cell 8** to the east. This opening is occupied by a timber frame of a head and surrounds and by a modern timber glazed panel door. To the right (south), is a second east facing entrance opening that extends onto ground floor toilets (**Cell 9**). This second opening is occupied by a timber frame of a head and surrounds and by a further modern timber partially glazed and partially panelled door.

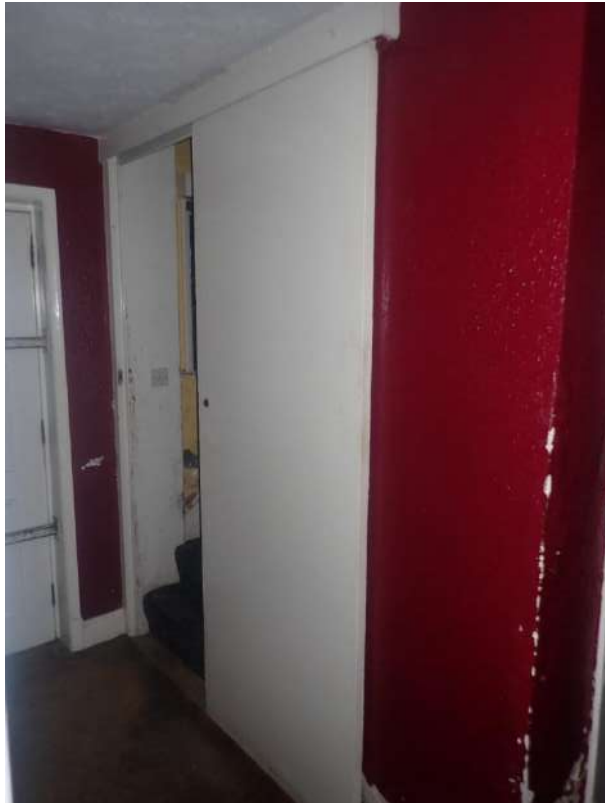
**Plate 154: View of the southern portion of the west wall of Cell 7, from the north-east**

**Plate 154** shows the southern portion of the west wall of **Cell 7**, which also been rendered over with modern plasterwork. Horizontal timber skirting boards occur at its base. To the left (south), is a modern timber sliding door that operates from a sliding mechanism at its head. This extends onto the stairwell (**Cell 10**) that in turn leads up to the first floor of the building. The eastern portion of the south wall of **Cell 7** is also shown. This has also been rendered over with modern plasterwork. Horizontal timber skirting boards occur at its base. The inner face of the south facing ground floor entrance opening that was recorded externally at the South Elevation of this building is also shown. This opening is occupied by a timber door within a timber frame of a head and surrounds.

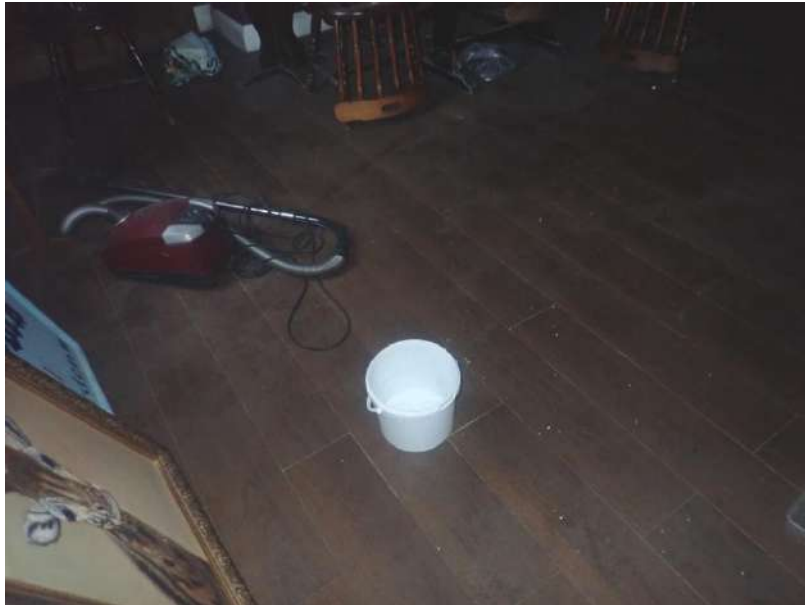
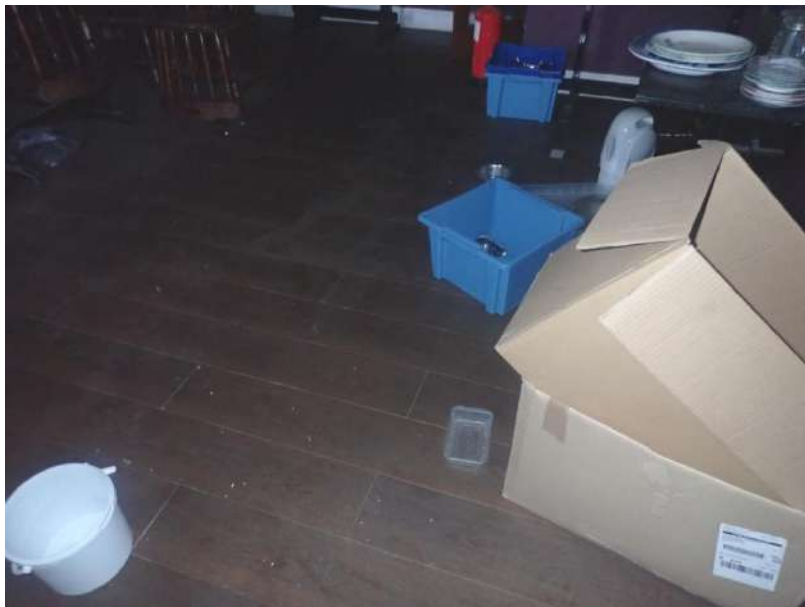
**Plates 155 and 156** feature the nature of the flooring of **Cell 8**, which is of horizontal timber planking.

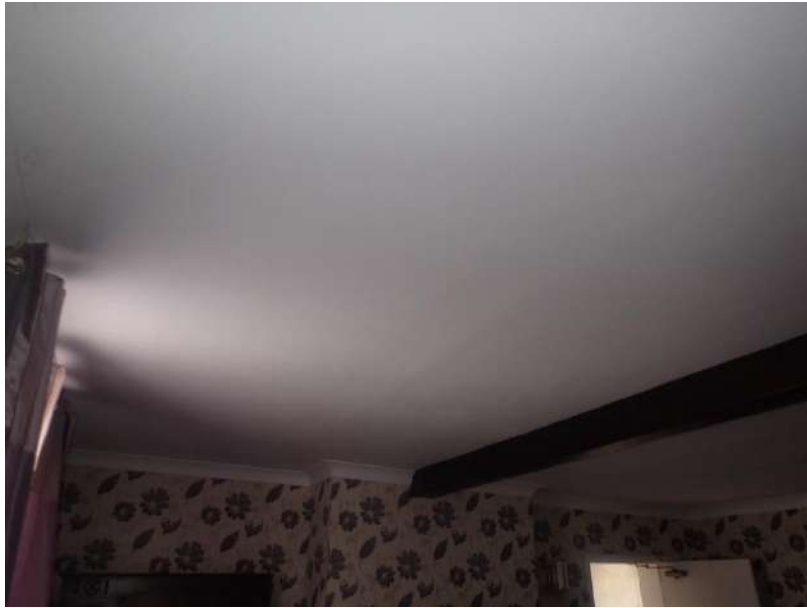
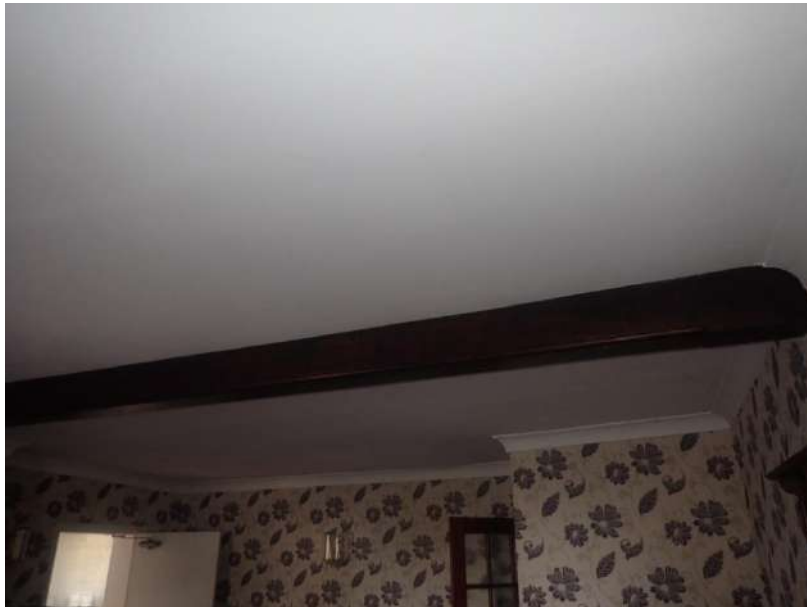
**Plate 159: View of the ceiling of Cell 8, from the north-west**

**Plates 159 and 160** show the roof ceiling structure of **Cell 8**, which has been rendered over with modern plasterwork. Of particular note is the east-west orientated principal horizontal timber joist, which may be an original feature.

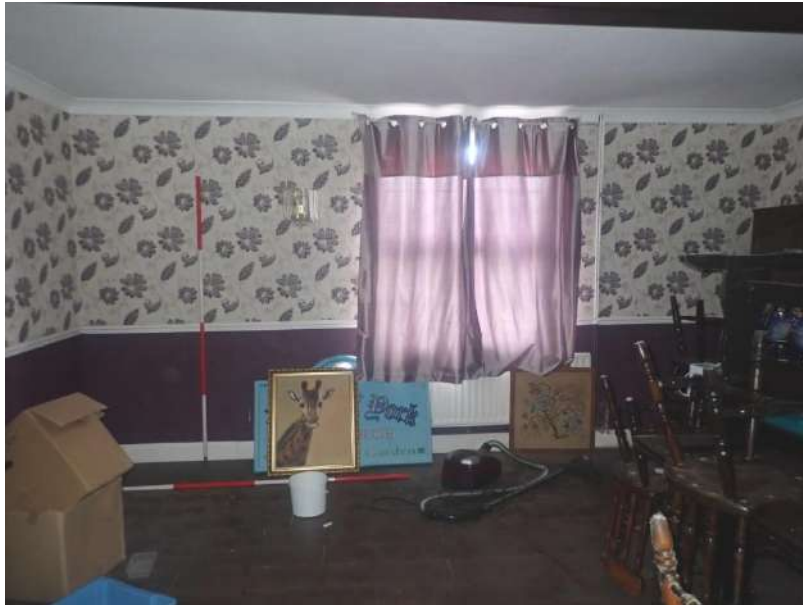
**Plate 165:** View of the north wall of Cell 8, from the south-east

**Plate 165** furnishes a detailed view of the north wall of **Cell 8** and of the inner face of the north facing ground floor window opening that was recorded externally at the North Elevation of this building. The wall has been covered over with wallpaper. Horizontal timber dado rails occur at its mid levels and horizontal timber skirting boards at its base. Plaster cornice work may be seen at its uppermost levels.

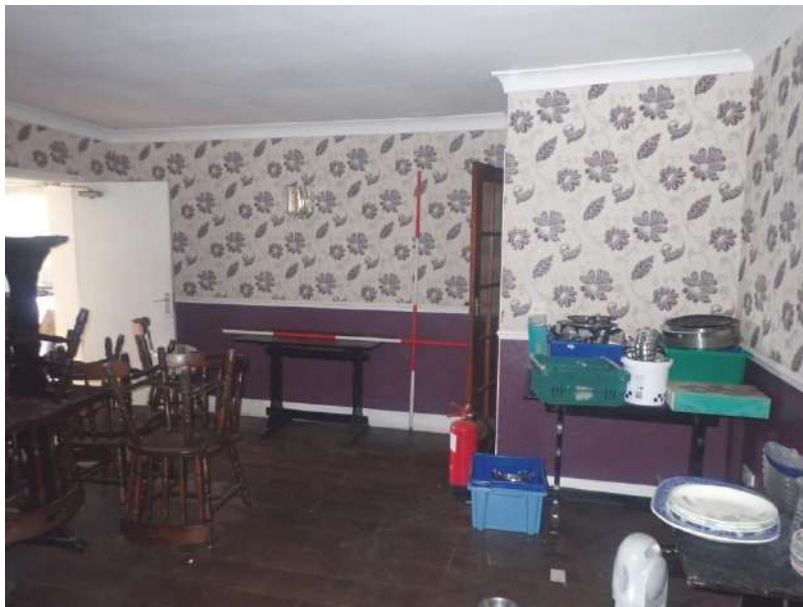
**Plate 166:** View of the south wall of Cell 8, from the north-west

**Plate 166** shows the south wall of **Cell 8**, which is covered over with wallpaper. Horizontal timber dado rails occur at its mid levels and horizontal timber skirting boards at its base. Plaster cornice work may be seen at its uppermost levels.

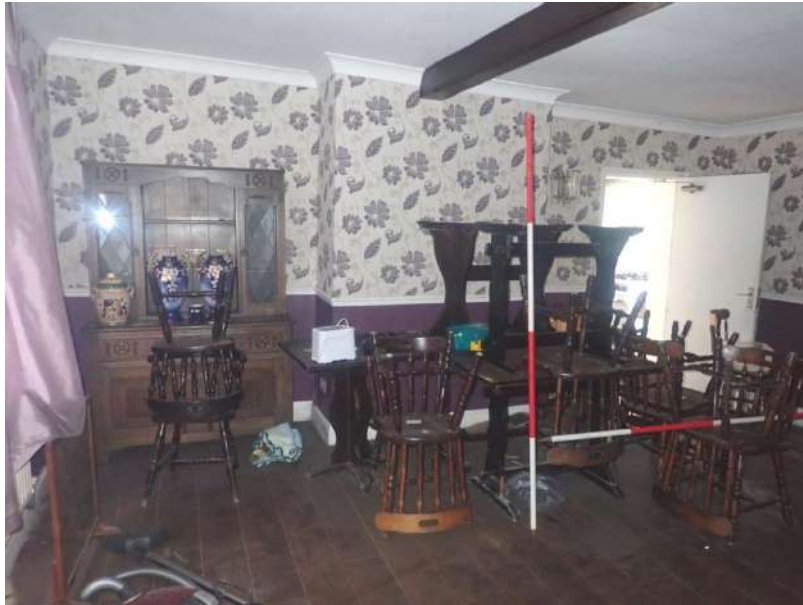
**Plate 167: View of the east wall of Cell 8, from the north-west**

**Plate 167** shows the east wall of **Cell 7**, which is also the internal dividing wall with **Cells 1 and 2** to the east. This east wall is covered over with wallpaper. Horizontal timber dado rails occur at its mid levels and horizontal timber skirting boards at its base. Plaster cornice work may be seen at its uppermost levels. The central feature here is the blocked off former chimney breast, which may be an original feature. Also shown is the inner face of the east facing entrance opening that was also recorded within **Cell 1** and leads onto it. This opening is occupied by a timber frame of a head and surrounds and by a modern timber door, which has been boarded over.
