HISTORIC BUILDING RECORDING AT THE  
FORMER DUKE OF YORK PUBLIC HOUSE,  
106, RISEGATE ROAD,  
GOSBERTON RISEGATE, LINCOLNSHIRE

**National Grid Reference: TF 2186 3004**  
**Planning Reference: H08-0964-21**  
**Site Code: RRGR22**  
**Accession Number: LCNCC: 2022.147**

PREPARED FOR MRS. S. GOODENOUGH

January 2023

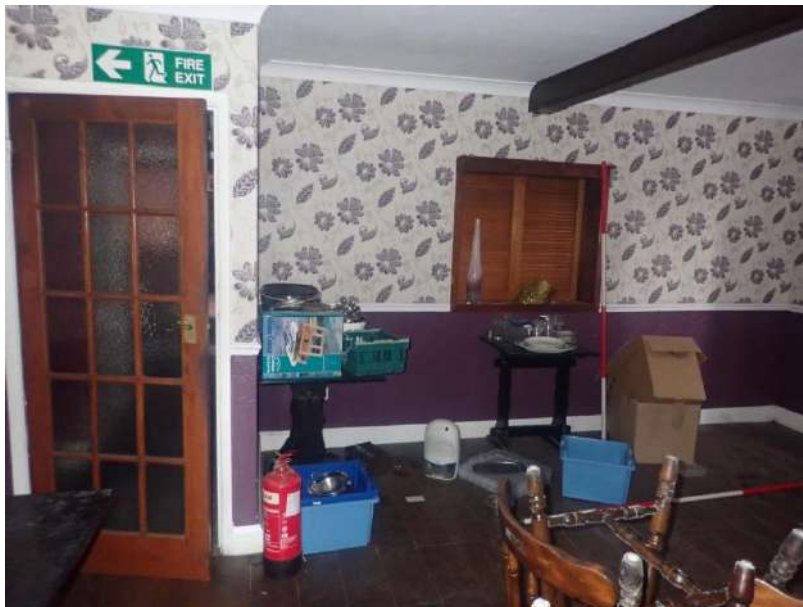
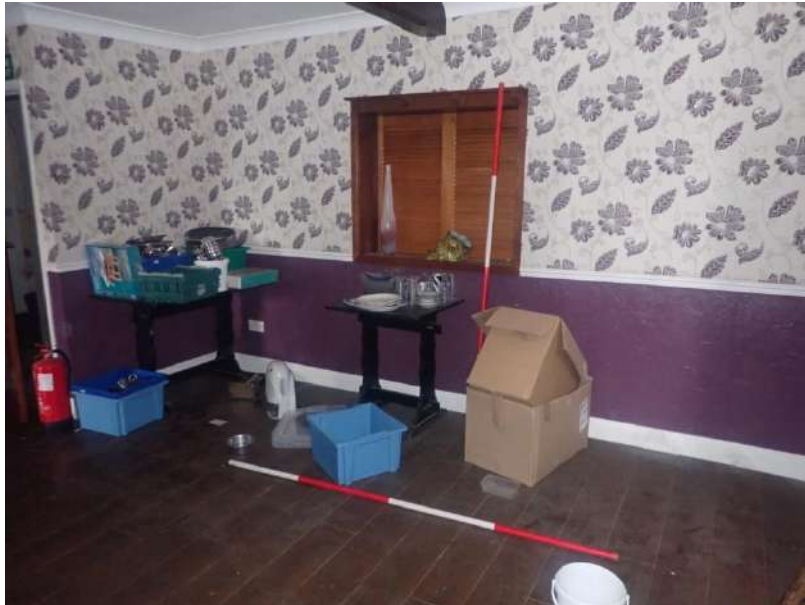
**Plates 168 and 169** feature the west wall of **Cell 8**, which is also the internal dividing wall with the adjoining **Cell 6** to the west. This west wall has also been covered over with wallpaper. Horizontal timber dado rails occur at its mid levels and horizontal timber skirting boards at its base. Plaster cornice work may be seen at its uppermost levels. Also shown is the modern timber servery hatch, which was also recorded within **Cell 6**. To the left (south), is the inner face of the ground floor west facing entrance opening that was also recorded within **Cell 7**. This opening is occupied by a timber frame of a head and surrounds and by the timber glazed panelled door and leads onto **Cell 7** to the west.

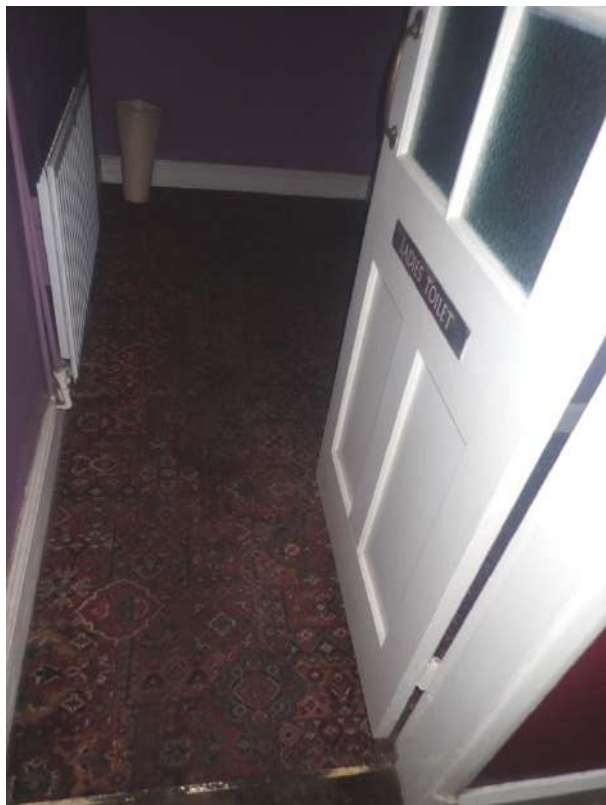
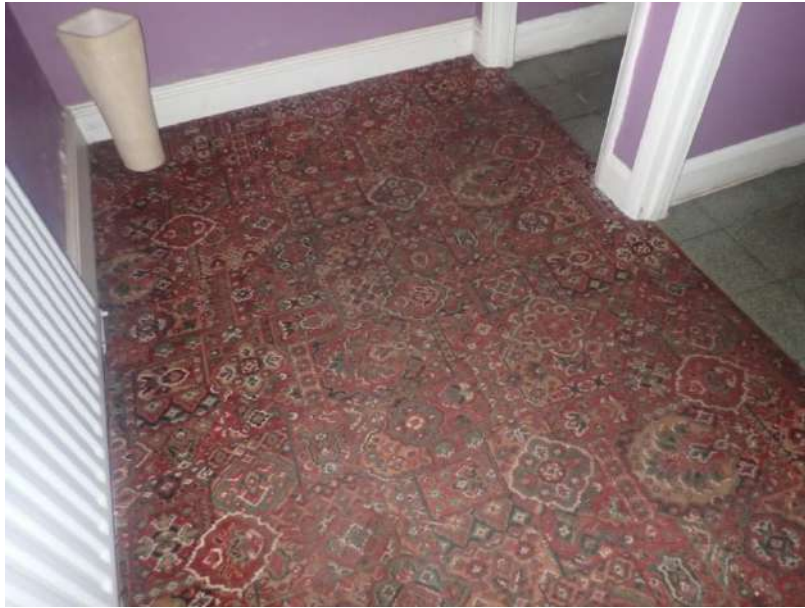
**Plates 170 and 171** show the carpeted flooring of **Cell 9**.

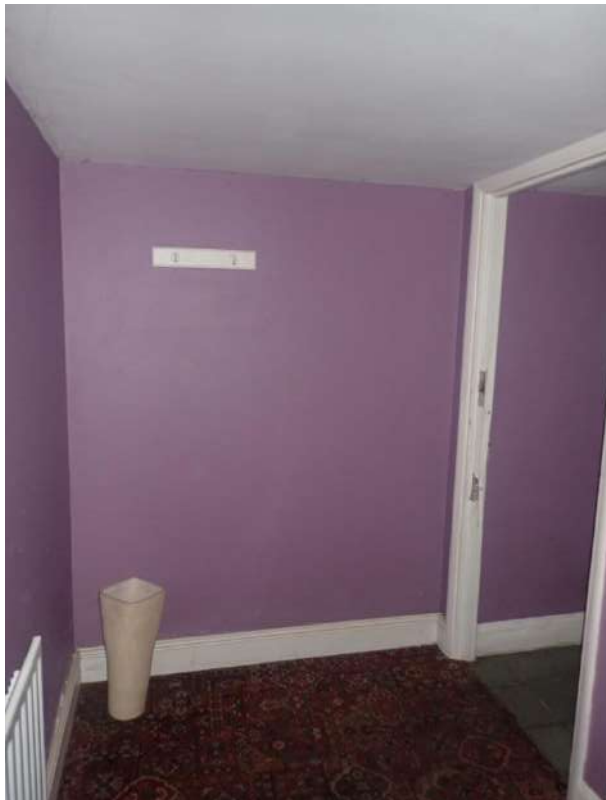
**Plate 174:** View of the east wall of Cell 9, from the south-west

**Plate 174** presents a view of the east wall of **Cell 9**, which has been rendered over with modern plasterwork. Modern horizontal timber skirting boards occur at its base.

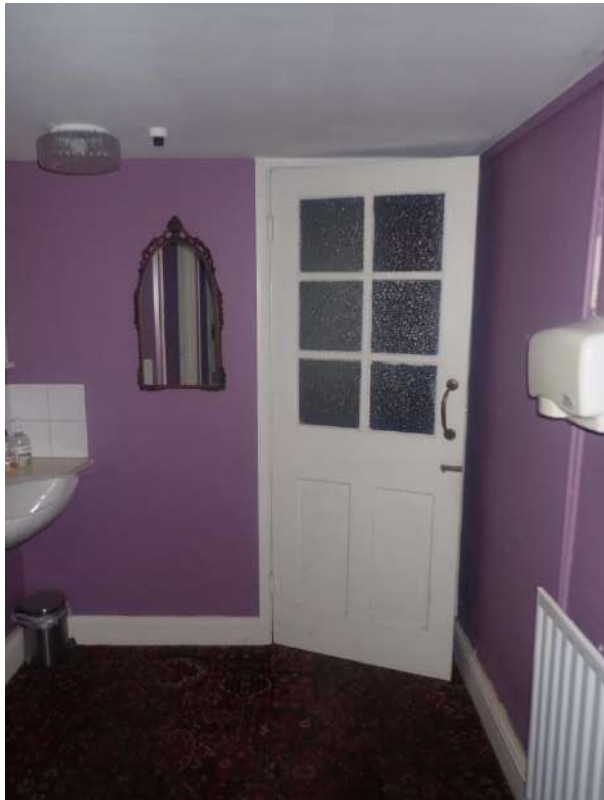
**Plate 175: View of the west wall of Cell 9, from the north-east**

**Plate 175** features much of the west wall of **Cell 9**, which is also the internal dividing wall with the adjoining **Cell 7** to the west. This west wall has been rendered over with modern plasterwork. Modern horizontal timber skirting boards occur at its base. To the right (north), is the inner face of the west facing entrance opening that extends onto **Cell 7** to the west. This opening is occupied by a timber frame with a head and surrounds and by a modern timber door that is partially glazed and partially panelled.

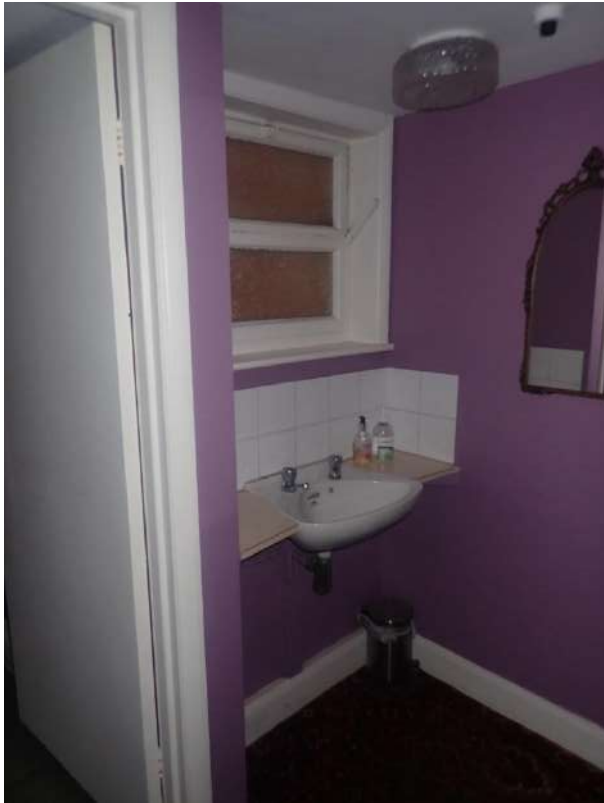
**Plate 176: Views of the west wall and the south wall of Cell 9, from the north-east**

**Plate 176** features the remainder of the west wall and also of the south wall of **Cell 9**. Here also, this south wall has been rendered over with modern plasterwork. Modern horizontal timber skirting boards occur at its base. The central feature of this south wall is the inner face of the south facing ground floor window opening that was recorded externally at the South Elevation of this building. This opening is occupied by a slightly recessed glazed modern Upvc casement window, which has been boarded over externally.

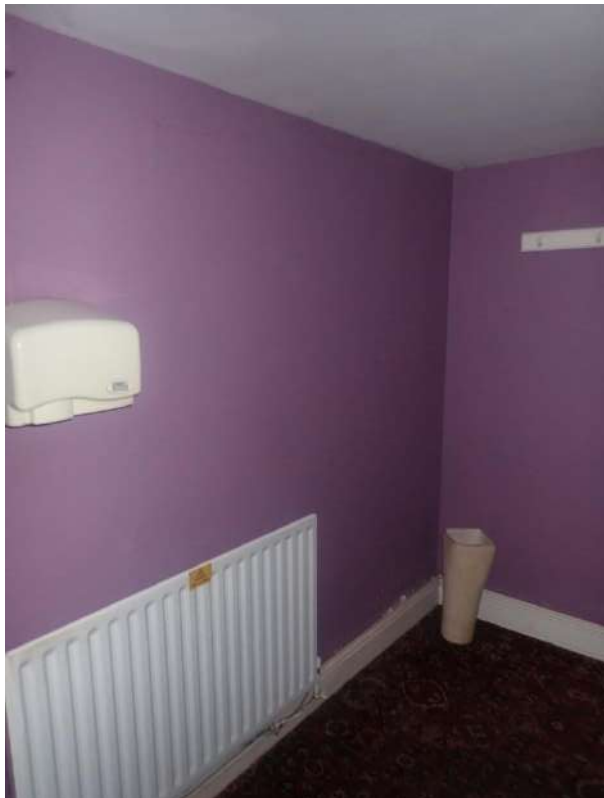
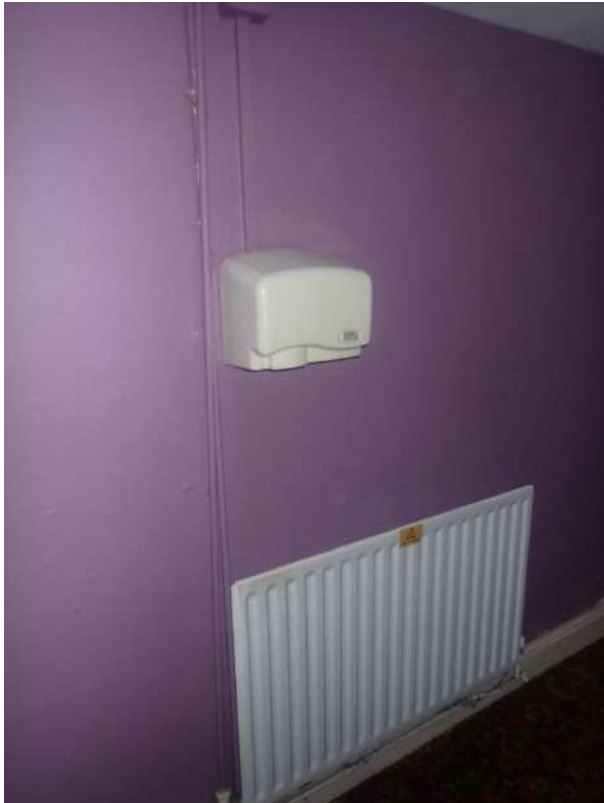
**Plates 177 and 178** show the north wall of **Cell 9**. Here also, this north wall has been rendered over with modern plasterwork. Modern horizontal timber skirting boards occur at its base. This is also the internal dividing wall with the adjoining **Cell 8** to the north.

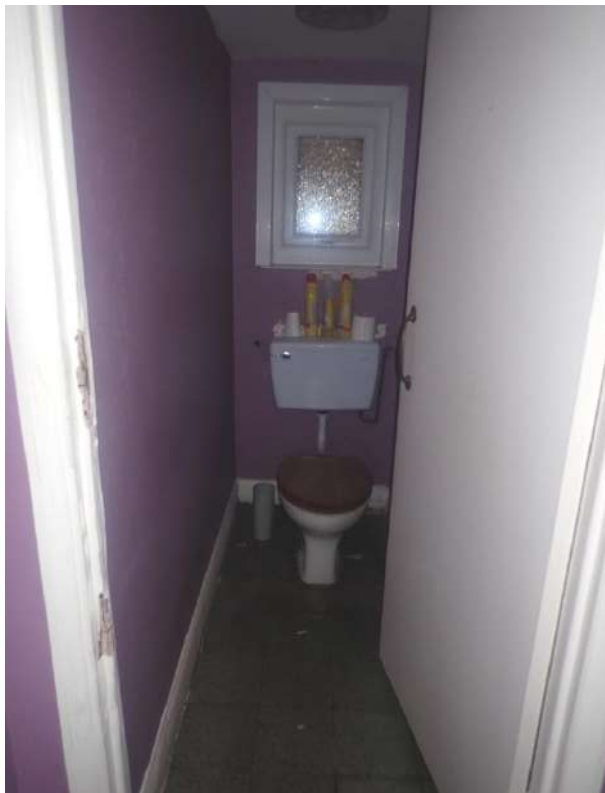
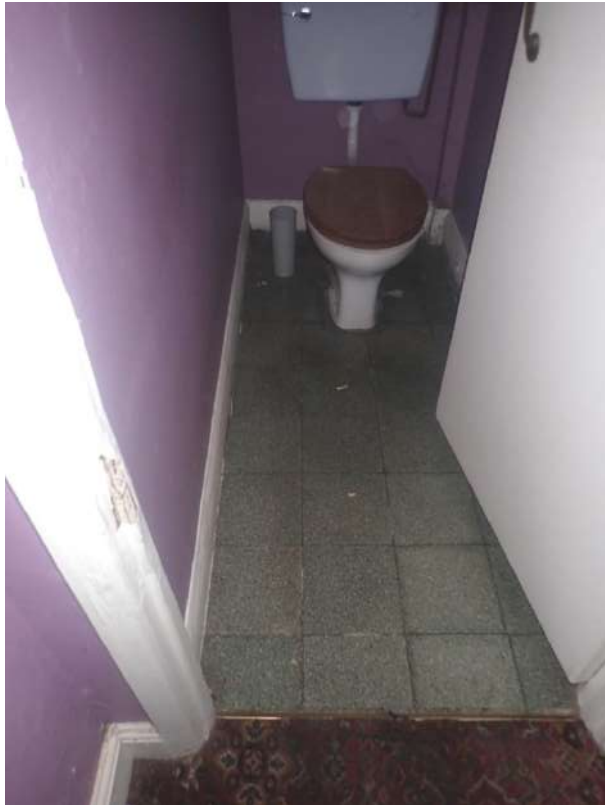
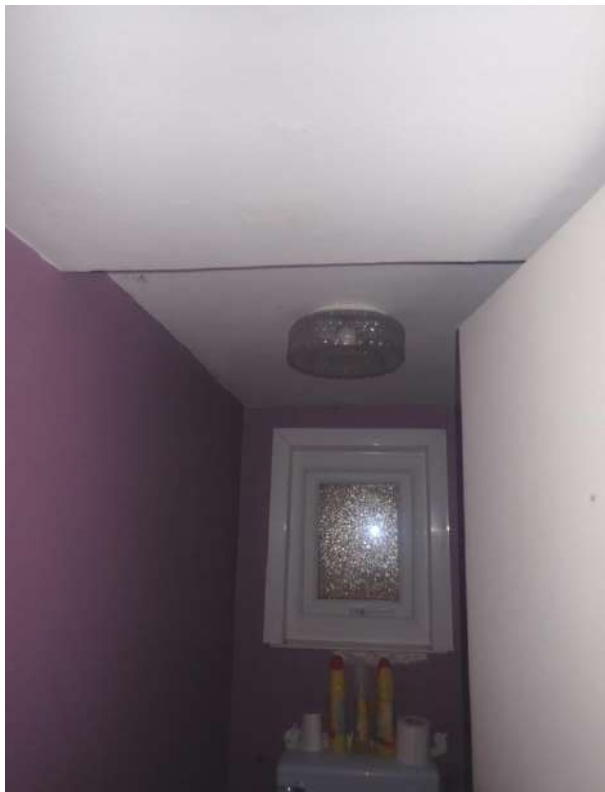
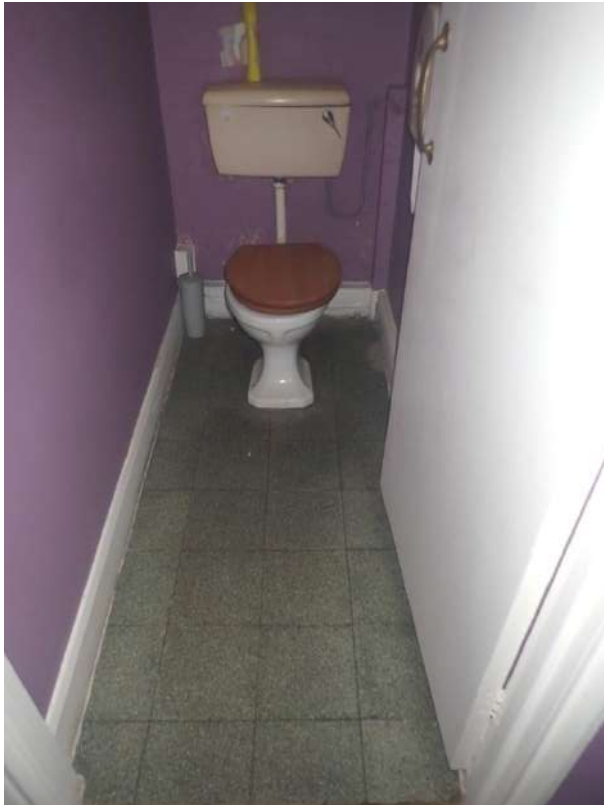
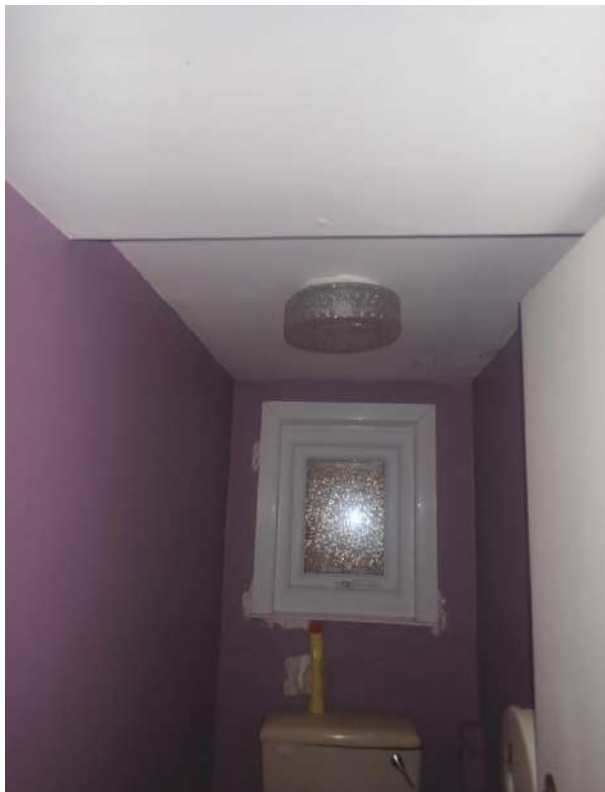
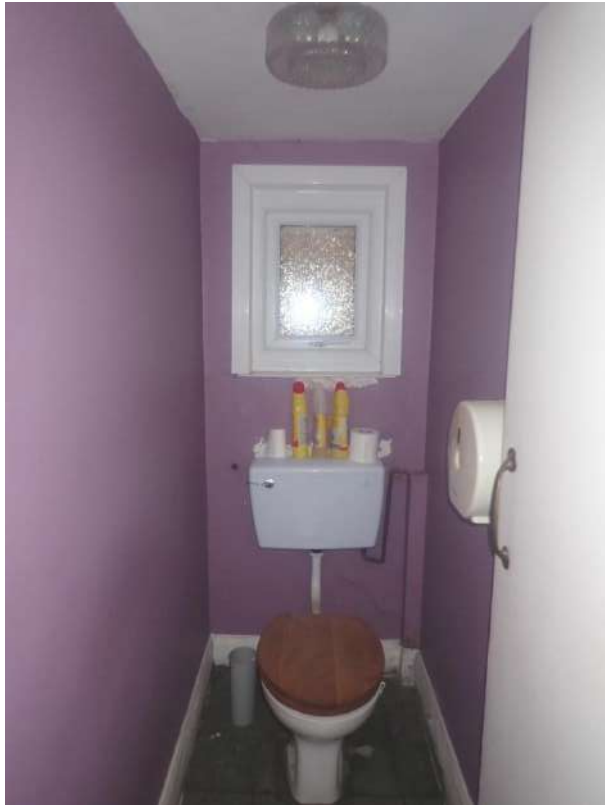
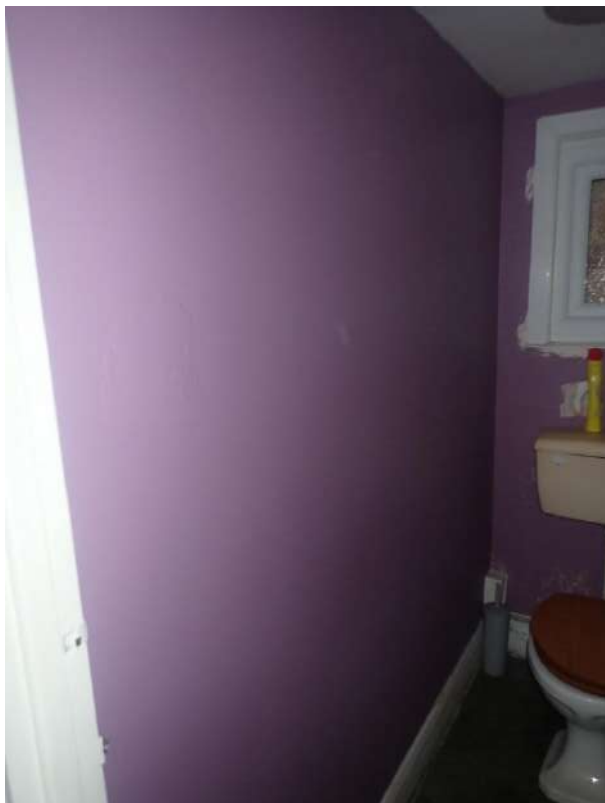
**Plates 179-185** present views of the two toilets which are both within the interior of the single storey modern toilet extension. Both toilets have flooring of modern ceramic floor tiling and ceilings, which have been rendered over with modern plasterwork. All of the walls have also been rendered over with modern plasterwork and have horizontal skirting boards at their bases. At the back wall of each toilet are the inner faces of two small glazed Upvc windows, which were recorded externally at the South Elevation of this building.

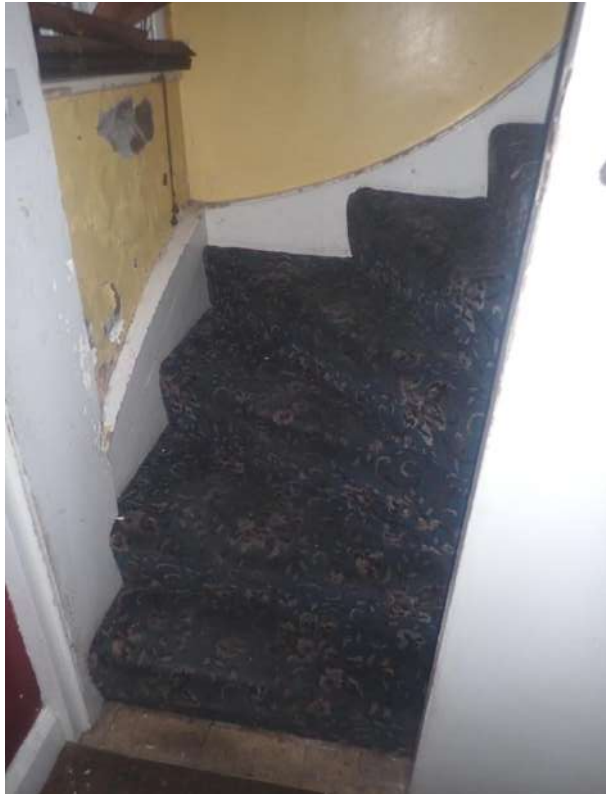
**Plate 186: View of the lower levels of the stairwell of Cell 10, from the north-east**

**Plate 186** features the lower levels of the ground floor stairwell of **Cell 10** along with the lower levels of the south and west walls of **Cell 10**. The stairwell is covered with modern carpeting. The exposed walls are rendered over with plasterwork with timber skirting boards alongside the stairwell and at the lowermost levels of these walls.

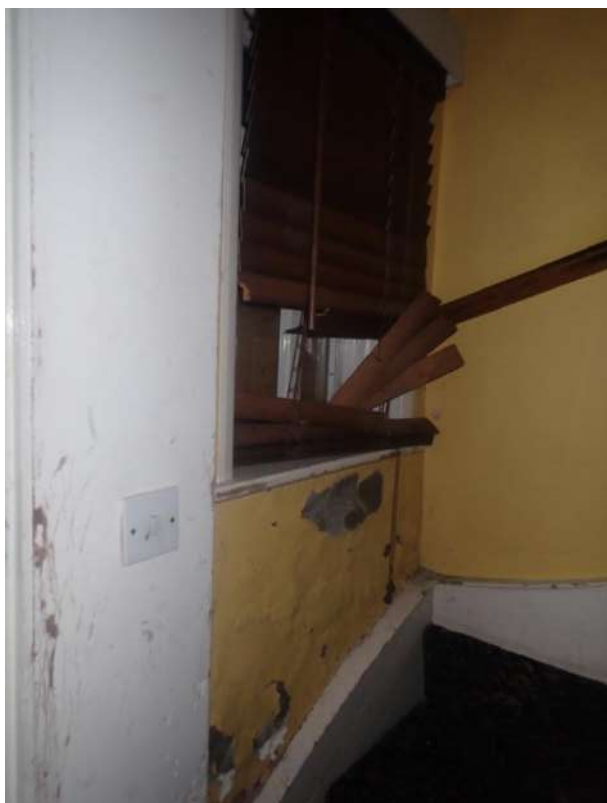
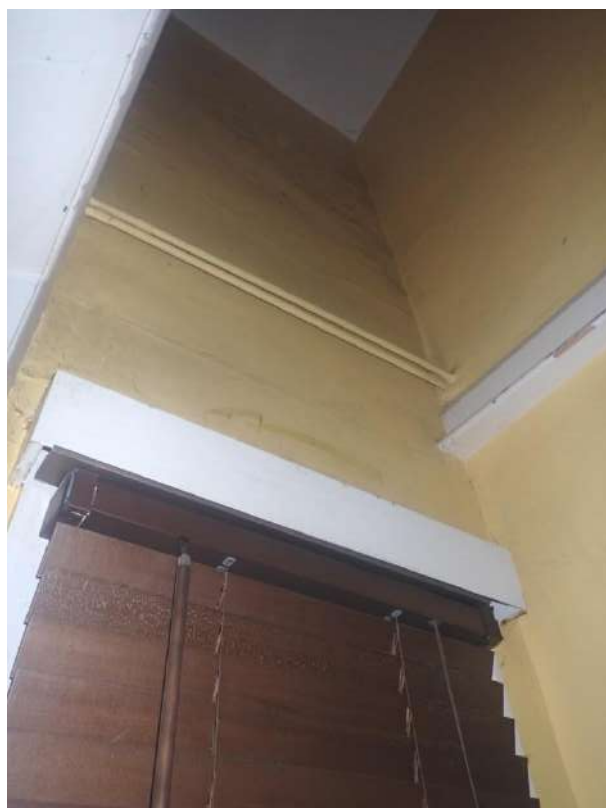
**Plates 187 and 188** feature the south wall of **Cell 10**, which has been rendered over with plasterwork. Timber skirting boards occur at its base. The inner face of a ground floor south facing window opening is also featured. This was recorded externally at the South Elevation of this building. The opening is occupied by timber blinds.

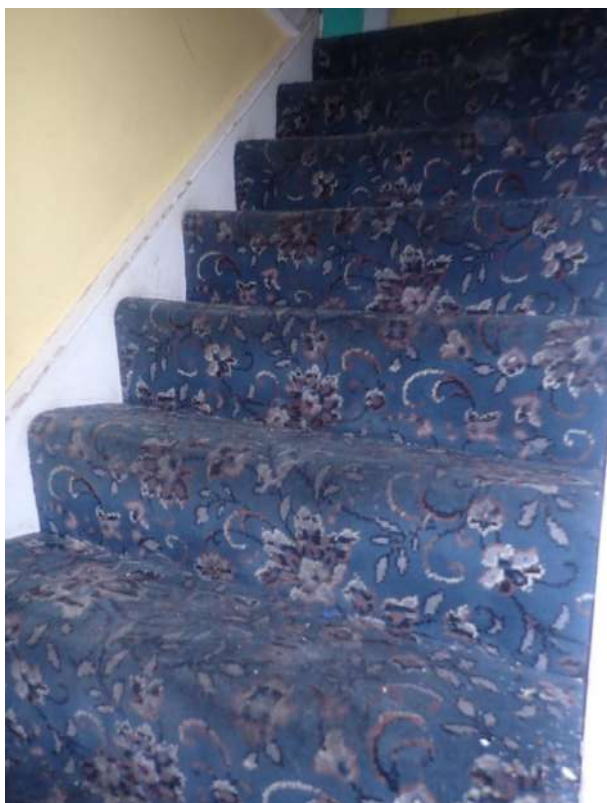
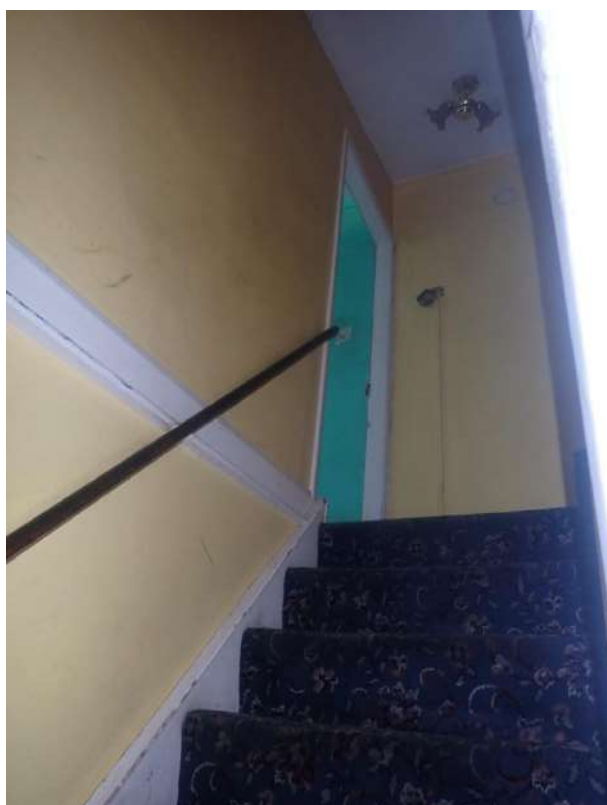
**Plates 189 and 190** provide further views of the carpeted stairwell that extends up to the first floor landing. A timber handrail is shown attached to the west wall, whilst the north wall on the first floor landing is also featured. This has been rendered over with plasterwork.

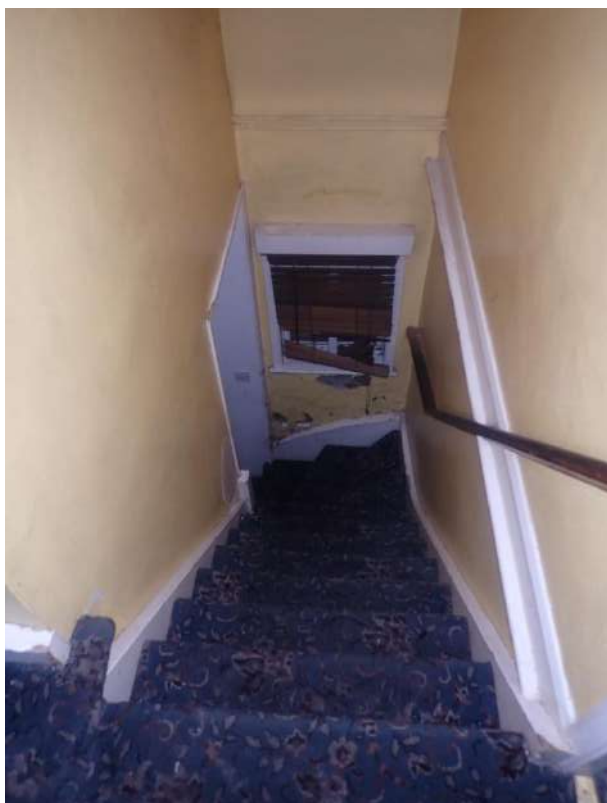
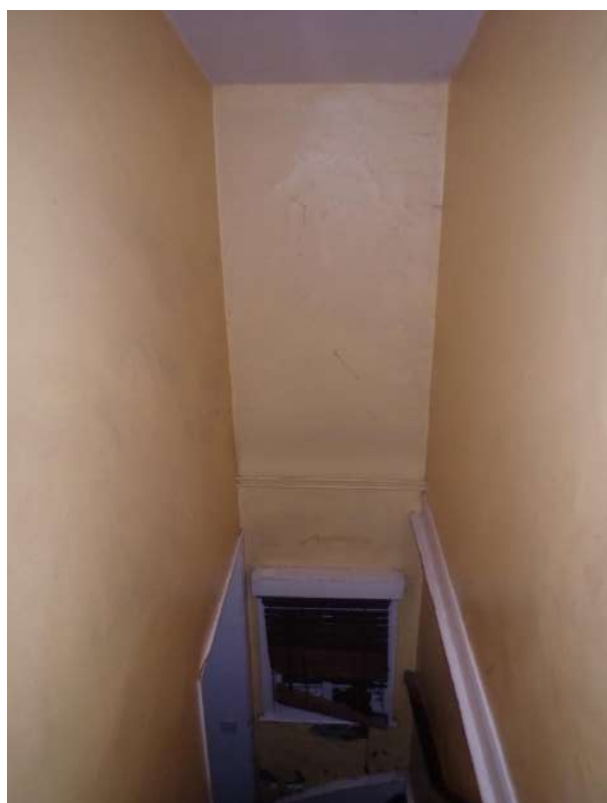
**Plates 191 and 192** feature further views of the stairwell of **Cell 10** looking downwards from the first floor landing.

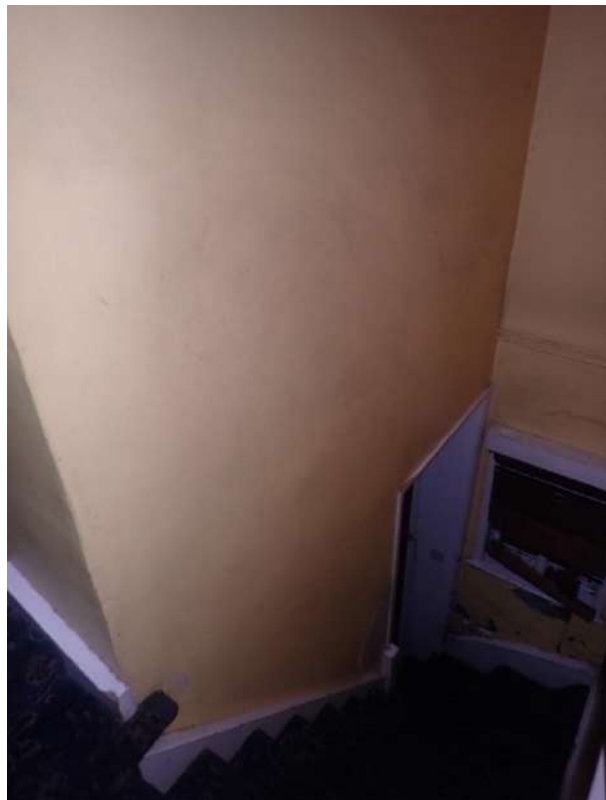
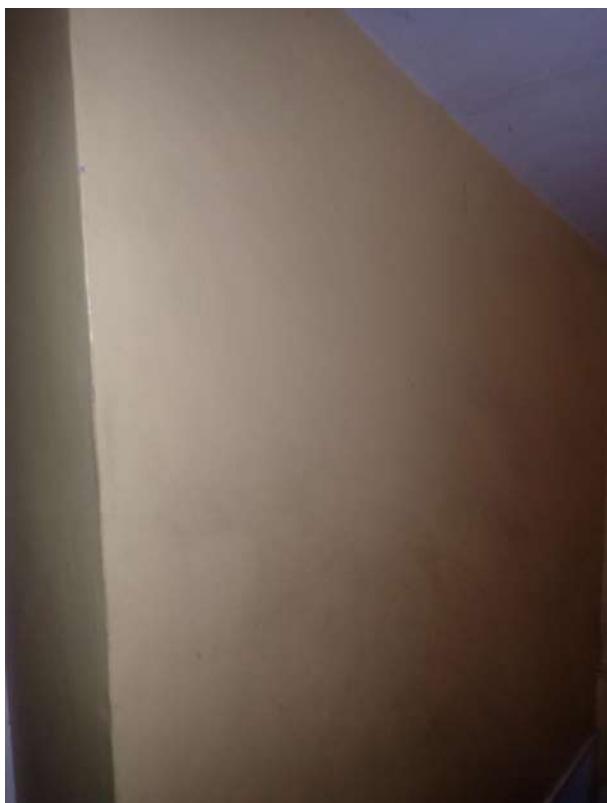
**Plates 194 and 195** provide views of the east wall of **Cell 10**, which has been rendered over with plasterwork. At the base of the wall are timber skirting boards alongside the stairwell.

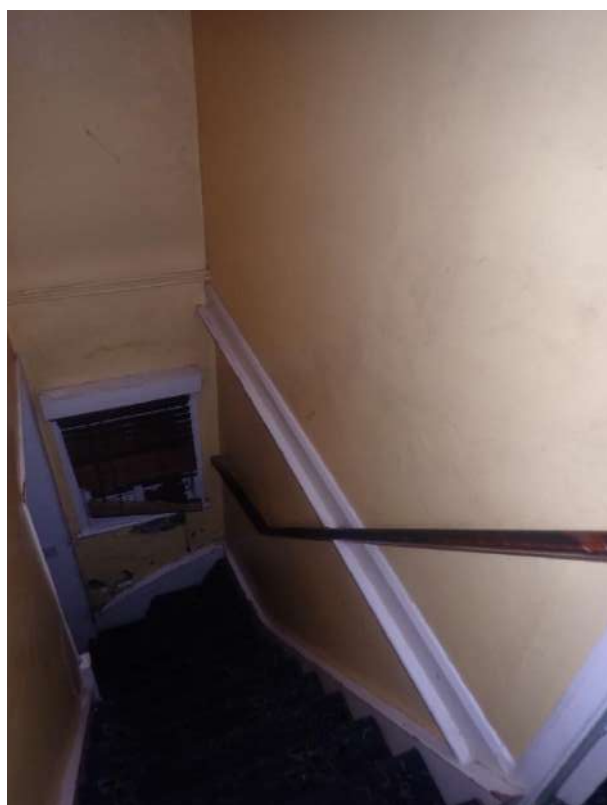
**Plate 196: View of the west wall of Cell 10, from the north-west**

**Plates 196 and 197** present images of the west wall of **Cell 10** which has been rendered over with plasterwork. At the base of the wall are timber skirting boards alongside the stairwell.

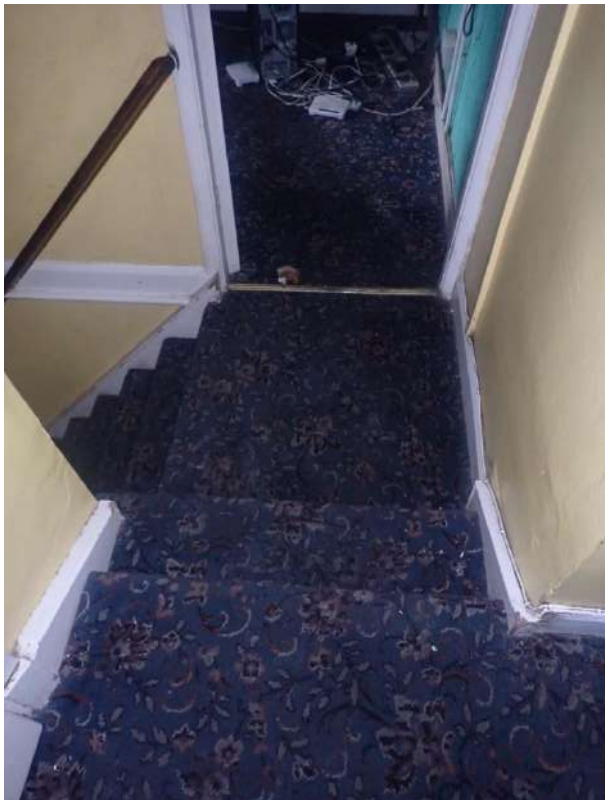
**Plate 198: View of the first floor landing of Cell 10, from the north-east**

**Plate 198** features the first floor carpeted landing.

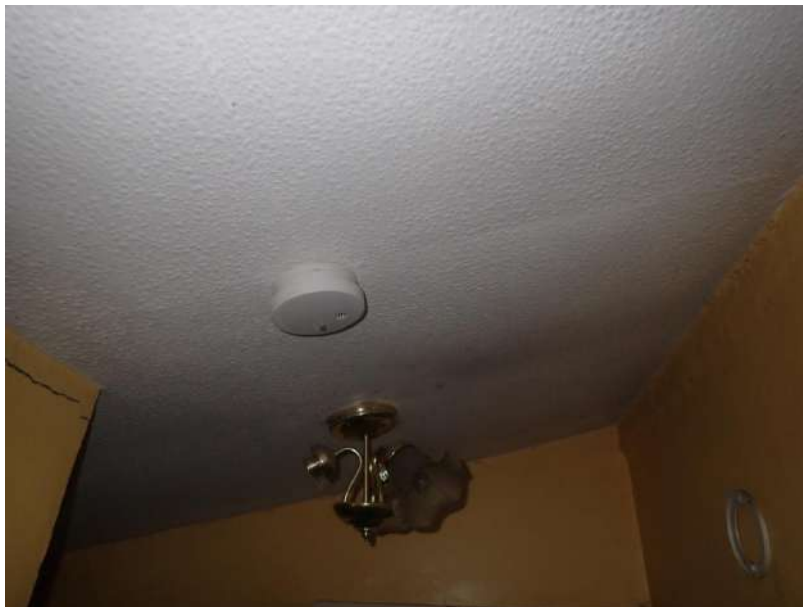
**Plate 200:** View of the ceiling of Cell 10, from the north-east

**Plate 200** features a further view of the ceiling of **Cell 10**, which has been covered over with lining paper.

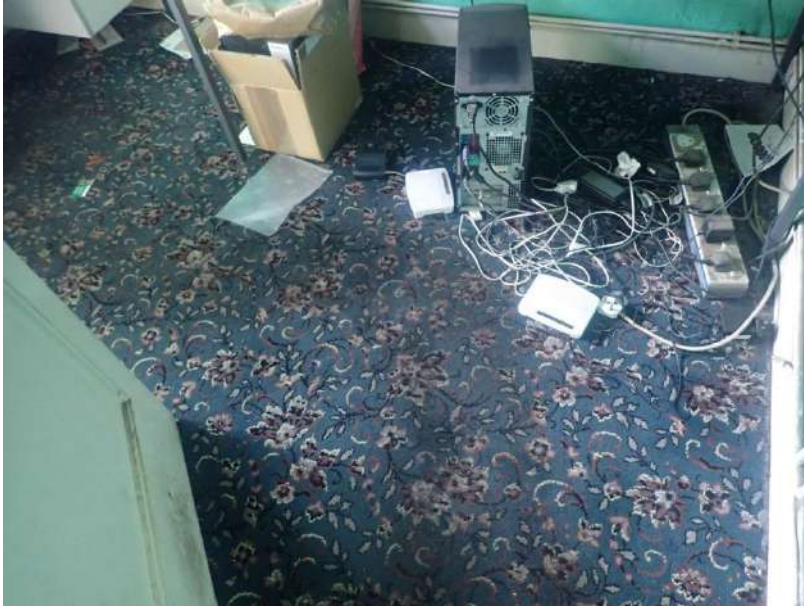
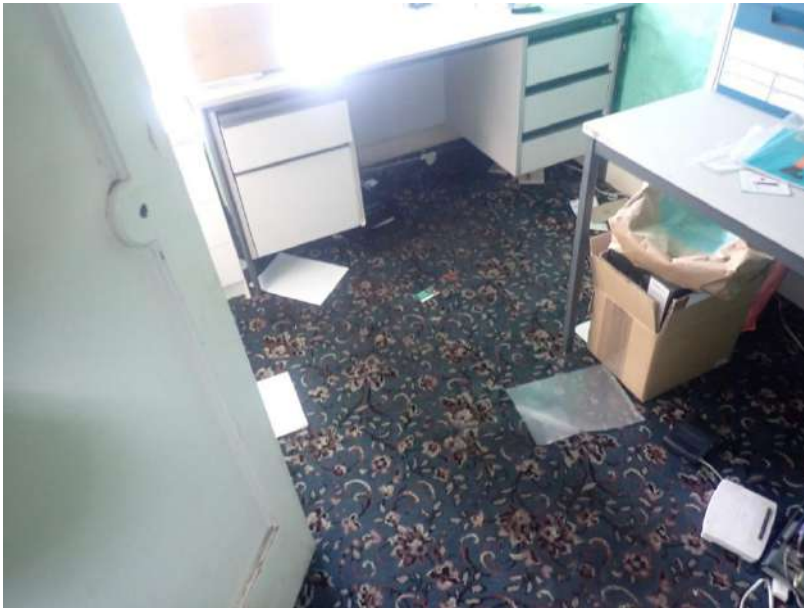
**Plates 201 and 202** feature the flooring of **Cell 11**, which is covered with modern carpeting.

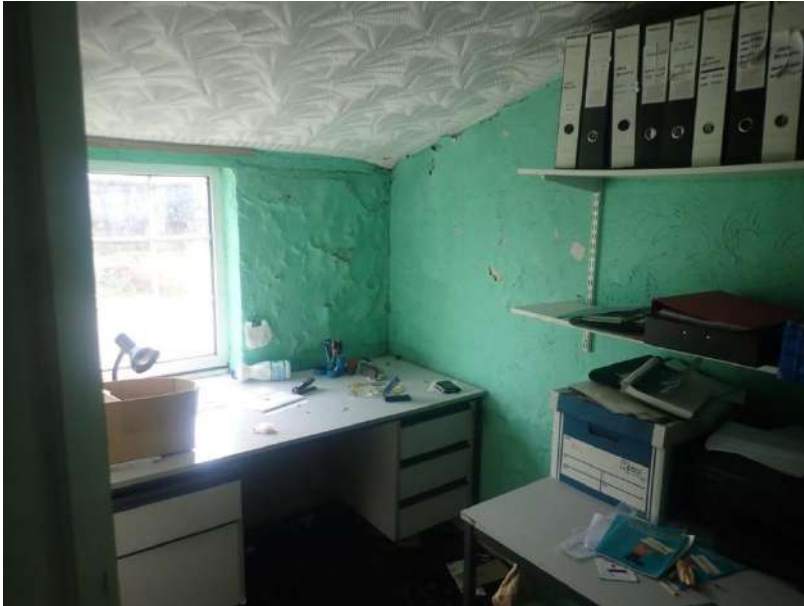
**Plate 203: General view of the interior of Cell 11, from the north-east**

**Plate 203** features a general view of the interior of **Cell 11**.

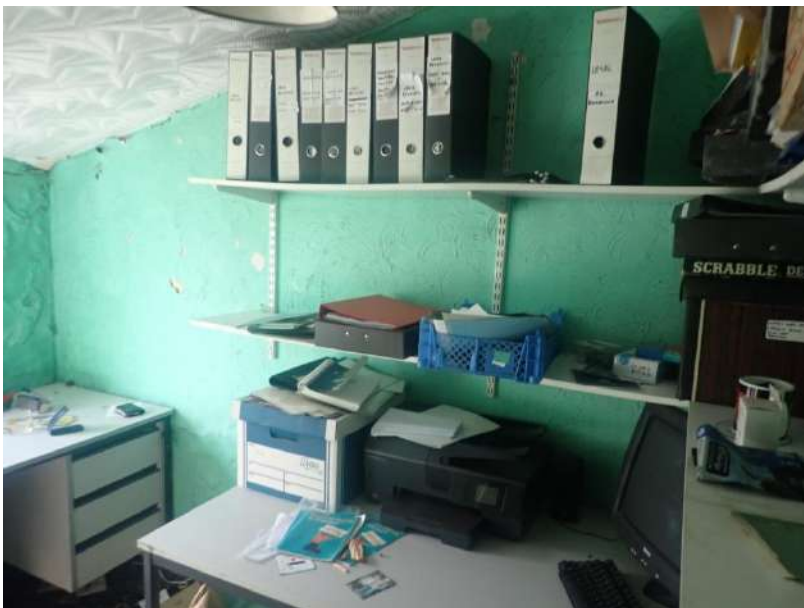
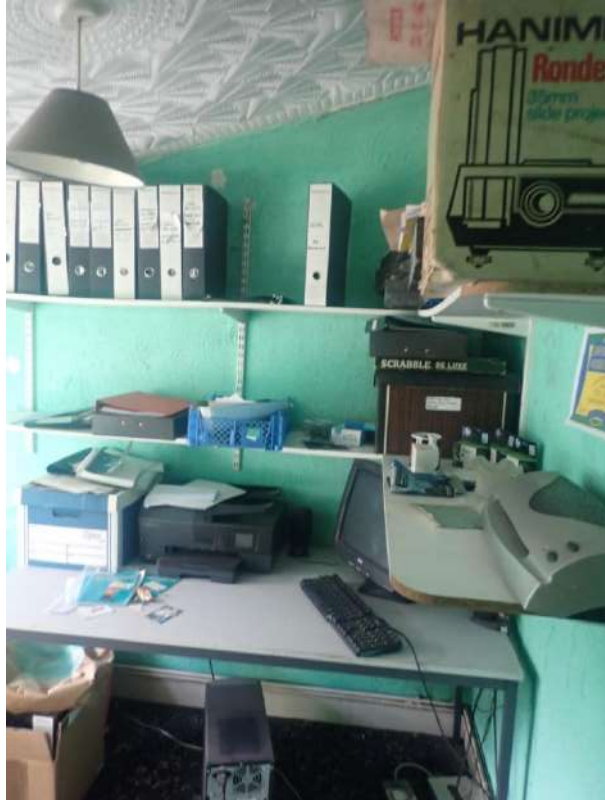
**Plates 204 and 207** present views of the west wall of **Cell 11**, which has been rendered over with plasterwork.

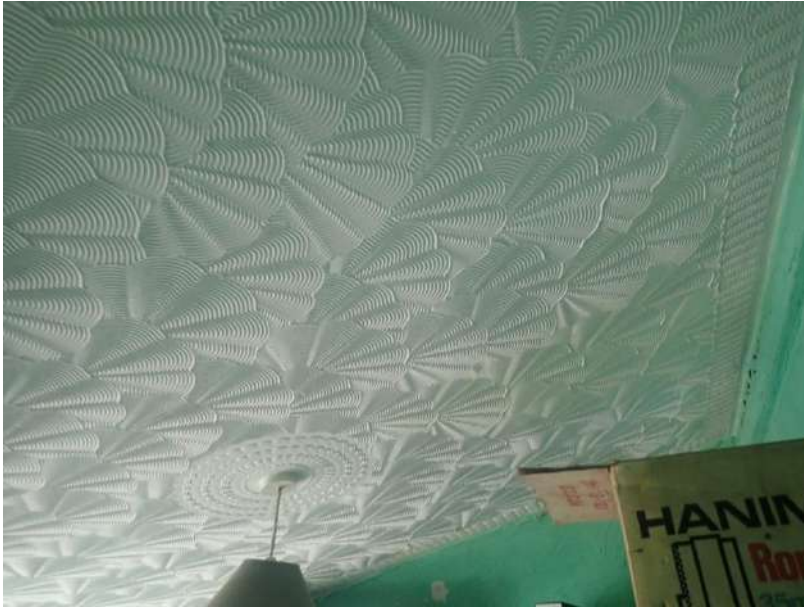
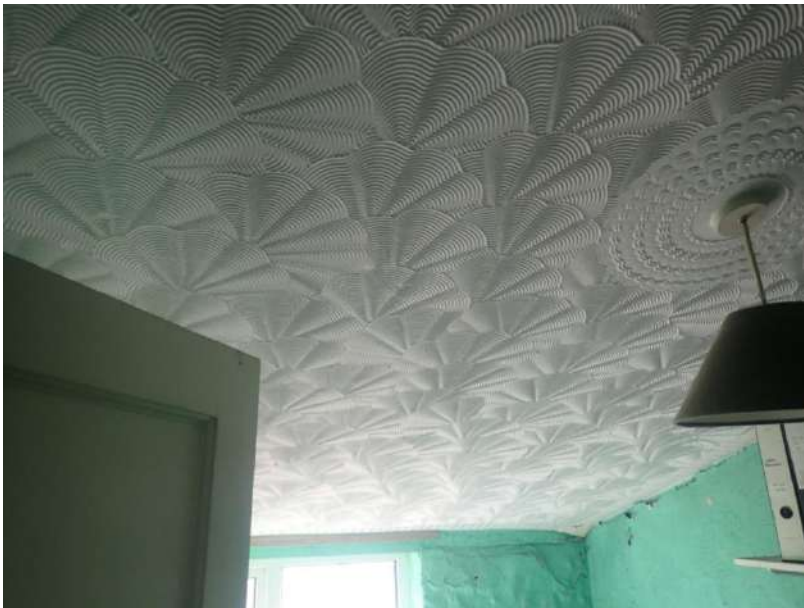
**Plates 205 and 206** furnish views of the ceiling of **Cell 11**, which has been rendered over with modern plasterwork. Its low angle reflects that of the low angled half gabled roof structure of the above rear outshut.

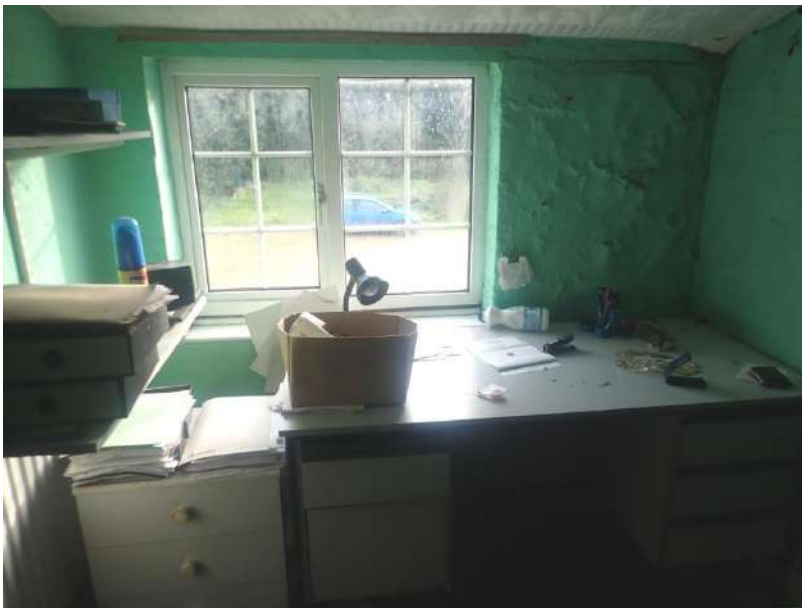
**Plate 208:** View of the south wall of Cell 11, from the north-west

**Plate 208** presents a view of the south wall of **Cell 11**, which has also been rendered over with plasterwork. Also shown is the inner face of the first floor south facing window opening that was recorded externally at the South Elevation of this building.

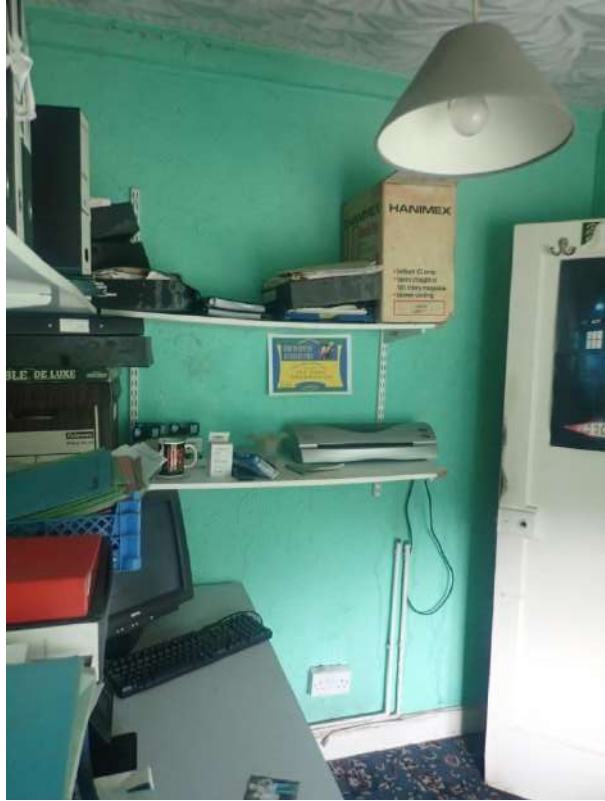
Plate 209: View of the north wall of Cell 11, from the south-west

**Plate 209** features the north wall of **Cell 11**, which has also been rendered over with plasterwork. This is also the internal dividing wall with the adjoining **Cell 12** to the north.

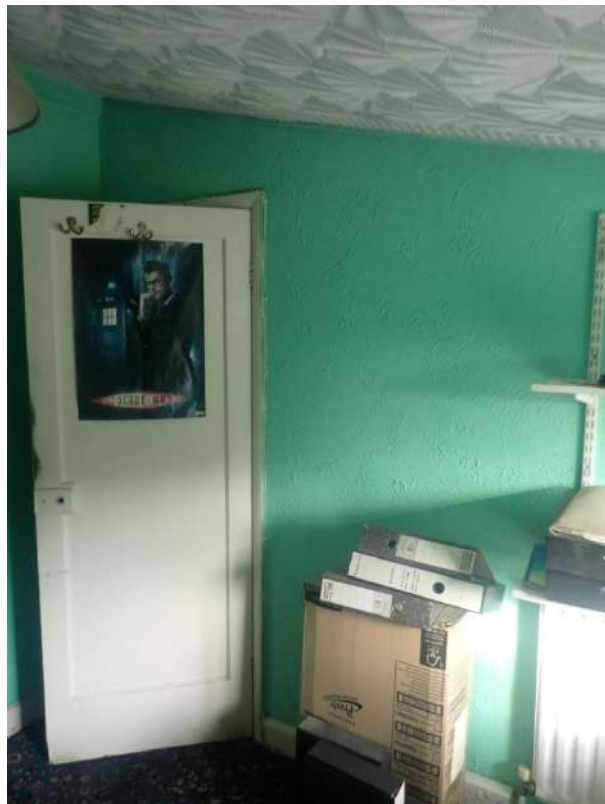
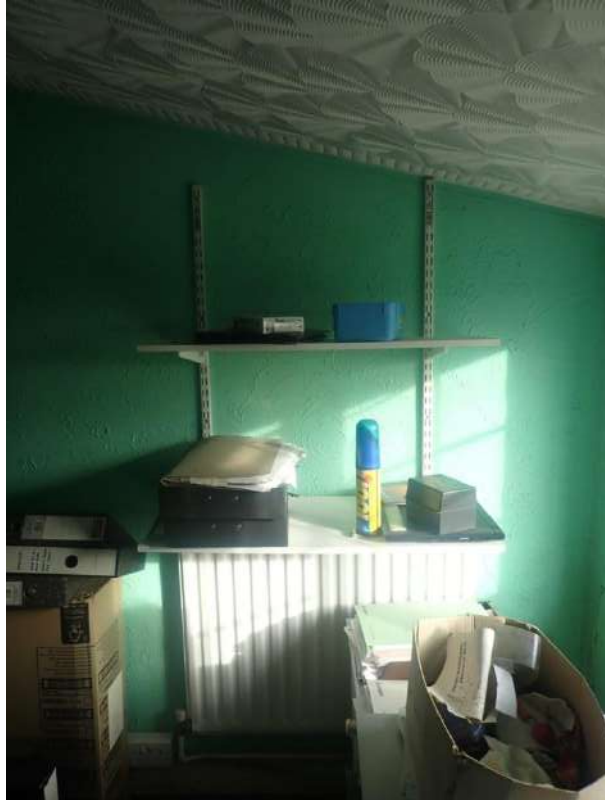
**Plates 210 and 211** show the east wall of **Cell 11**, which has similarly been rendered over with plasterwork. To the left (north), is the inner face of the west facing entrance opening, which leads onto the first floor landing of **Cell 10**. This opening is occupied by a timber frame of a head and surrounds and by a modern panelled timber door.

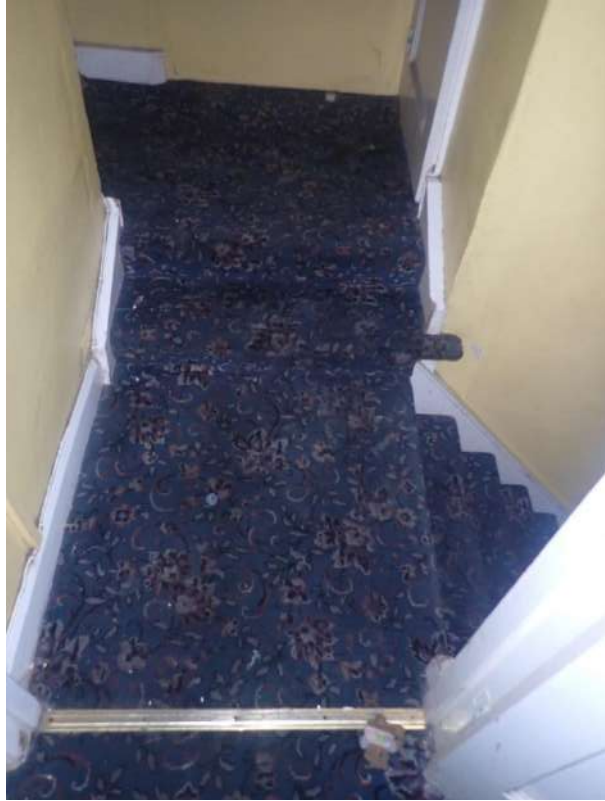
**Plate 212: View of the first floor landing of Building 2, from the south-west**

**Plate 212** features the lower levels of the first floor landing at the northern end of **Cell 10**. This shows the flooring here which is covered with modern carpeting.

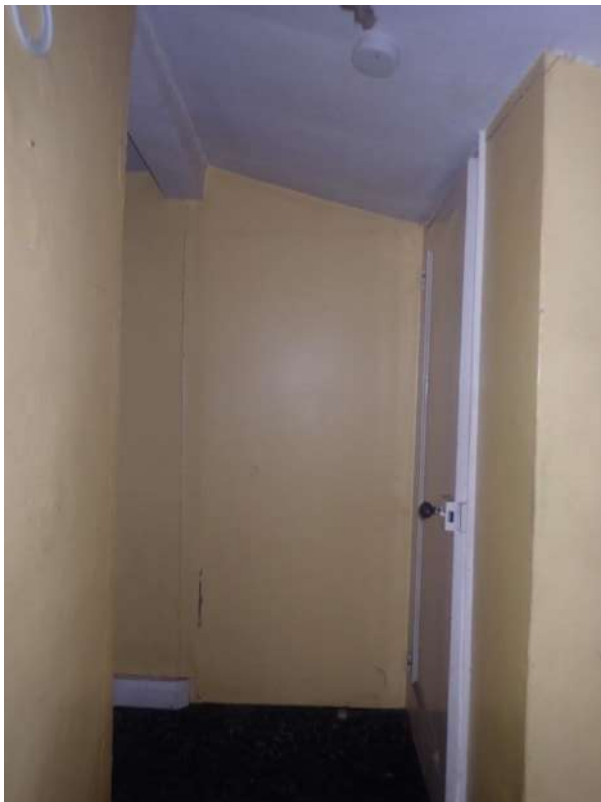
**Plate 213: View of part of the east wall of the first floor landing of Building 2, from the south-west**

**Plate 213** shows the southern portion of the east wall of the first floor landing. This east wall has been rendered over with plasterwork. Horizontal timber skirting boards are at its base.

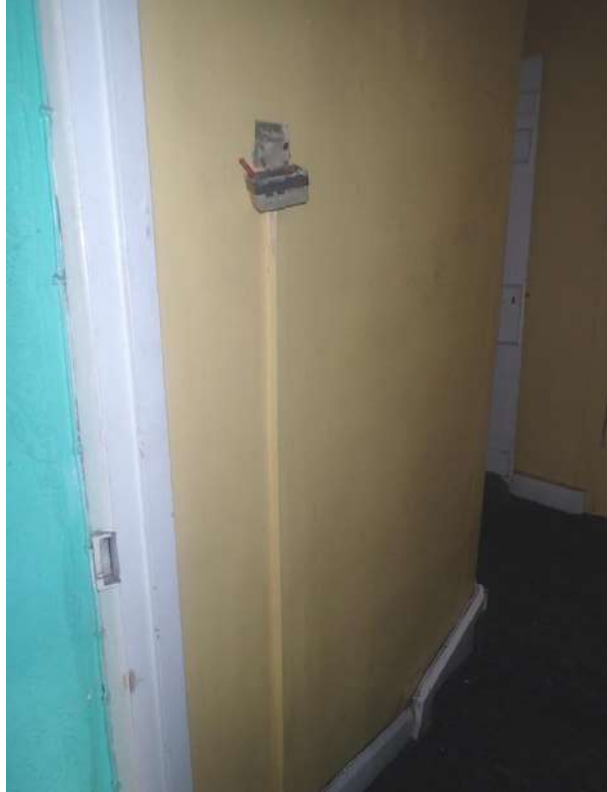
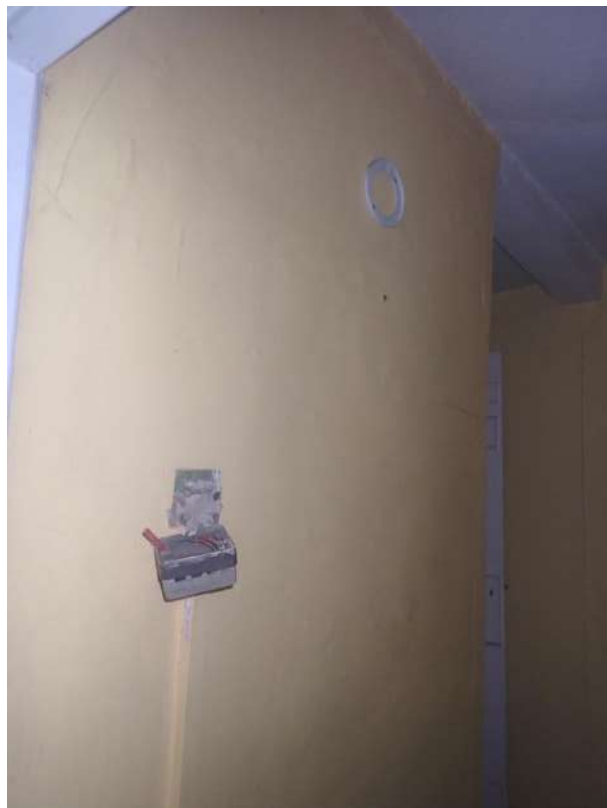
**Plates 214 and 215** present views of the north wall of this first floor landing. This north wall has been rendered over with plasterwork. Horizontal timber skirting boards are at its base.
