HISTORIC BUILDING RECORDING AT THE  
FORMER DUKE OF YORK PUBLIC HOUSE,  
106, RISEGATE ROAD,  
GOSBERTON RISEGATE, LINCOLNSHIRE

**National Grid Reference: TF 2186 3004**  
**Planning Reference: H08-0964-21**  
**Site Code: RRGR22**  
**Accession Number: LCNCC: 2022.147**

PREPARED FOR MRS. S. GOODENOUGH

January 2023

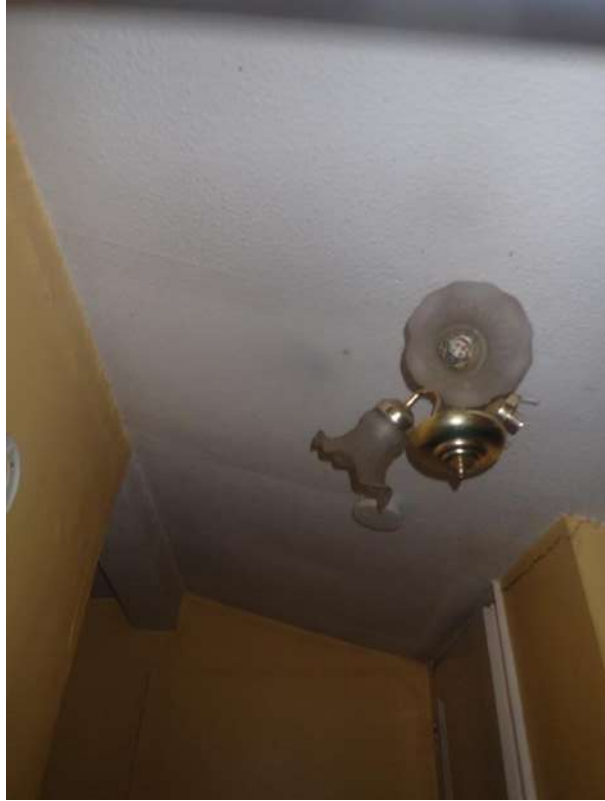
**Plate 216: View of the ceiling of the first floor landing of Building 2, from the south-west**

**Plate 216** furnishes a view of the ceiling of the first floor landing of **Building 2**. This is covered with lining paper and reflects the low angled half gabled roof of the above rear outshut.

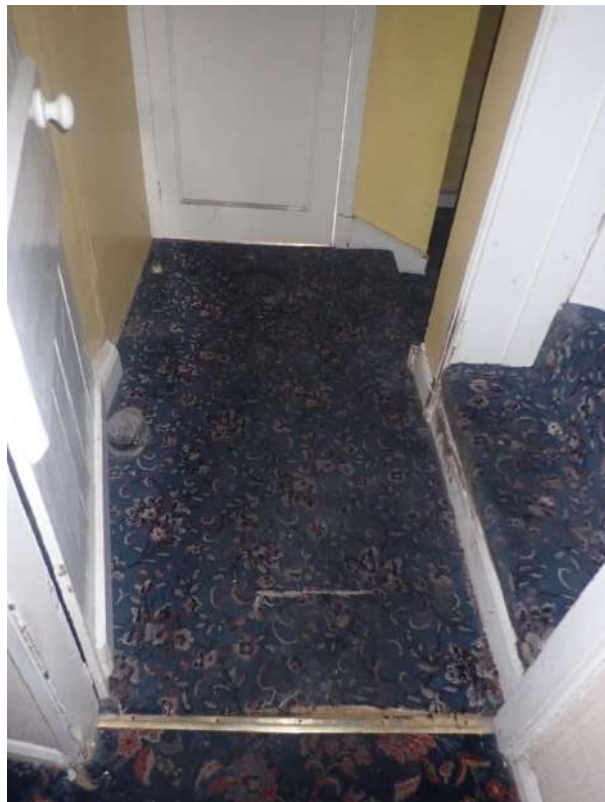
**Plate 217: View of the flooring of the upper levels of the first floor landing of Building 2, from the north-west**

**Plate 217** provides a view of the flooring of the upper levels of the first floor landing of **Building 2**. This is covered by modern carpeting

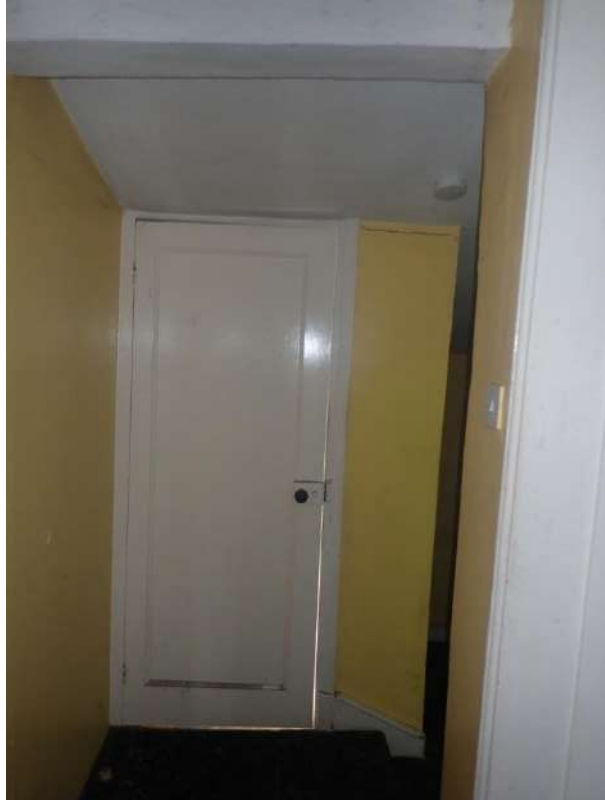
**Plate 218:** View of the south wall and of the ceiling of the first floor landing of **Building 2**, from the north-west

**Plate 218** provides a view of the south wall of the first floor landing, part of which has been rendered over with plasterwork. Timber skirting boards occur at its base. Much of this south wall is occupied by a south facing entrance opening that extends onto the first floor bathroom or **Cell 14** to the south. This opening is occupied by a timber frame of a head and surrounds and a simple panelled timber door.

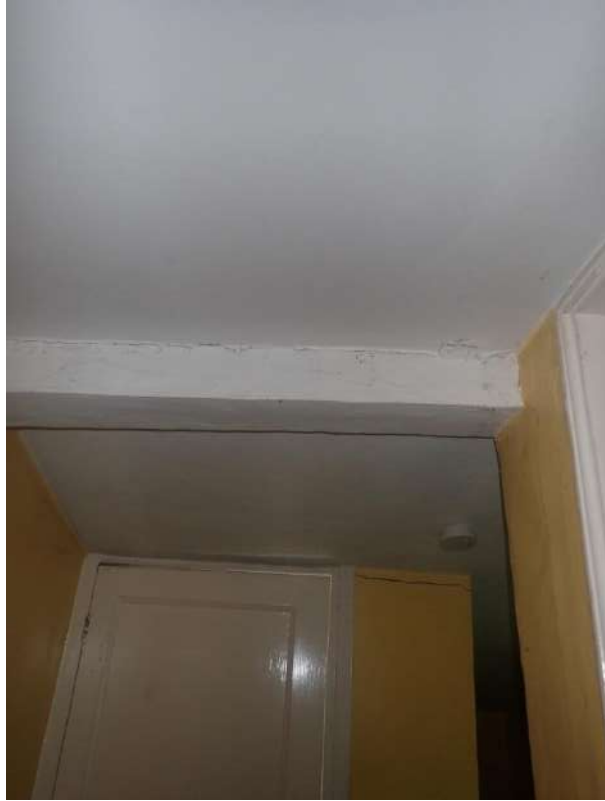
**Plate 219: View of the ceiling of the first floor landing of Building 2, from the north-west**

**Plates 219 and 221** feature the ceiling of this first floor landing, which is clearly in two parts. These are bisected by an east-west orientated principal horizontal timber joist. To the south of this joist, the angle of this ceiling reflects the low angle of the half gabled roof structure of the above rear outshut. To the north of this joist, the ceiling here has been rendered over with plasterwork and is part of the original main body of the public house. The joist denotes the boundary between this building and the rear outshut.

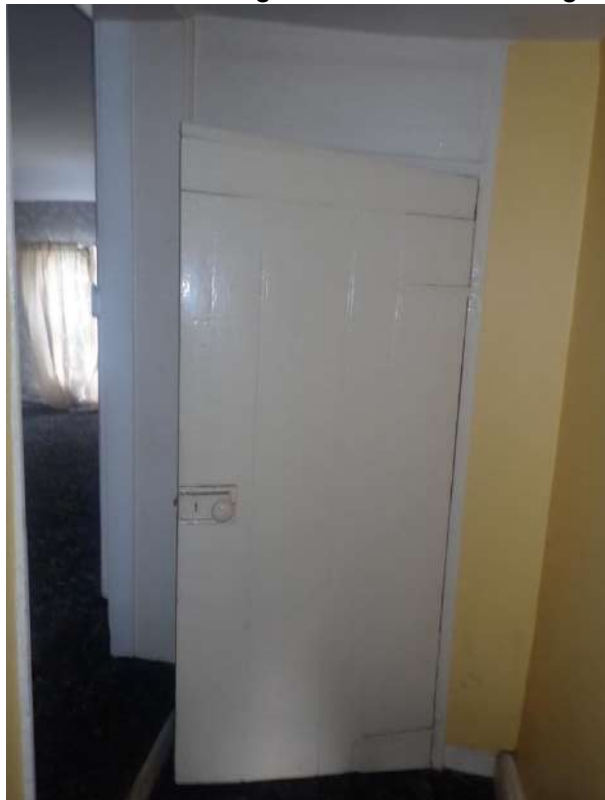
**Plate 220: View of the north wall of the first floor landing of Building 2, from the south-east**

**Plate 220** provides a view of the north wall of this first floor landing, part of which has been rendered over with plasterwork. Timber skirting boards occur at its base. A north facing entrance opening is also shown, which is occupied by a timber frame of a head and surrounds and a door that is composed of a series of vertical tongued and grooved timber planks. The door is attached to the frame by two metal strap hinges. This leads onto **Cell 13** to the north. To the left (west), is a second west facing entrance opening that is occupied by a timber frame of a head and surrounds. This extends onto **Cell 12** to the west.

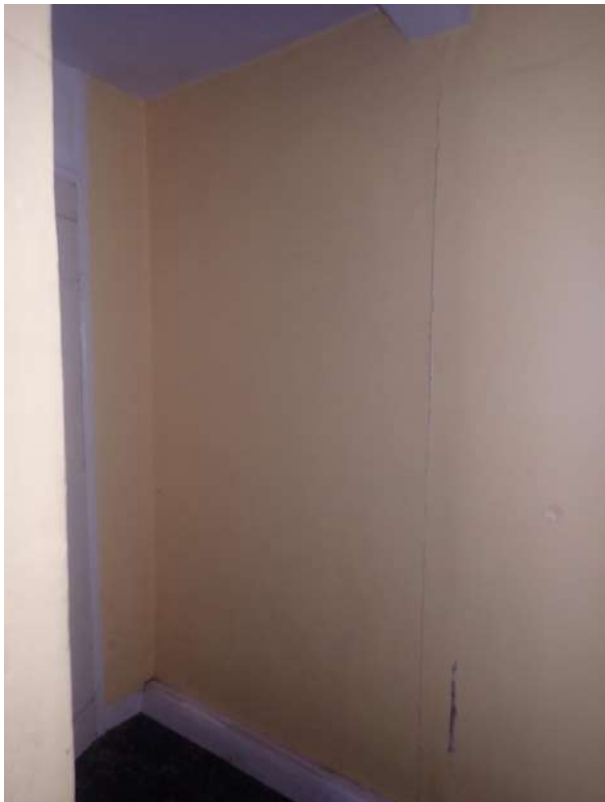
**Plate 222: View of the east wall of the first floor landing of Building 2, from the south-west**

**Plate 222** features the northern portion of the east wall of this first floor landing, which has been rendered over with plasterwork. Timber skirting boards occur at its base.

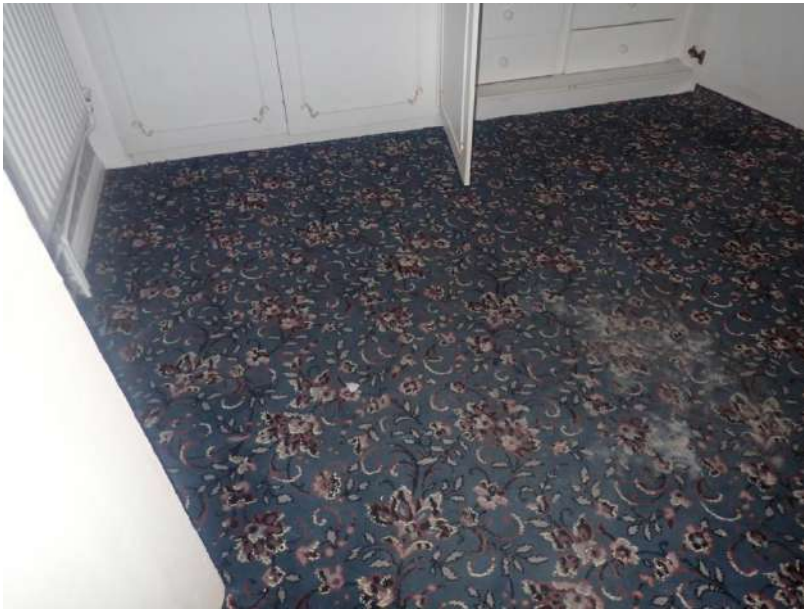
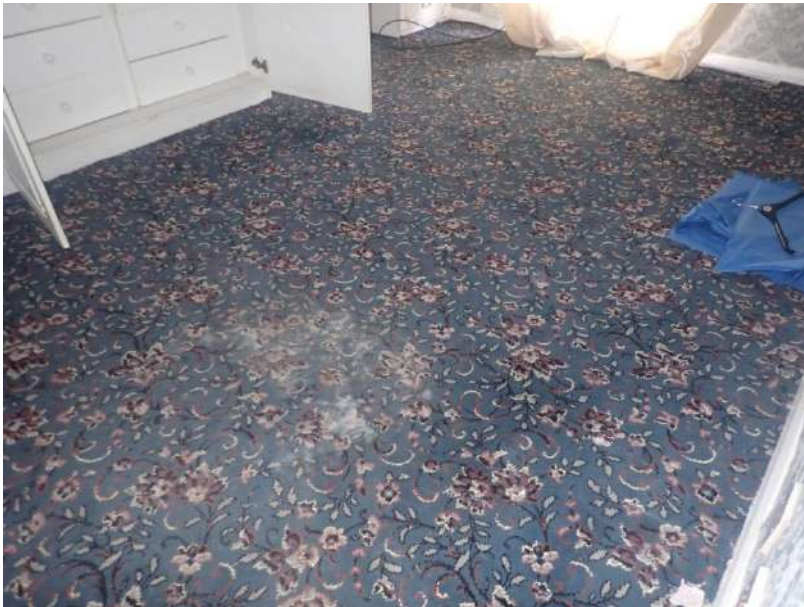
**Plates 223 and 224** feature the flooring of **Cell 12**, which is carpeted.

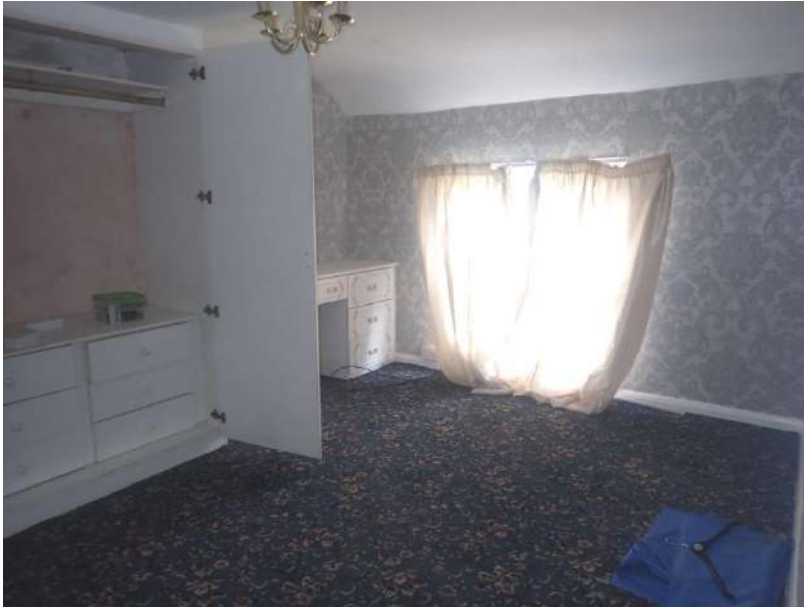
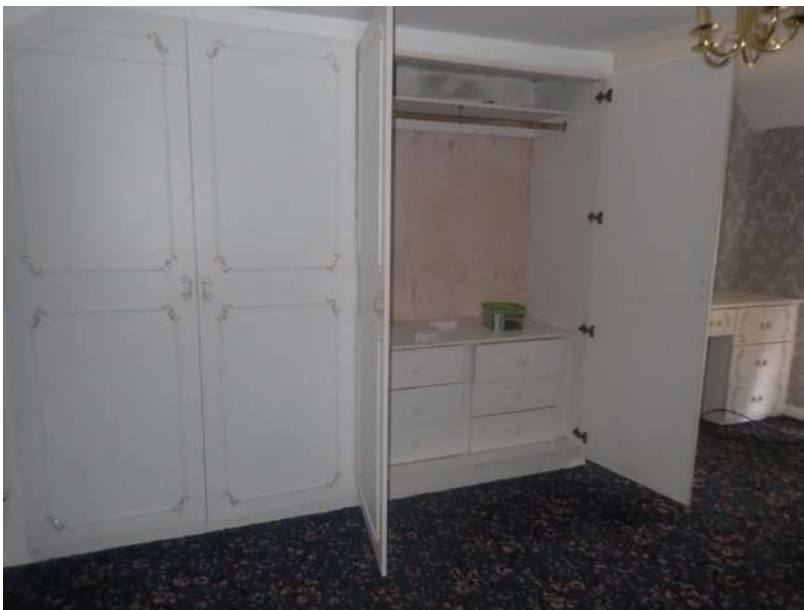
**Plates 225 and 226** provide general views of the interior of **Cell 12** from south-eastern positions.

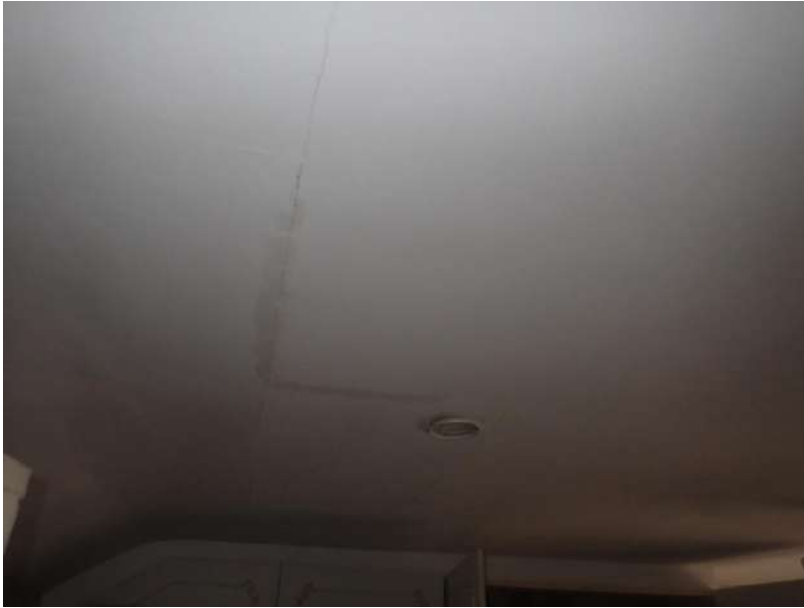
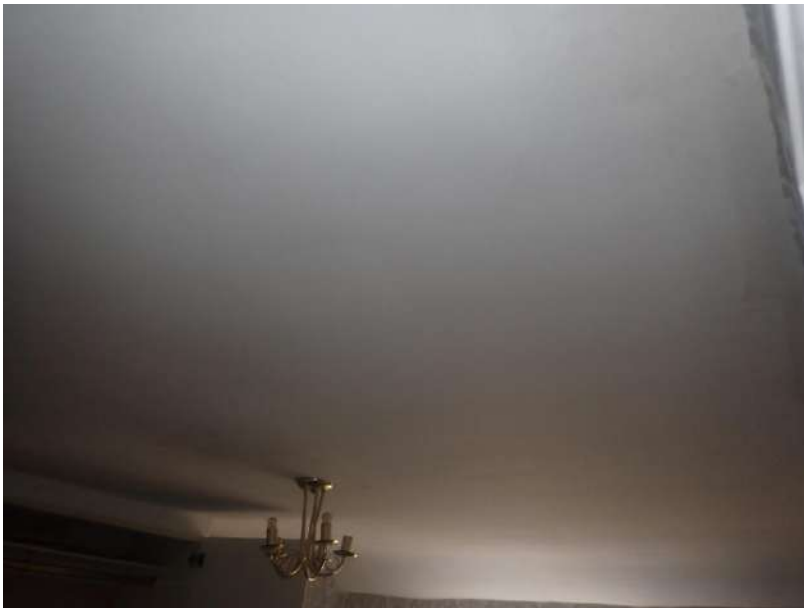
**Plates 227 and 228** show the nature of the ceiling structure of **Cell 12**, which has been rendered over with modern plasterwork.

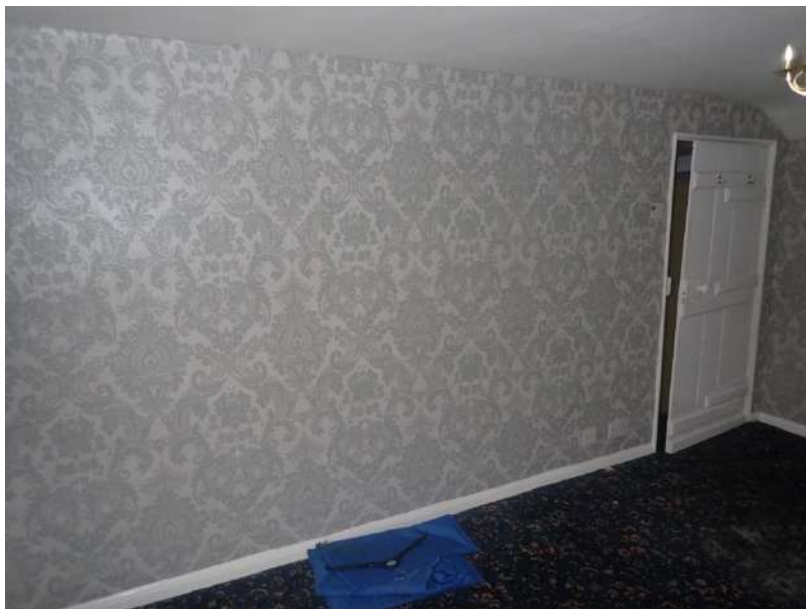
**Plate 229:** View of the east wall of Cell 12, from the north-west

**Plates 229 and 232** furnish views of the east wall of **Cell 12**, which is also the internal dividing wall with the adjoining **Cell 13**, to the east. This east wall has been covered over with modern wallpaper. Horizontal timber skirting boards occur at its base. To the right (south), is the inner face of the east facing entrance opening that leads onto the first floor landing. This opening is occupied by a timber frame of a head and surrounds and by a door that is composed of a series of vertical tongued and grooved timber planks that are in turn affixed to an internal framework of horizontal timbers.

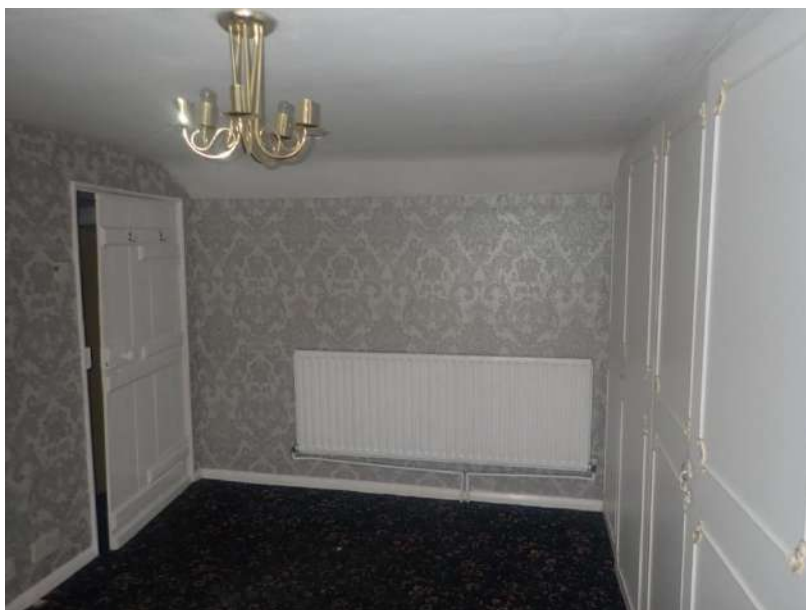
**Plate 230** View of the south wall of Cell 12, from the north-west

**Plate 230** presents a view of the south wall of **Cell 12**, which is covered over with modern wallpaper. Horizontal timber skirting boards occur at its base. The angle of the gabled roof of the building may be observed above this south wall.

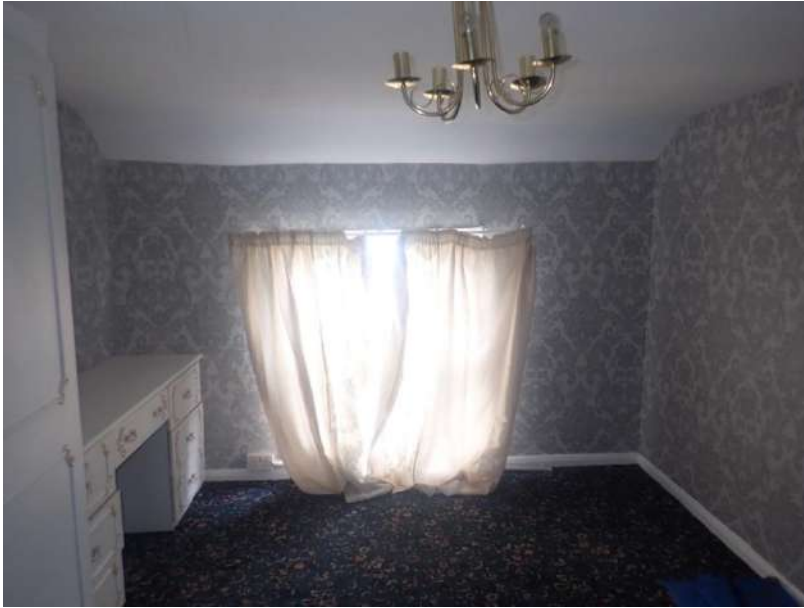
**Plate 231:** View of the north wall of Cell 12, from the south-west

**Plate 231** presents a view of the north wall of **Cell 12**, which is covered over with modern wallpaper. Horizontal timber skirting boards occur at its base. The central feature of this north wall is the inner face of the first floor north facing window opening that was recorded externally at the North Elevation of the building. The angle of the gabled roof of the building may be observed above this north wall.

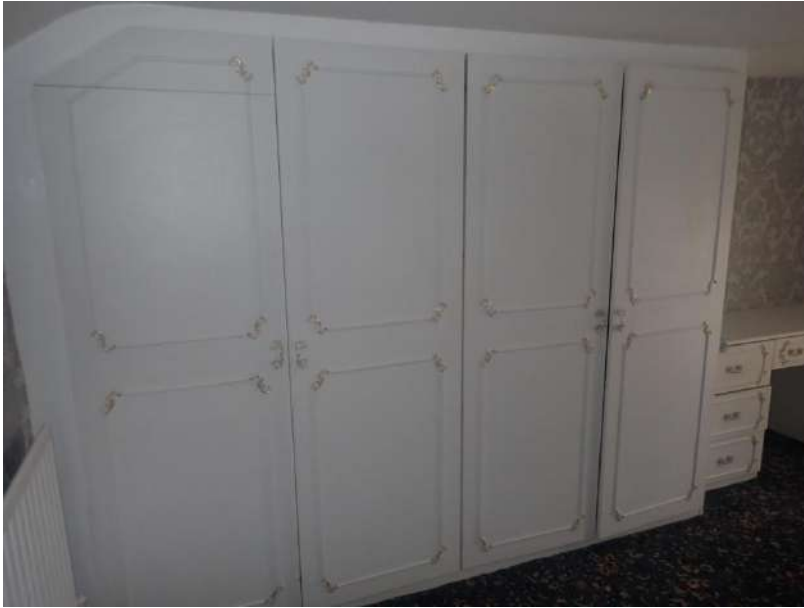
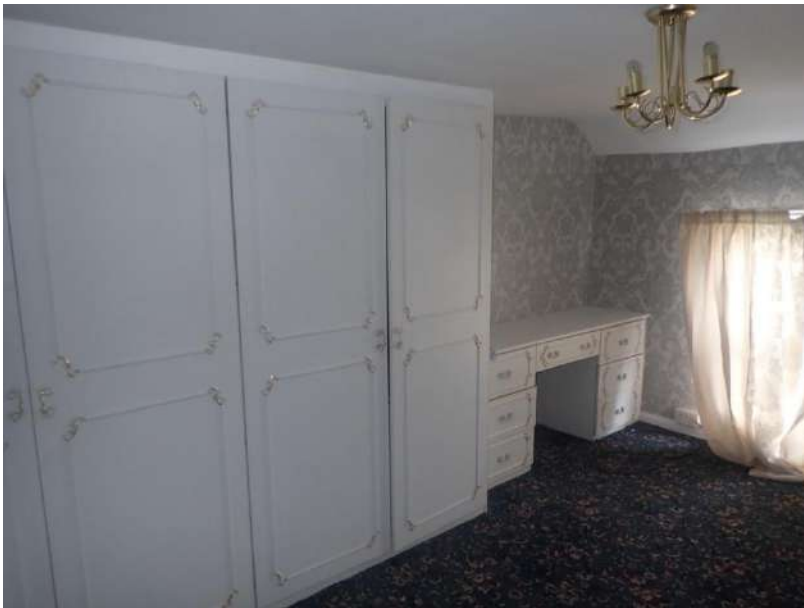
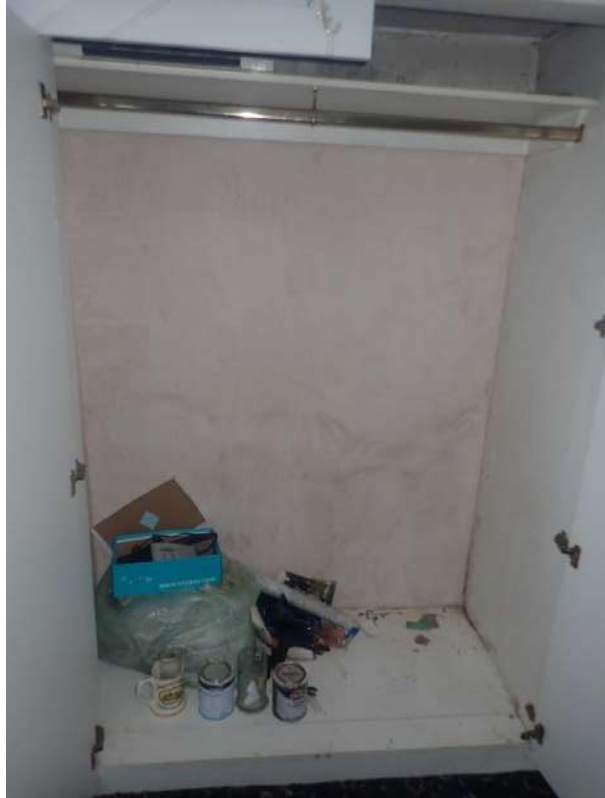
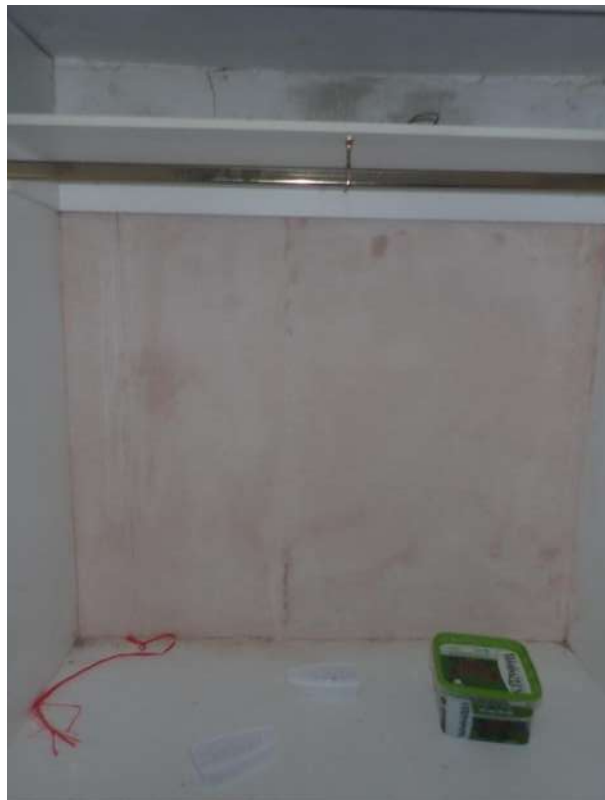
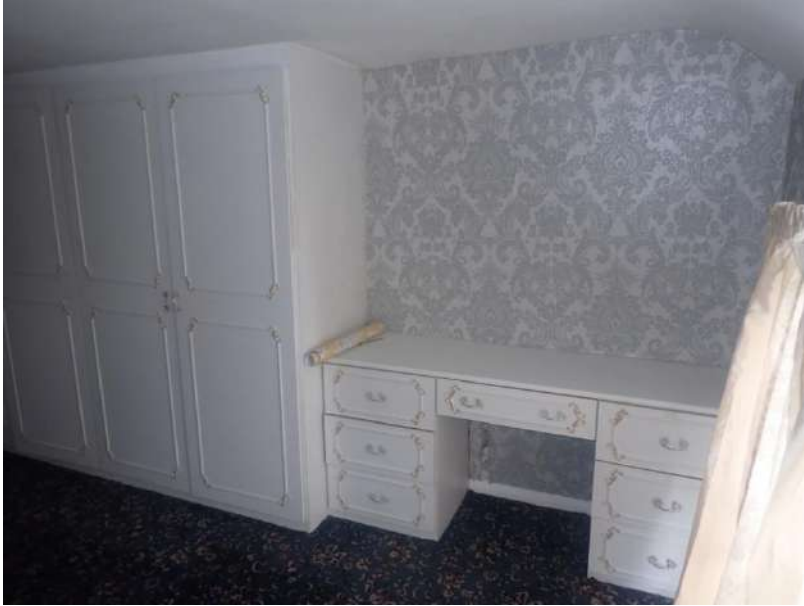
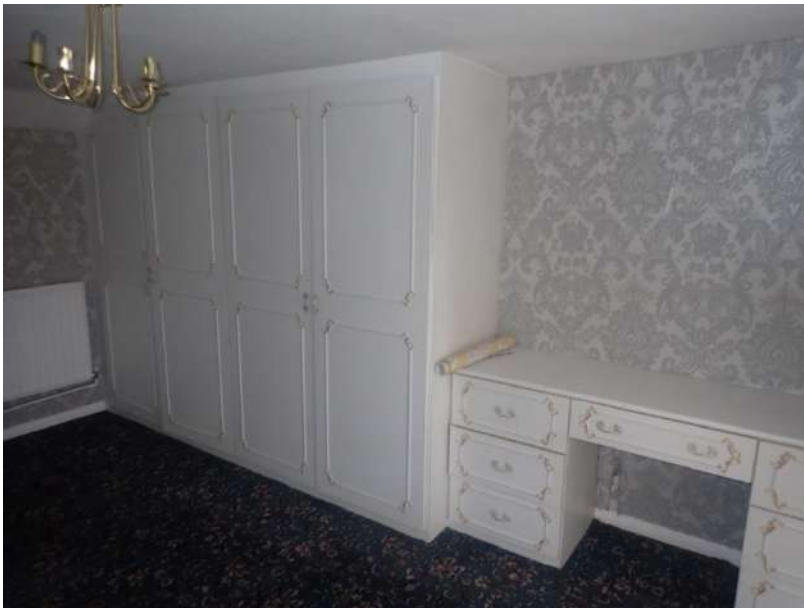
**Plates 233-238** provide a number of views from differing vantage points of the west wall of **Cell 12**, much of which is occupied by modern fitted cupboards. Outside of the modern fitted cupboards, the wall is covered with modern wallpaper. Horizontal timber skirting boards occur at its base. **Plates 235 and 236** feature the interiors of the fitted cupboards and feature the plasterwork rendering here.

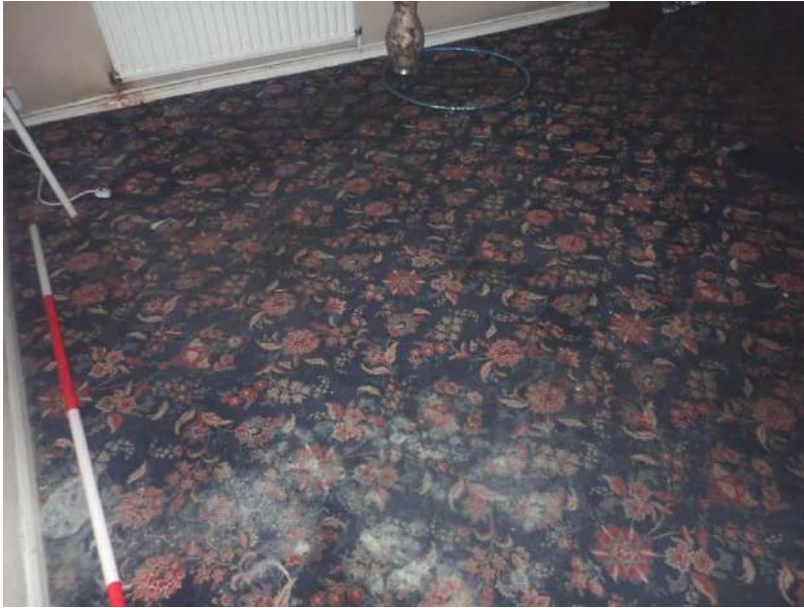
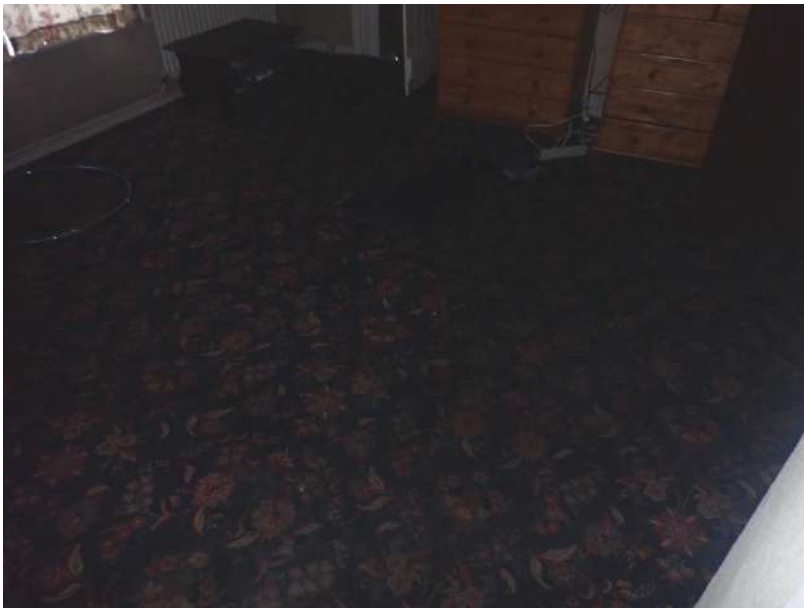
**Plates 239 and 240** feature the flooring of **Cell 13**, which is carpeted.

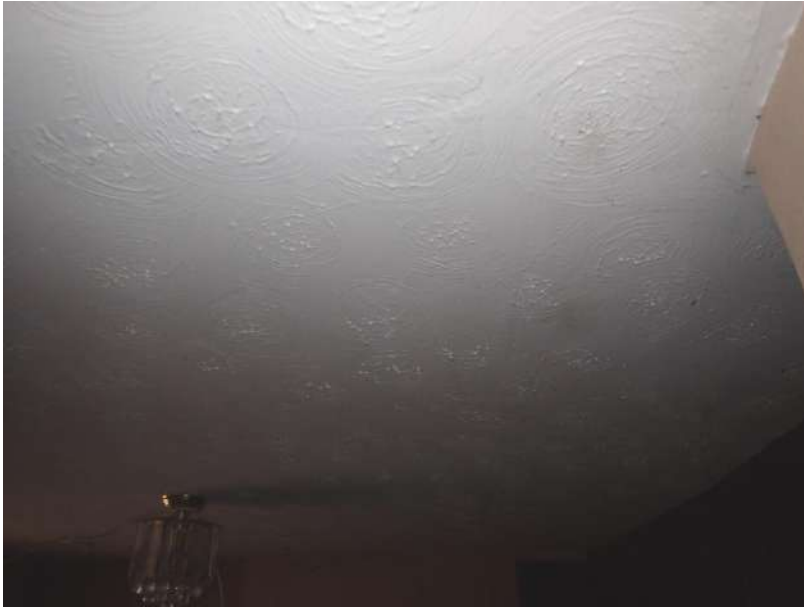
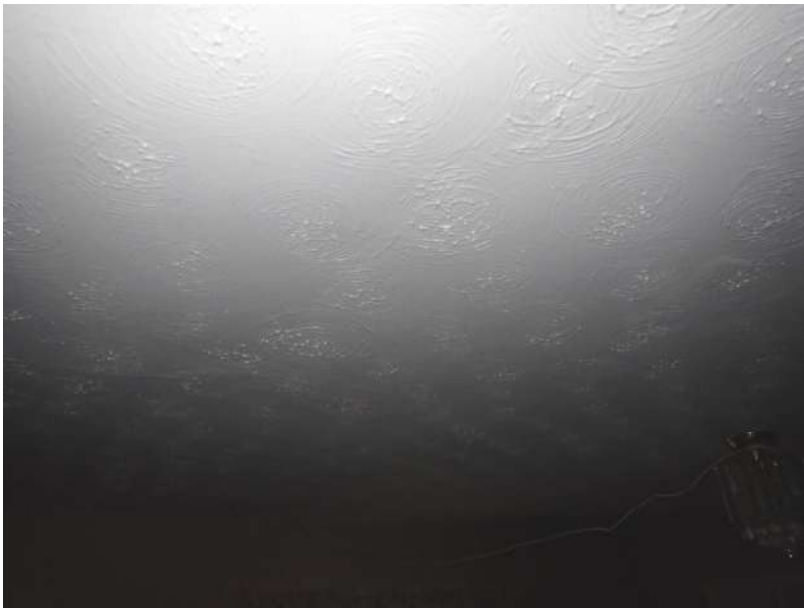
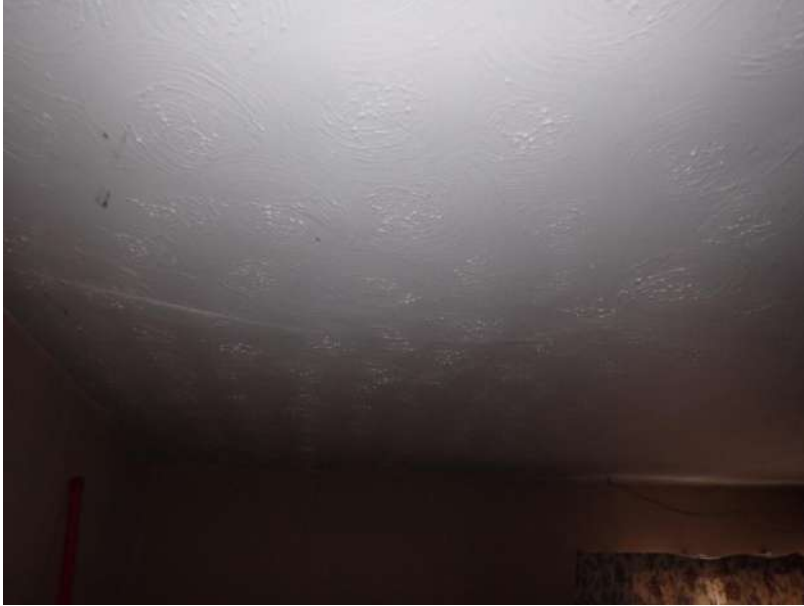
**Plates 243-245** feature the nature of the ceiling structure of **Cell 13**, which has been rendered over with modern plasterwork.

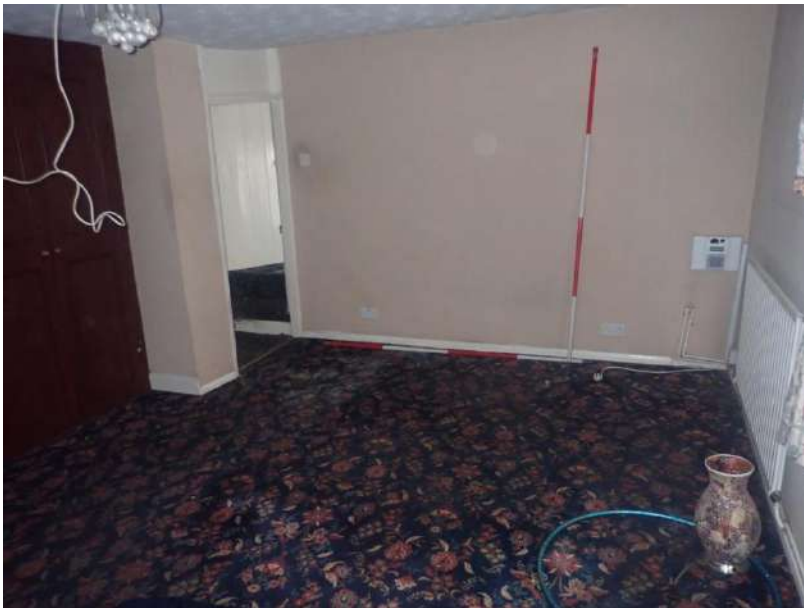
**Plate 246:** View of the west wall of Cell 13, from the north-east

**Plate 246** presents a view of the west wall of **Cell 13**, which has been rendered over with plasterwork. Horizontal timber skirting boards occurs at its base. This is also the internal dividing wall with the adjoining **Cell 12** to the west.

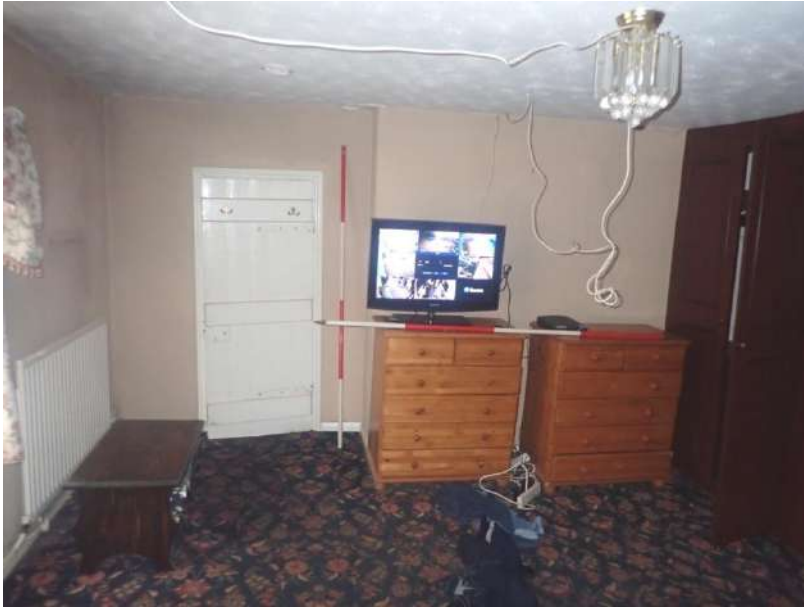
**Plate 247:** View of the east wall of Cell 13, from the north-west

**Plate 247** presents a view of the east wall of **Cell 13**, which is also the internal dividing wall with the adjoining **Cell 2** to the east. This east wall has also been rendered over with plasterwork. Horizontal timber skirting boards occurs at its base. Also shown is part of a chimney breast and to the left (north), is the inner face of an east facing entrance opening that extends onto **Cell 2** to the east. This opening is occupied by a timber frame of a head and surrounds and by a timber door that is composed of a series of vertical tongued and grooved timber planks that are attached to an internal framework of horizontal timbers.

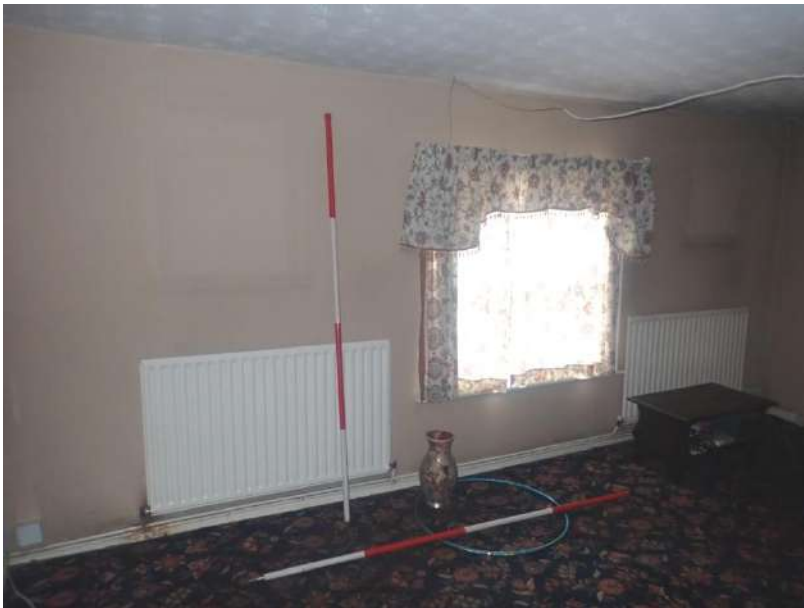
**Plate 248:** View of the north wall of Cell 13, from the south-west

**Plate 248** features the north wall of **Cell 13**, which has been rendered over with plasterwork. Horizontal timber skirting boards occurs at its base. Also shown is the inner face of the first floor north facing window opening that was recorded externally at the North Elevation of this building.

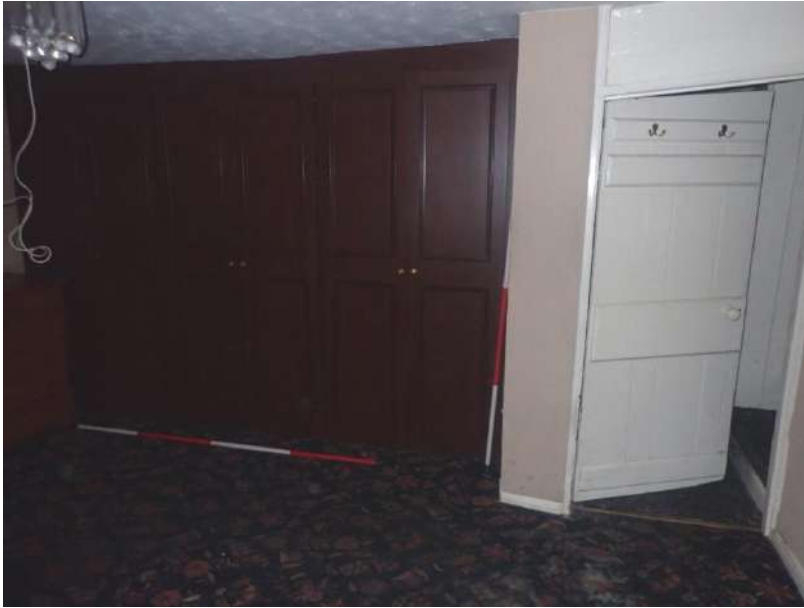
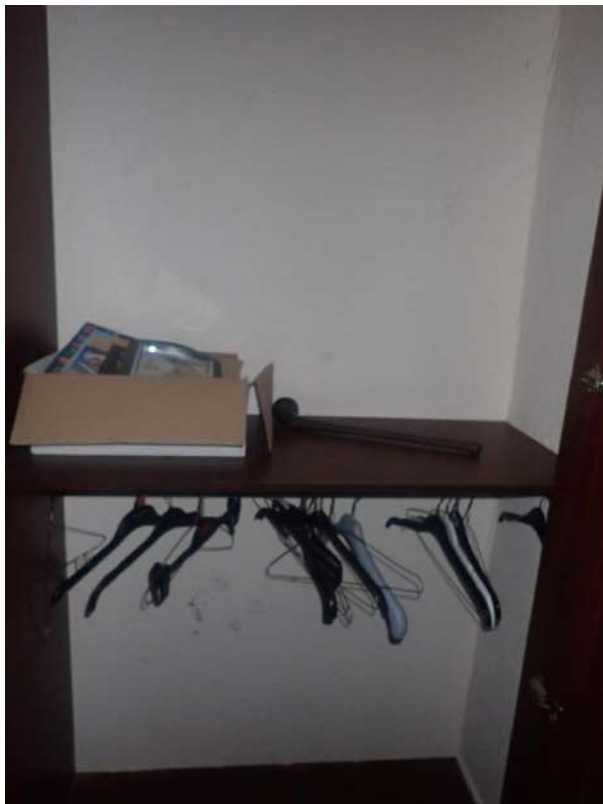
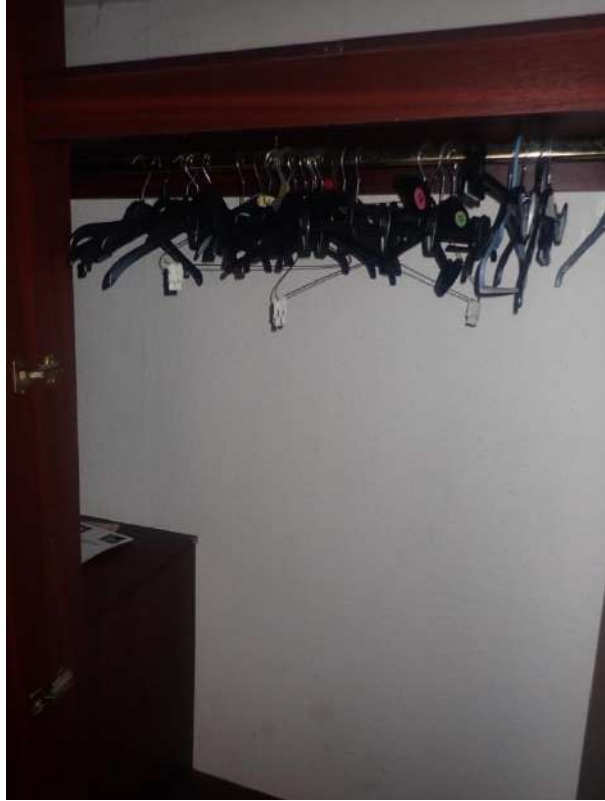
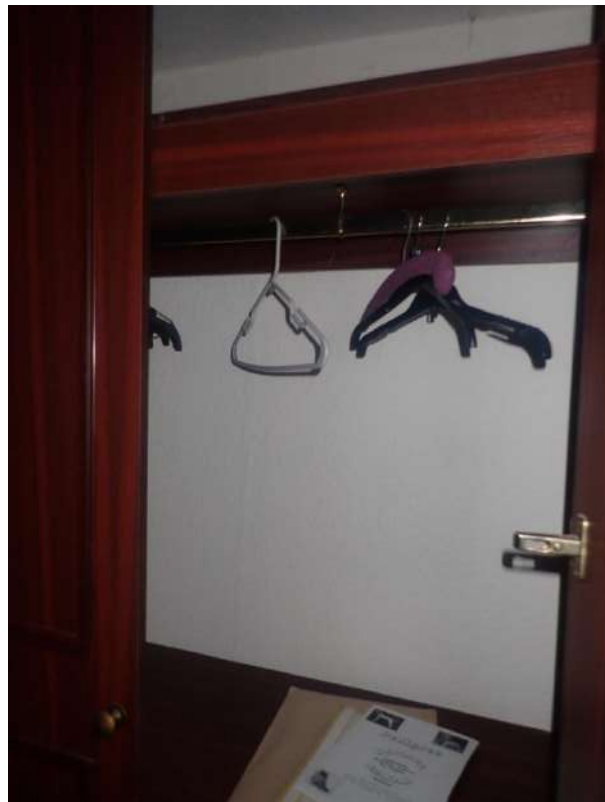
**Plates 249-252** feature the south wall of **Cell 13**, much of which is occupied by modern fitted cupboards. To the right (west), is the inner face of a south facing entrance opening that leads onto the first floor landing. This opening is occupied by a timber frame of a head and surrounds and by a timber door that is composed of a series of vertical tongued and grooved timber planks that are attached to an internal framework of horizontal timbers. **Plates 250-252** feature the interiors of the fitted cupboards, which show modern plasterwork rendering. Horizontal timber skirting boards occurs at its base.

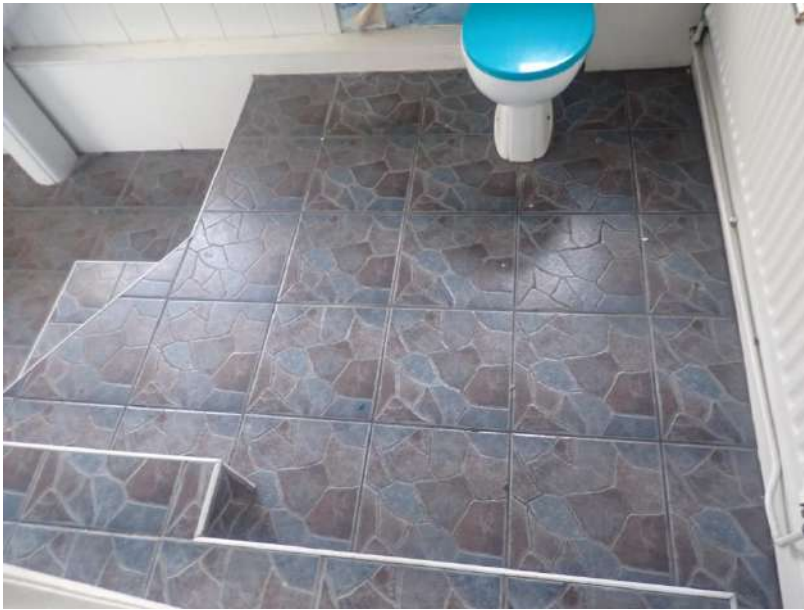
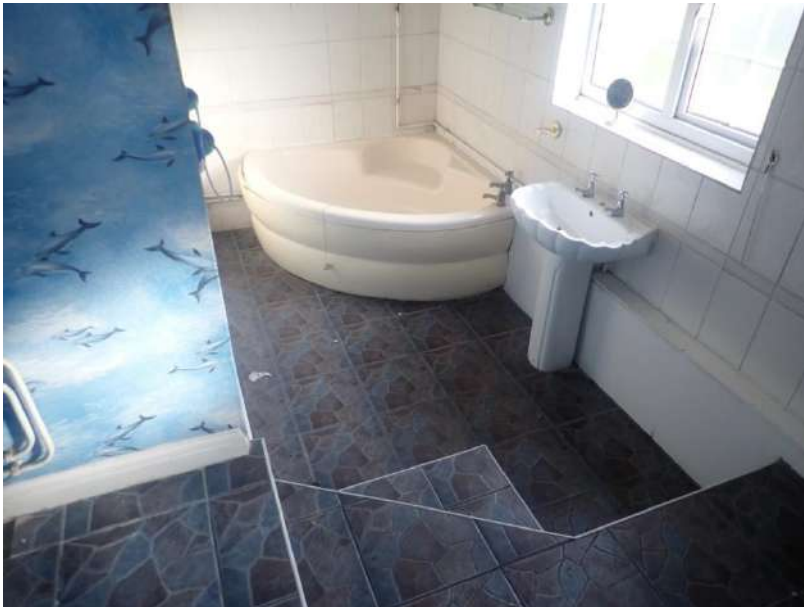
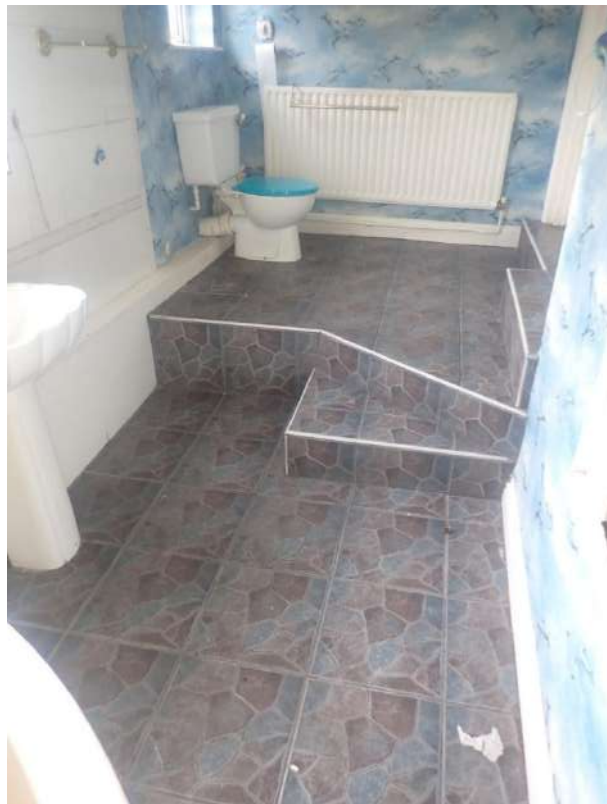
**Plates 253-254 and 256** present several views of the nature of the flooring of **Cell 14**, which is of modern ceramic floor tiling on two levels.

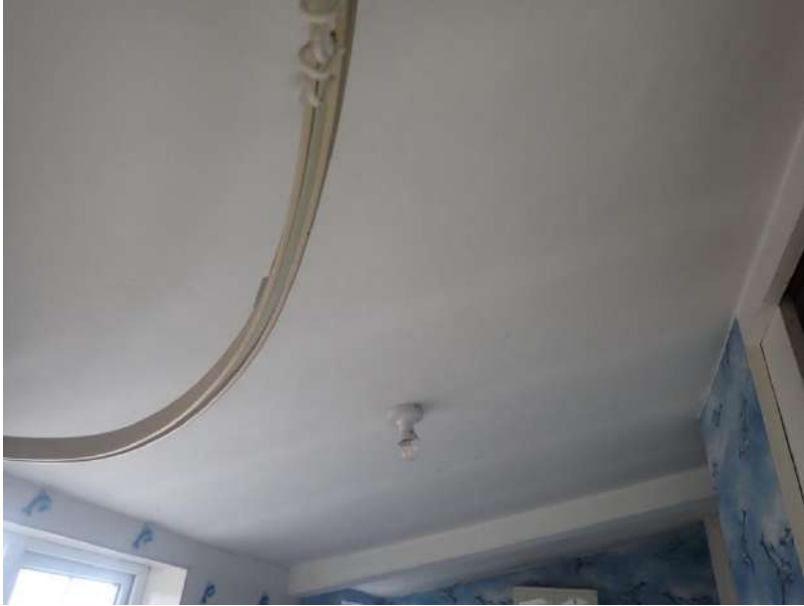
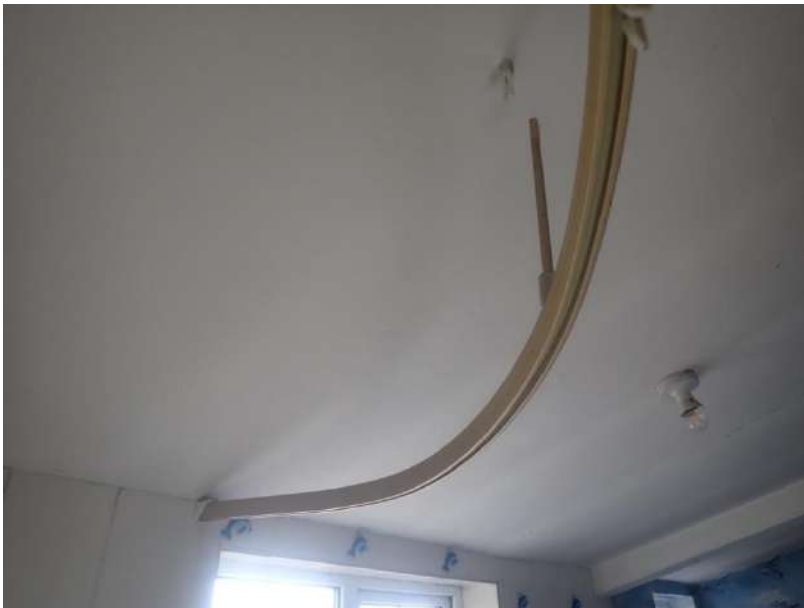
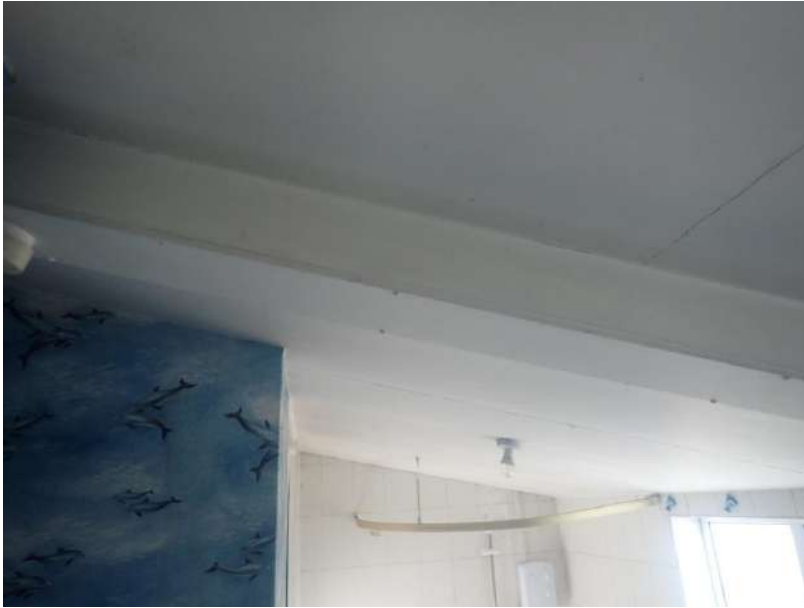
**Plates 257-261** furnish a number of views of the nature of the ceiling structure of **Cell 14**, which has been rendered over with modern plasterwork. Its low angle reflects the low angled half gabled roof structure of the above rear outshut. Of particular note is the angled and north-south orientated principal rafter, which has been boxed in.

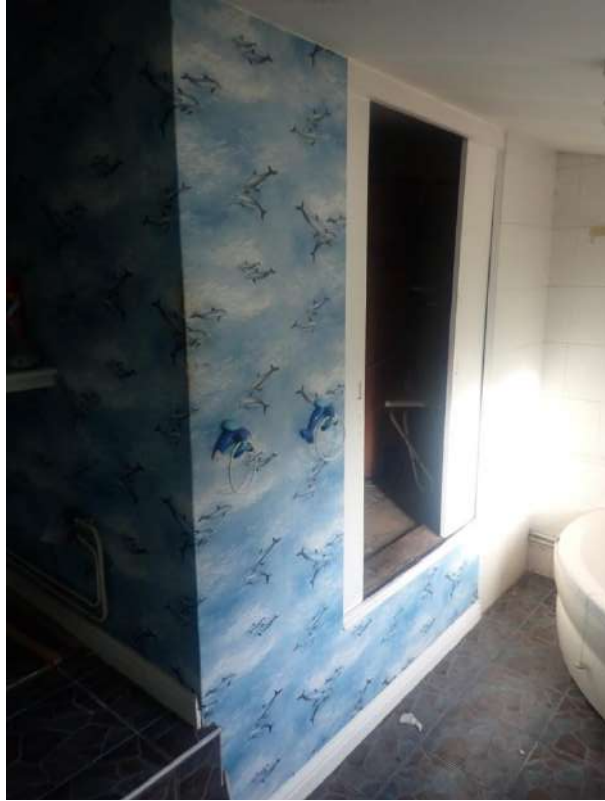
**Plate 263: View of the north wall of Cell 14, from the south-west**

**Plate 263** features the eastern portion of the north wall of **Cell 14**, which has been covered over with modern wallpaper. This north wall also houses a built in modern airing cupboard, from which the external panel here has been removed. Horizontal timber skirting boards occur at its base.

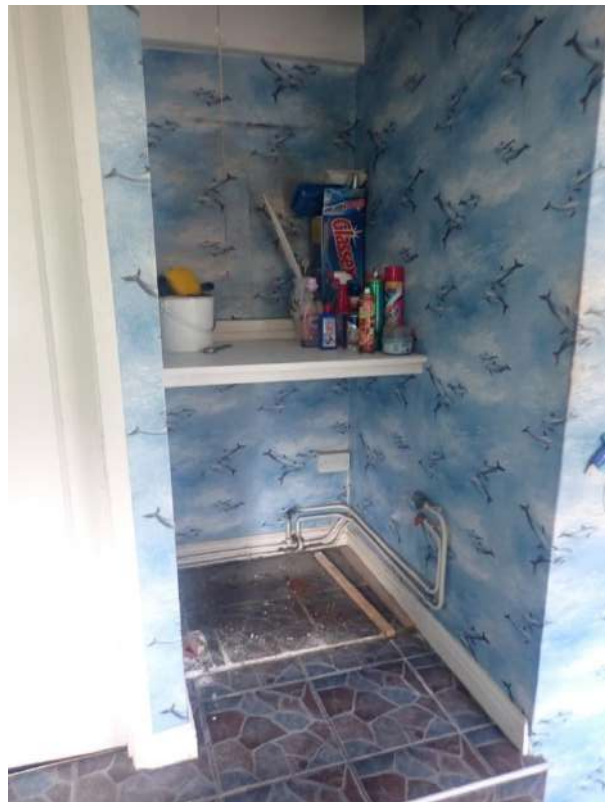
**Plate 264: View of the north wall of Cell 14, from the south-west**

**Plate 264** shows an alcove which houses a wash hand basin within the north wall of **Cell 14**, which has been covered over with modern wallpaper. Horizontal timber skirting boards occur at its base.

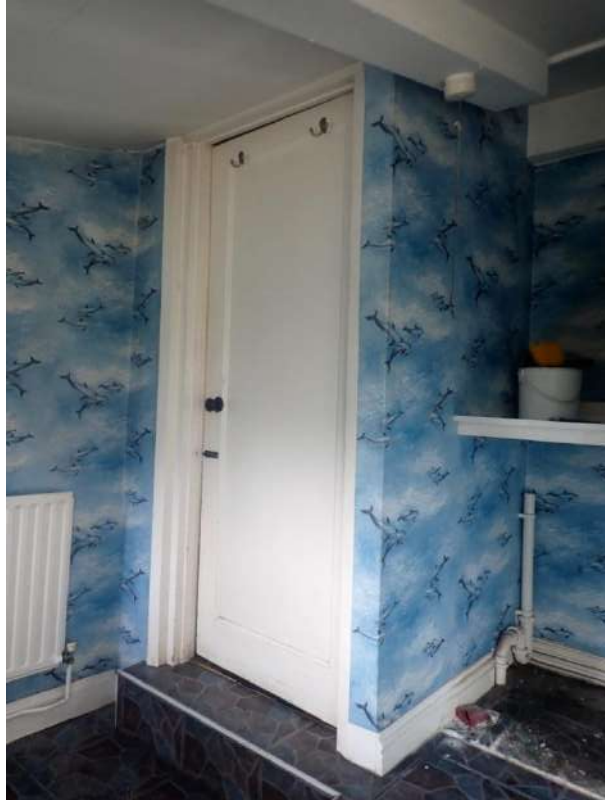
**Plate 265:** View of the north wall of Cell 14, from the south-east

**Plate 265** presents a view of the western portion of the north wall of **Cell 14** and shows the north facing entrance opening that leads onto the first floor landing of **Building 2**. This opening is occupied by a timber frame of a head, surrounds and architrave and by a modern panelled timber door.
