HISTORIC BUILDING RECORDING AT THE  
FORMER DUKE OF YORK PUBLIC HOUSE,  
106, RISEGATE ROAD,  
GOSBERTON RISEGATE, LINCOLNSHIRE

**National Grid Reference: TF 2186 3004**  
**Planning Reference: H08-0964-21**  
**Site Code: RRGR22**  
**Accession Number: LCNCC: 2022.147**

PREPARED FOR MRS. S. GOODENOUGH

January 2023

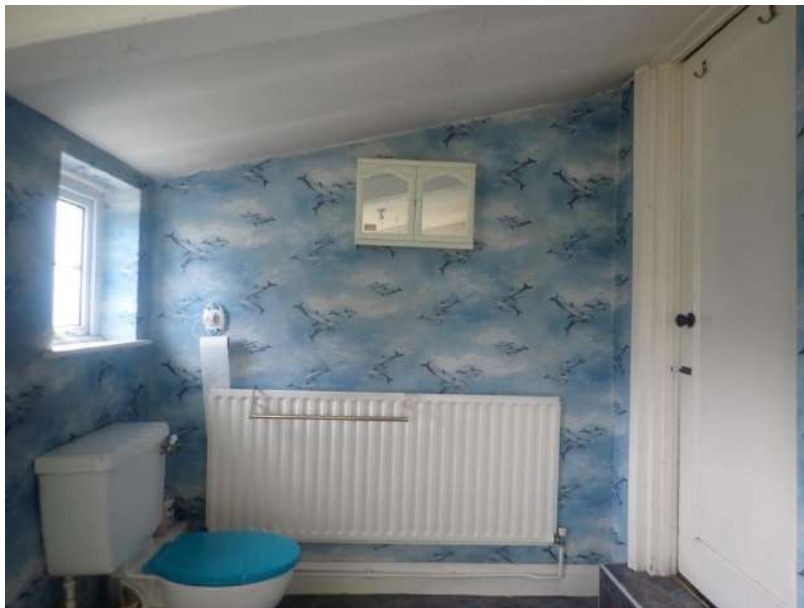
**Plate 266:** View of the west wall of Cell 14, from the north-east

**Plate 266** features the west wall of **Cell 14**, which has been covered over with modern wallpaper. Horizontal timber skirting boards occur at its base.

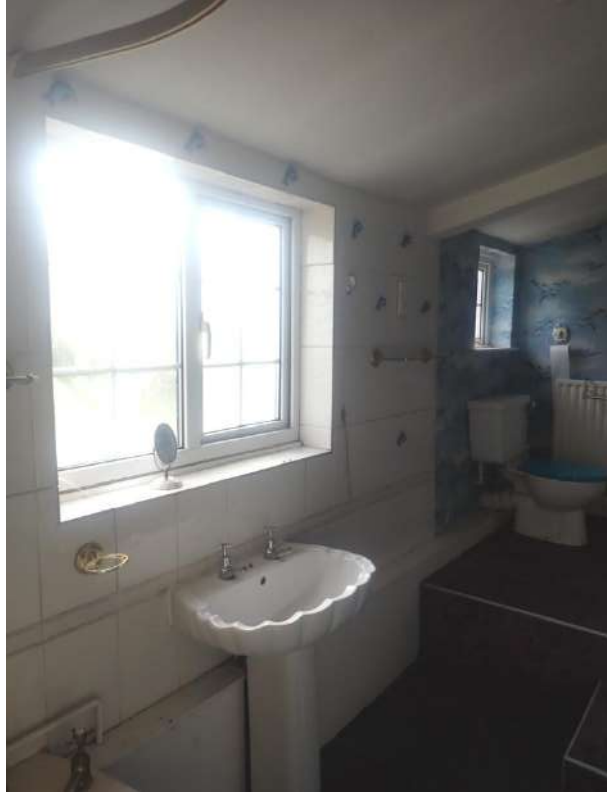
**Plate 267: View of the north wall of Cell 14, from the north-east**

**Plates 267 and 268** show the south wall of **Cell 14**, which has been covered over with modern ceramic wall tiling. Also featured are the slightly recessed inner faces of two south facing first floor window openings that were recorded externally at the South Elevation of this building.

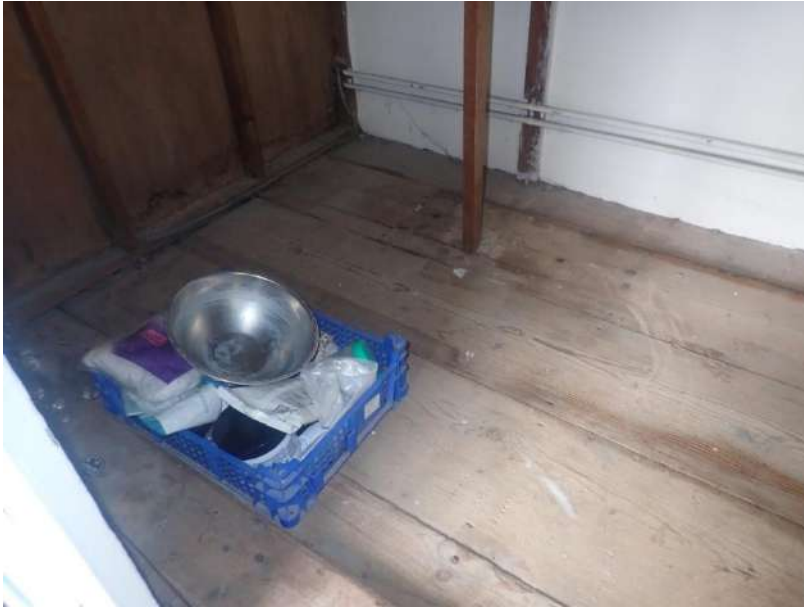
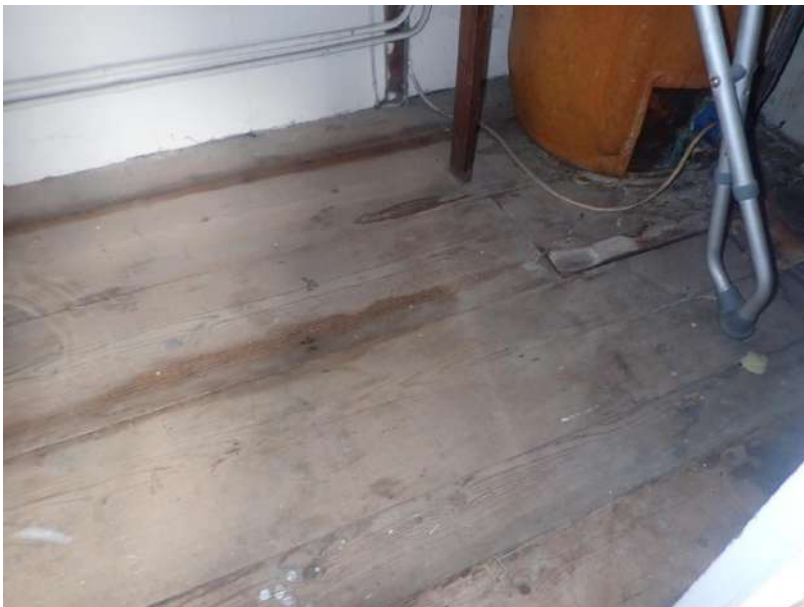
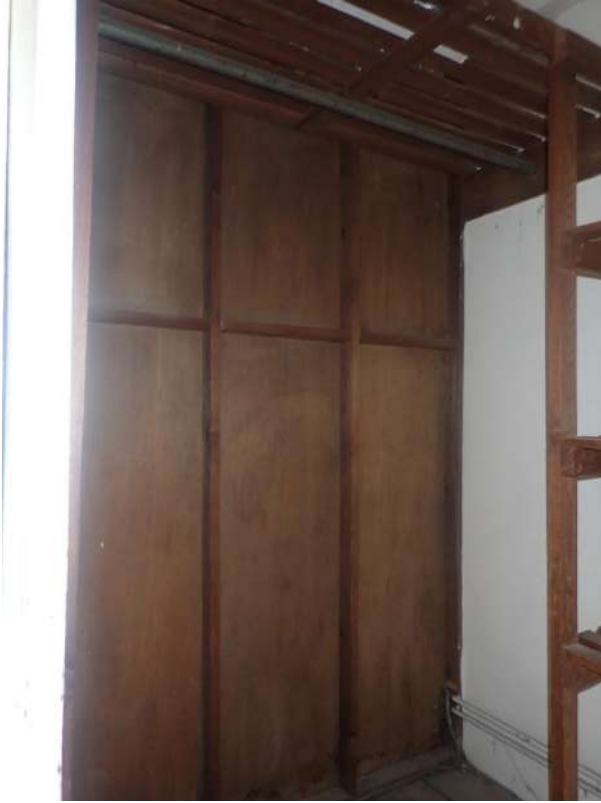
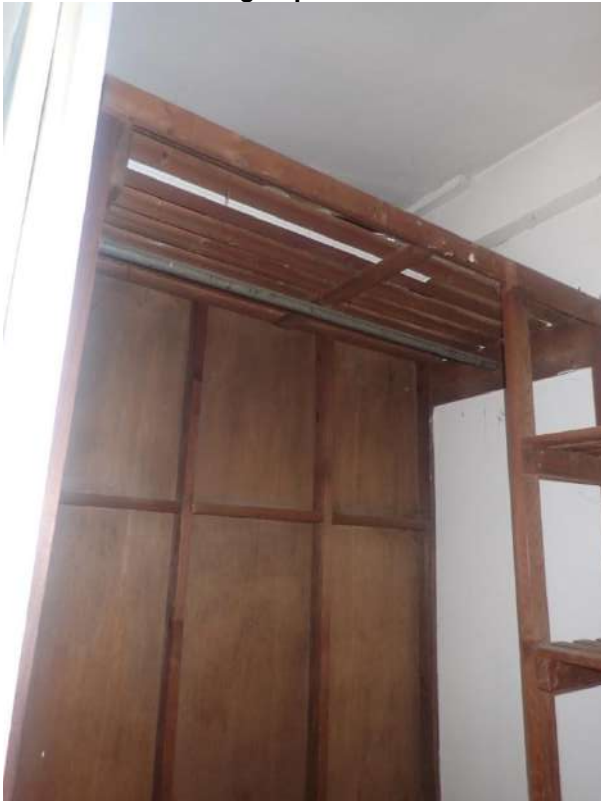
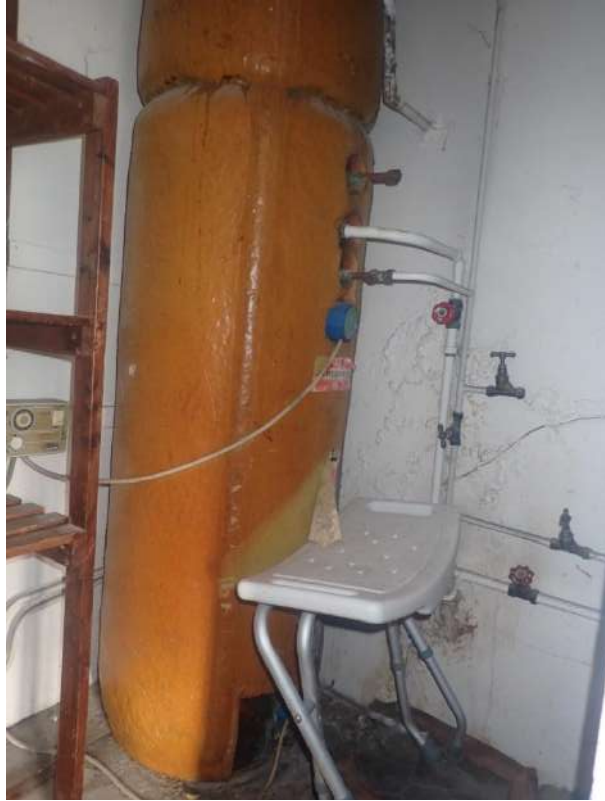
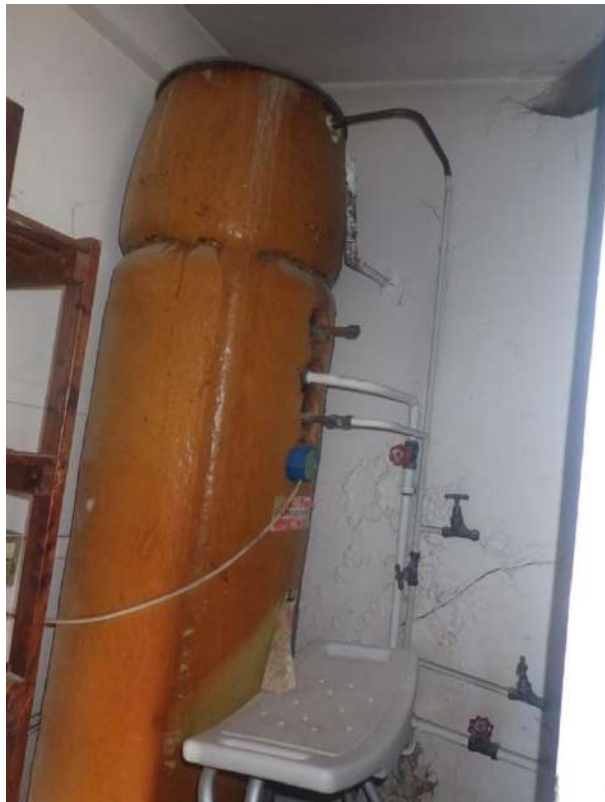
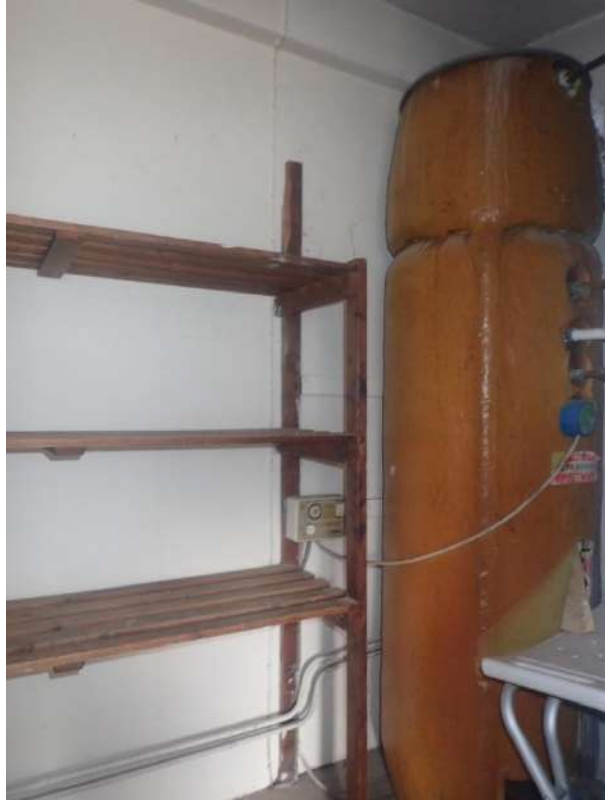
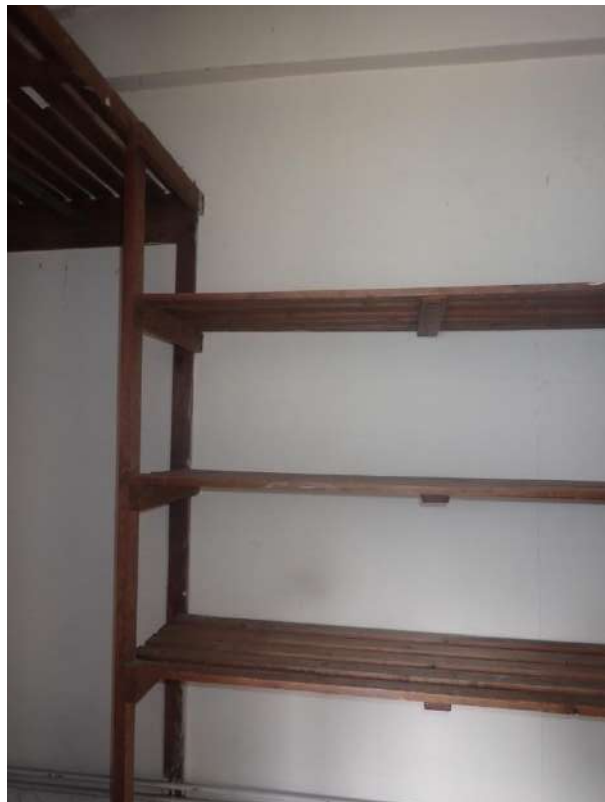
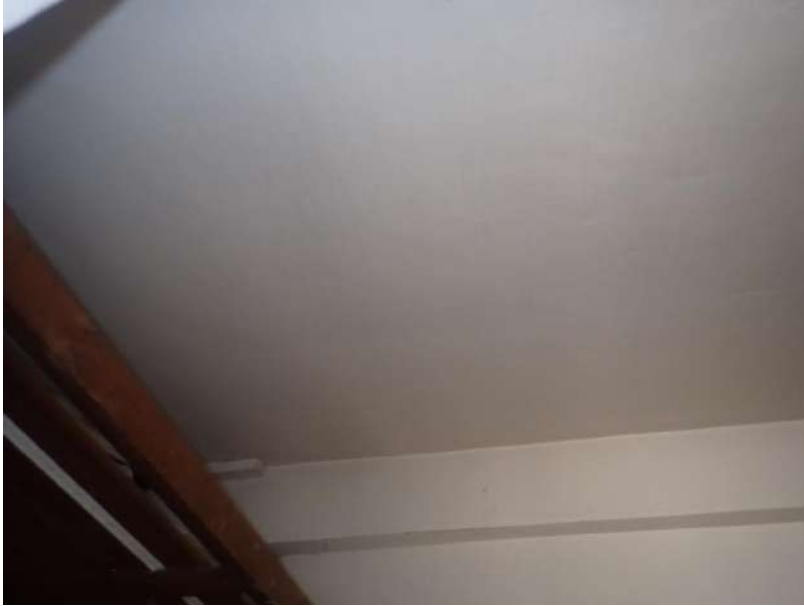
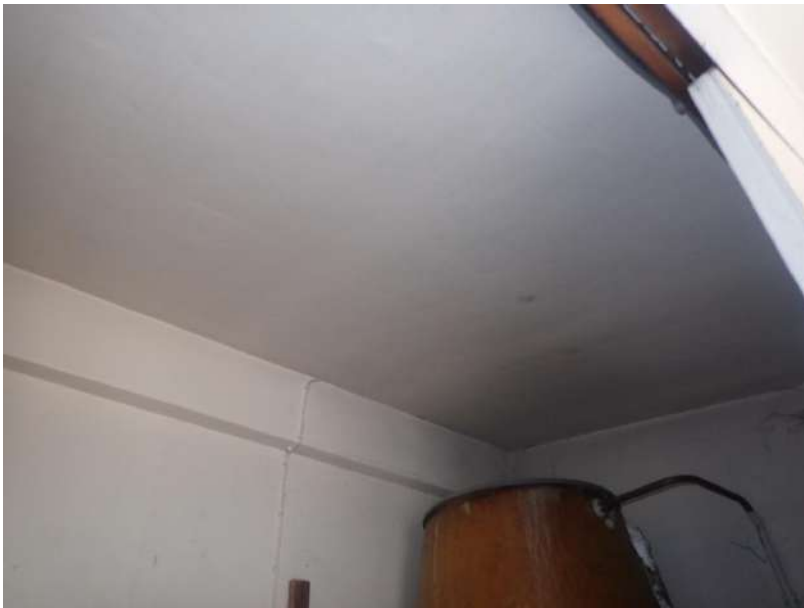
**Plates 269-278** feature the interior of the airing cupboard, which has been built into the north wall of **Cell 14**. The base is of horizontal timber planking. The west side is of timber boarding, which is attached to an internal framework and vertical and horizontal timbers, whilst the northern and eastern sides are original portions of the west and north walls of this first floor bathroom, which

have been rendered over with modern plasterwork. The ceiling inside here has also been rendered over with modern plasterwork.

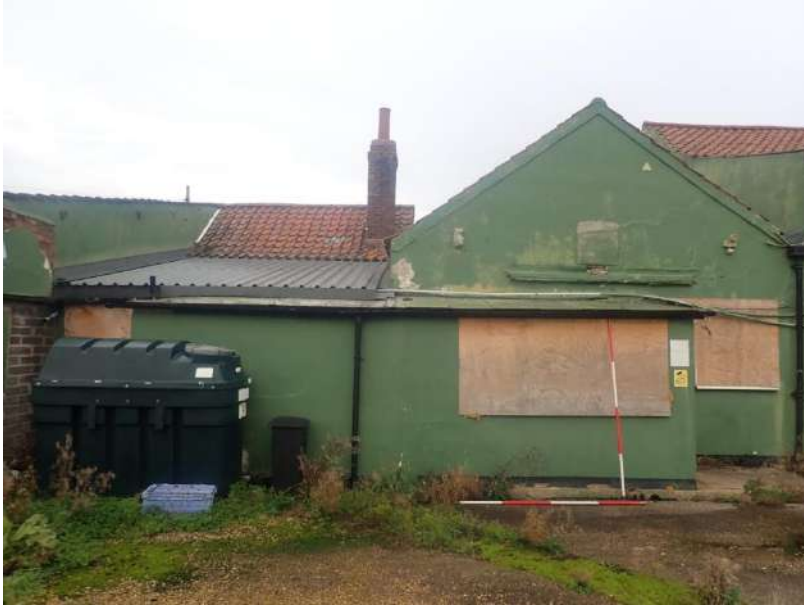
**Plate 279: View of the South Elevation of Building 3, from the south-east**

**Plates 279 and 281** present detailed views of the South Elevation of **Building 3**. The entire wall fabric of this Elevation has been covered over with a modern cement rendering. At ground floor levels is a boarded up south facing window opening. At mid levels are the remains of a former external canopy. It may also be observed that this building is bonded to **Building 4** to the south-west and south.

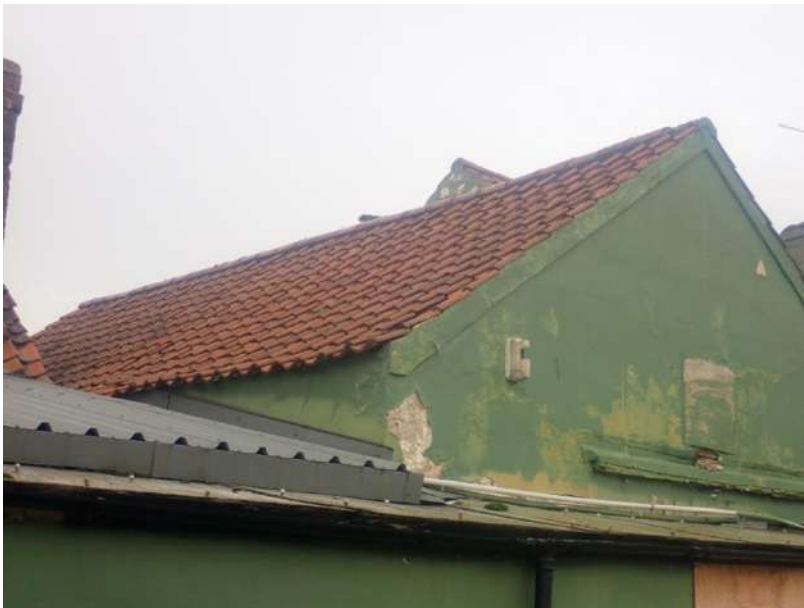
**Plate 280: View of Building 3, from the south-west**

**Plates 280** presents a view of a small visible portion of the West Elevation of **Building 3**, which has been covered with the same modern cement rendering and also shows the gabled roof of this building with its roof covering of red pantiles.

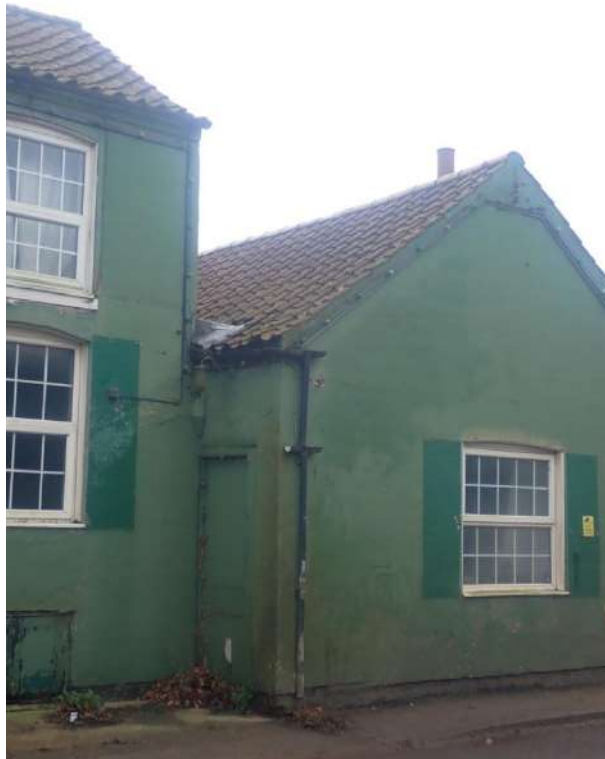
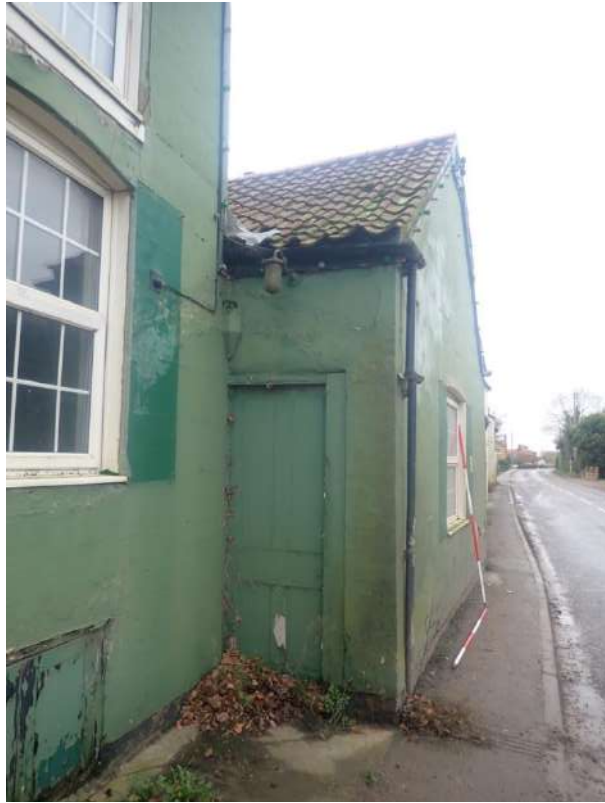
**Plates 282 and 283** show the northern end of **Building 3** and in particular the small visible portion of the East Elevation of this building, which has been covered with the same modern cement rendering. Also of particular note is the partially blocked off east facing entrance opening, which is occupied by a timber frame of a head and surrounds and by a panelled timber door. At just below roof levels is modern horizontal Upvc guttering, which extends on to modern vertical Upvc downpipe.

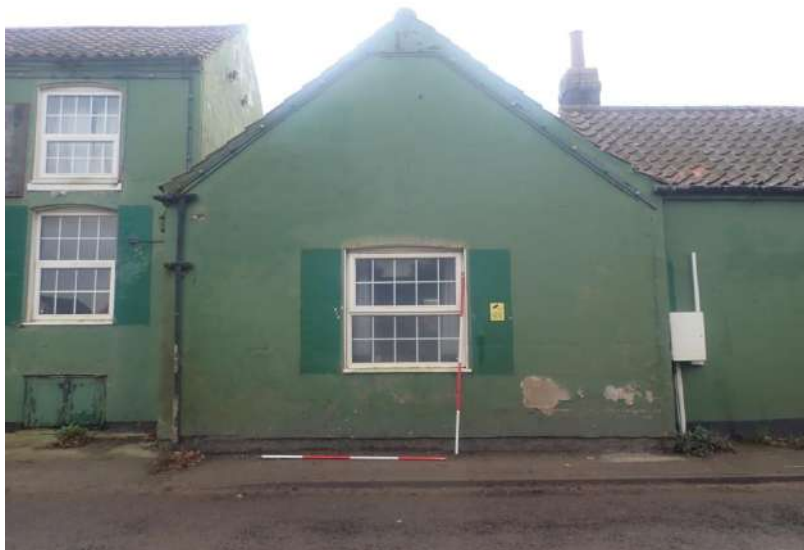
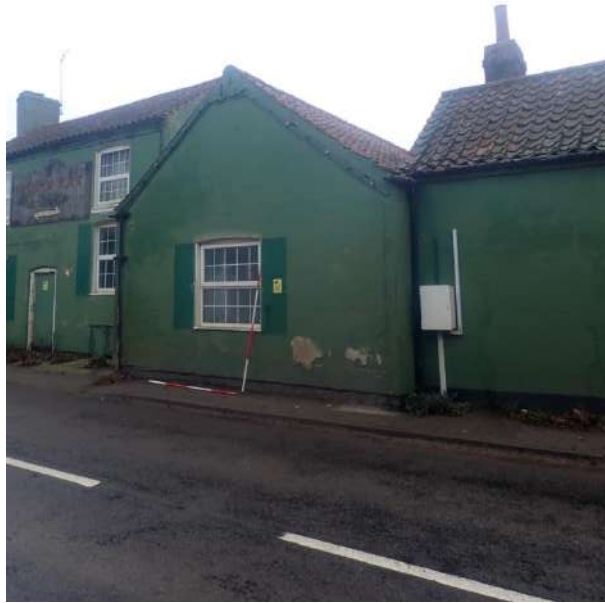
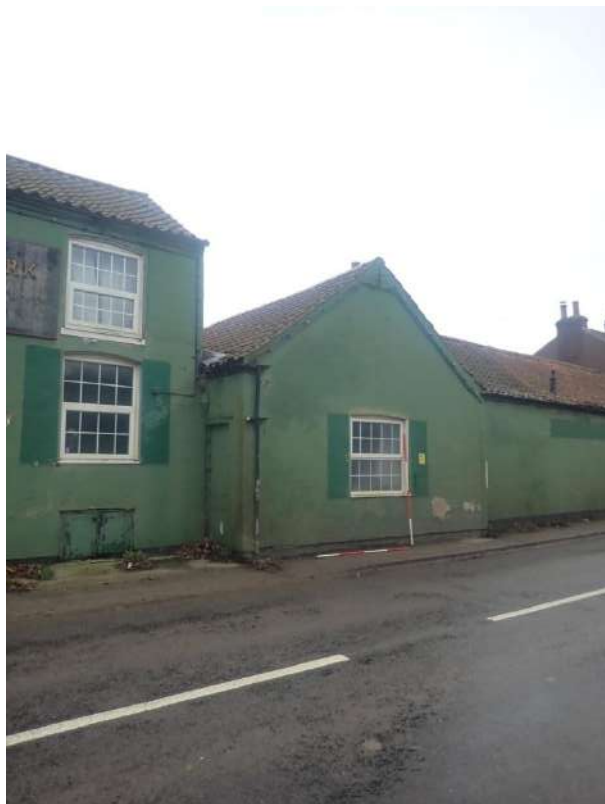
**Plates 284-286** present several views of the North Elevation of **Building 3**. Here also, the entire wall fabric of this Elevation has been covered over with the same modern cement rendering. Also featured is a north facing ground floor window opening, which is probably an original feature and which is occupied by a modern glazed Upvc window.

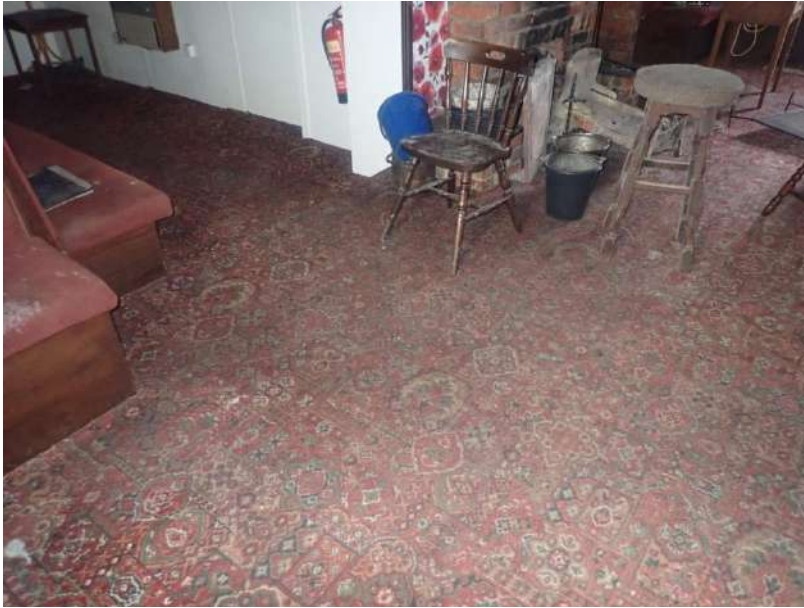
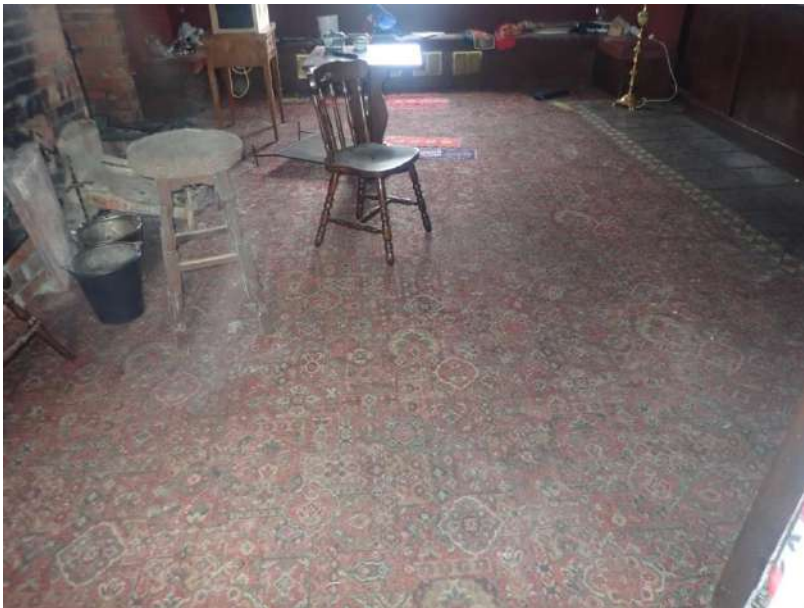
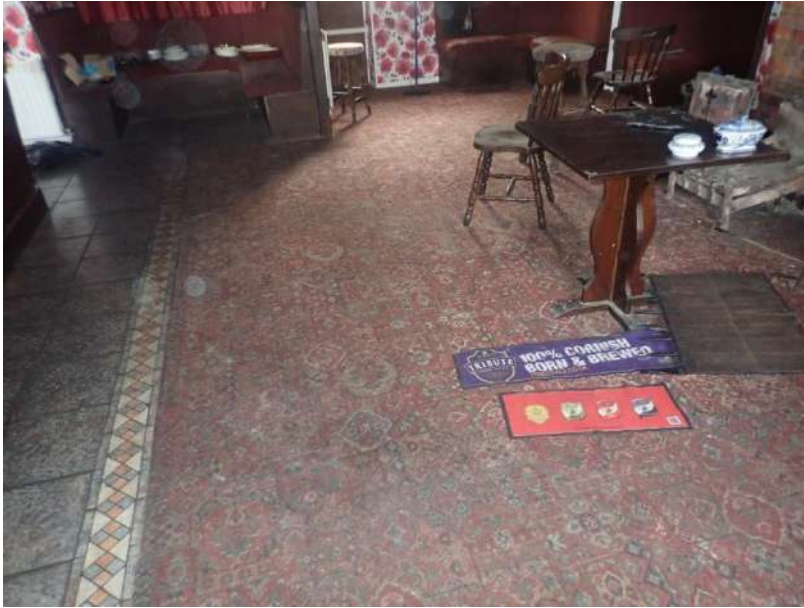
**Plates 290 and 291** furnish several images of the flooring of **Cell 15**, which has been covered with modern carpeting. A series of modern ceramic floor tiles occur at the public bar area.

**Plates 295-297** feature further views of the nature of the flooring of **Cell 15**.

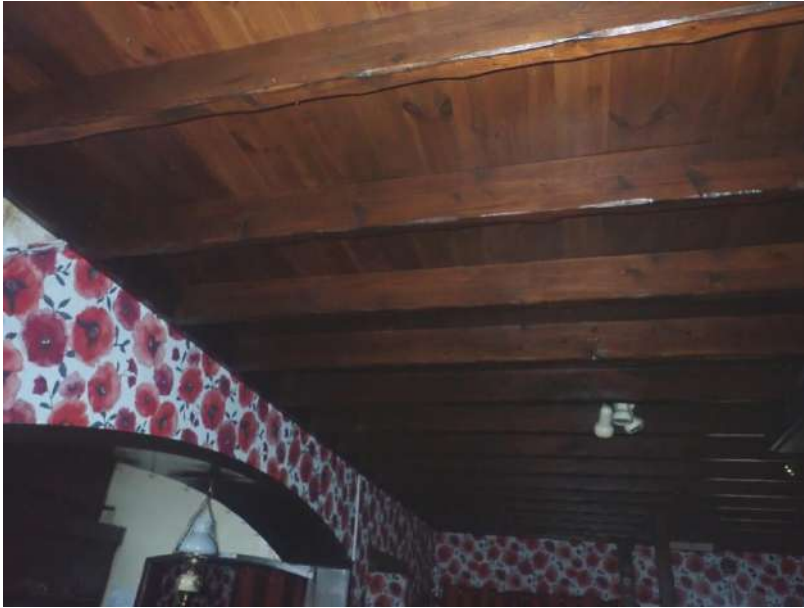
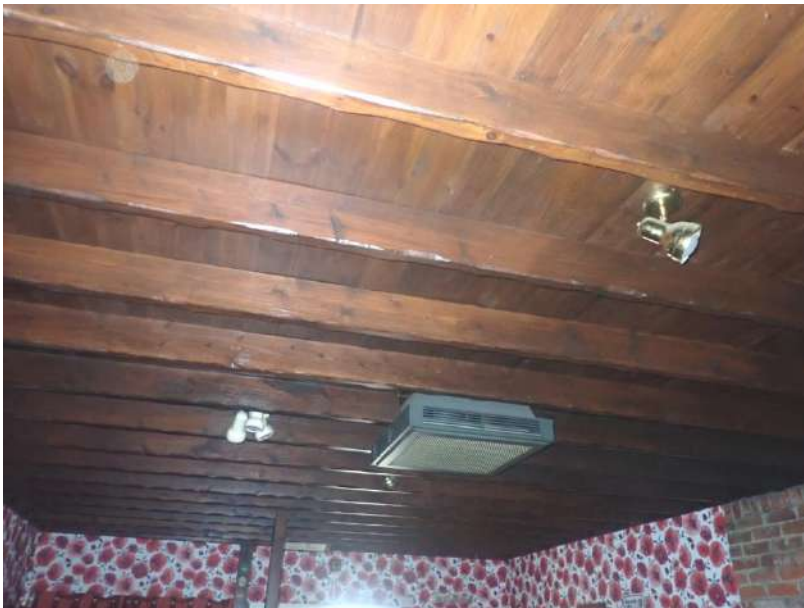
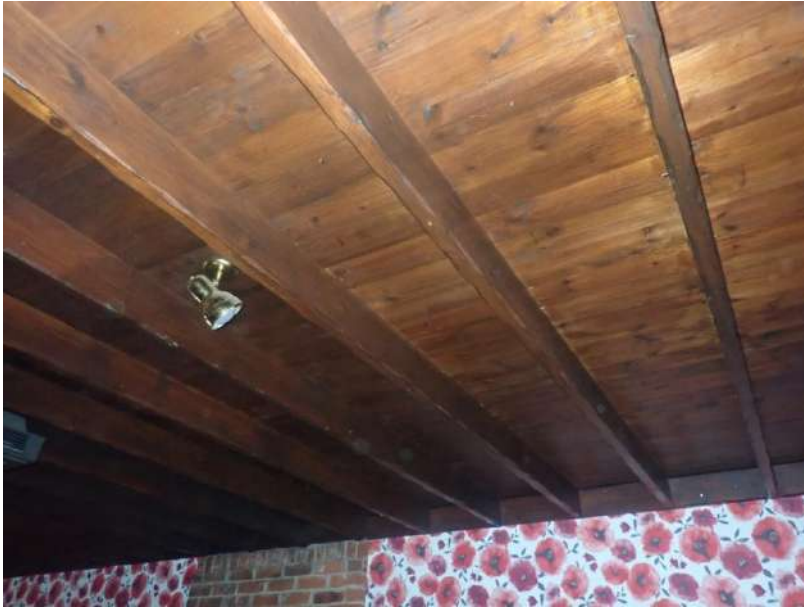
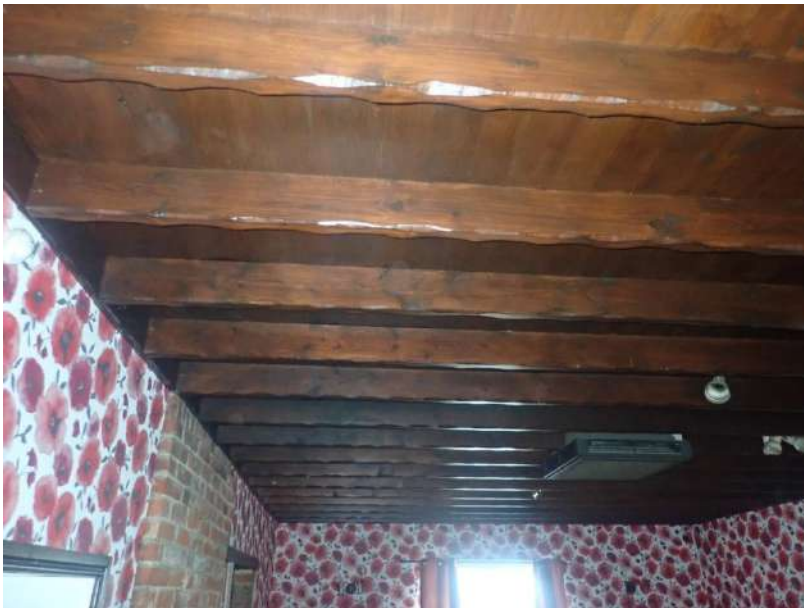
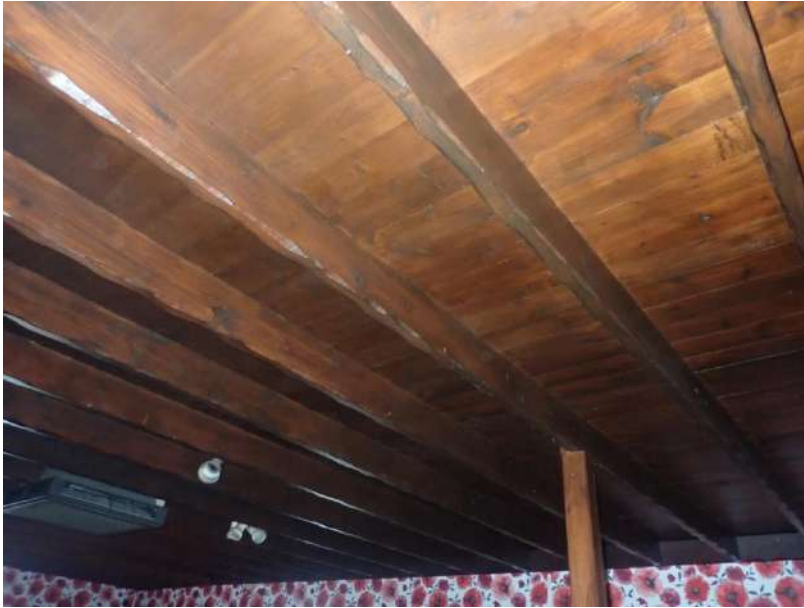
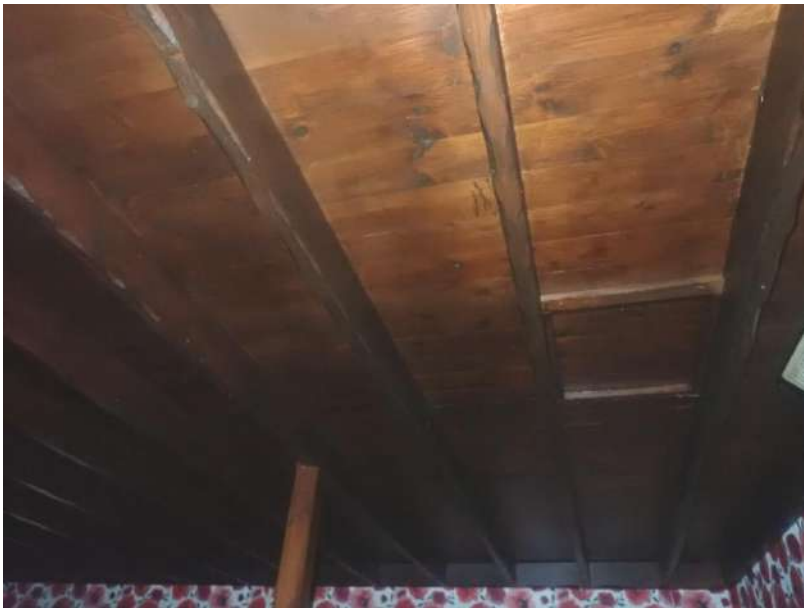
**Plates 298-303** provide a number of views from differing vantage points of the nature of the ceiling structure of **Cell 15**. This consists of a series of east-west orientated and moulded horizontal timber joists. These provide support to the first floor, floor covering of horizontal timber planking, which are on a different north-south alignment.

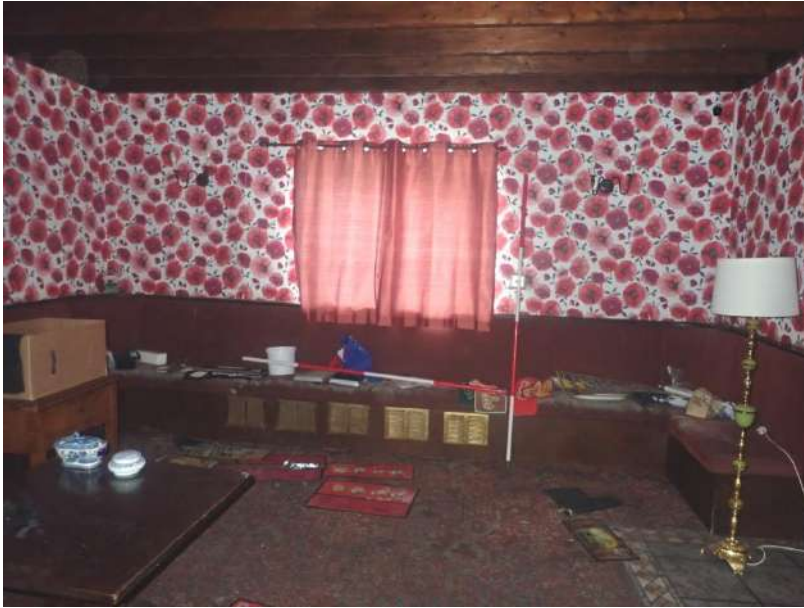
**Plate 304: View of the north wall of Cell 15, from the south-east**

**Plate 304** presents a view of the north wall of **Cell 15**. This has been covered with modern wallpaper. The lower levels have modern timber panelling attached to the wall fabric along with modern soft furnishings/seating. Also featured is the inner face of the ground floor north facing window opening that was recorded externally at the North Elevation of this building.

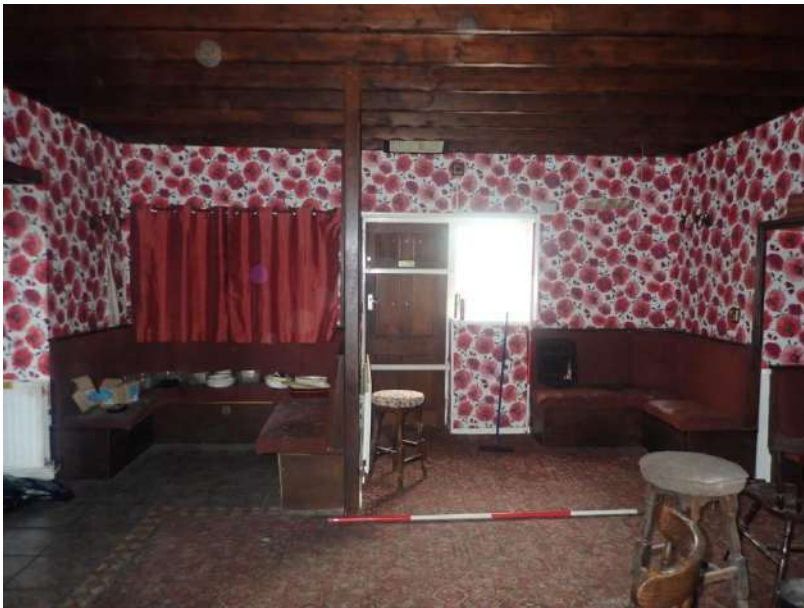
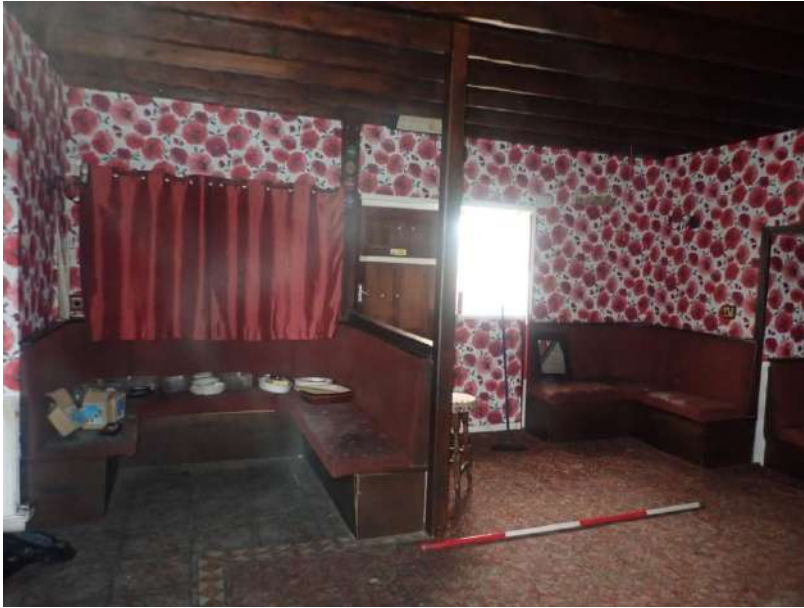
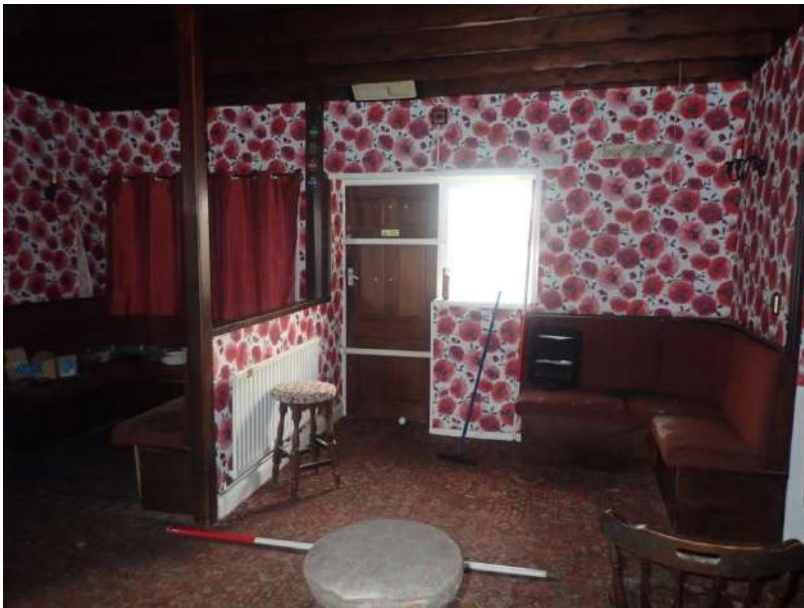
**Plates 305-307** present several views of the south wall of **Cell 15**. This has been covered with modern wallpaper. The lower levels have modern timber panelling attached to the wall fabric along with modern soft furnishings/seating. Horizontal timber skirting boards occur at its base. Also featured is the inner face of a south facing ground floor window opening that was recorded externally at the South Elevation of this building. A low partition bisects the seating here. At the northern end of the partition is a vertical timber which extends upwards to the ceiling. To the right (west), are the inner faces of a south facing entrance opening that is occupied by a timber frame of a head and surrounds and a modern panelled timber door along with the inner face of an adjacent south facing window opening with a timber window frame of a head and surrounds and a modern glazed timber casement window. Both openings were originally external, but are now within the interior of **Building 4**.

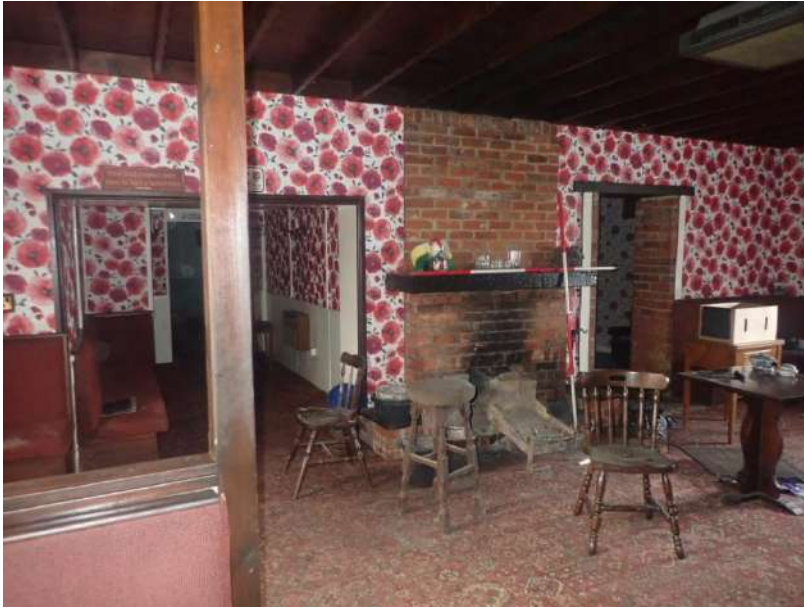
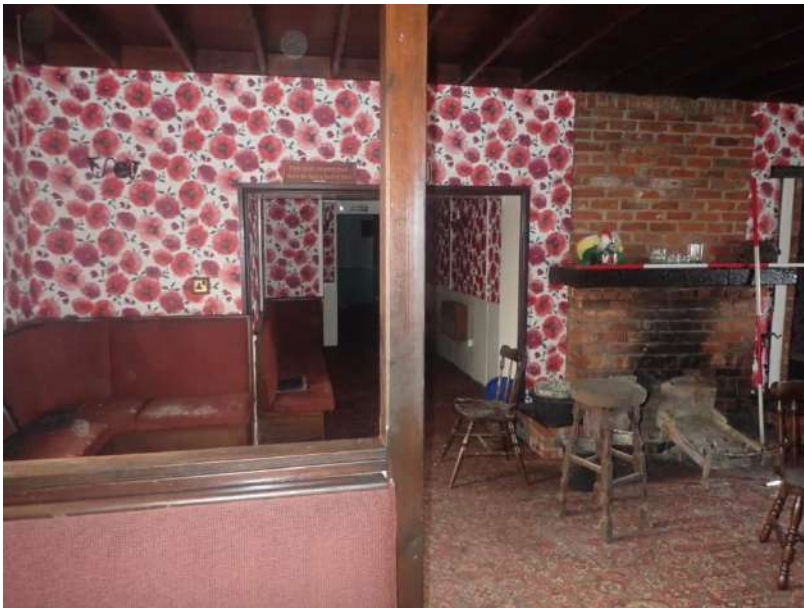
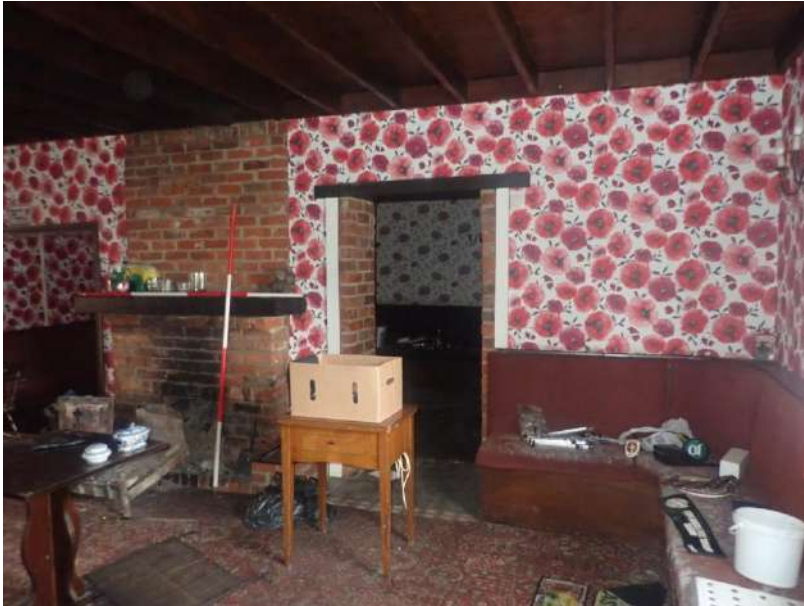
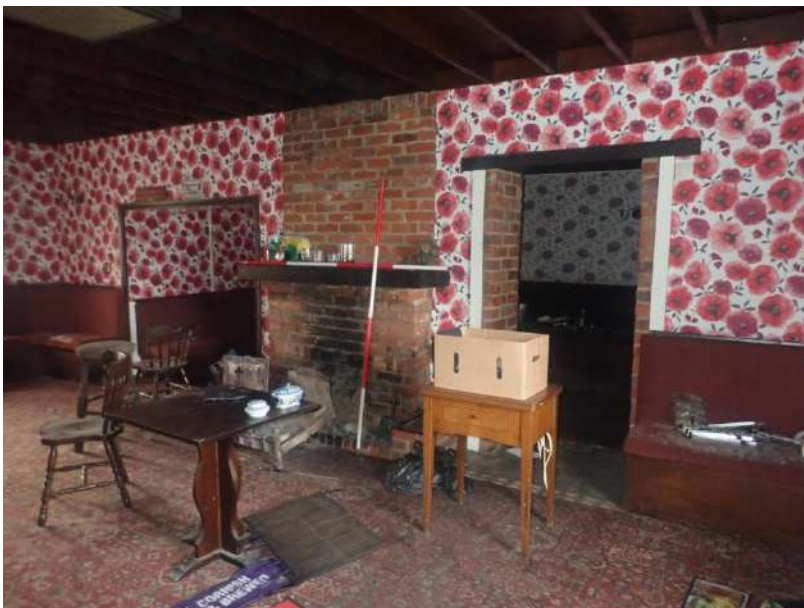
**Plates 308-311** present a number of views of the west wall of **Cell 15**, much of which is covered with wallpaper. This is also the internal dividing wall with the adjoining **Cells 16-18**. At the northern and southern ends are further modern soft furnishings/seating at the lower levels. The central feature of this west wall is the vertical brick fireplace backing. The brickwork here is composed of courses of brick stretchers in Stretcher Bond. At the base of the fireplace backing is a fireplace/surround with a brickwork base atopped with timber to either side. To the right (north), is an open west facing access into the adjoining **Cell 18** of **Building 5**. This opening is flanked to either side with brickwork in Stretcher Bond and above the opening is an horizontal timber lintel which is inserted into the fabric of the west wall. To the left (south), is a second open access that extends onto the adjoining **Cell 16** of **Building 4**. This further west facing opening is occupied by a wide timber frame of a head, surrounds and architrave.

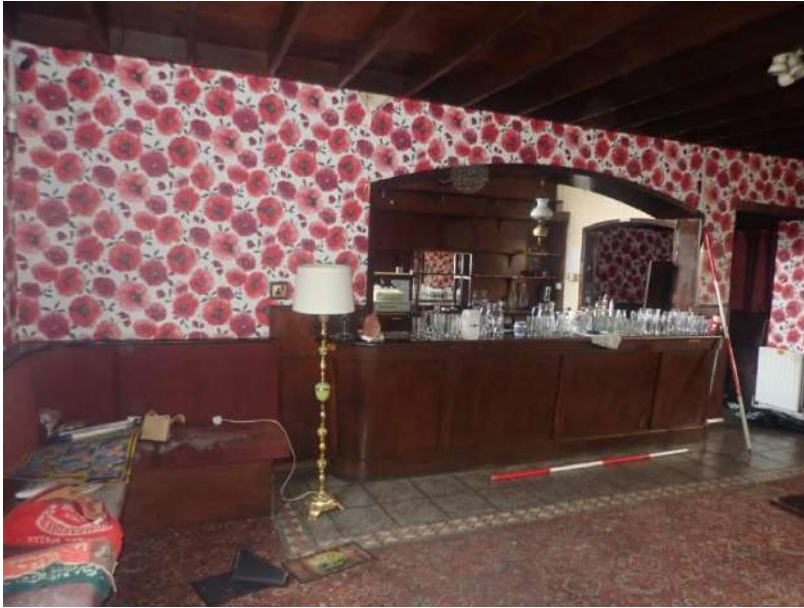
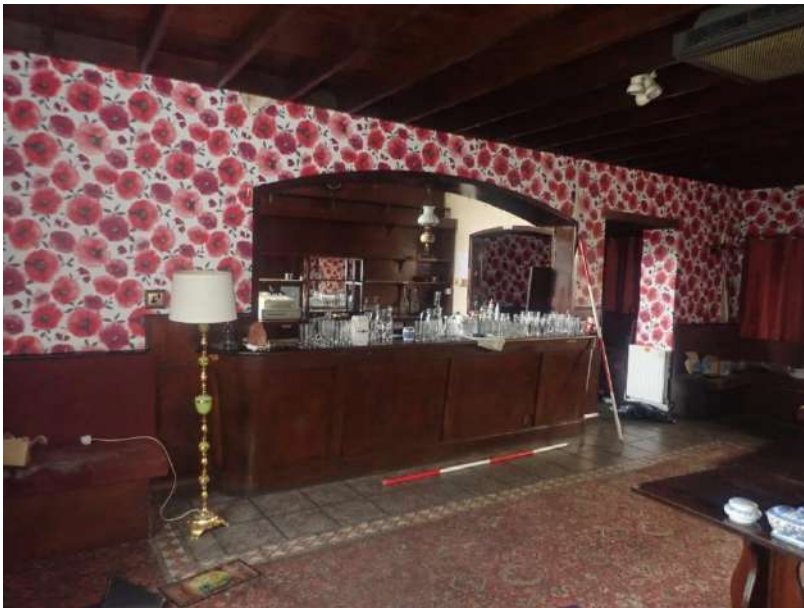
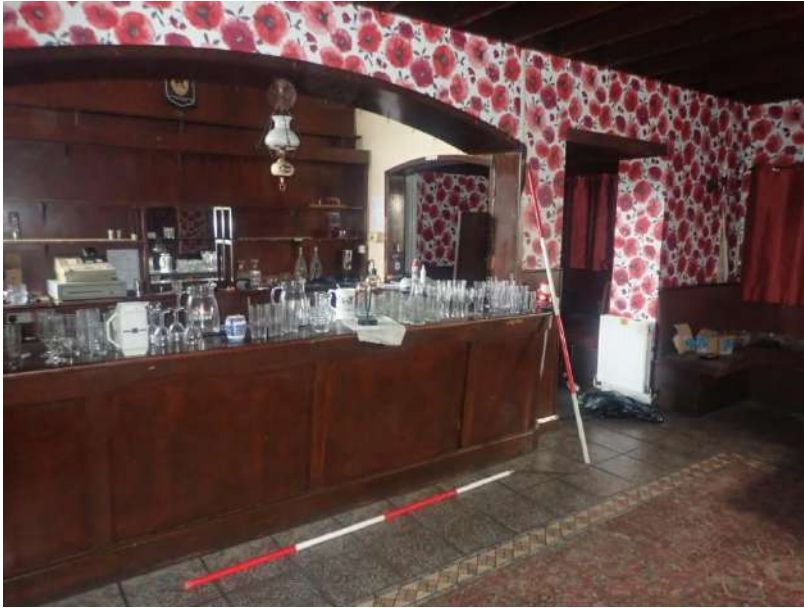
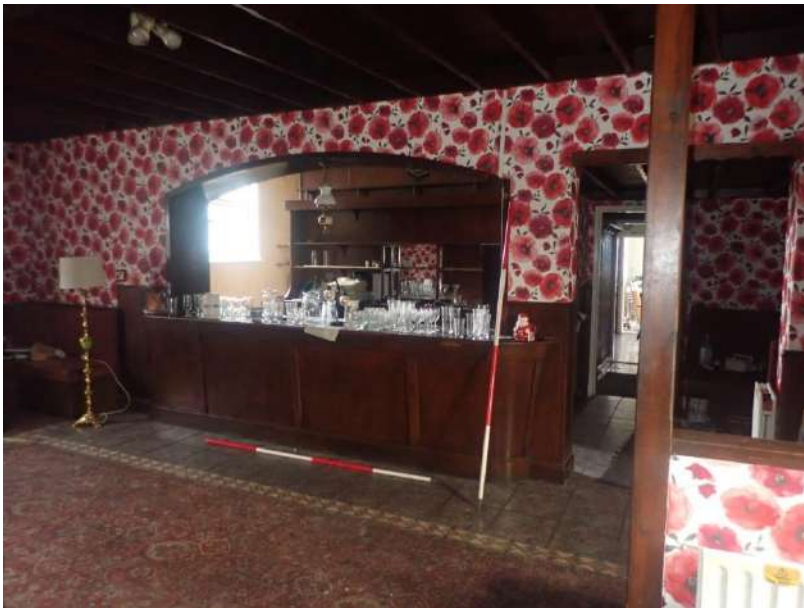
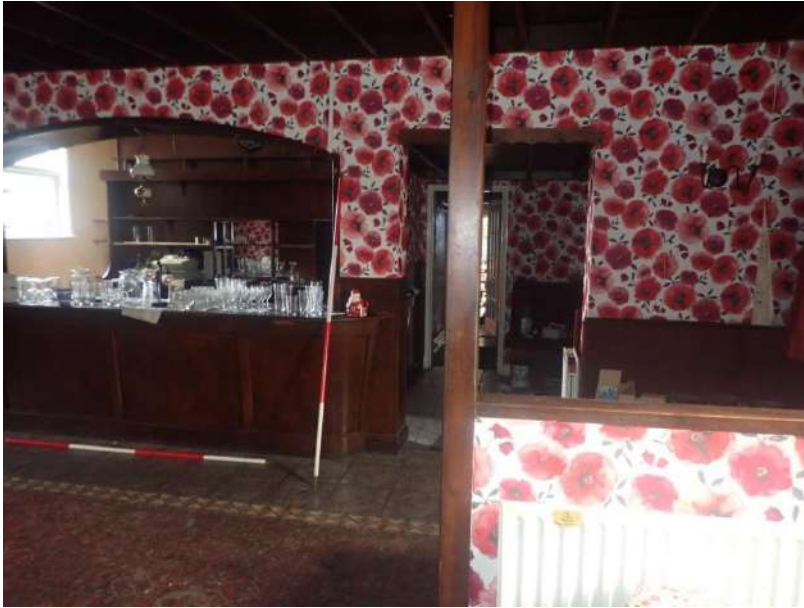
**Plates 312-316** furnish a number of views of the east wall of **Cell 15**, which also houses the front face of the public bar with its vertical timber panelling and timber counter top. The bar opening itself is edged with vertical timbers to either side with a curved head also in timber. The remainder of this east wall, which is also the internal dividing wall with the adjoining **Cell 6** to the east, has been covered with modern wallpaper with modern soft furnishings/seating at the lower levels. To the right (south), is the east facing open access that leads onto the adjoining **Cell 5** to the east. Above this opening is an horizontal timber lintel which is inserted into the fabric of the east wall.
