HISTORIC BUILDING RECORDING AT THE  
FORMER DUKE OF YORK PUBLIC HOUSE,  
106, RISEGATE ROAD,  
GOSBERTON RISEGATE, LINCOLNSHIRE

**National Grid Reference: TF 2186 3004**  
**Planning Reference: H08-0964-21**  
**Site Code: RRGR22**  
**Accession Number: LCNCC: 2022.147**

PREPARED FOR MRS. S. GOODENOUGH

January 2023

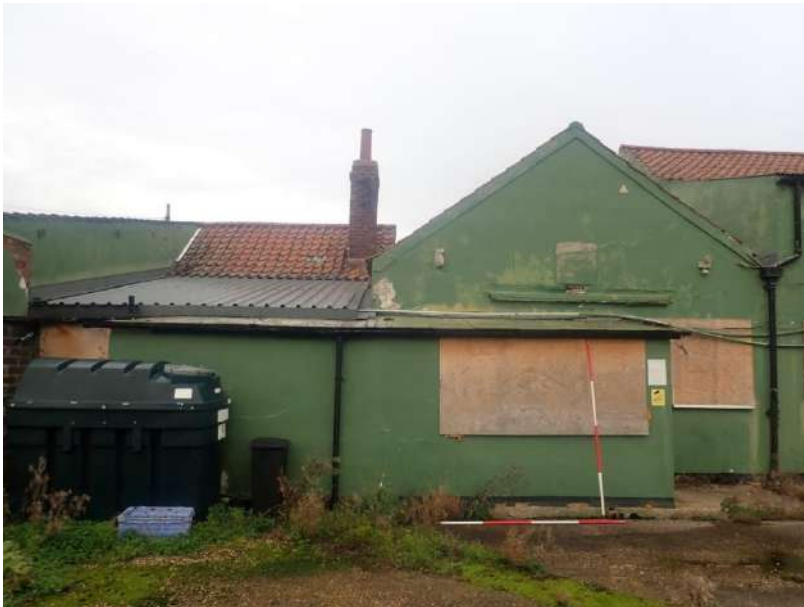
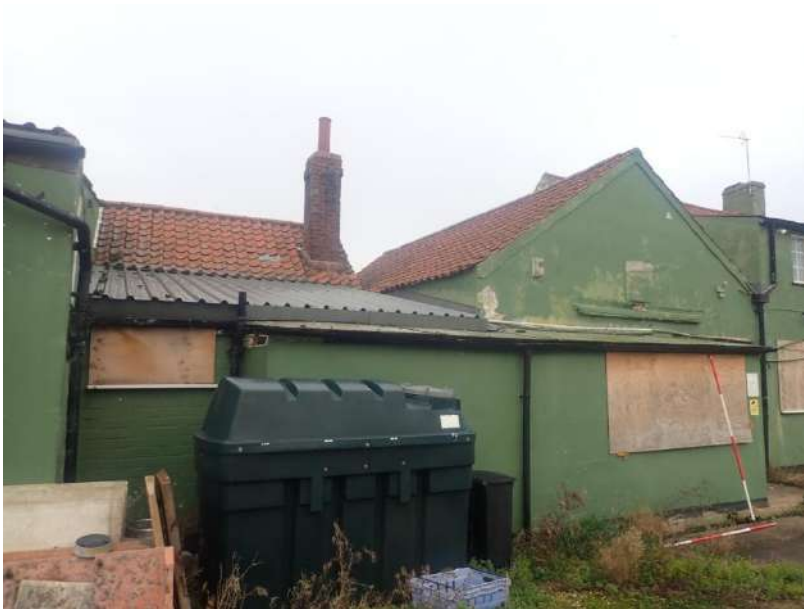
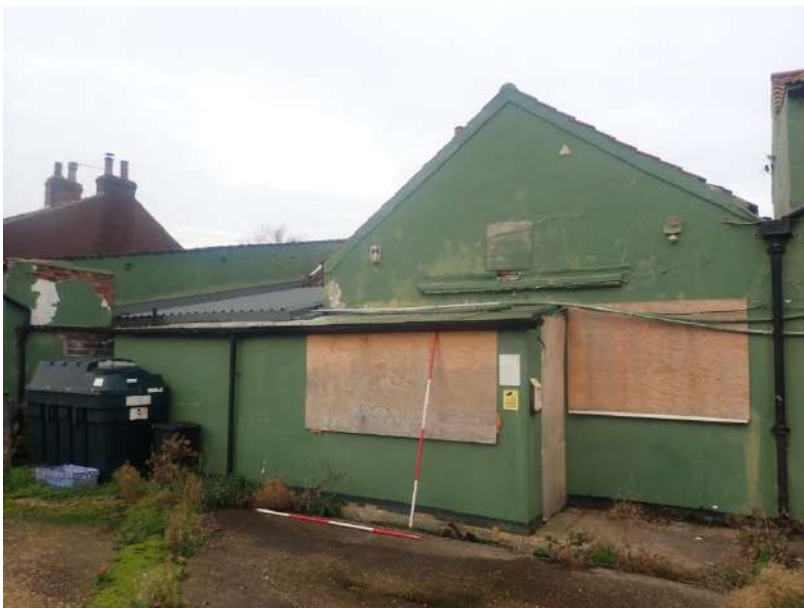
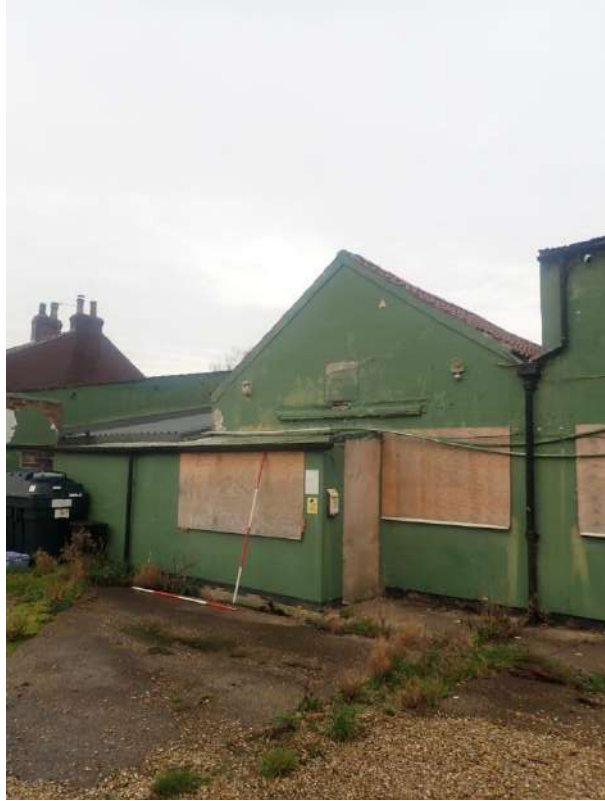
**Plates 317-320** present several views from various southern positions of the South Elevation and a small section of the East Elevation of this building. **Building 4** is bonded to **Building 3** to the east and north-east, to **Building 5** to the north and to **Building 6** to the west. **Building 4** would appear to be a modern addition to this public house complex. It is of one storey in height and possesses a low angled half gabled roof with a mix of roof coverings of corrugated metal sheeting and of corrugated plastic roof sheeting. The entire wall fabric of these Elevations has been covered over with modern cement rendering. At just below roof levels is modern horizontal Upvc guttering that extends onto a slightly off centre vertical modern Upvc downpipe. Also featured are two south facing window openings, both of which have been entirely boarded over. Within the small section of the East Elevation is a boarded up east facing entrance opening.

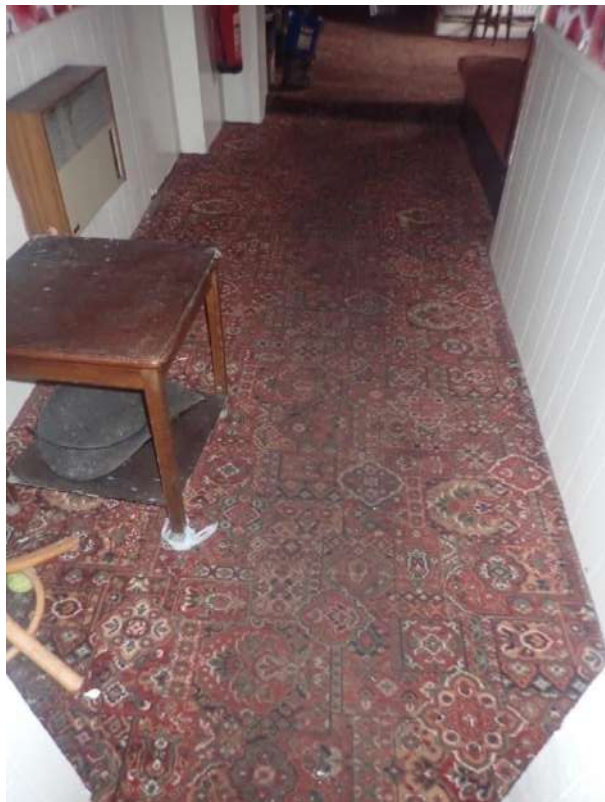
**Plate 323: View of the flooring of Cell 16, from the south-west**

**Plate 323** features the flooring of **Cell 16**, which is covered with modern carpeting.

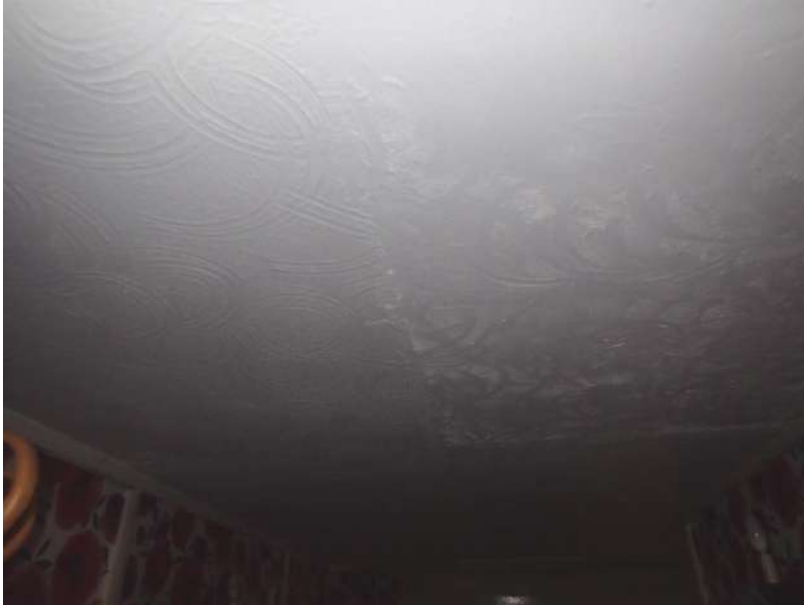
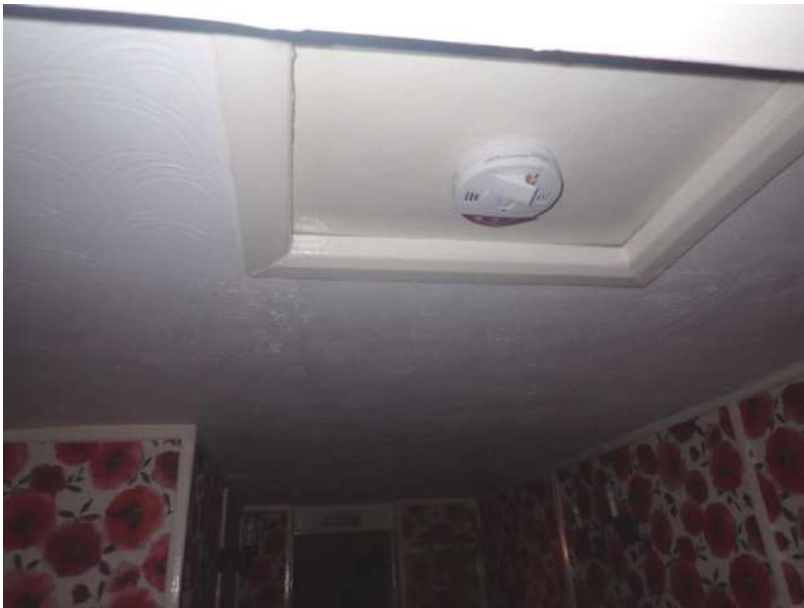
**Plates 324-325** provide views of the nature of the ceiling structure of **Cell 16**, which has been rendered over with plasterwork. **Plate 320** also features a small timber hatch, which provided access into the roof space of **Building 4**.

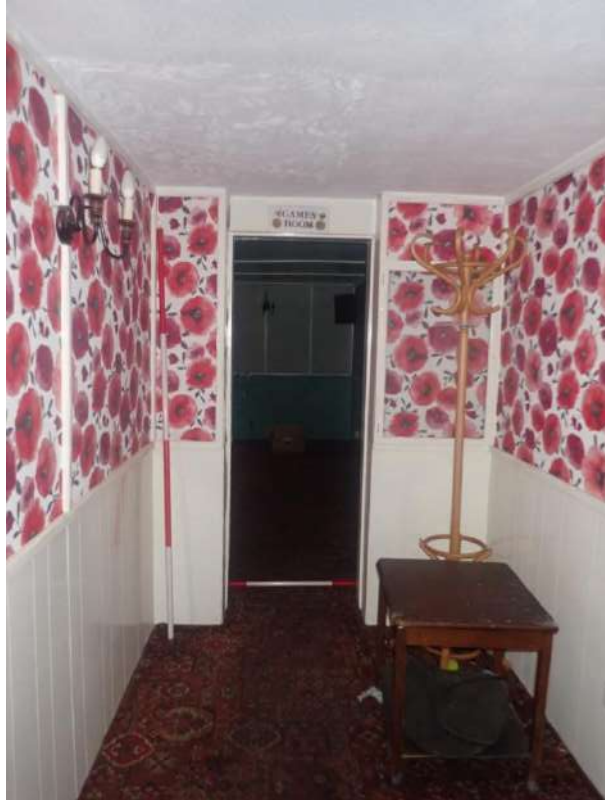
**Plate 326: View of the west wall of Cell 16, from the north-east**

**Plate 326** furnishes a detailed view of the west wall of **Cell 16**. Most of the wall fabric has been covered over with modern wallpaper within a framework of vertical and horizontal timbers, whilst the lower levels of the wall have timber panelling. The central feature of this west wall is the west facing entrance opening, which extends onto a former games room or **Cell 24** and the interior of **Building 6**. This opening is occupied by a timber frame of a head and surrounds.

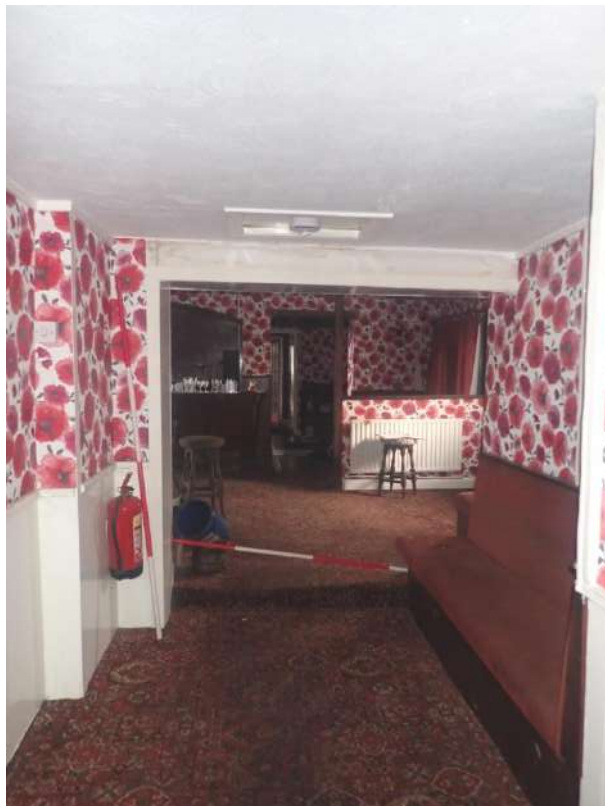
**Plate 327: View of the eastern end of Cell 16, from the south-west**

**Plate 327** features the eastern end of **Cell 16**, with its open access into the interior of **Cell 15** to the east or the former public lounge bar of the public house. This image shows the inner face of the access opening, which is contained within a wide timber frame of a head and one surround. To the left (north) is a small section of walling, which has been covered with modern wallpaper with timber panelling at its lower levels.

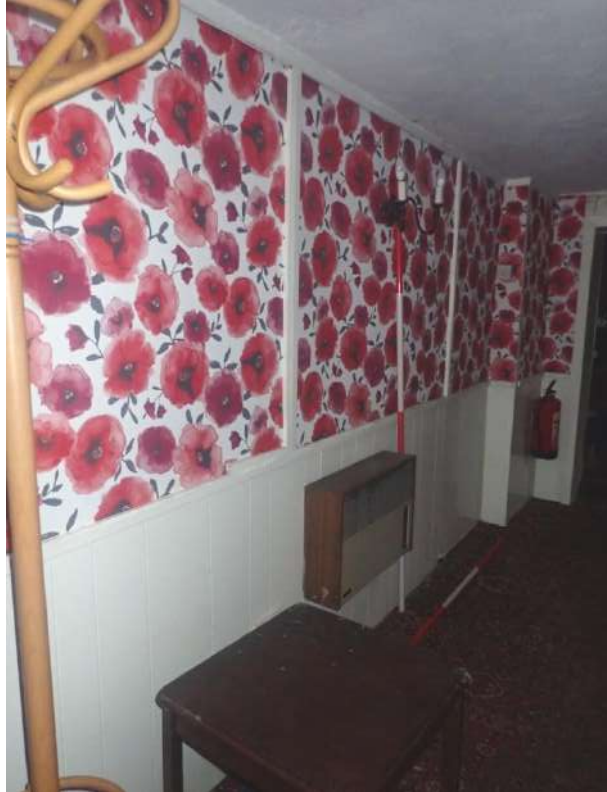
**Plate 328: View of the north wall of Cell 16, from the south-west**

**Plate 328** provides a view of the north wall of **Cell 16**, much of which has been covered with modern wallpaper within a framework of vertical and horizontal timbers, whilst the lower levels of the wall have timber panelling.

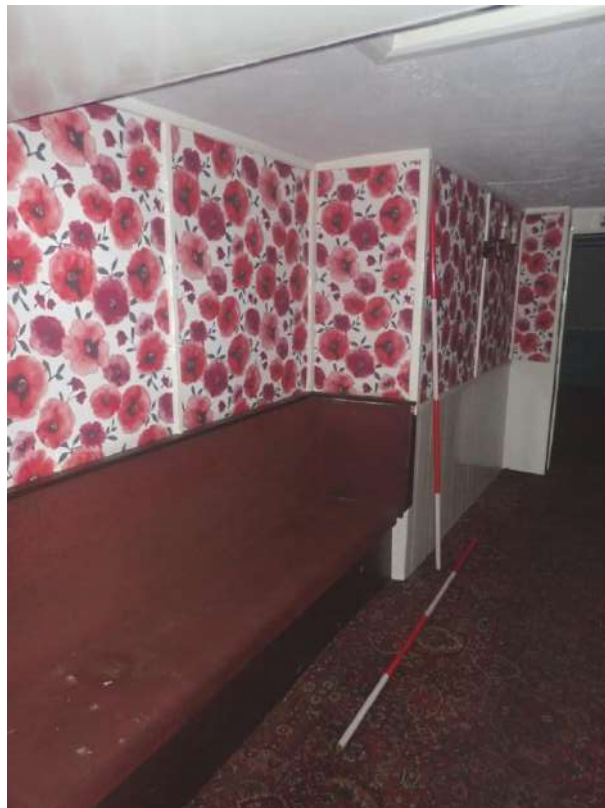
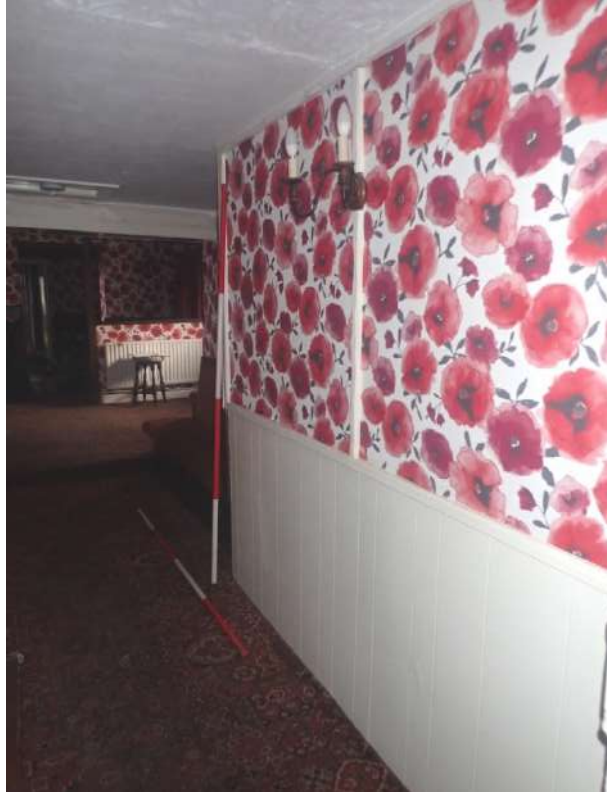
**Plates 329 and 330** show the south wall of **Cell 16**, which is dog-legged. Much of this north wall has been covered with modern wallpaper within a framework of vertical and horizontal timbers, whilst the lower levels of the wall have timber panelling. To the east is further modern soft furnishings/seating.

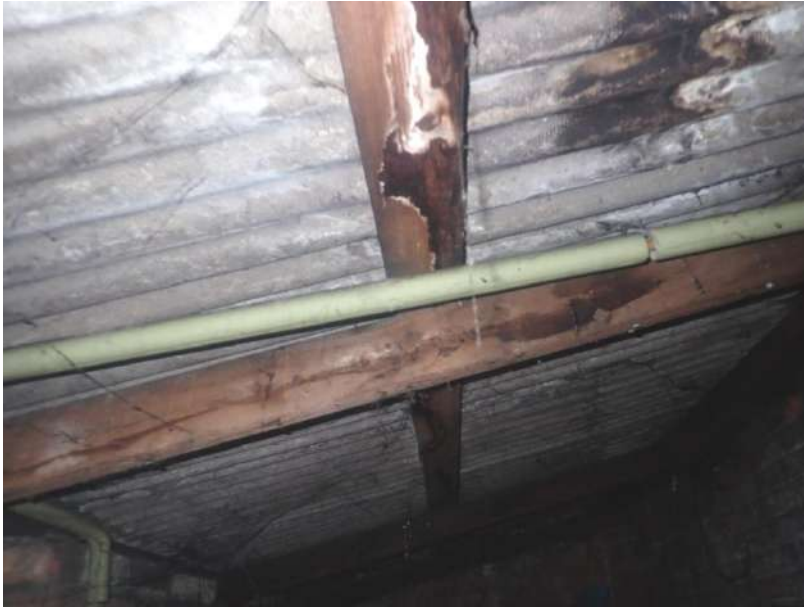
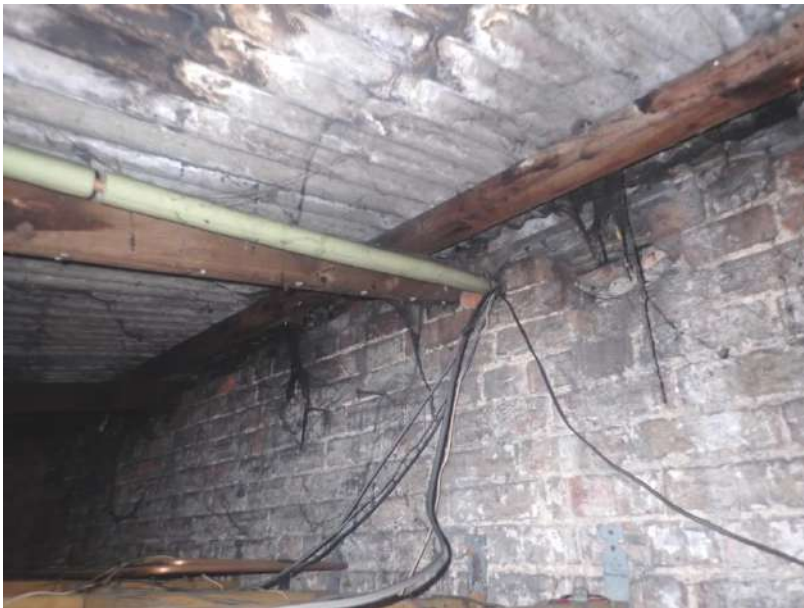
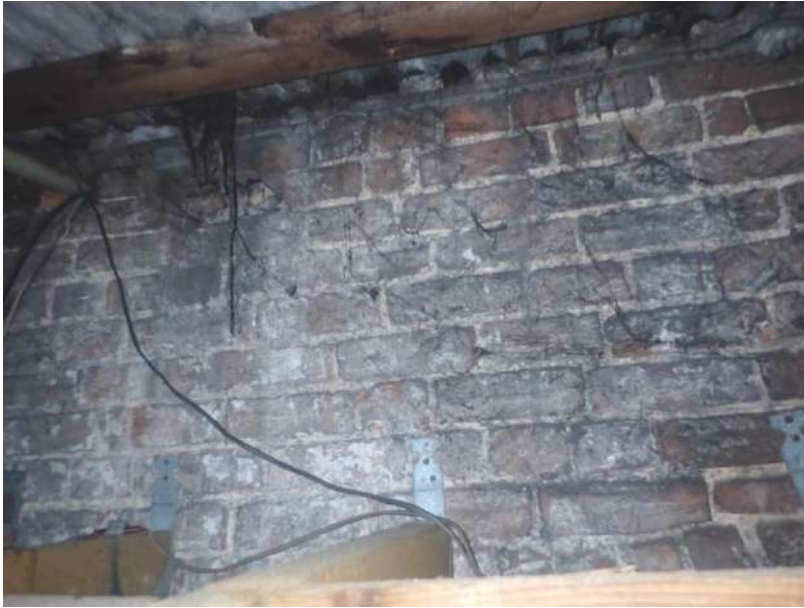
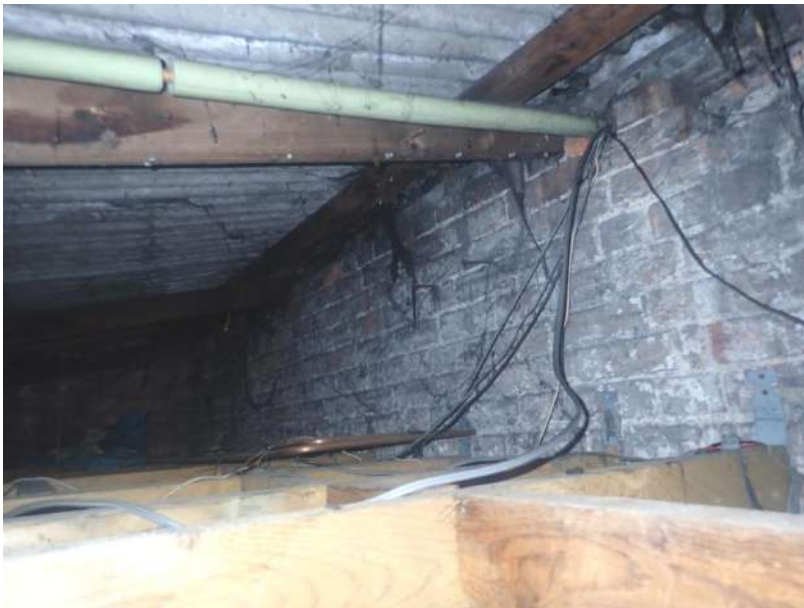
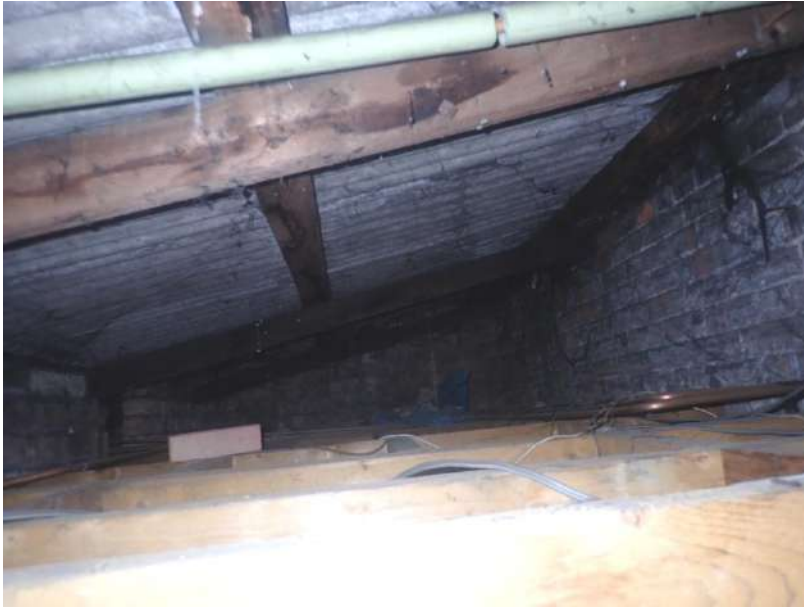
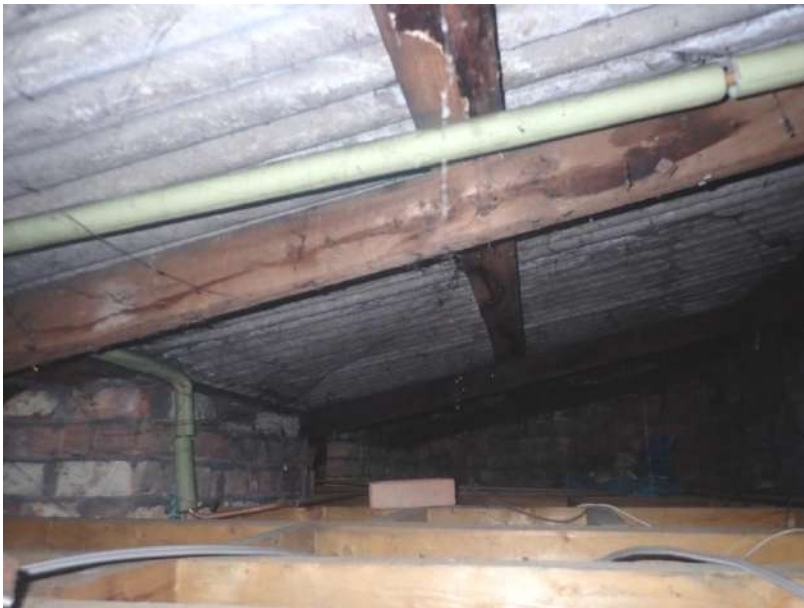
**Plates 331-336** present a number of views of the roof space above **Cell 16**. This is a relatively simple timber framework of north-south orientated angled timber rafters and east-west aligned horizontal timber purlins to which is attached the roof covering of sheets of corrugated metal. Of particular note is the exposed brickwork wall fabric to the north, which is part of the upper levels of the South Elevation of the adjoining **Building 5**. The northern ends of the timber rafters of this roof structure are inserted into this wall fabric, which is mostly composed of courses of brick stretchers and of further courses of mixed brick headers and brick stretchers.

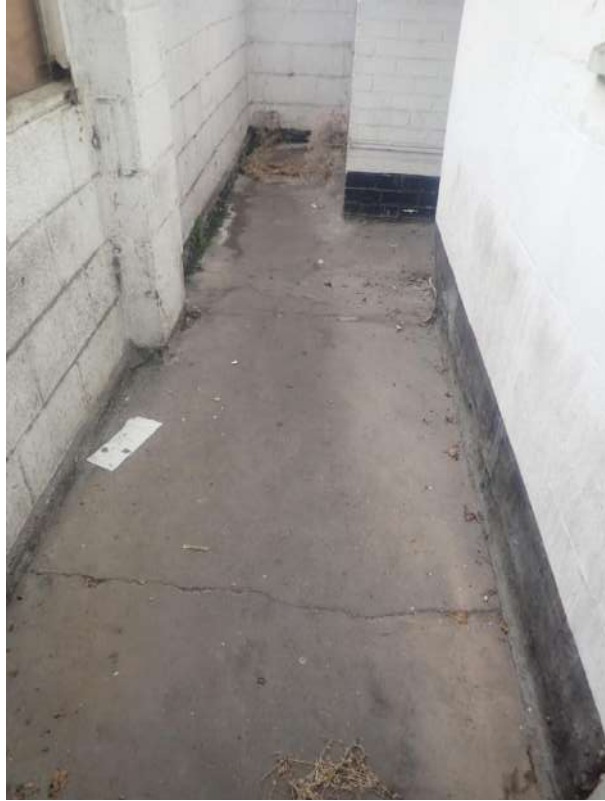
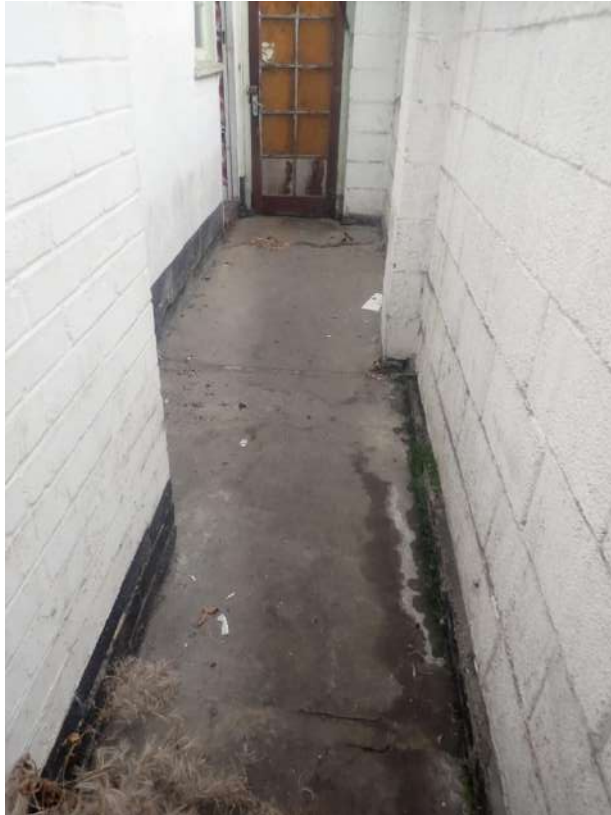
**Plates 337 and 340** feature the nature of the flooring of the Corridor, which is of modern concrete.

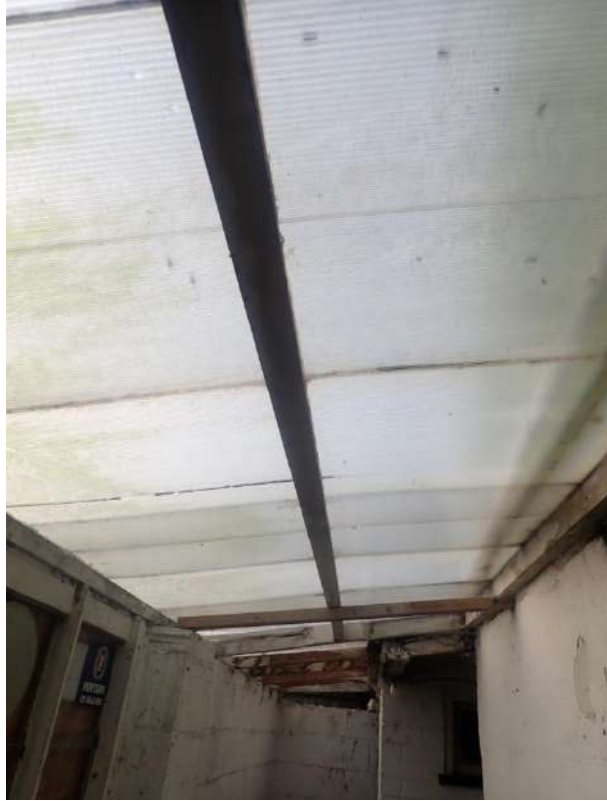
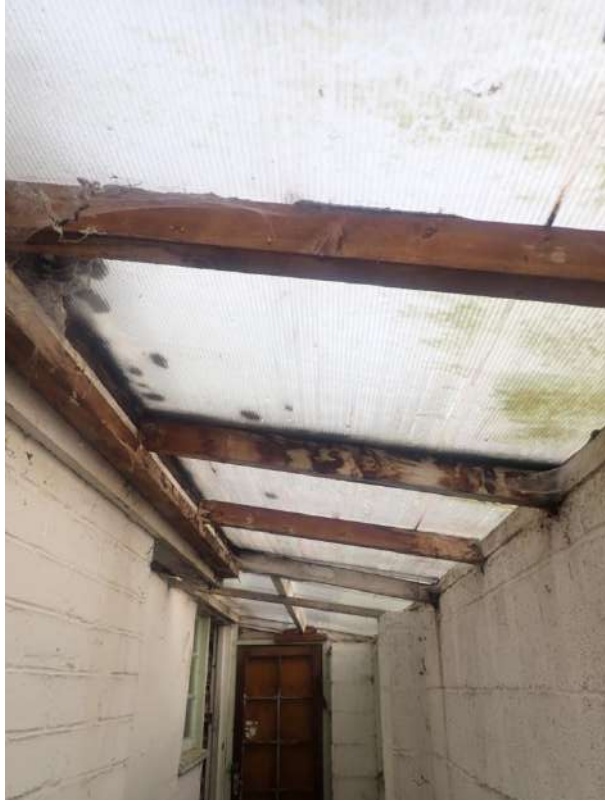
**Plates 338 and 342** feature the nature of the roofing structure of the Corridor, which is composed of modern plastic sheeting attached to a framework of low angled timber rafters and horizontal timber purlins.

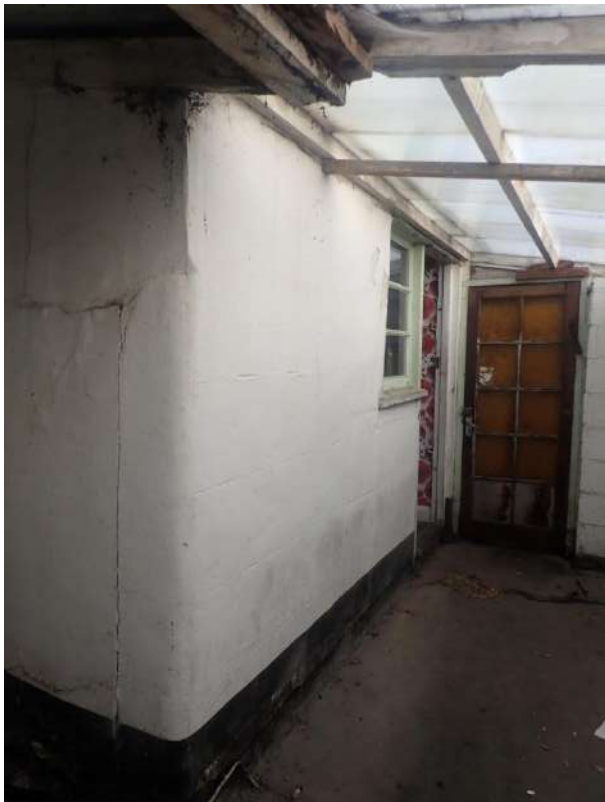
**Plate 343: View of the north wall of the Corridor leading to Cell 17, from the south-west**

**Plate 343** features a portion of the north wall of the Corridor. This is also part of the former external South Elevation to **Building 3**. This is probably constructed of brickwork, which has been covered over with modern cement rendering. Also shown is the outer face of south facing ground floor window and entrance openings that were recorded internally within **Cell 15** of **Building 3**.

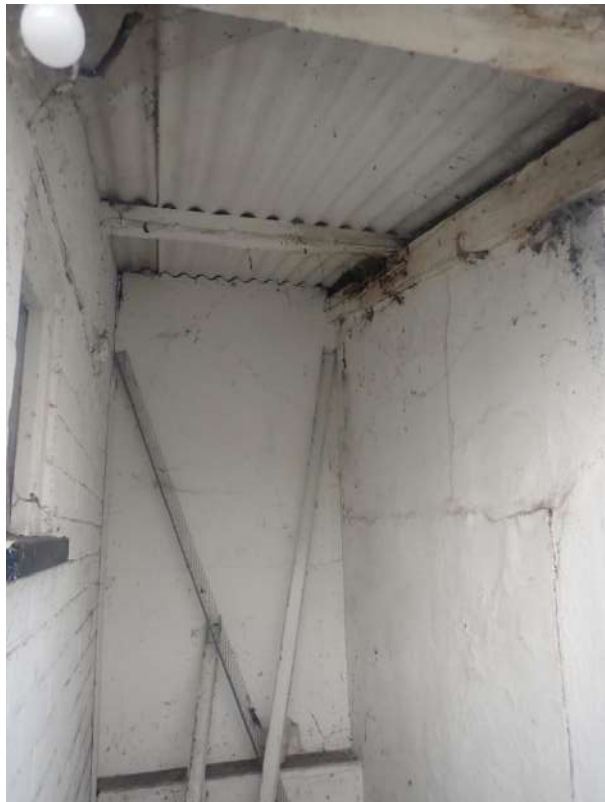
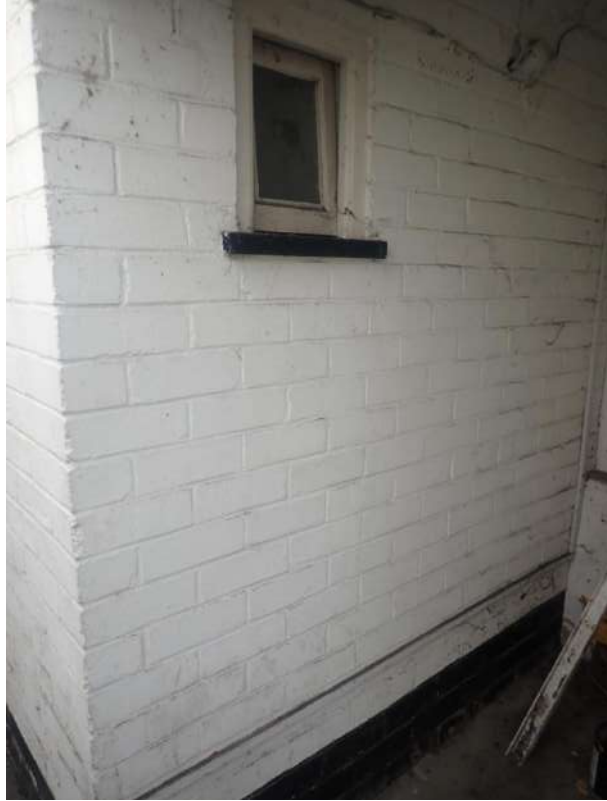
**Plate 344: View of the alcove within the north wall of the Corridor leading to Cell 17, from the south**

**Plates 344 and 345** feature an alcove within the northern side of the Corridor. The eastern face of which is part of the former external West Elevation to **Building 3**. This is also probably constructed of brickwork, which has been covered over with modern cement rendering. Adjoining this, the north face of this alcove is an external face to **Cell 16** of **Building 4**. This is also probably constructed of brickwork, which has also been covered over with modern cement rendering. Above this alcove is a small portion of the low angled half gabled roof structure of **Building 4**, with its roof covering of sheets of corrugated metal that is supported on a timber framework of low angled timber rafters and horizontal timber purlins.

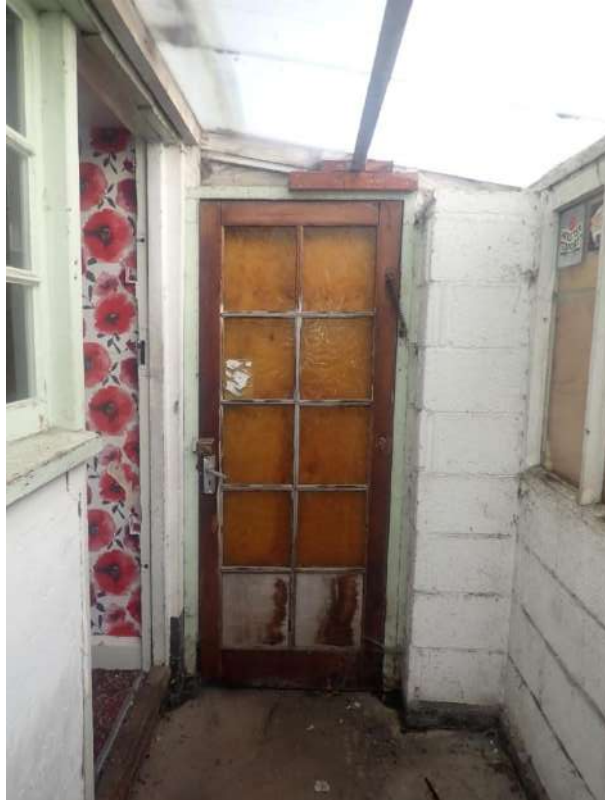
**Plate 349: View of the west wall of the Corridor leading to Cell 17, from the north-east**

**Plate 349** provides a view of the west wall or the western end of the Corridor. The wall fabric here is composed of courses of modern breeze blockwork.

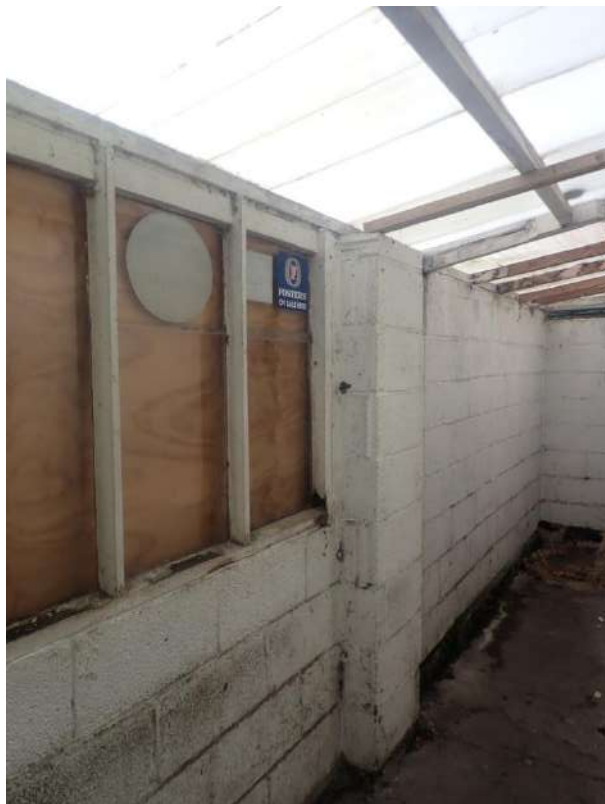
**Plate 350: View of the east wall of the Corridor leading to Cell 17, from the south-west**

**Plate 350** shows the east wall or the eastern end of the Corridor. The wall fabric here is composed of courses of modern breeze blockwork. Also featured is the inner face of the east facing entrance opening that was recorded externally at the East Elevation of this building and which is boarded over. This inner face is occupied by a timber frame of a head and surrounds and by an unglazed modern glass panelled timber door.

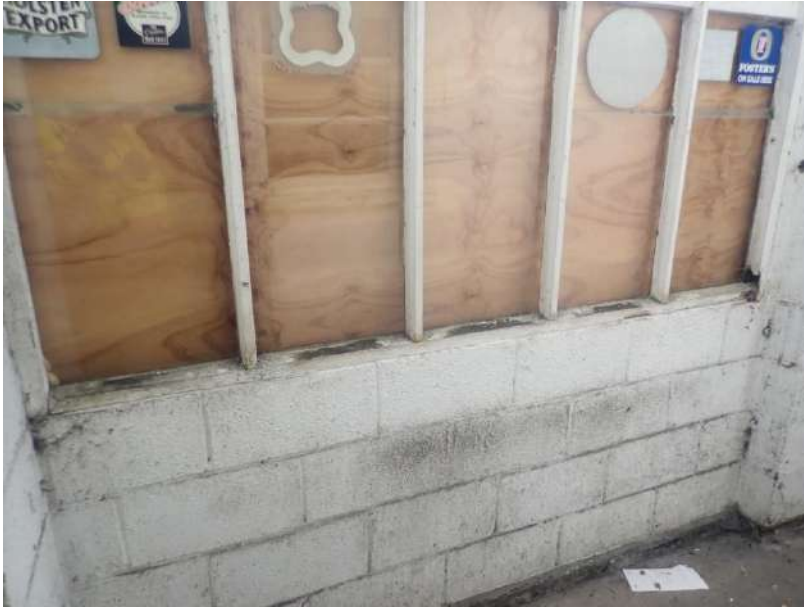
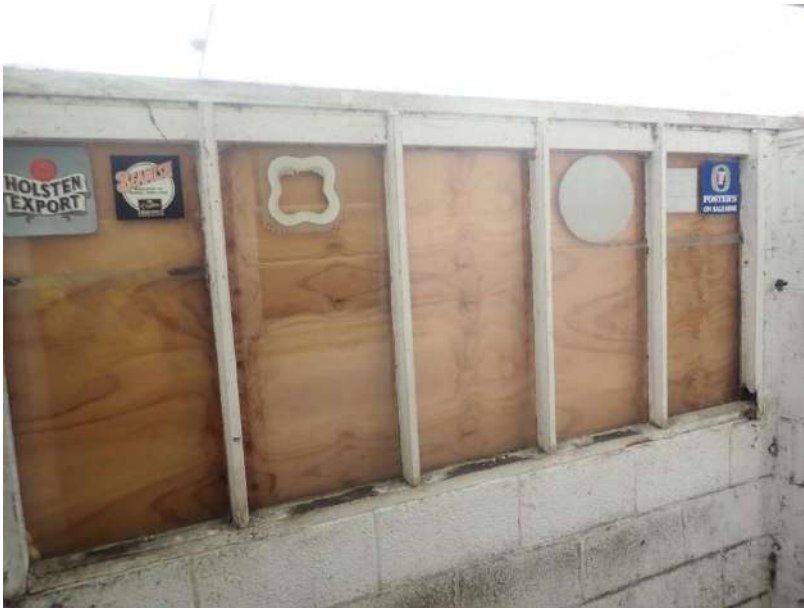
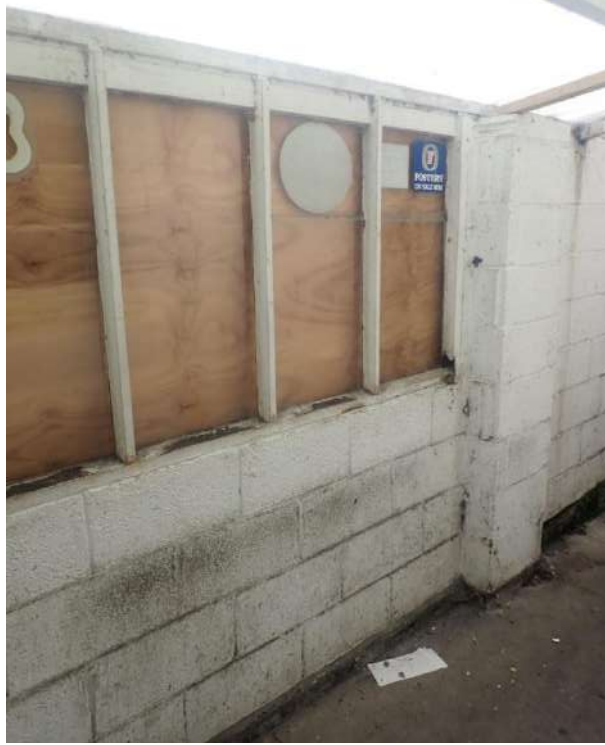
**Plate 351: View of the south wall of the Corridor leading to Cell 17, from the north-east**

**Plates 351-354** furnish several images of the south wall of the Corridor, the wall fabric of which is composed of courses of modern breeze blockwork. Also featured is the inner face of a south

facing window opening that was recorded externally at the South Elevation of this building, and which is boarded over. This is a modern glazed timber casement window.

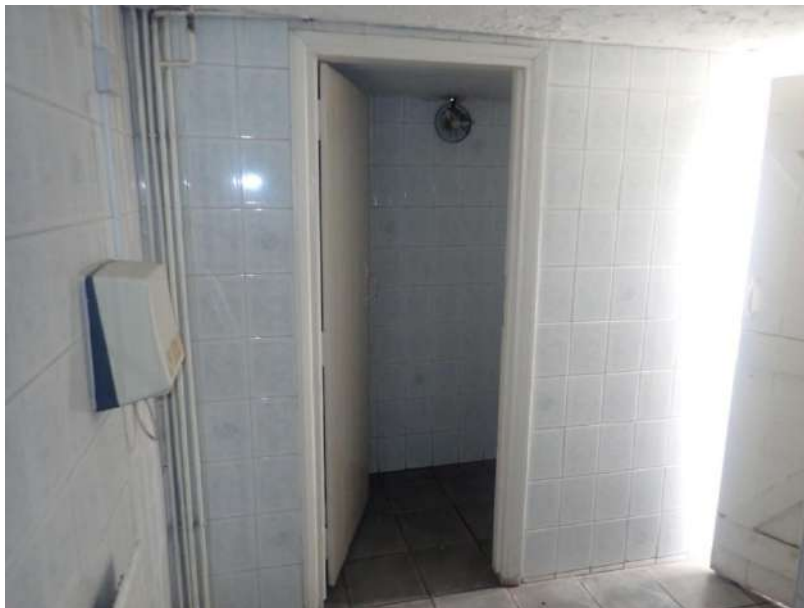
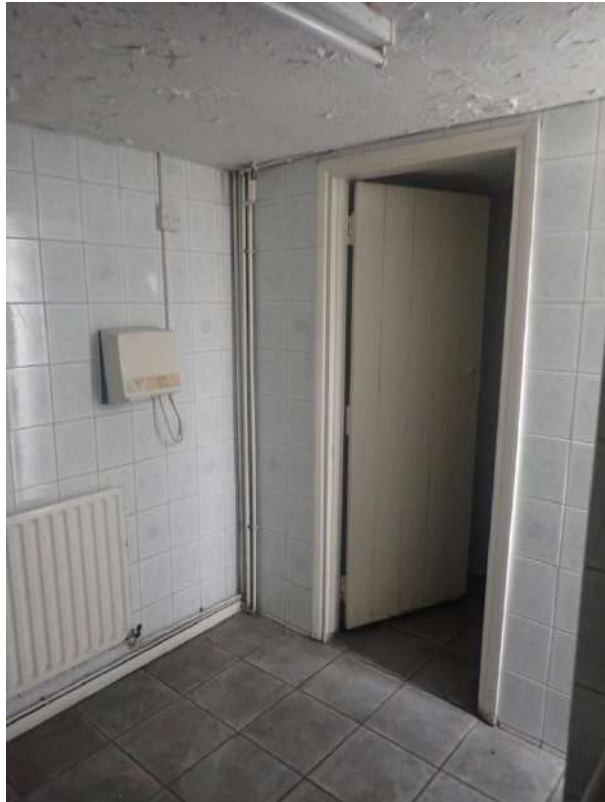
**Plate 363: View of the interior of Cell 17, from the south-west**

**Plates 362-364** also show the inner face of the main south facing entrance opening into **Cell 17**, which is occupied by a timber frame of a head and surrounds and by a timber door that is composed of a series of vertical tongued and grooved timber planks that are affixed to an internal timber framework of angled and horizontal timbers. The entrance opening into the main toilet is also featured and is occupied by a timber frame of a head and surrounds and by a second door

that is also composed of a series of vertical tongued and grooved timber planks that are affixed to an internal timber framework of angled and horizontal timbers.

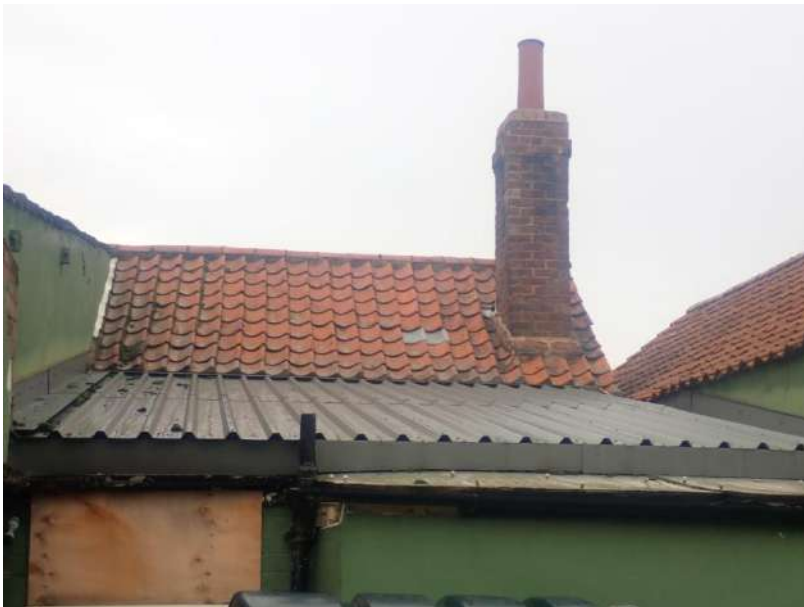
**Plate 375:** View of the roofing of Building 5, from the south-east

**Building 5** is a single storey building of this former public house complex. This has a gabled roof with a roof covering of red pantiles and a vertical brick chimney stack at the eastern end of the roof. The southern side of this roof is featured in detail on **Plate 375**. The chimney stack is

composed of courses of courses of brick stretchers and is topped with a ceramic chimney pot. **Building 5** is bonded to **Building 3** to the east and to **Buildings 4 and 6** to the south.

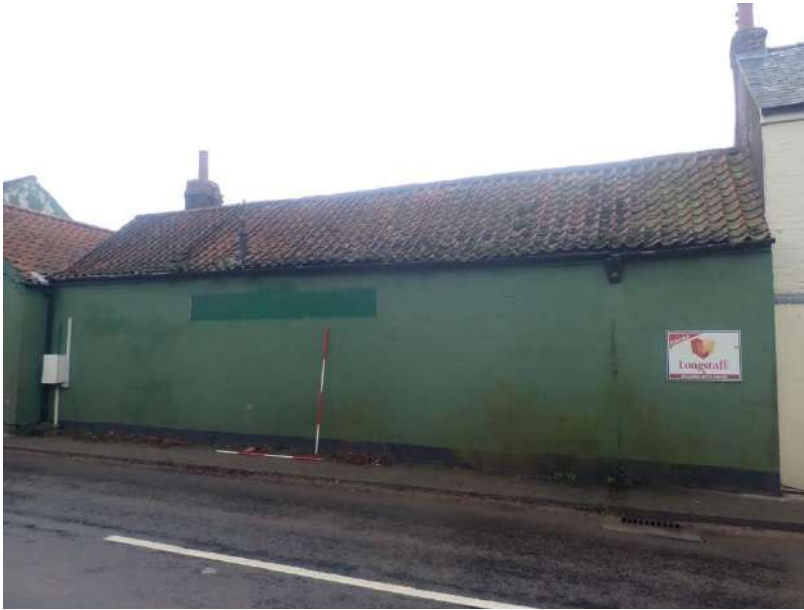
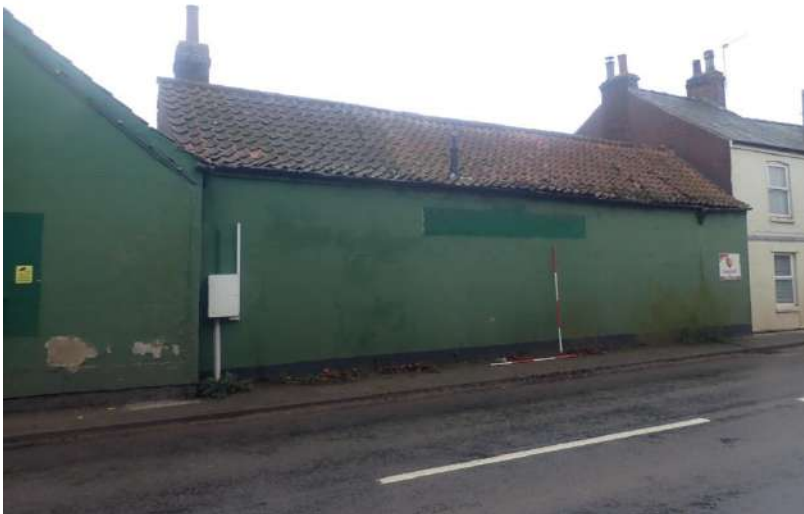
**Plate 376: View of the North Elevation of Building 5, from the north-west**

**Plates 376 and 377** present detailed views of the North Elevation of **Building 5**. The wall fabric of this Elevation has been entirely covered over with modern cement rendering. The northern side of the gabled roof with its roof covering of red pantiles is also featured. At just below roof levels is modern horizontal Upvc guttering.

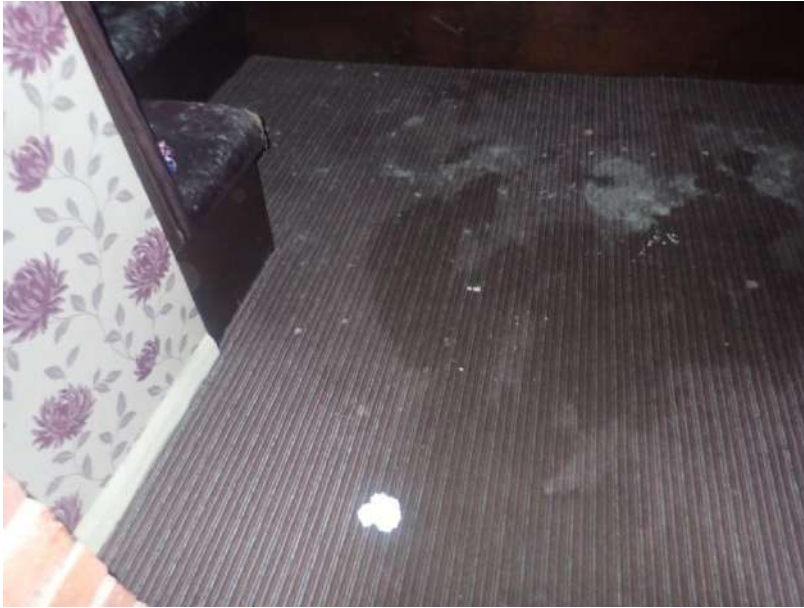
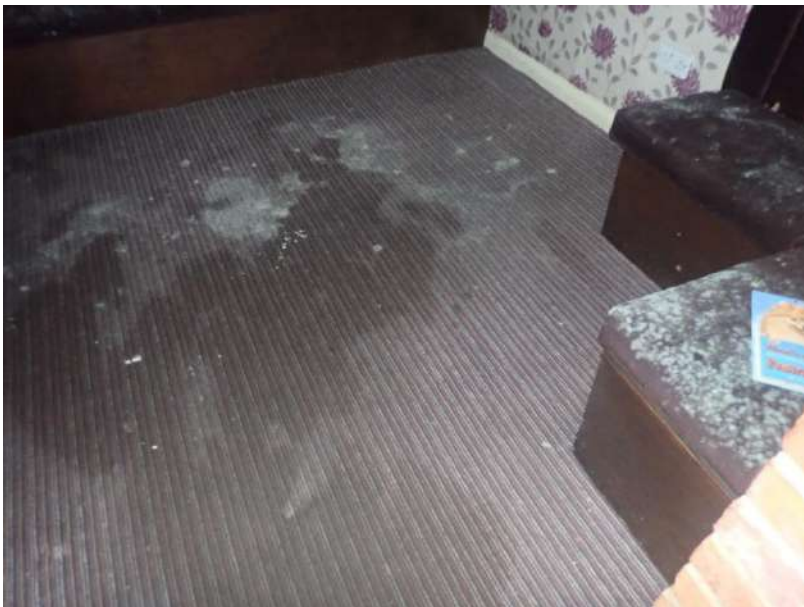
**Plate 378: View of the flooring of Cell 18, from the north-east**

**Plates 378 and 379** illustrate the nature of the flooring of **Cell 18**, which has been covered with modern carpeting.

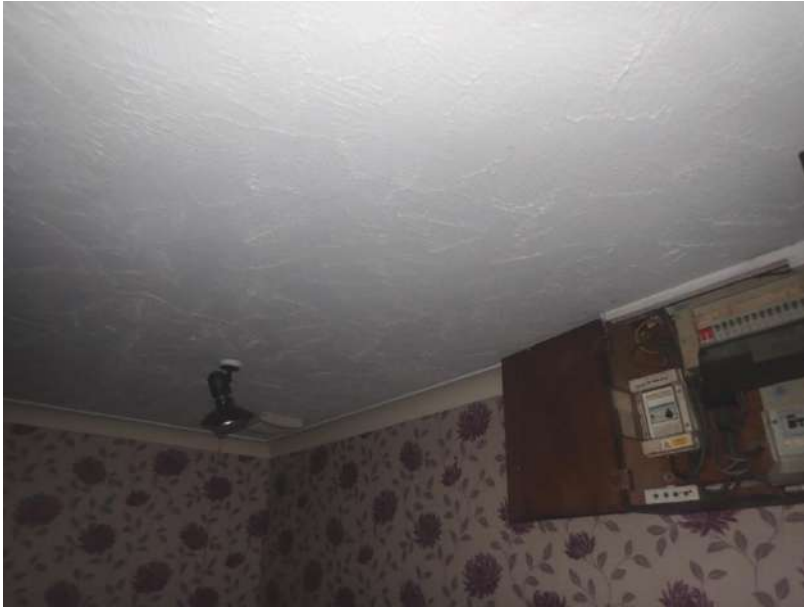
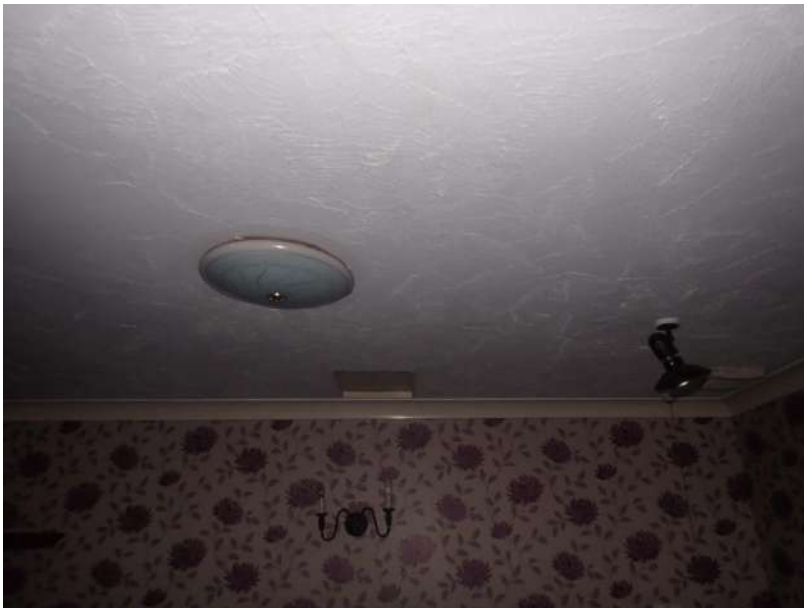
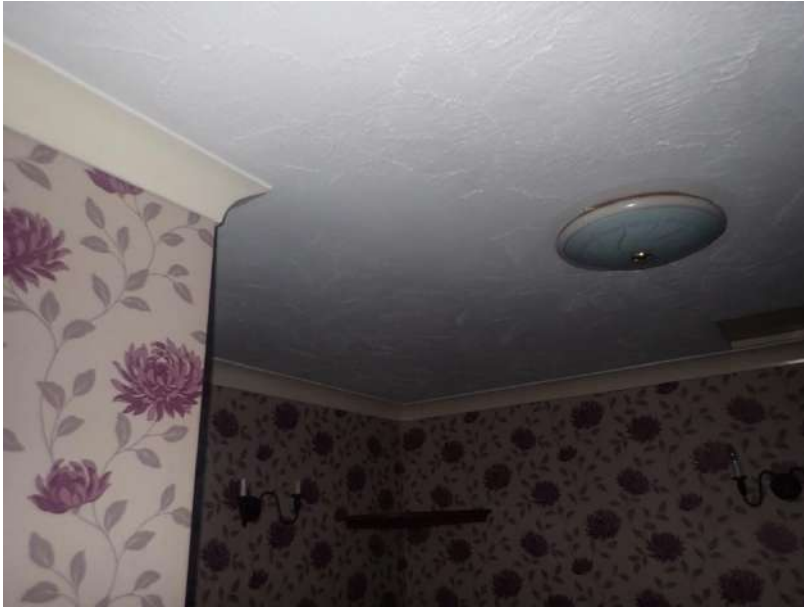
**Plate 380: View of the ceiling of Cell 18, from the south-east**

**Plates 380-382** show the nature of the ceiling structure of **Cell 18**, which has been rendered over with modern plasterwork.

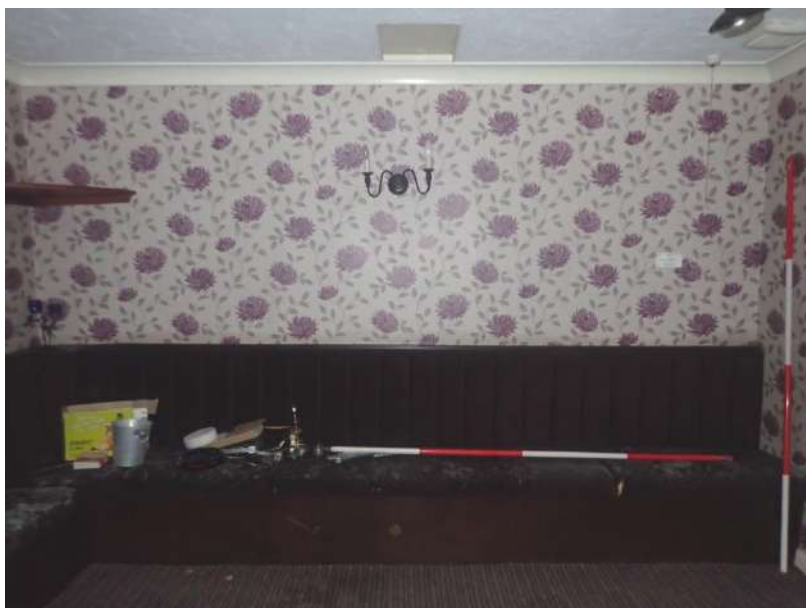
**Plate 385: View of the west wall of Cell 18, from the south-east**

**Plate 385** features the west wall of **Cell 18**, which has been covered over with modern wallpaper. Plaster cornice work may be seen at the uppermost levels. The lower levels of the west wall are occupied by modern soft furnishings/seating. This is also the internal dividing wall with the adjoining **Cells 21 and 22** to the west.
