HISTORIC BUILDING RECORDING AT THE  
FORMER DUKE OF YORK PUBLIC HOUSE,  
106, RISEGATE ROAD,  
GOSBERTON RISEGATE, LINCOLNSHIRE

**National Grid Reference: TF 2186 3004**  
**Planning Reference: H08-0964-21**  
**Site Code: RRGR22**  
**Accession Number: LCNCC: 2022.147**

PREPARED FOR MRS. S. GOODENOUGH

January 2023

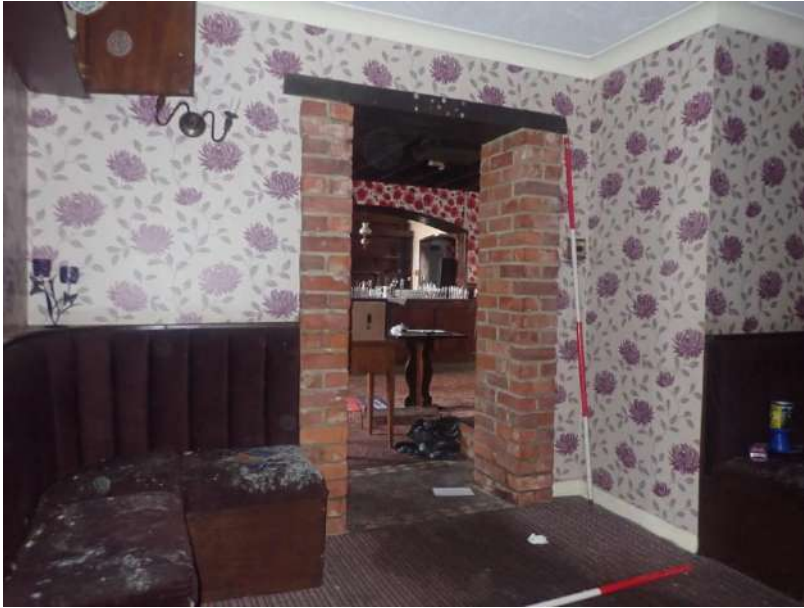
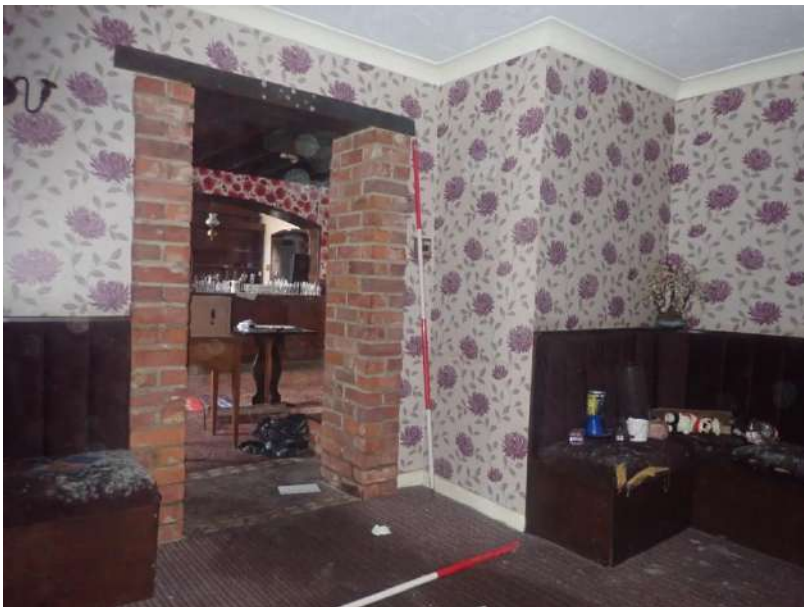
**Plates 386 and 387** show the east wall of **Cell 18**, which is also the internal dividing wall with the adjoining **Cell 15** of **Building 3** to the east. This east wall has also been covered over with modern wallpaper. Plaster cornice work may be seen at the uppermost levels. The lower levels of the east wall are occupied by modern soft furnishings/seating. The central features of this east wall are the chimney breast to the right (south) and the open access into the adjoining **Cell 15** to the east. This open access is flanked to either side by brickwork composed of courses of brick

stretchers. Above the opening is an horizontal timber lintel, which has been incorporated into the wall fabric here.

**Plate 386:** View of the east wall of Cell 18, from the north-west

**Plate 387:** View of the east wall of Cell 18, from the north-west

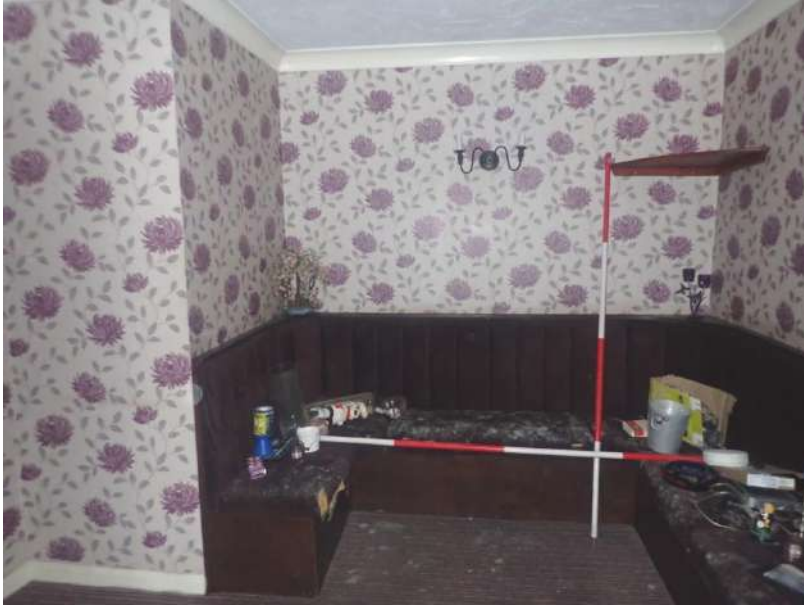
**Plate 388** provides a view of the south wall of **Cell 18**, which is also the internal dividing wall with the adjoining **Cell 16** to the south. This south wall has also been covered over with modern wallpaper. Plaster cornice work may be seen at the uppermost levels. The lower levels of the south wall are occupied by modern soft furnishings/seating.

**Plate 388:** View of the south wall of Cell 18, from the north-west

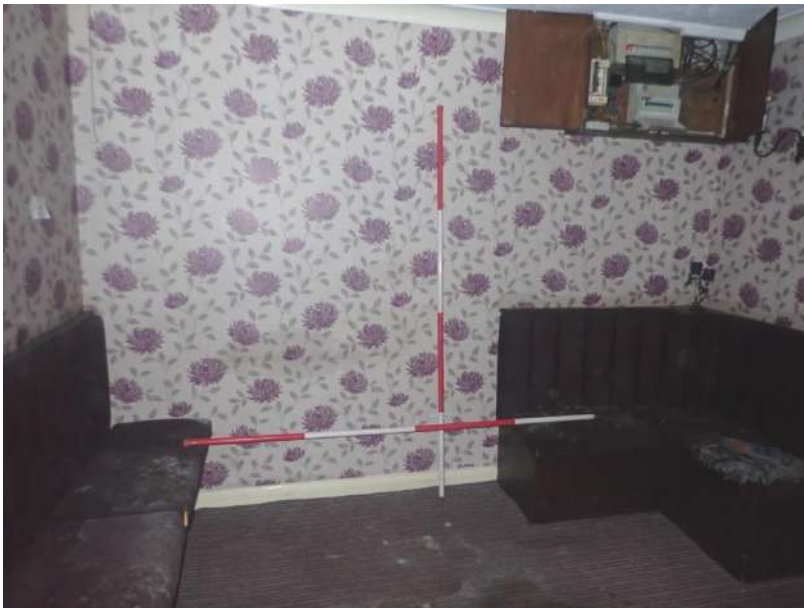
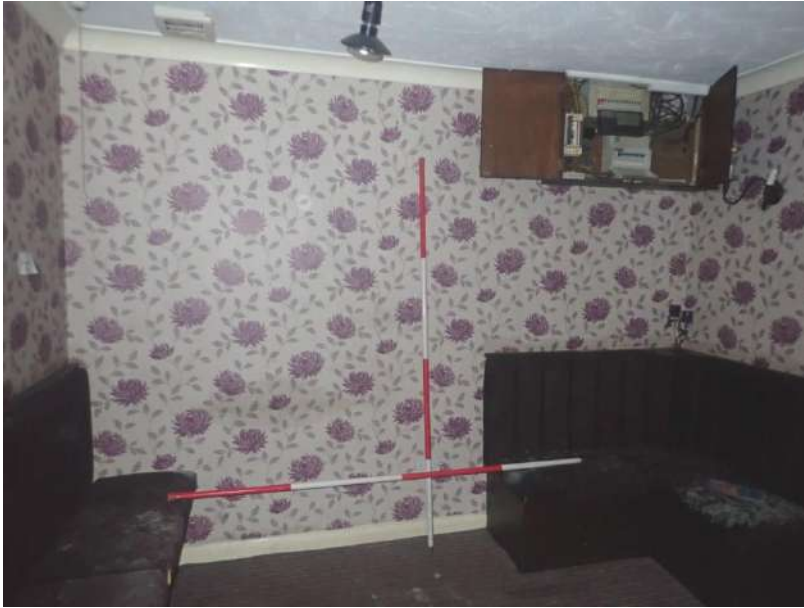
**Plate 389:** View of the north wall of Cell 18, from the south-east

**Plates 389 and 390** show the north wall of **Cell 18**, which has also been covered over with modern wallpaper. Plaster cornice work may be seen at the uppermost levels. The lower levels of the north wall are occupied by modern soft furnishings/seating and by horizontal timber skirting boards at the base.

**Plate 390: View of the north wall of Cell 18, from the south-east**

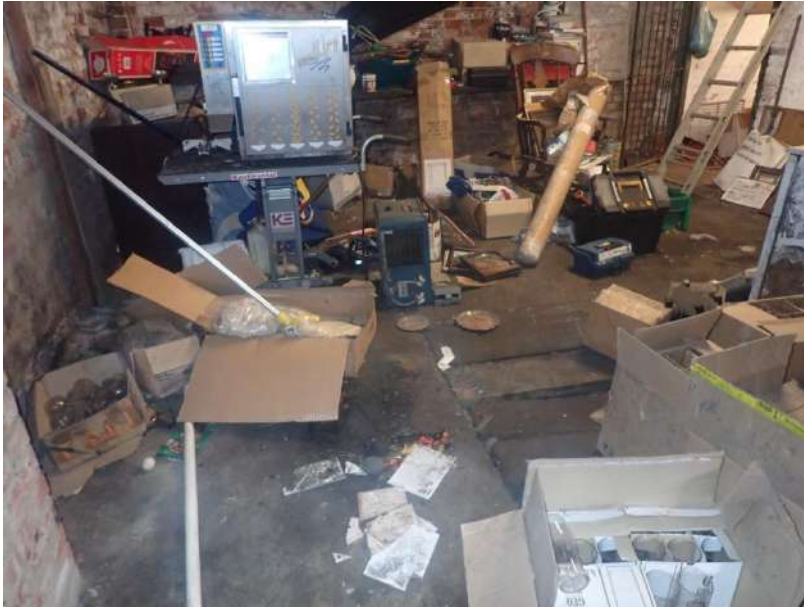
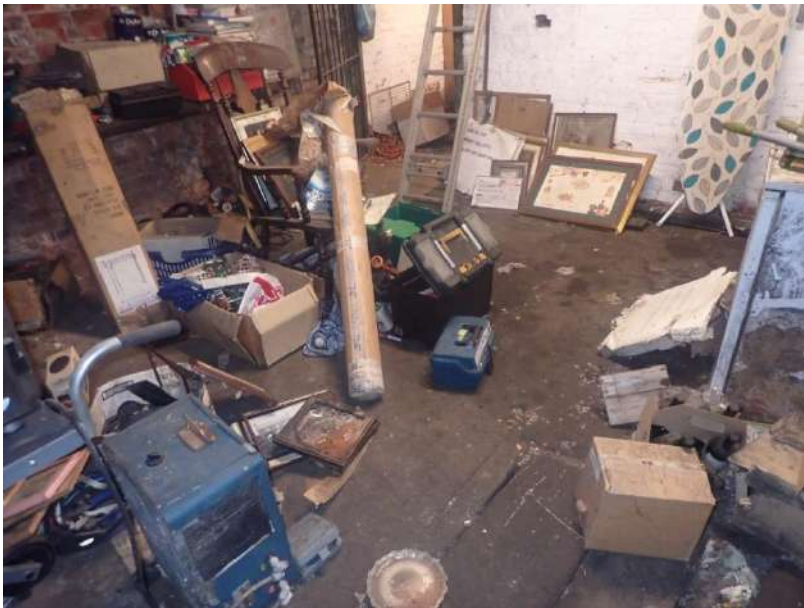
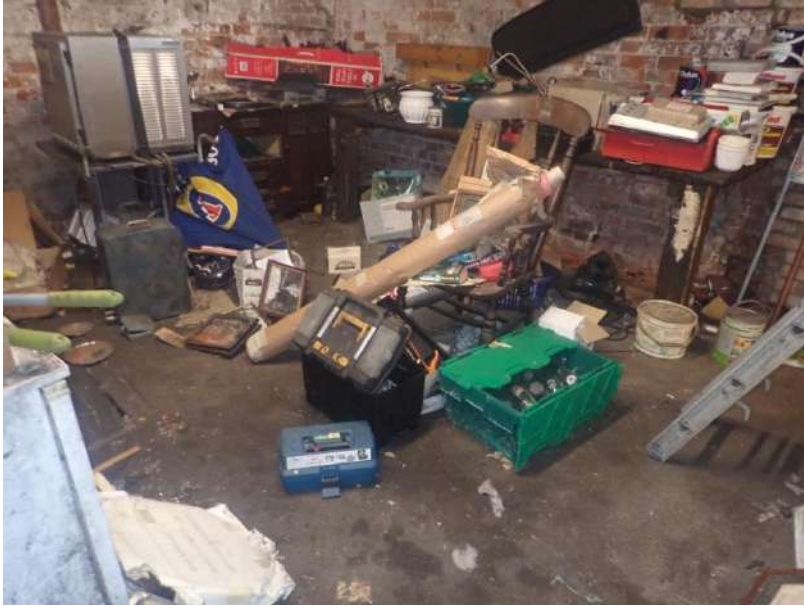
**Plates 392-394** feature the nature of the flooring of **Cell 19**, which is of modern concrete.

**Plate 392: View of the flooring of Cell 19, from the south**

**Plate 393: View of the flooring of Cell 19, from the south-west**

**Plate 394:** View of the flooring of Cell 19, from the south-east

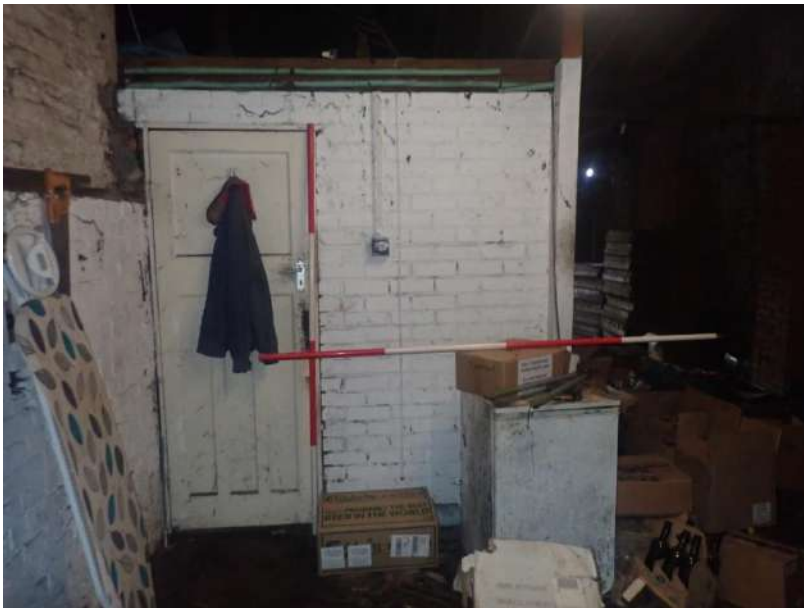
**Plate 395:** View of the south wall of Cell 19, from the north-west

**Plate 395** provides a view of the probable remnants of the former south wall of **Cell 19**, and hence of this western portion of **Building 5**. This surviving remnant is of brick, which is composed of courses of brick stretchers in Stretcher Bond. To the left (east) and built into this wall fabric is a south facing entrance opening, which extends onto the adjoining **Cell 24** of **Building 6**. This opening is occupied by a timber frame of a head and surrounds and by a modern panelled timber door.

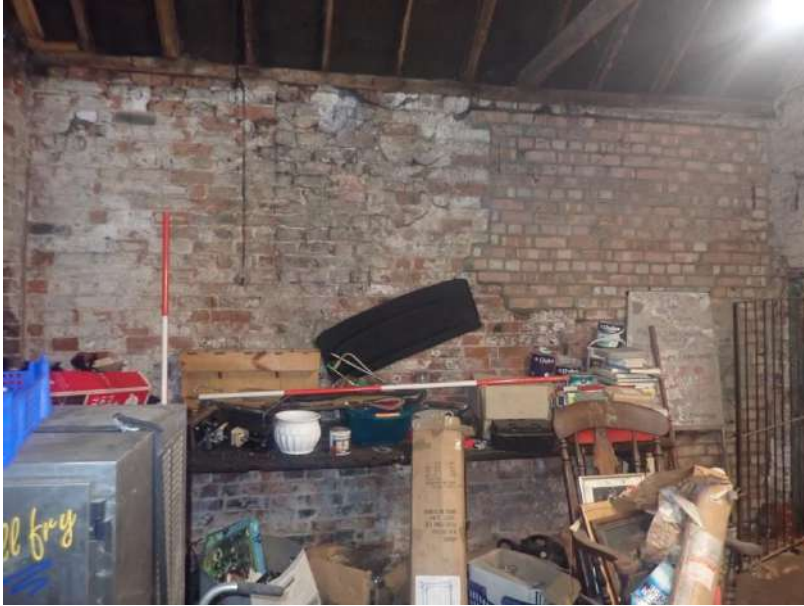
**Plate 396:** View of the north wall of Cell 19, from the south-west

**Plates 396 and 397** provide detailed views of the north wall of **Cell 19**. The detail of the brickwork wall fabric of the western portion of this north wall has become partially obscured by being covered with paintwork. The eastern portion of this north wall has been the subject of modern repair and the brickwork here is composed of 2-3 courses of brick stretchers alternating with single courses of brick headers in a variation of English Garden Wall Bond. Horizontal timber wallplates extend along the top of this north wall.

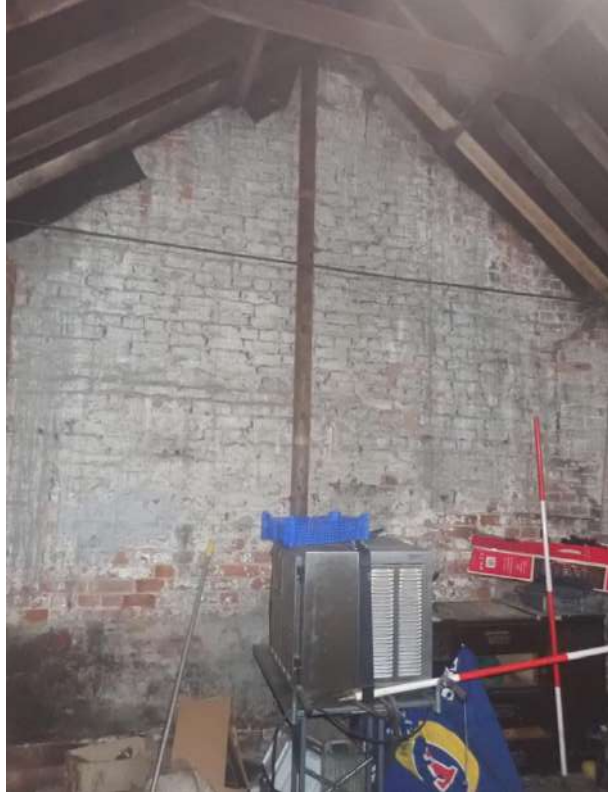
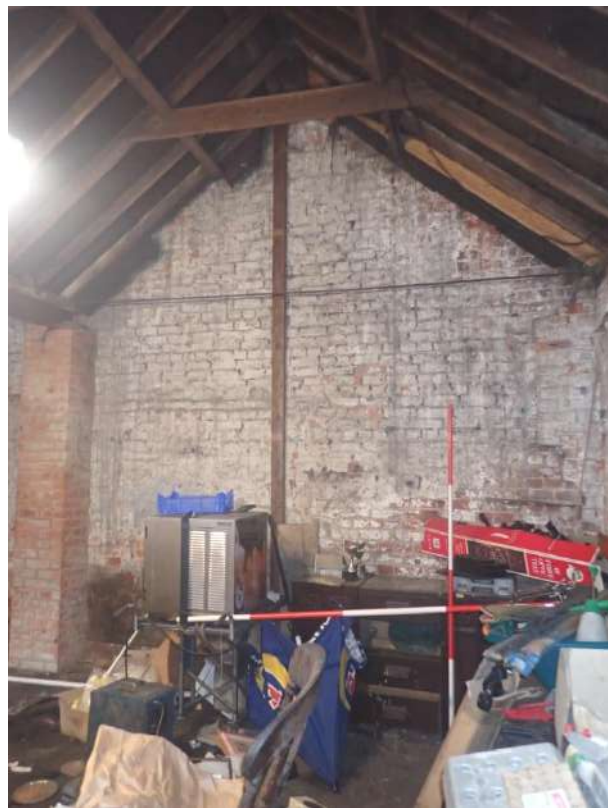
**Plates 398 and 399** present detailed images of the west wall of **Cell 19**. Much of the detail of the brickwork wall fabric of this west wall has become obscured by being covered with paintwork. However, it is still possible to discern individual courses of brick headers and of brick stretchers. The western ends of the horizontal timber purlins of the overlying roof structure may be seen to be inserted into the uppermost levels of this brickwork wall fabric.

**Plate 398: View of the west wall of Cell 19, from the north-east**

**Plate 399: View of the west wall of Cell 19, from the north-east**

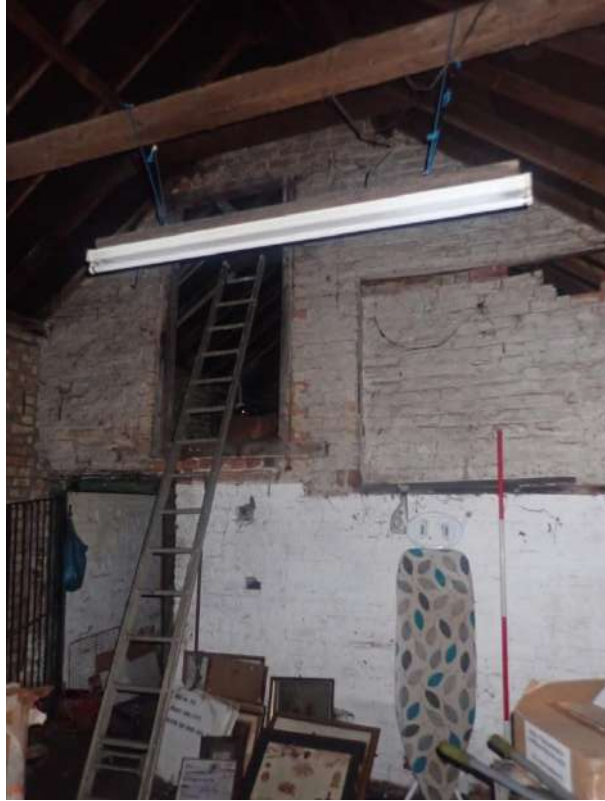
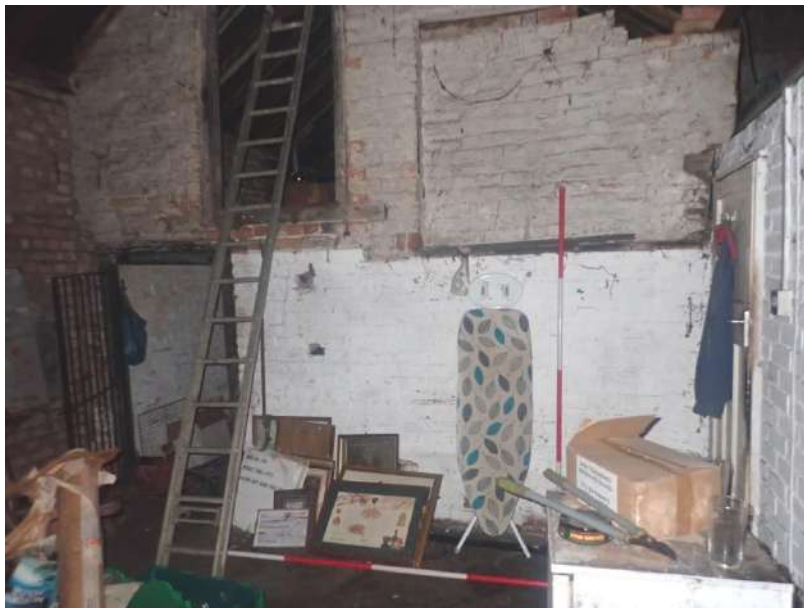
**Plate 400:** View of the east wall of Cell 19, from the south-west

**Plate 401:** View of the east wall of Cell 19, from the south-west

**Plates 400-402** furnish several detailed views of the east wall of **Cell 19**. Here also, much of the detail of the brickwork wall fabric of this east wall has become obscured by being covered with paintwork. However, it is still possible to discern individual courses of brick headers and of brick stretchers. The eastern ends of the horizontal timber purlins of the overlying roof structure may be seen to be inserted into the uppermost levels of this brickwork wall fabric. To the right (south), is a probable infilled east facing former internal window opening. This former opening has been

infilled with brick. The detail here has also become obscured by being covered over with paintwork, though individual courses of brick stretchers may be observed. This former opening has the remnants of a timber frame of a head and surrounds incorporated into the brickwork wall fabric here. To the left (north), and at ground floor levels is an east facing entrance opening, which extends onto **Cell 21** to the east. This opening is occupied by a timber frame of a head and surrounds and by a modern metal grilled door. It may also be seen that a mezzanine floor has been added to this portion of **Building 5** and a further east facing mezzanine entrance opening may also be observed. This second opening is also occupied by a timber frame of a head, surrounds and a timber threshold at the base of the opening. This leads onto the adjoining **Cell 20** to the east.

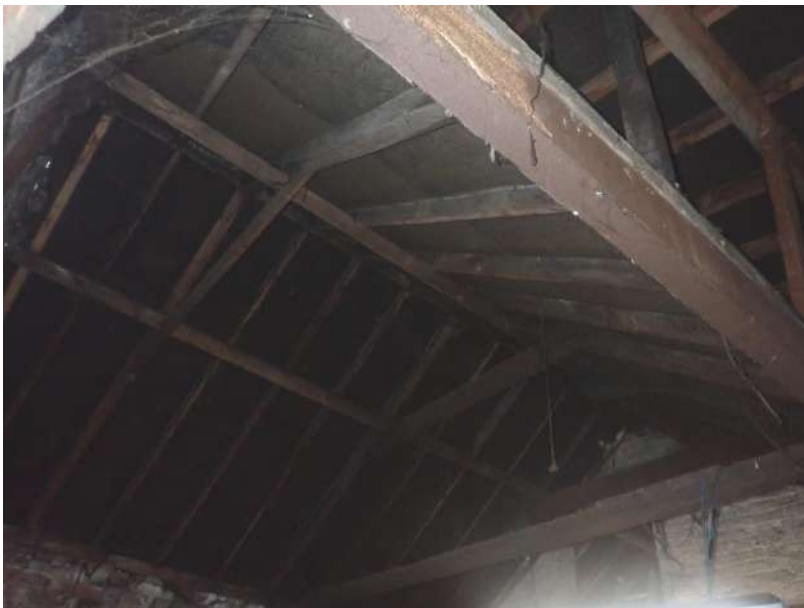
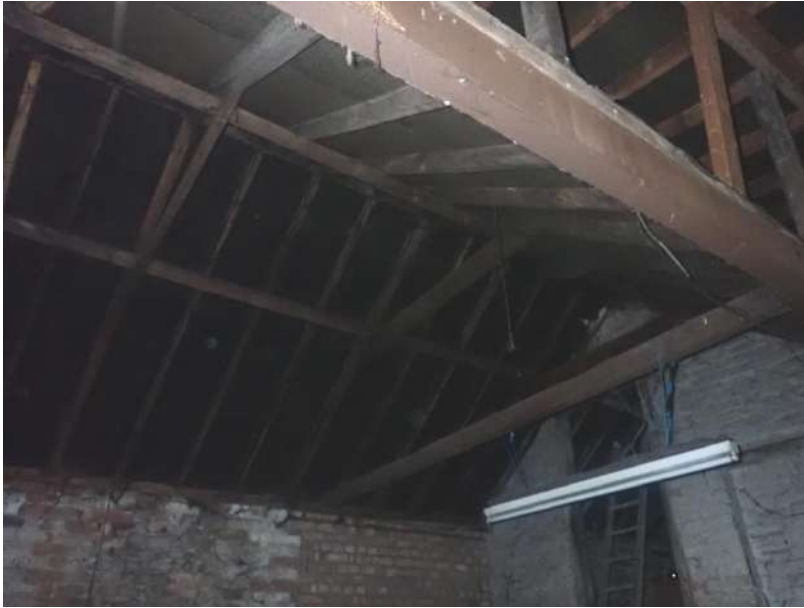
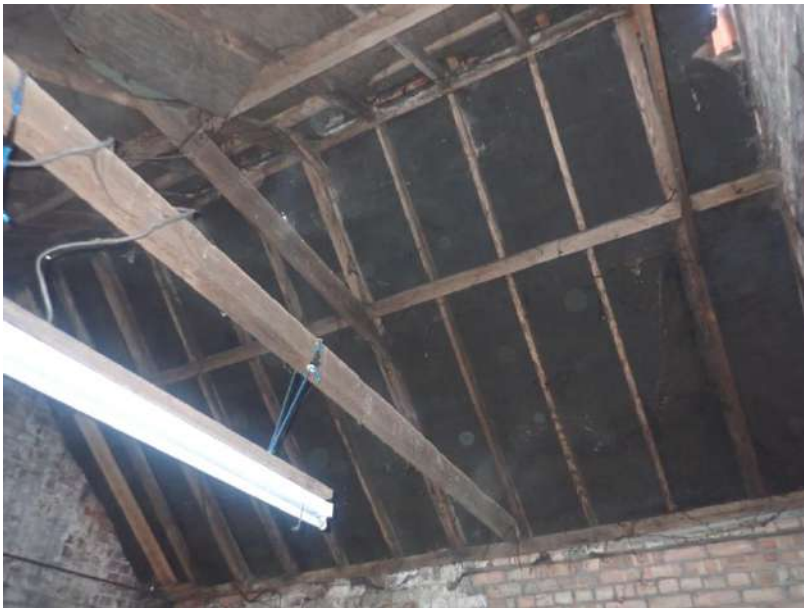
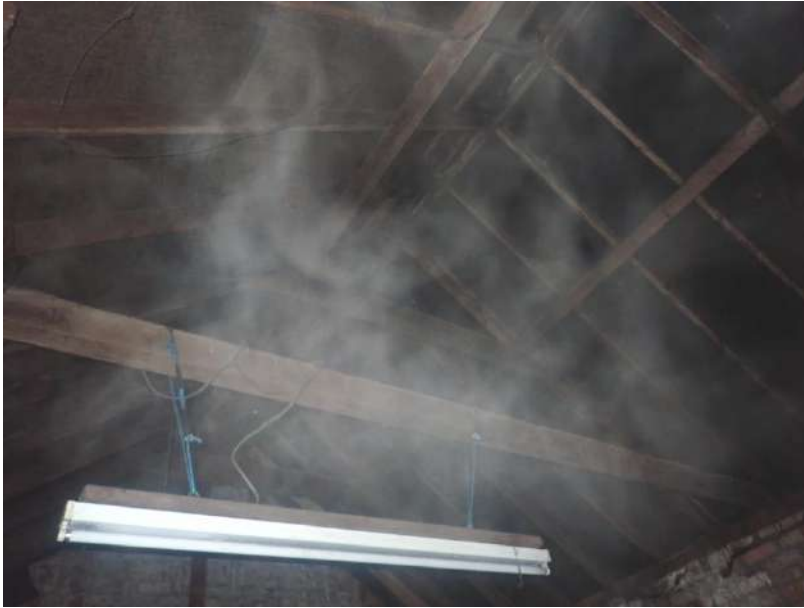
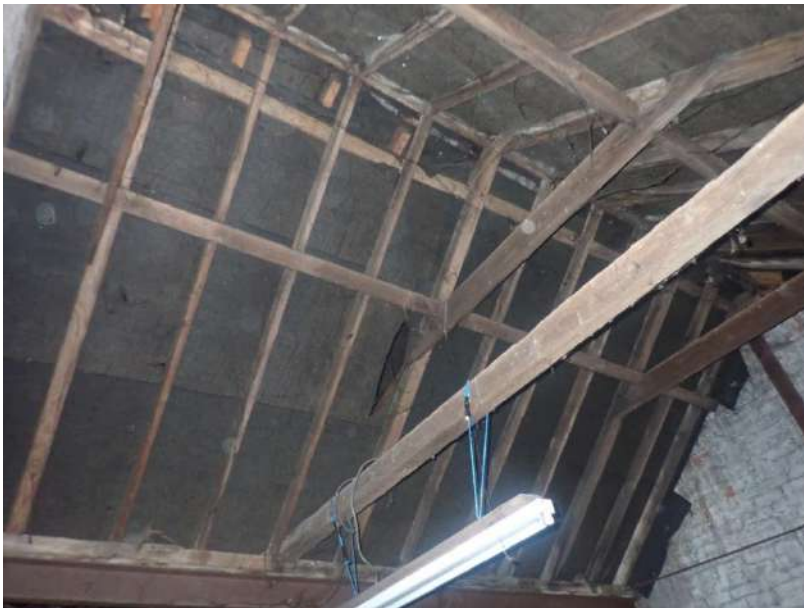
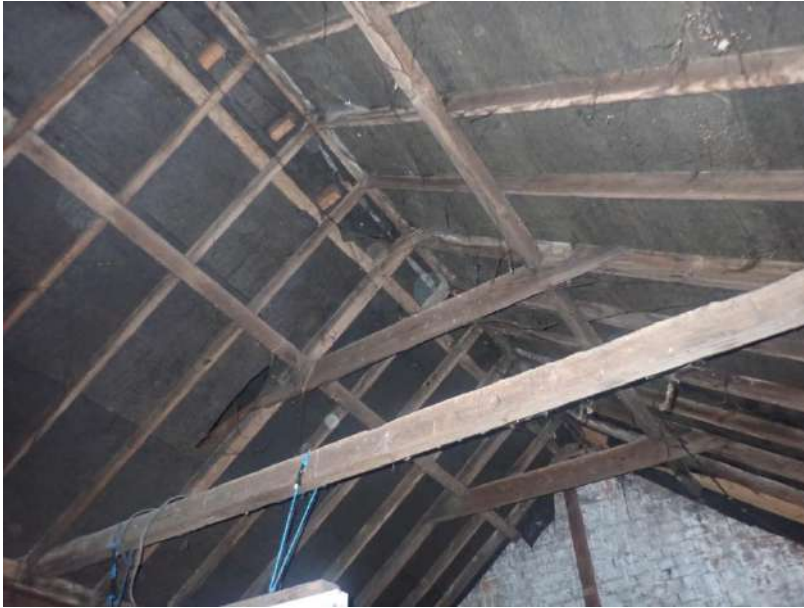
Plate 403: View of the roof supporting structure of Cell 19, from the south-west

**Plate 404:** View of the roof supporting structure of Cell 19, from the south-west

**Plate 405:** View of the roof supporting structure of Cell 19, from the south-east

**Plates 403-408** present a number of views from differing positions of the nature of the roof supporting structure of **Cell 19** and hence of the western end of **Building 5**. This structure comprises a framework of timber rafters and of horizontal timber purlins that extend along both sides of this structure along with further horizontal timber purlins at the roof apex. The upper ends of the rafters are attached to the purlins at the roof apex, whilst their basal ends are attached to the timber wallplates that extend along the top of the north wall. At the upper levels and attached to the rafters are several horizontal timber collars. At the lower levels, and also affixed to the rafters are several horizontal timber tie beams. Both the collars and the tie beams provide additional support and reinforcement to this structure.

**Plate 406: View of the roof supporting structure of Cell 19, from the south-east**

**Plate 407: View of the roof supporting structure of Cell 19, from the south-west**

**Plate 408: View of the roof supporting structure of Cell 19, from the north-east**

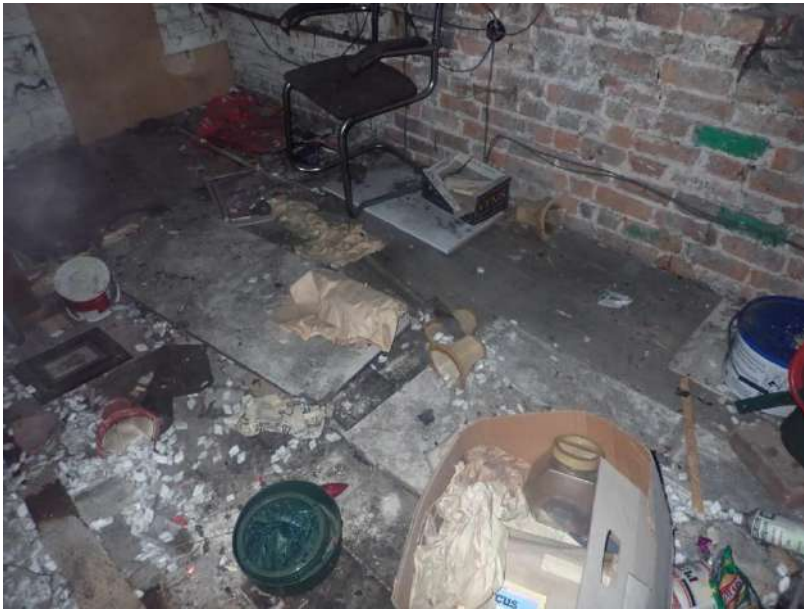
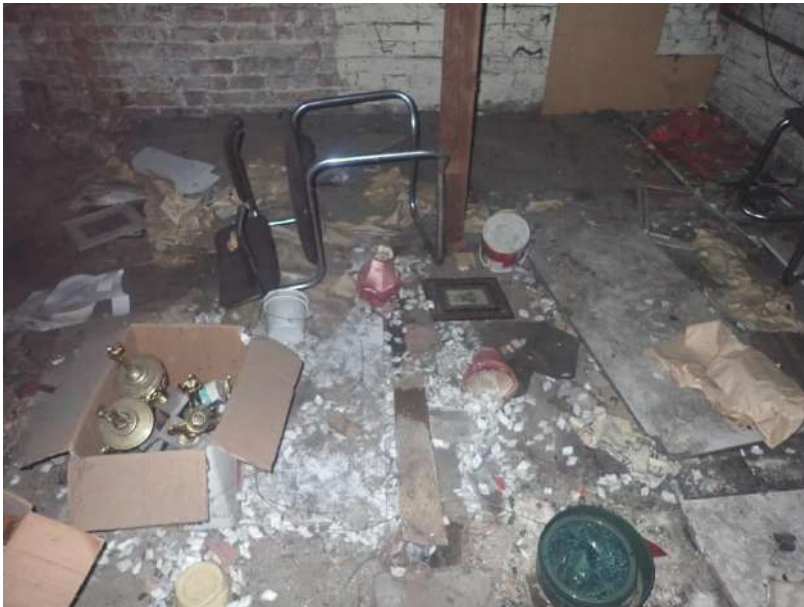
**Plate 409: View of the flooring of Cell 20, from the north-west**

**Plate 410: View of the flooring of Cell 20, from the south-west**

**Plates 409 and 410** show the nature of the flooring of **Cell 20**, which is of horizontal timber planking.

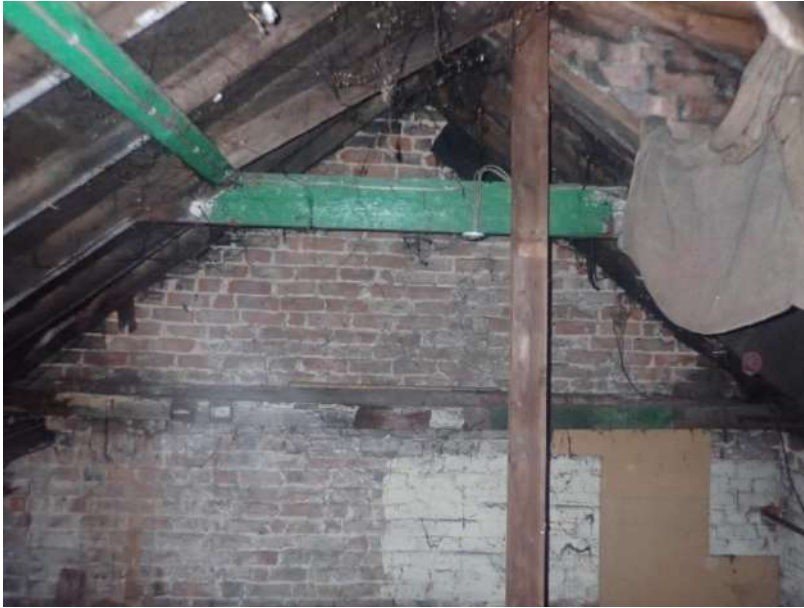
**Plate 411** presents a detailed view of the east wall of **Cell 20**. The brickwork wall fabric of this east wall is mostly composed of courses of brick stretchers with further occasional courses of mixed brick headers and brick stretchers. The eastern ends of the horizontal timber purlins of the overlying roof structure may be seen to be inserted into the uppermost levels of the brickwork wall fabric here.

**Plate 411:** View of the east wall of Cell 20, from the south-west

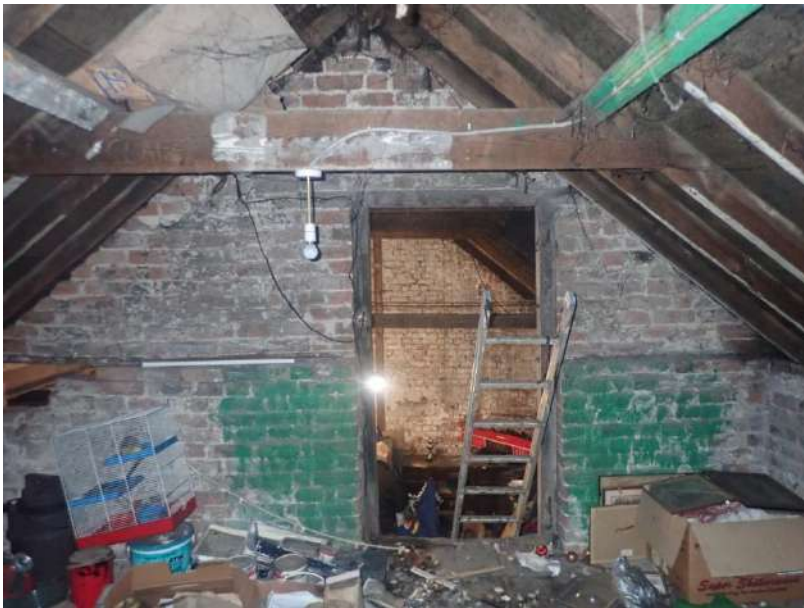
**Plate 412:** View of the west wall of Cell 20, from the east

**Plate 412** provides a detailed image of the west wall of **Cell 20**. The brickwork wall fabric of this west wall is mostly composed of courses of brick stretchers with further occasional courses of mixed brick headers and brick stretchers. The western ends of the horizontal timber purlins of the overlying roof structure may be seen to be inserted into the uppermost levels of the brickwork wall fabric here. Also featured is the west facing entrance opening, which leads onto the adjoining **Cell 19** to the west. This opening is occupied by a timber frame of a head and surrounds and by a timber threshold at the base of the opening.

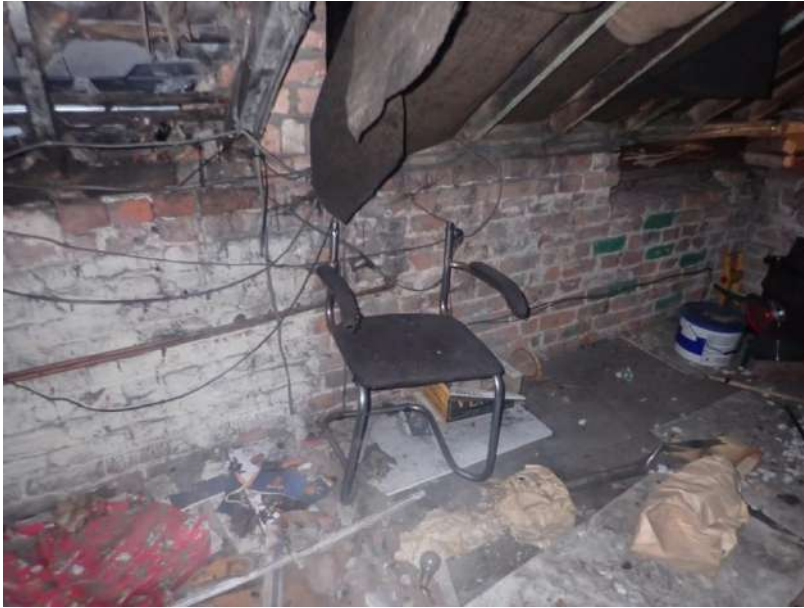
**Plate 413** presents a view of the low south wall of **Cell 20**. The brickwork wall fabric of this south wall is mostly composed of courses of brick stretchers with further occasional courses of mixed brick headers and brick stretchers. Horizontal timber wallplates may be seen to extend along the top of this south wall.

**Plate 413:** View of the south wall of Cell 20, from the north-east

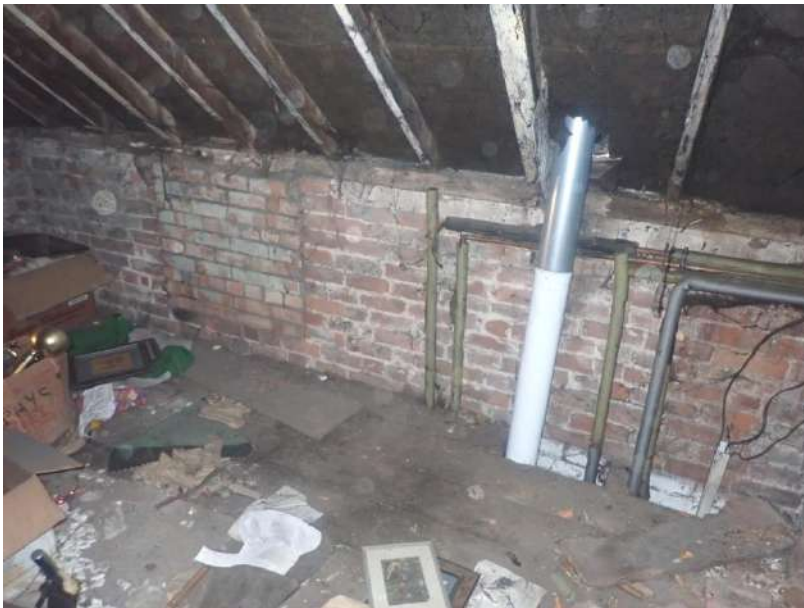
**Plate 414:** View of the north wall of Cell 20, from the south-west

**Plate 414** furnishes a detailed view of the low north wall of **Cell 20**. The brickwork wall fabric of this north wall is mostly composed of courses of brick stretchers with further occasional courses of mixed brick headers and brick stretchers. Horizontal timber wallplates may be seen to extend along the top of this north wall. The remains of an infilled former first floor north facing window opening may also be observed within this wall fabric. The brick infilling is composed of three courses of brick stretchers alternating with single courses of brick headers in English Garden Wall Bond.

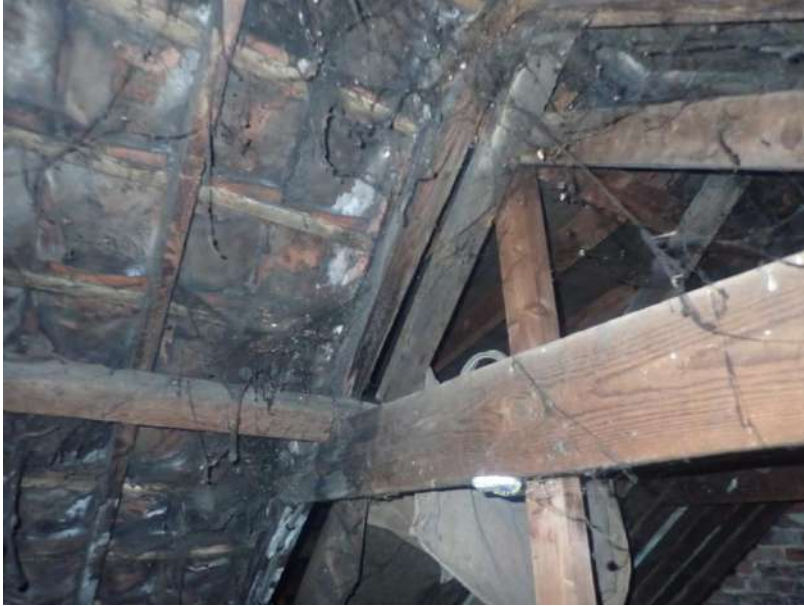
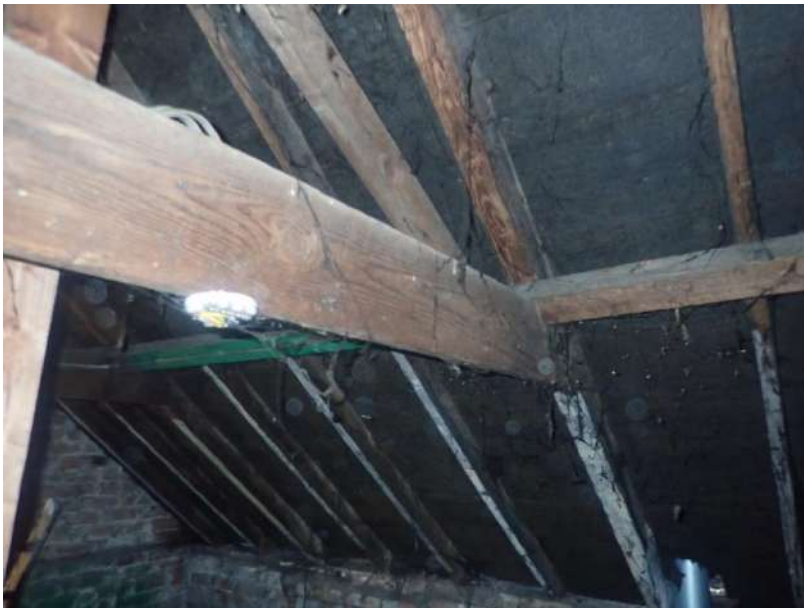
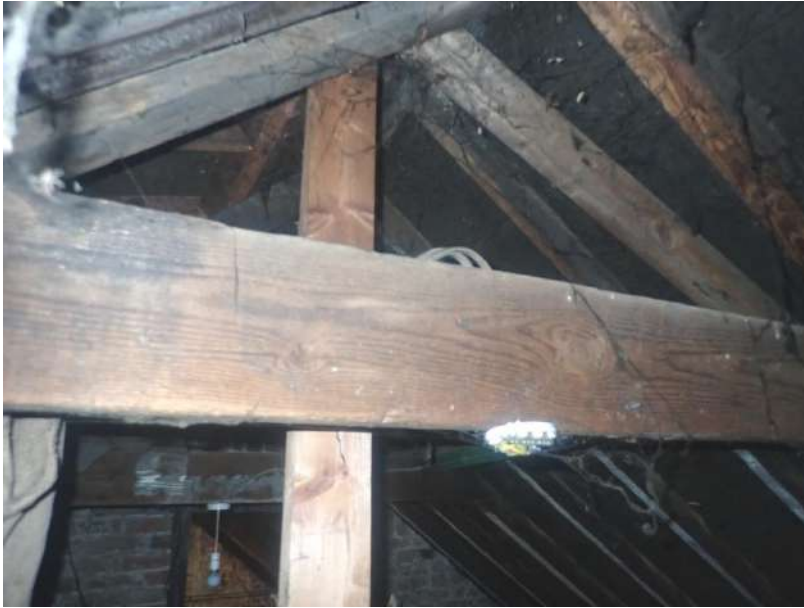
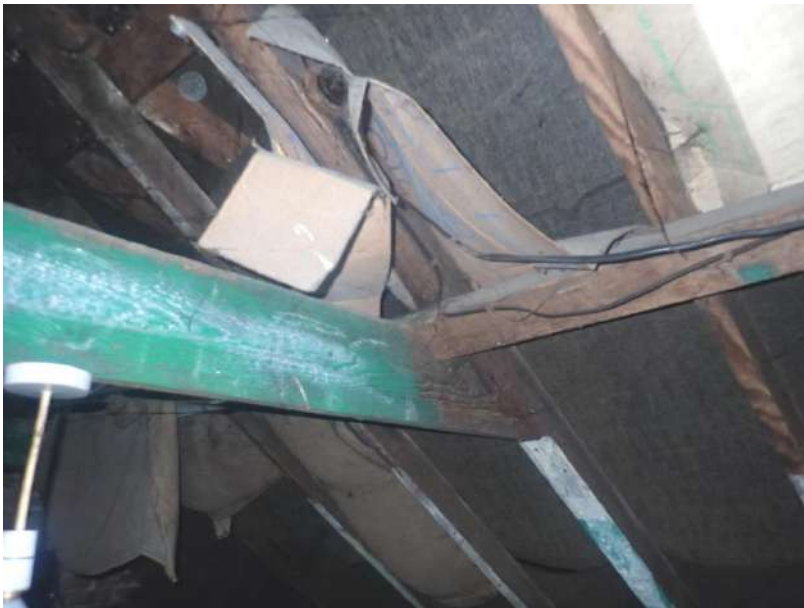
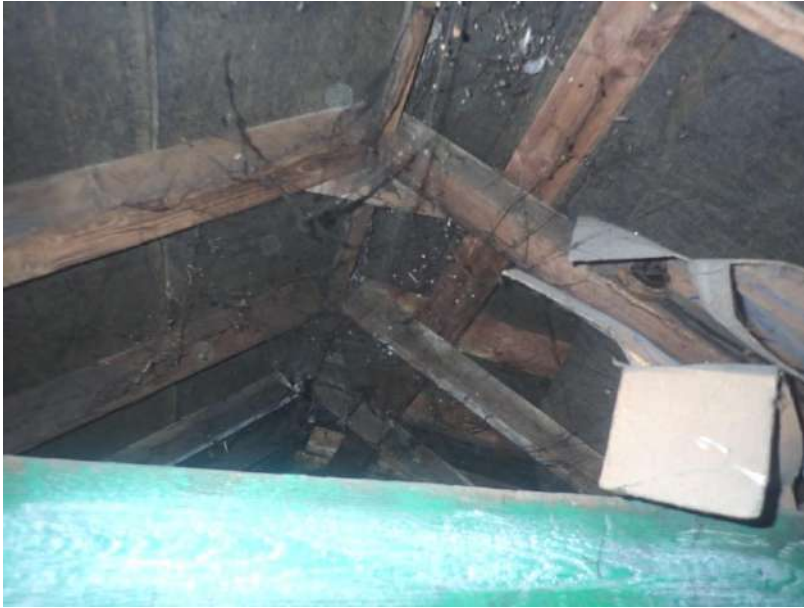
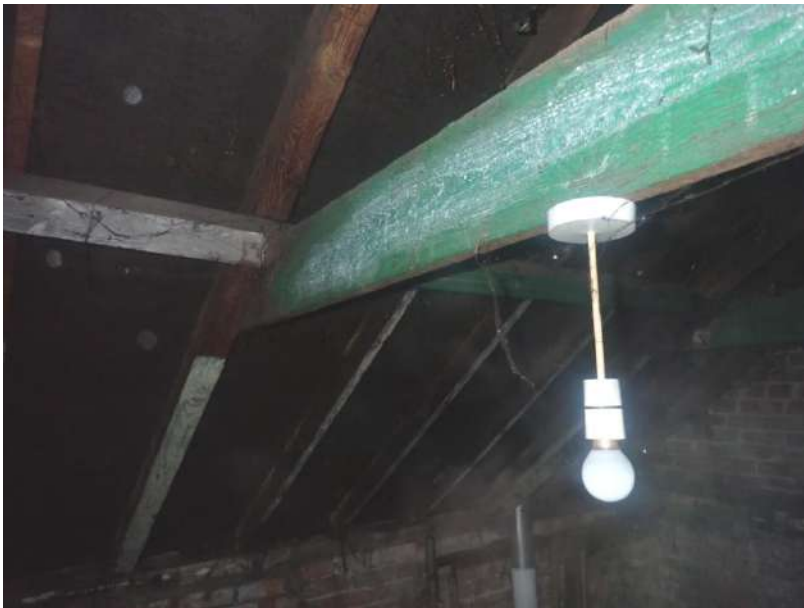
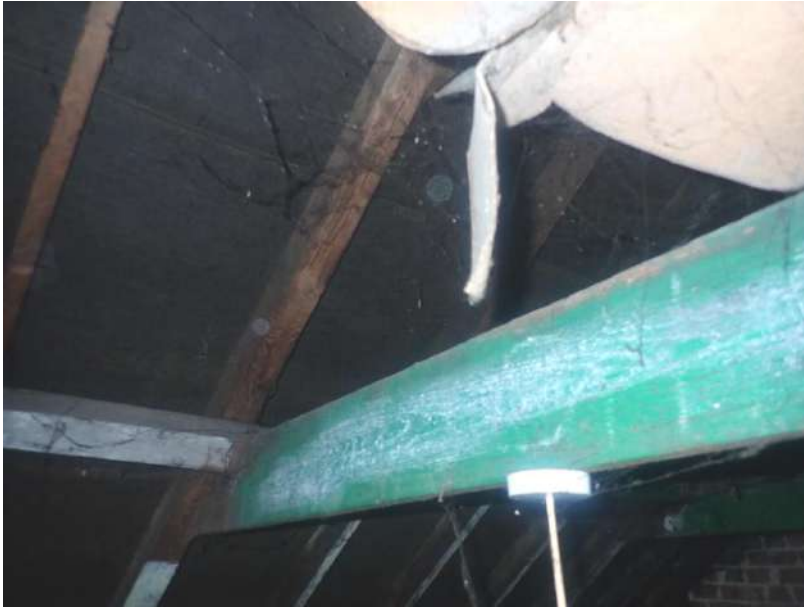
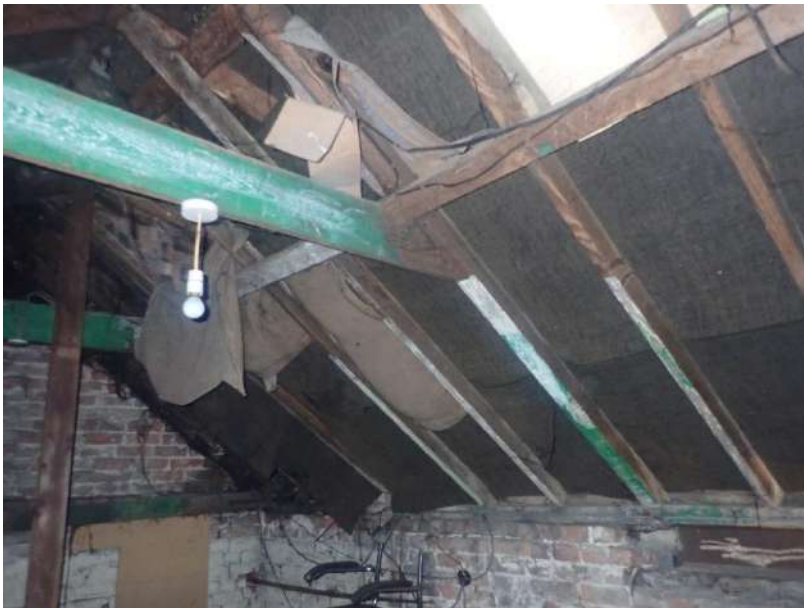
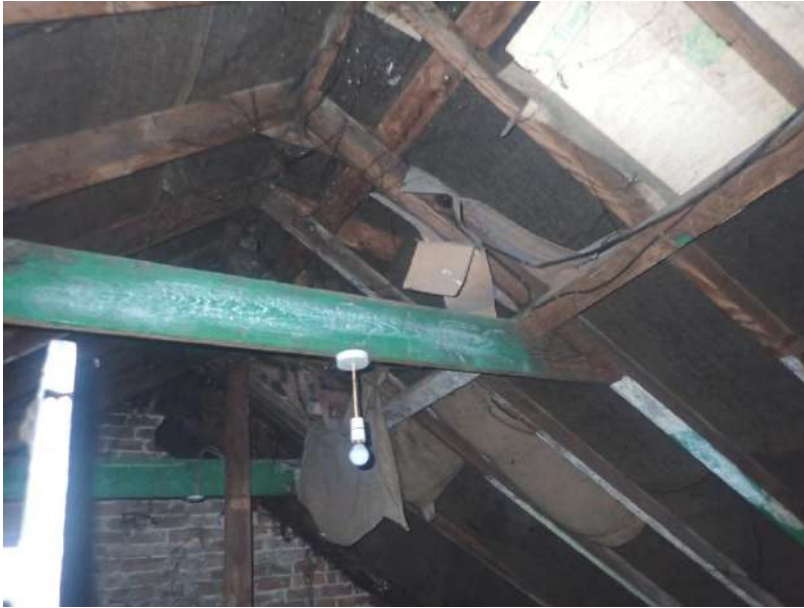
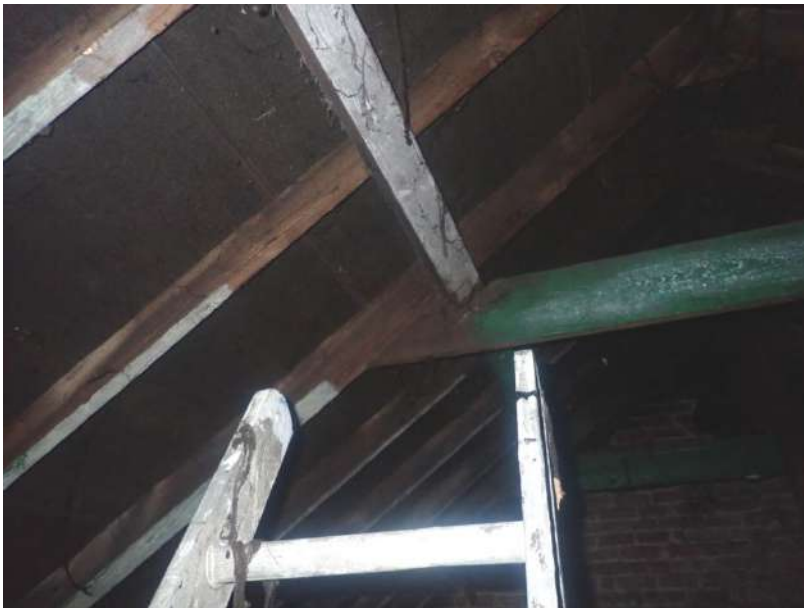
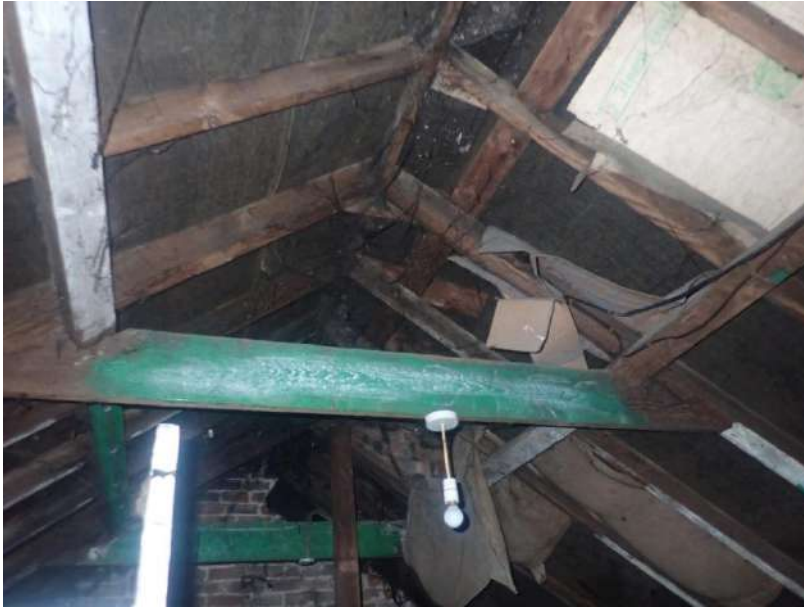
**Plate 415: View of the roof supporting structure of Cell 20, from the north-east**

**Plate 416: View of the roof supporting structure of Cell 20, from the south-east**

**Plates 415-425** present a large number of images of the nature of the roof supporting structure of **Cell 20** and hence of the central portion of **Building 5**. This structure comprises a framework of timber rafters and of horizontal timber purlins that extend along both sides of this structure along with further horizontal timber purlins at the roof apex. The upper ends of the rafters are attached to the purlins at the roof apex, whilst their basal ends are attached to the timber wallplates that extend along the top of the low north and south walls. At the upper levels and attached to the rafters are several horizontal timber collars. The collars provide additional support and reinforcement to this structure.

**Plate 417: View of the roof supporting structure of Cell 20, from the south-east**

**Plate 418: View of the roof supporting structure of Cell 20, from the north-west**

**Plate 419: View of the roof supporting structure of Cell 20, from the north-east**

**Plate 420: View of the roof supporting structure of Cell 20, from the south-west**

**Plate 421: View of the roof supporting structure of Cell 20, from the north**

**Plate 422: View of the roof supporting structure of Cell 20, from the north-west**

**Plate 423: View of the roof supporting structure of Cell 20, from the north-west**

**Plate 424: View of the roof supporting structure of Cell 20, from the north-west**

**Plate 425: View of the roof supporting structure of Cell 20, from the north-west**

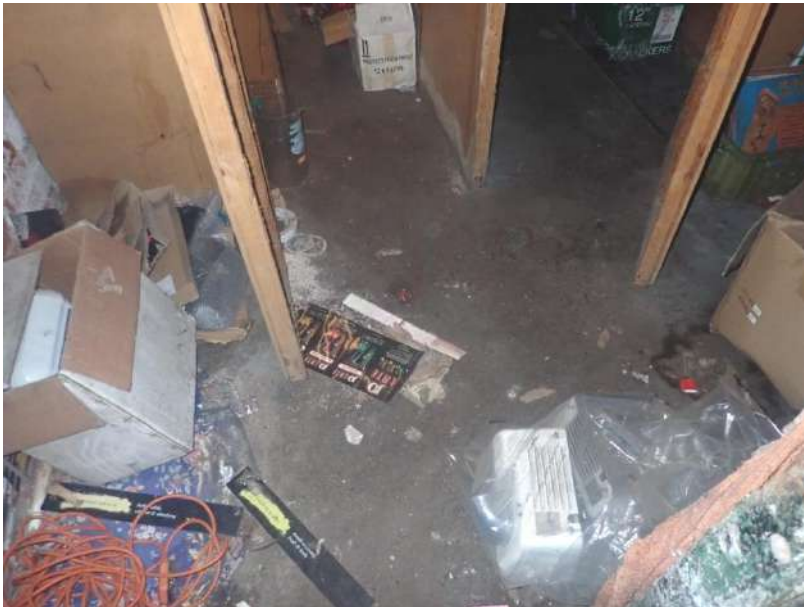
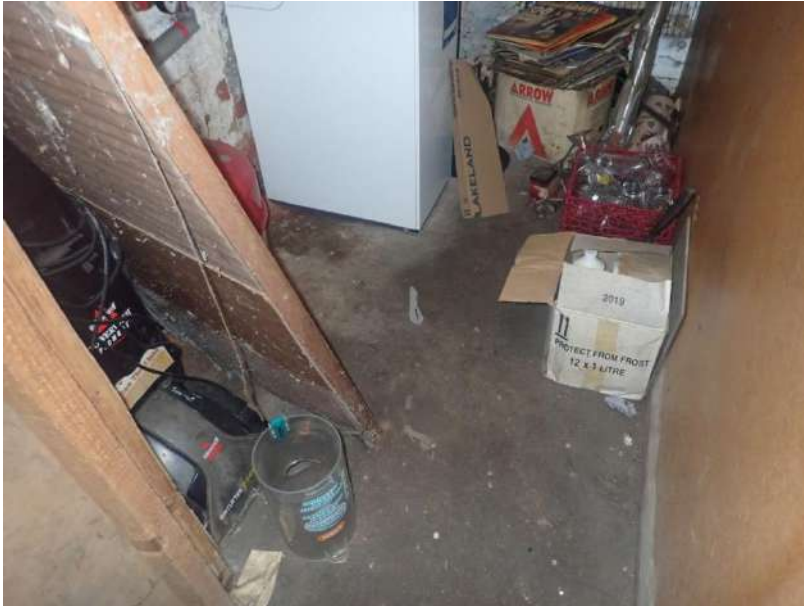
**Plate 426: View of the flooring of Cell 21, from the north-west**

**Plates 426 and 427** illustrate the nature of the flooring of **Cell 21**, which is of modern concrete.

**Plate 427:** View of the flooring of Cell 21, from the north-west
