HISTORIC BUILDING RECORDING AT THE  
FORMER DUKE OF YORK PUBLIC HOUSE,  
106, RISEGATE ROAD,  
GOSBERTON RISEGATE, LINCOLNSHIRE

**National Grid Reference: TF 2186 3004**  
**Planning Reference: H08-0964-21**  
**Site Code: RRGR22**  
**Accession Number: LCNCC: 2022.147**

PREPARED FOR MRS. S. GOODENOUGH

January 2023

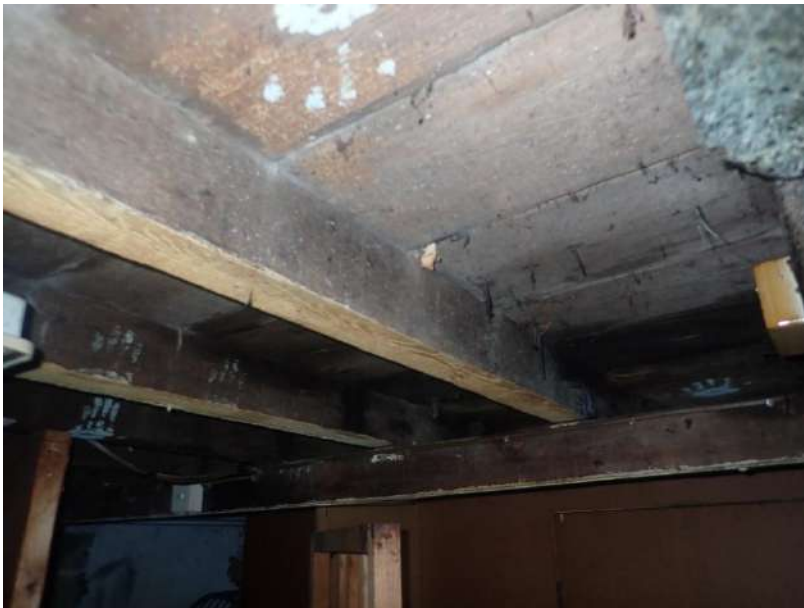
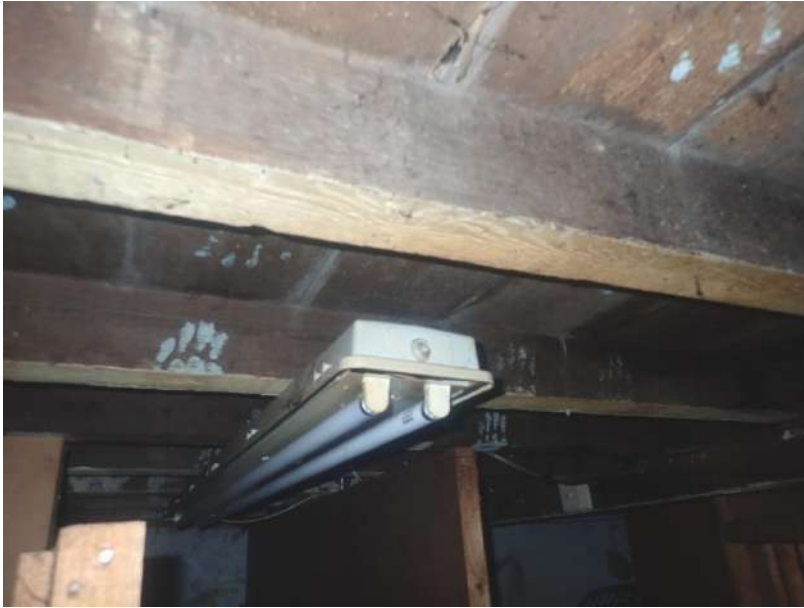
**Plate 428:** View of the ceiling of Cell 21, from the south-east

**Plates 428-430** present views of the nature of the ceiling structure of **Cell 21**. This is composed of a series of horizontal timber joists that are orientated from north-south. These in turn support the mezzanine floor covering above of horizontal timber planking, which are aligned from east-west.

**Plate 429:** View of the ceiling of Cell 21, from the south-east

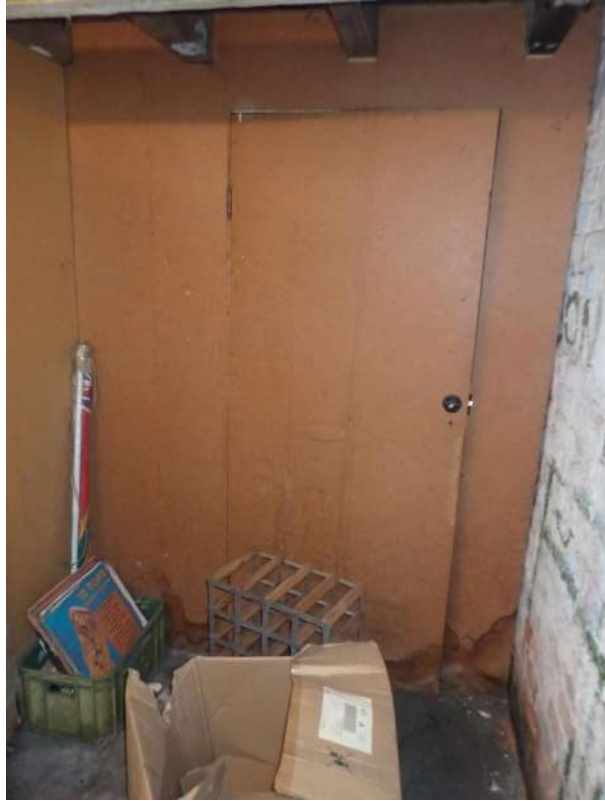
**Plate 431: View of the interior of Cell 21, from the north-west**

**Plates 431** provides a view of a modern hardboard partition with door, which separates this **Cell 21** from **Cell 23** to the south.

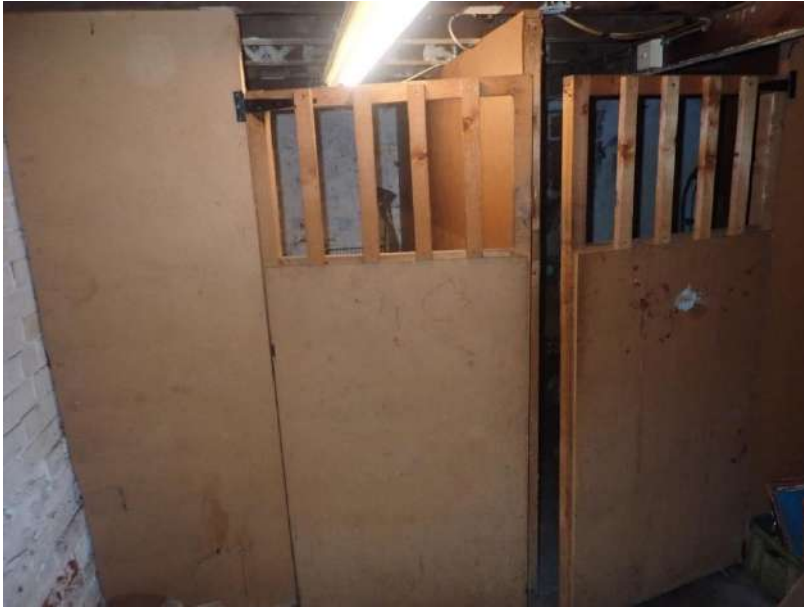
**Plate 433:** View of the interior of Cell 21, from the north-west

**Plate 433** provides a further view of the hardboard and timber door that extends onto the adjoining **Cell 22**, to the right (south) and also of the second hardboard and timber door that leads onto the boiler room of **Cell 21** to the east.

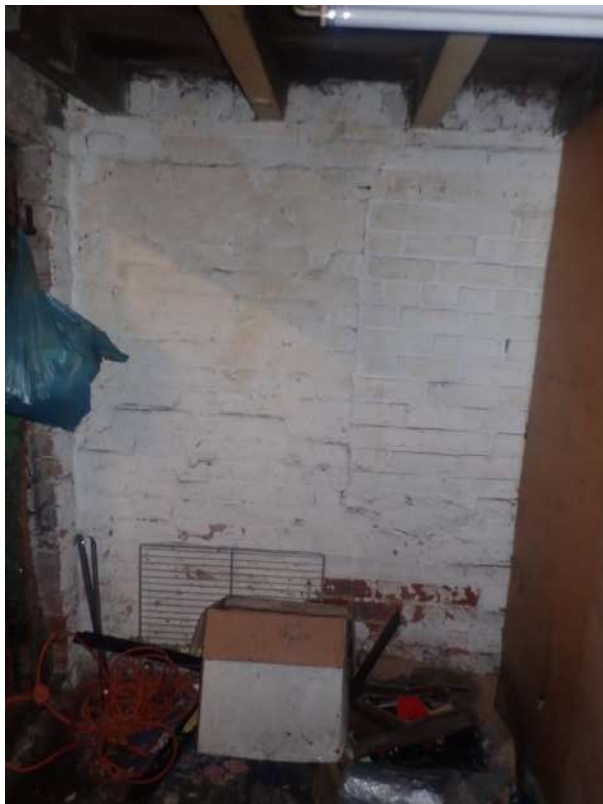
**Plate 434:** View of the interior of Cell 21, from the south-east

**Plate 434** features part of the north wall of **Cell 21**. Here the detail of the brickwork wall fabric has become obscured by being covered over with paintwork.

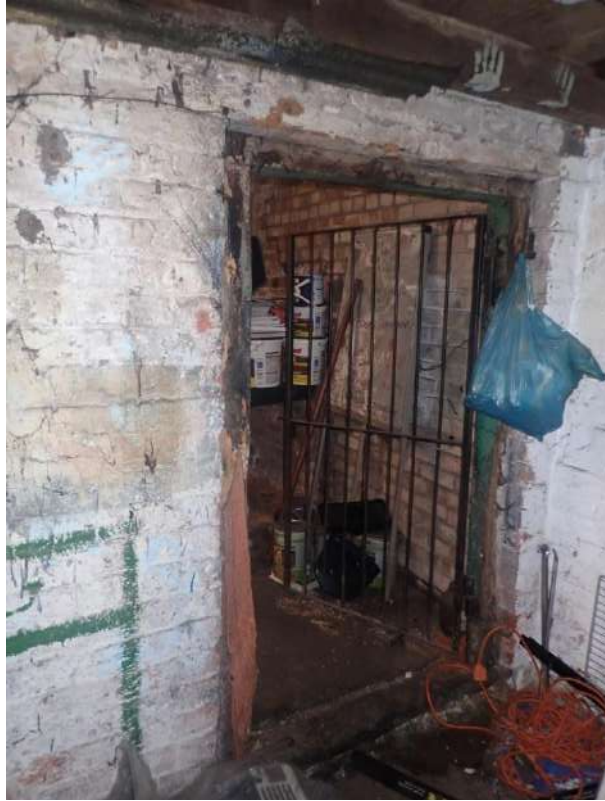
**Plate 435: View of the interior of Cell 21, from the south-east**

**Plate 435** provides a view of part of the west wall of **Cell 21** and shows the inner face of the west facing entrance opening that leads onto **Cell 19** to the west. This opening is occupied by a timber frame of a head and surrounds and by a modern metal gridded door. Above the opening is an horizontal timber lintel that is incorporated into the wall fabric here.

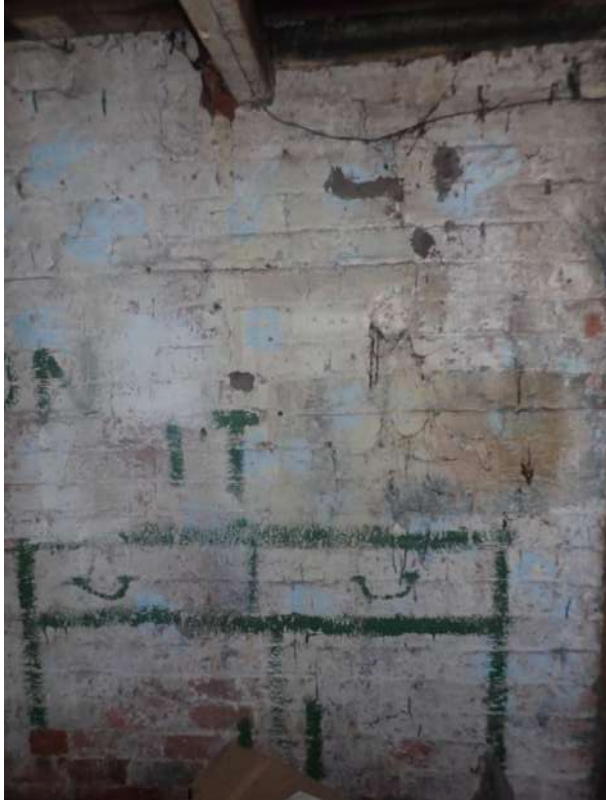
**Plate 436: View of the interior of Cell 21, from the east**

**Plate 436** provides a detailed view of the remainder of the west wall of **Cell 21**. Here also, the detail of the underlying brickwork wall fabric has become obscured by being covered over with paintwork.

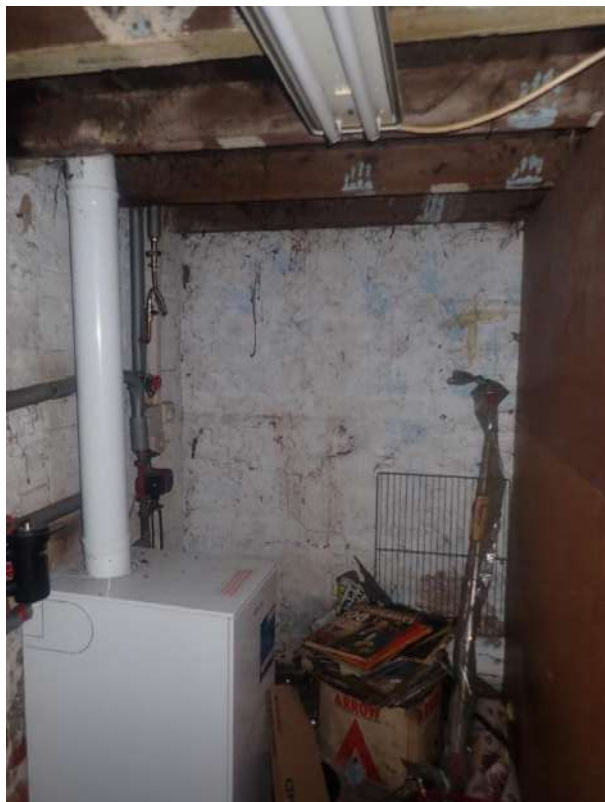
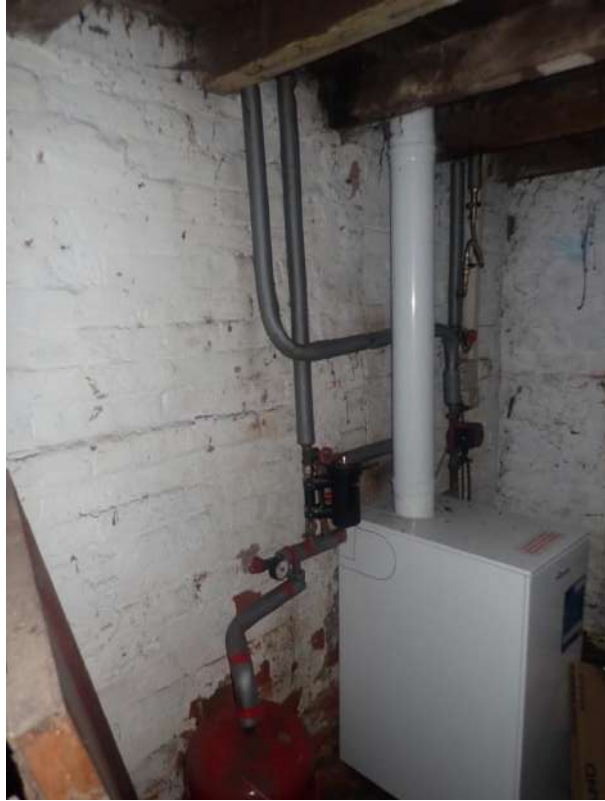
**Plates 437 and 438** detail the interior of the boiler room of **Cell 21**. The east and the north walls are shown of brick, though here also the detail of the underlying brickwork wall fabric has become obscured by being covered over with paintwork. To the right (south), is the internal modern hardboard partition that separates this boiler room from **Cell 22** to the south.

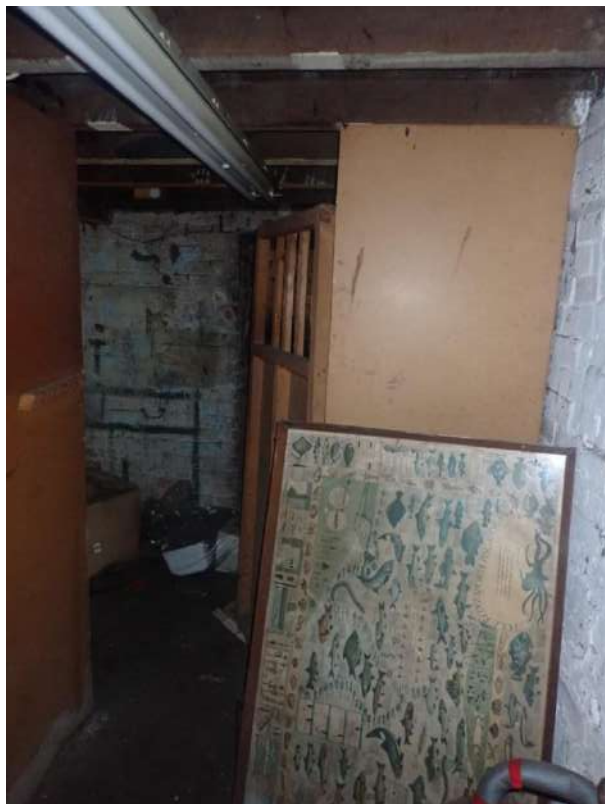
**Plate 439: View of the interior of Cell 21, from the north-east**

**Plates 439** provides a further view into the interior of the boiler room of **Cell 21** and shows the inner face of the hardboard and timber door and hardboard internal partition to the west.

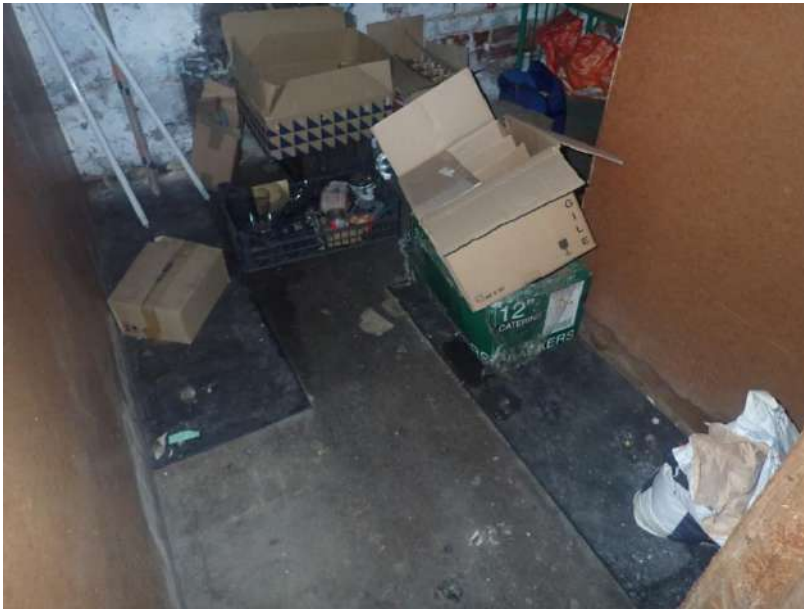
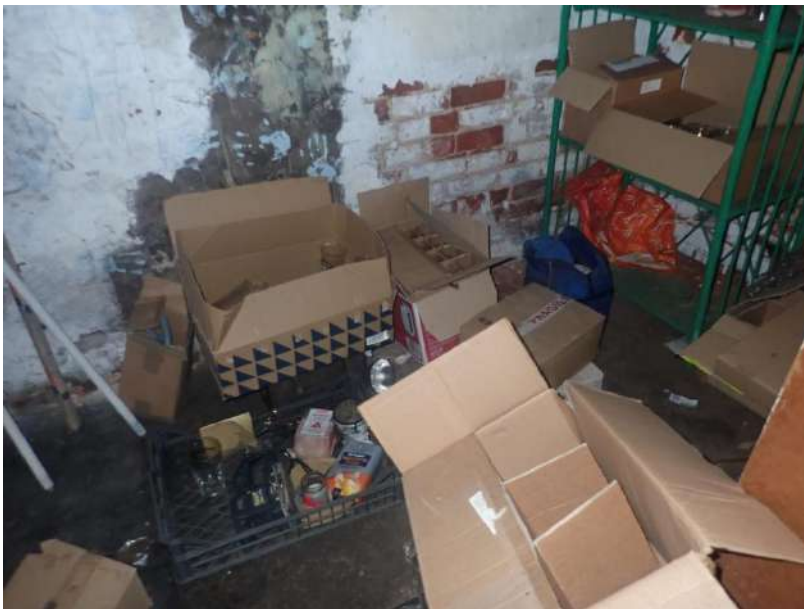
**Plates 440 and 441** illustrate the nature of the flooring of **Cell 22**, which is of modern concrete.

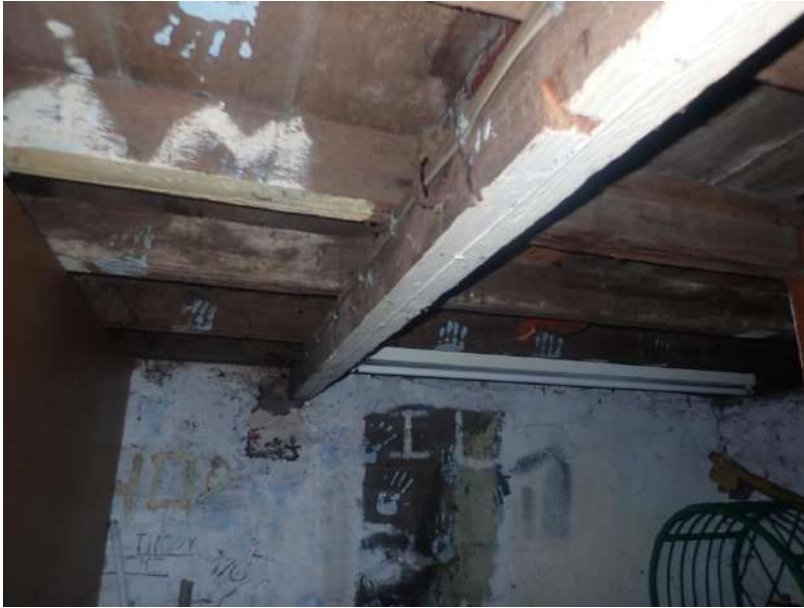
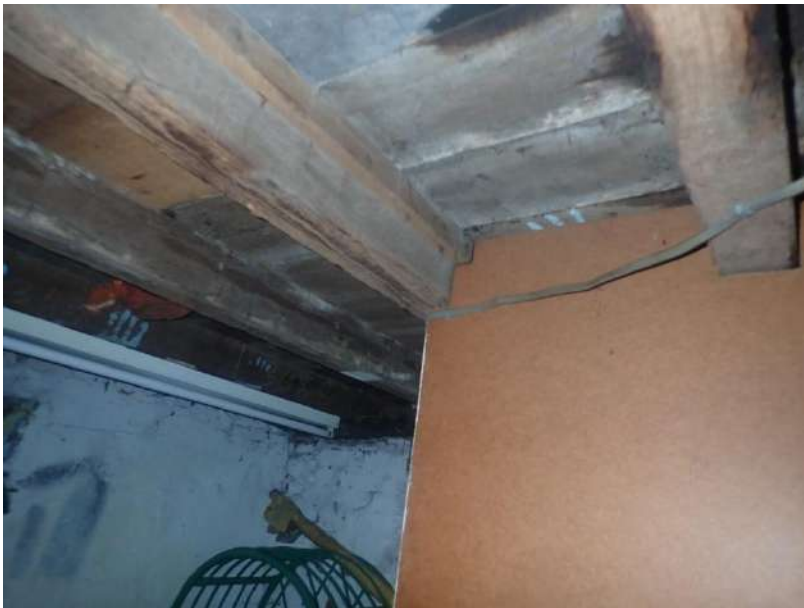
**Plates 442 and 443** provide detailed views of the nature of the ceiling structure of **Cell 22**. This is composed of a series of horizontal timber joists that are orientated from north-south. These in turn support the mezzanine floor covering above of horizontal timber planking, which are aligned from east-west.

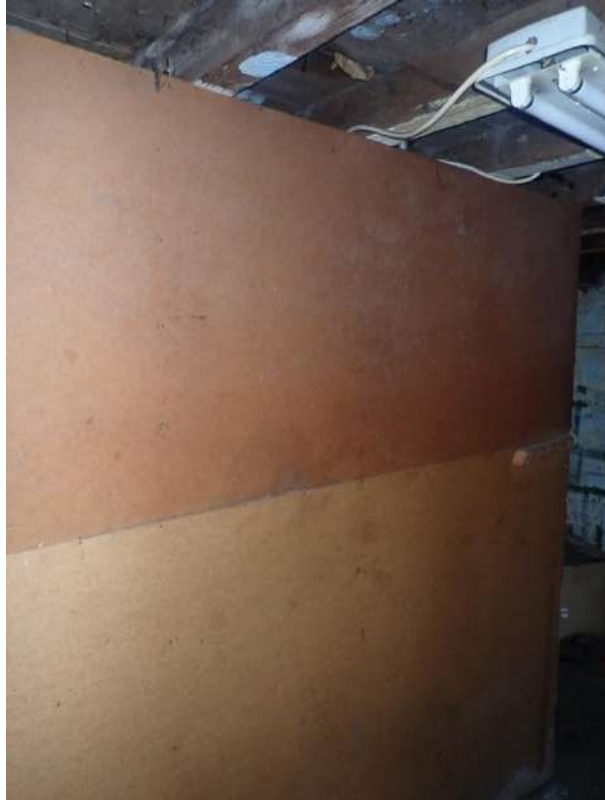
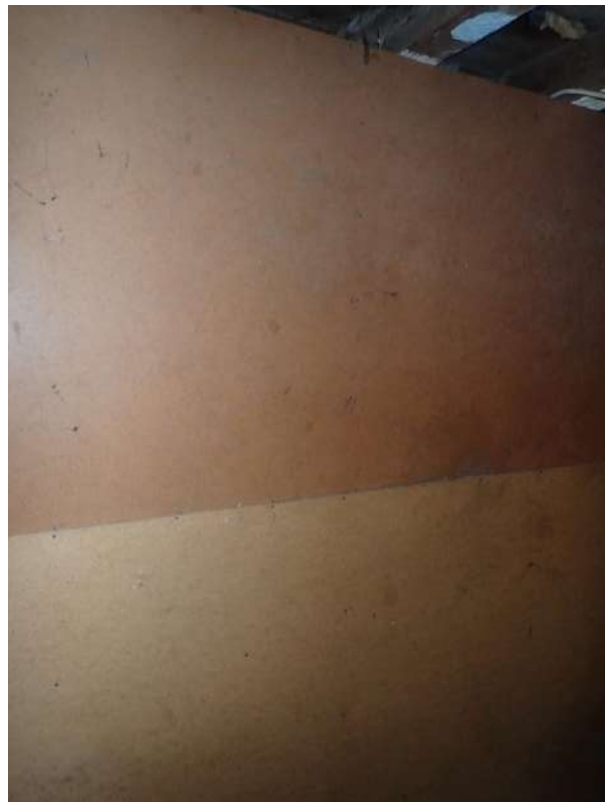
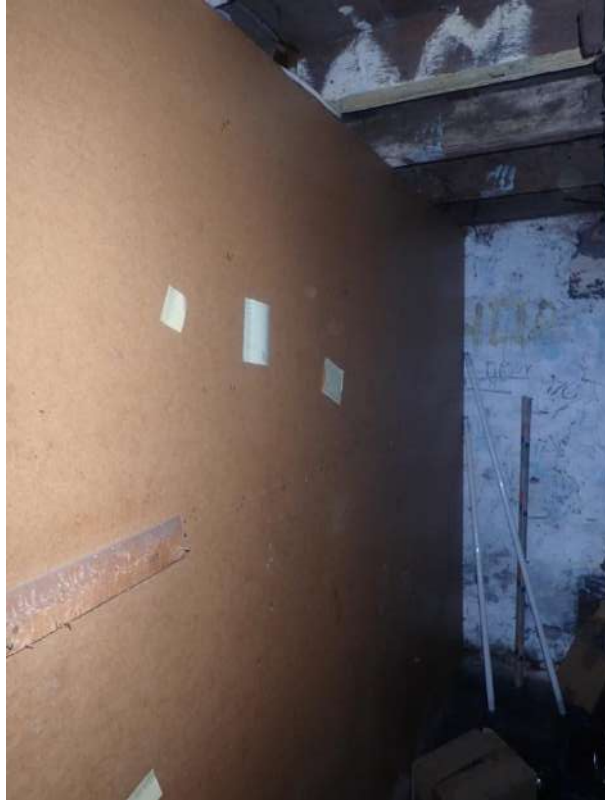
**Plates 444-446** feature the modern internal hardboard partition between **Cell 22** and **Cell 21** to the north.

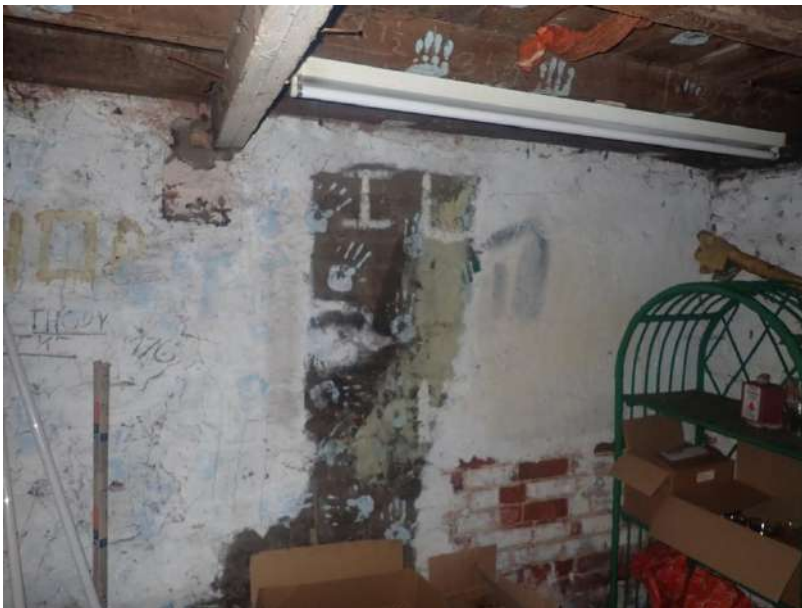
**Plate 447:** View of the interior of Cell 22, from the north-west

**Plate 447** presents a view of the east wall of **Cell 22**, which though constructed of brick, much of the detail of this underlying brickwork has become obscured by being painted over. At the lower levels, where this is absent, courses of brick stretchers and of mixed brick headers and brick stretches may be observed.

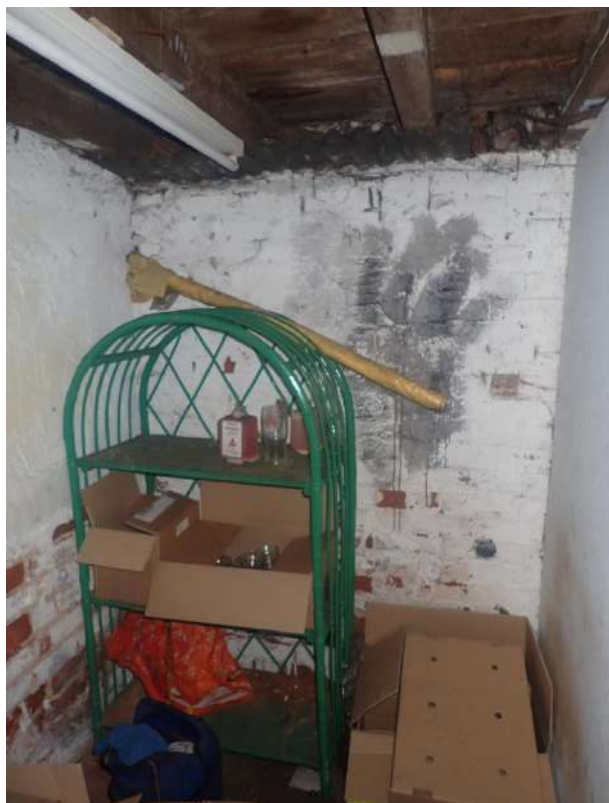
Plate 448: View of the interior of Cell 22, from the north

**Plate 448** presents a view of the south wall of **Cell 22**. Here also, the detail of the underlying brickwork wall fabric here has become obscured by being covered over with paintwork.

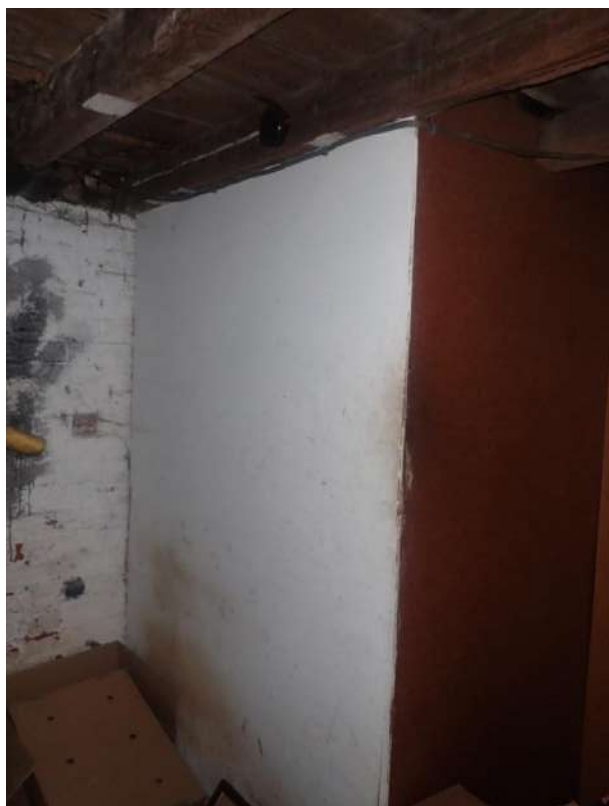
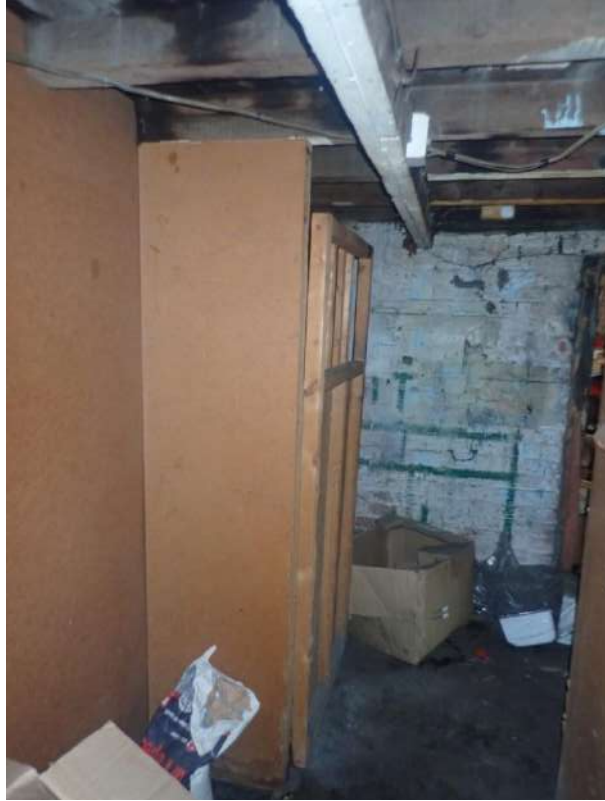
**Plates 449 and 450** feature the modern hardboard partition between this **Cell 22** and **Cell 23** to the south-west. The inner face of the modern hardboard and timber door that leads onto **Cell 21** to the west is also shown.

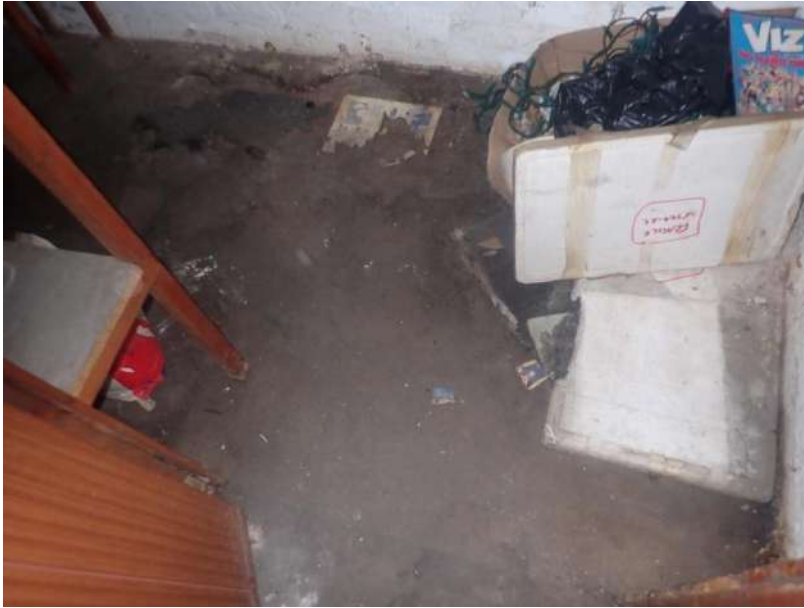
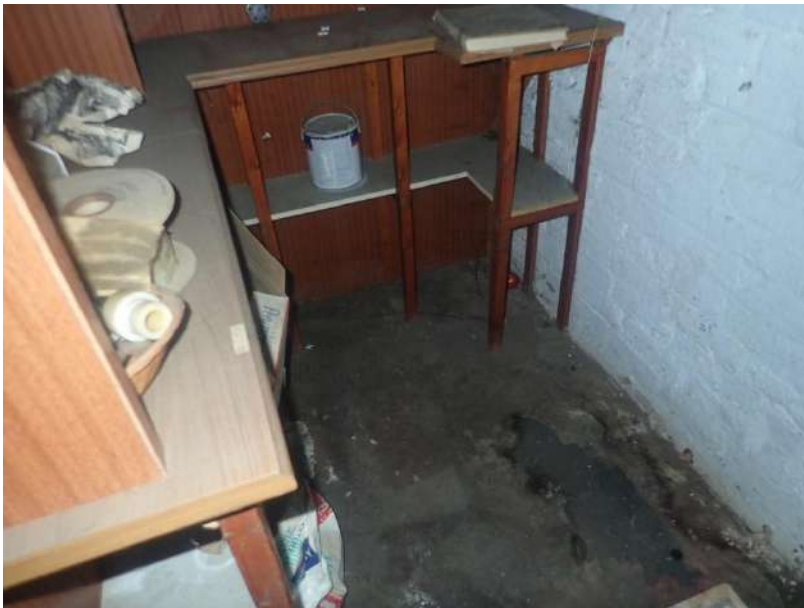
**Plates 451 and 452** feature the nature of the flooring of **Cell 23**, which is of modern concrete.

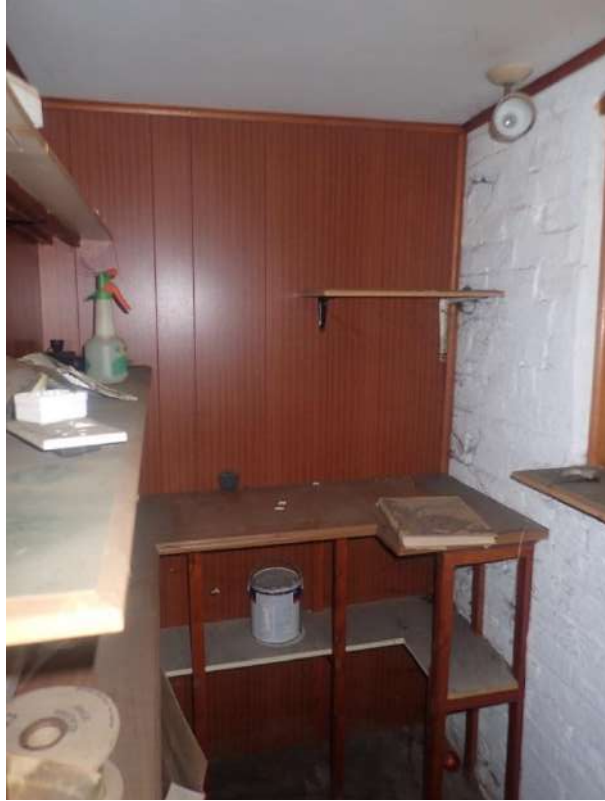
**Plate 453: View of the interior of Cell 23, from the south-west**

**Plate 453** shows the east wall of **Cell 23**, which is composed of modern timber panelling.

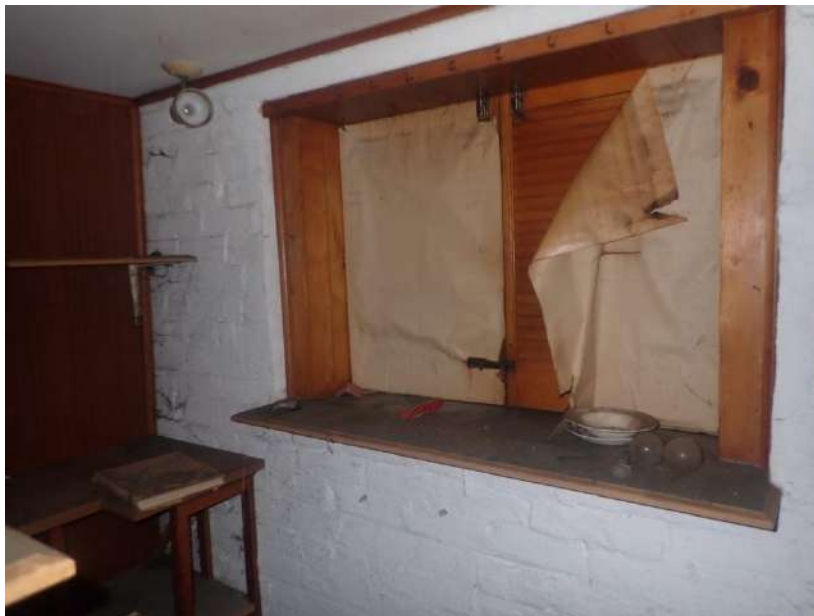
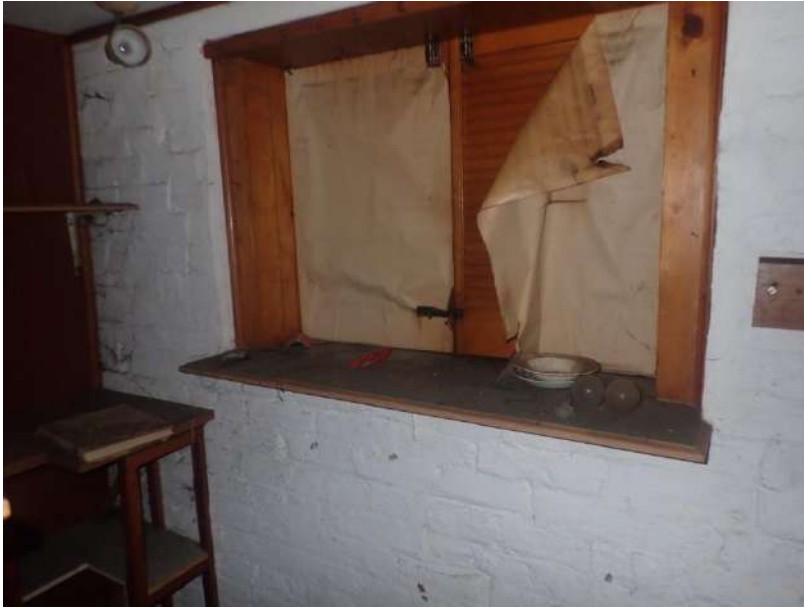
**Plates 454 and 455** present views of the south wall of **Cell 23**, the detail of the underlying brickwork wall fabric of which, has become obscured by being covered over with paintwork. The central feature here is the slightly recessed inner face of a modern timber serving hatch/counter, which served the former games room (**Cell 24**) to the public house to the east.

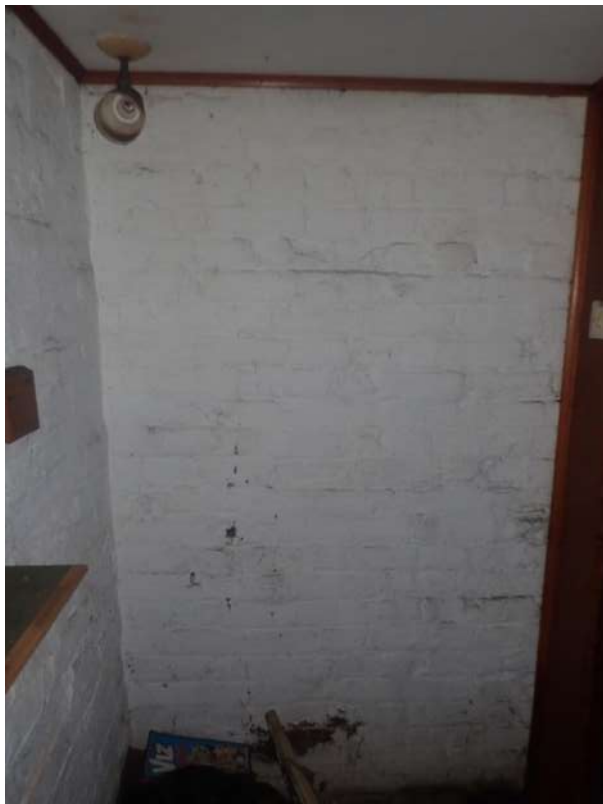
**Plate 456: View of the interior of Cell 23, from the north-east**

**Plate 456** provides a detailed view of the west wall of **Cell 23**. Here also, the detail of the underlying brickwork wall fabric of which, has become obscured by being covered over with paintwork.

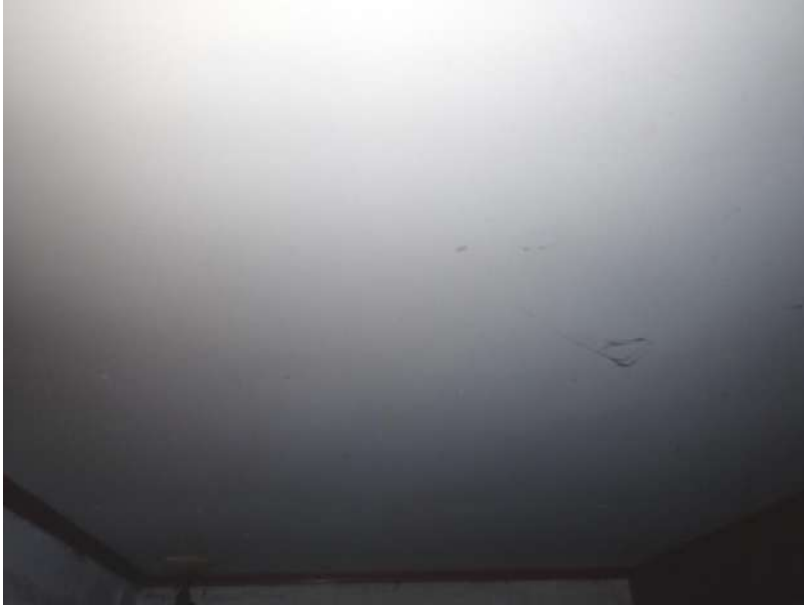
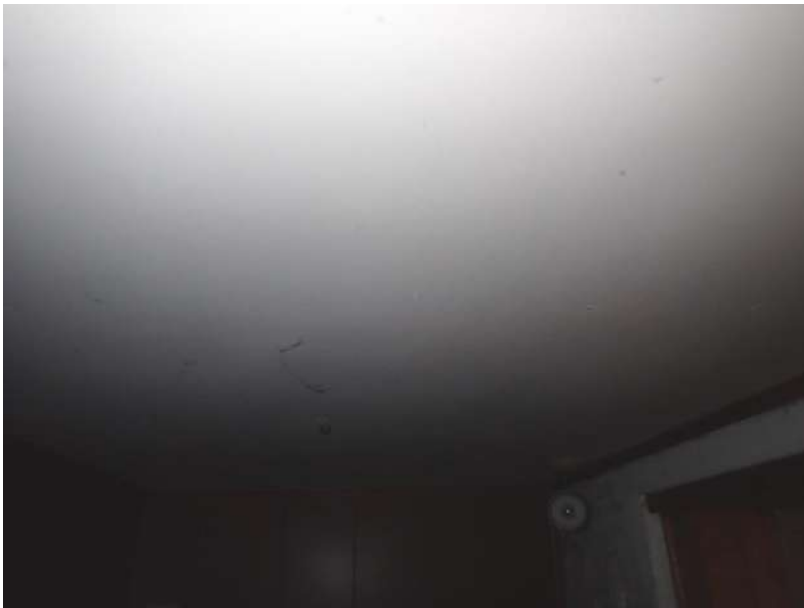
**Plates 457 and 458** illustrate the nature of the ceiling structure of **Cell 23**, which has been rendered over with modern plasterwork.

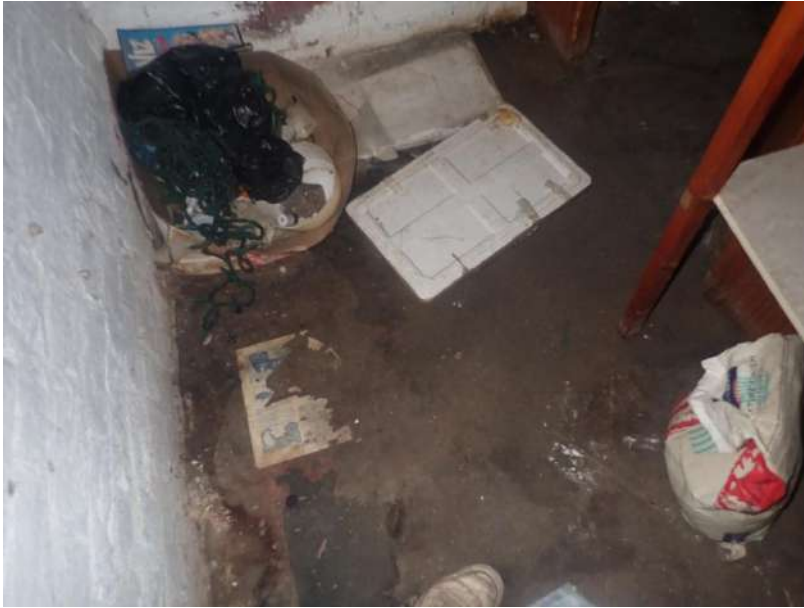
**Plate 461: View of the flooring of Cell 23, from the north-east**

**Plate 461** provides a further view of the nature of the flooring of **Cell 23**, which is of modern concrete.

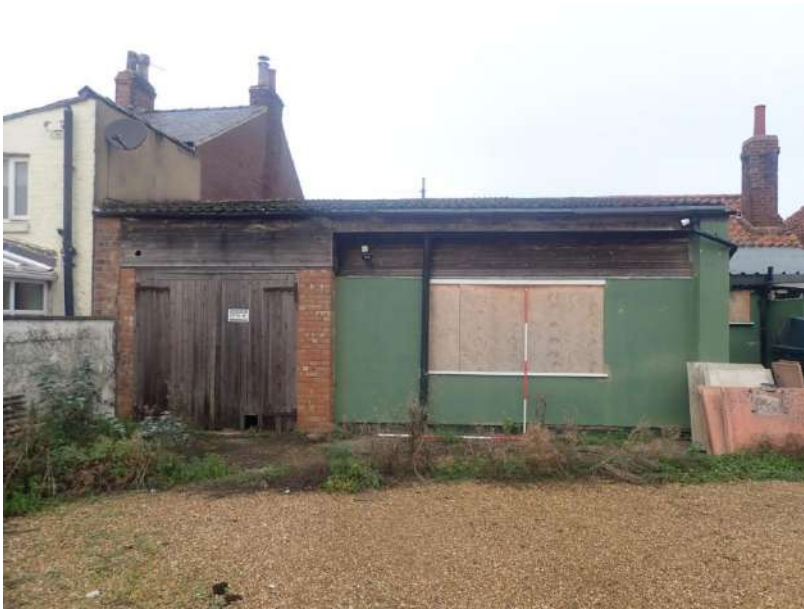
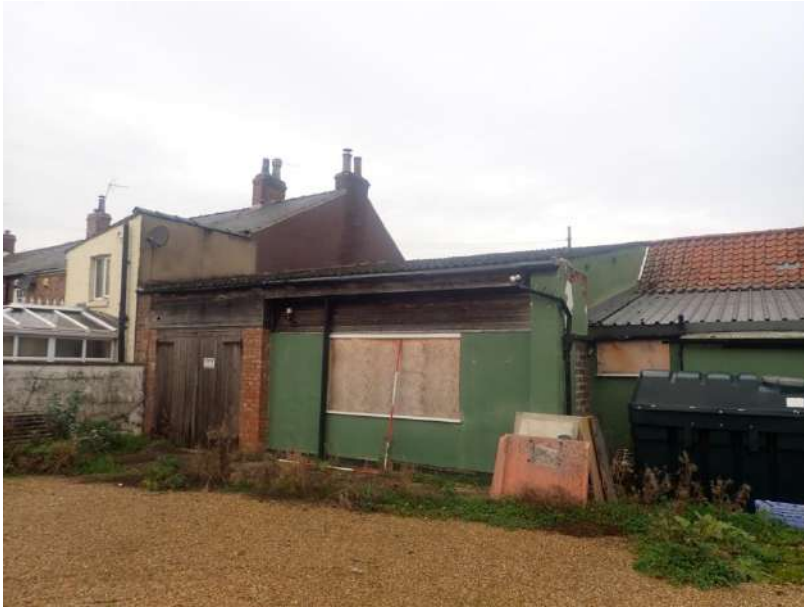
**Plates 462 and 463** show the South Elevation of **Building 6**, which is clearly a modern addition to this former pubic house complex. This is a single storey building with a low angled half gabled roof and a roof covering of sheets of corrugated metal, which had a former dual role with the eastern portion comprising a former games room and with the western portion along with **Cell 10** of **Building 5** to the north, functioning as a former working commercial garage. This duality of purpose is reflected in the appearance of this South Elevation, the eastern portion of the brickwork wall fabric of which has been covered over with modern cement rendering. Above this rendering and at just below roof levels is modern timber weatherboarding, which also extends westwards to the upper levels of the western portion of this building. Also within this eastern portion is a blocked off south facing window opening that has been boarded over.

Within the western portion of the building, the brickwork is visible as two columns which flank both sides. This brickwork is composed of courses of brick stretchers. Enclosed by these two columns is a south facing entrance opening, that is occupied by a timber frame of a head and surrounds and by a pair of timber doors, each in turn composed of a series of vertical tongued and grooved timber planks. The doors are attached to the frame by two pairs of cast metal strap hinges. A vertical metal pillar may also be seen to be supporting the frontal roof structure of the building. At just below roof levels is modern Upvc horizontal guttering that extends onto a vertical modern Upvc downpipe to the east.

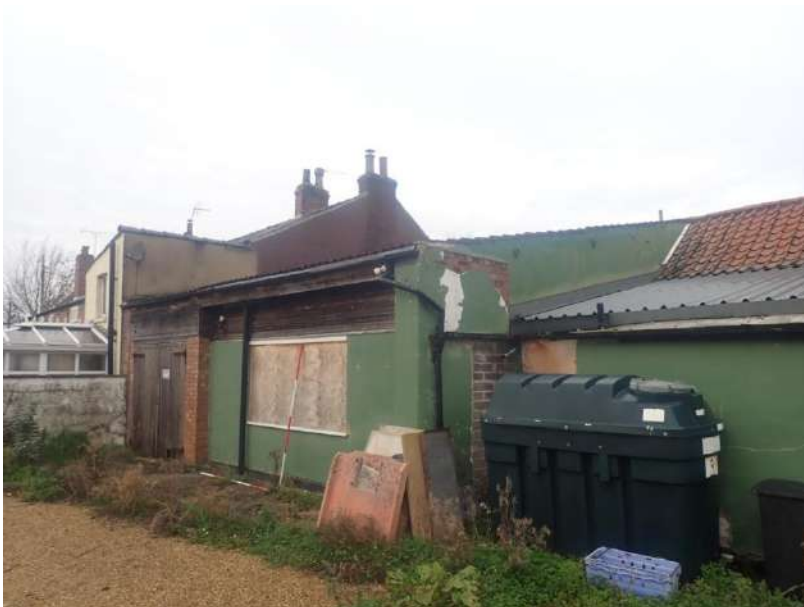
**Plate 464: View of the East Elevation of Building 6, from the south-east**

**Plate 464** provides a view of the East Elevation of this building. Most of the brickwork wall fabric on this Elevation has been covered with modern cement rendering. A portion of this brickwork is exposed, where this rendering is absent however. Here, this is composed of a mix of courses of

brick stretchers, of courses of mixed brick headers and stretchers and a single course of brick headers.

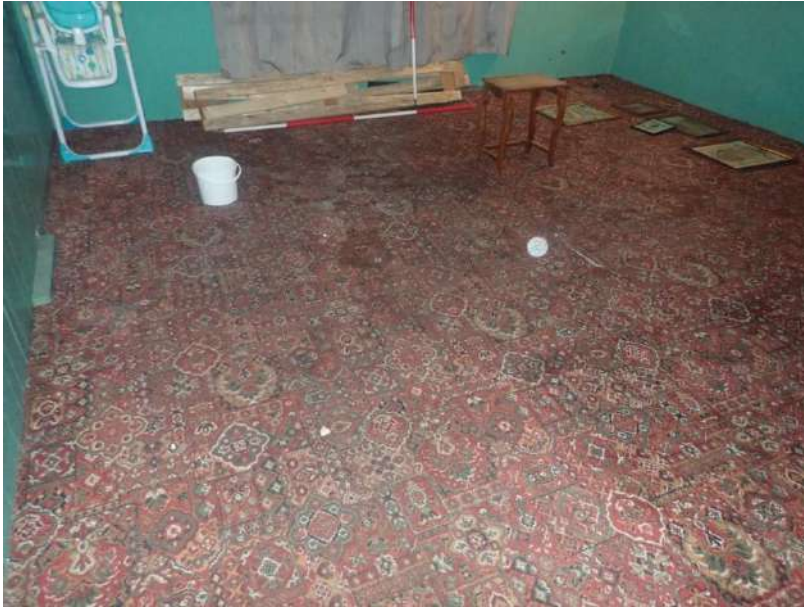
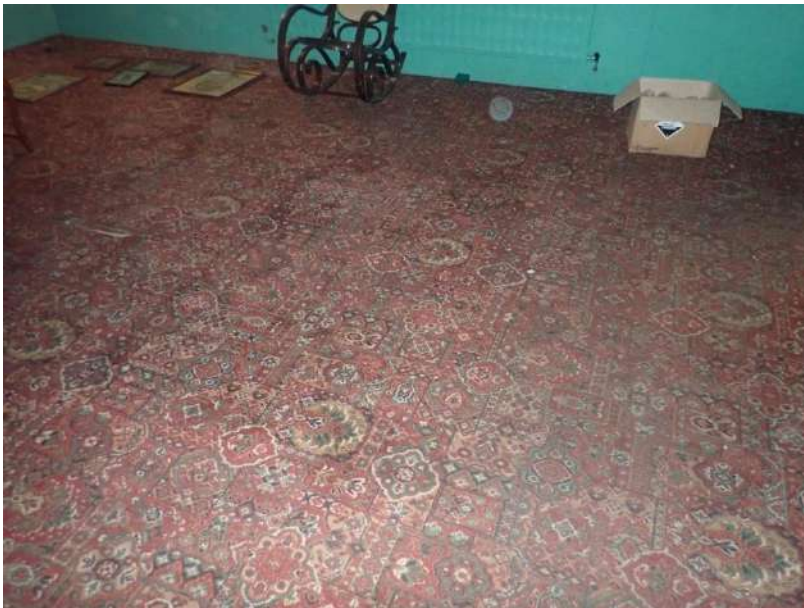
**Plates 467 and 468** feature the nature of the flooring of **Cell 24**, which is covered with modern carpeting.

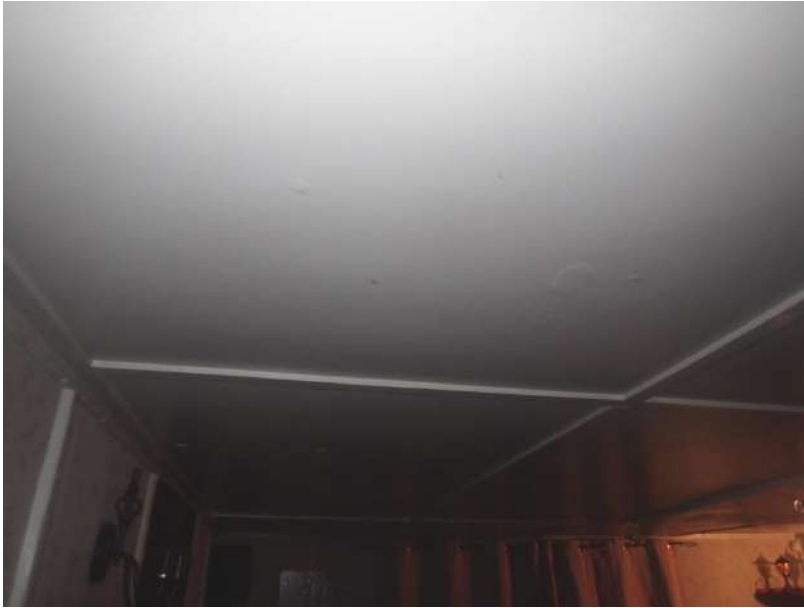
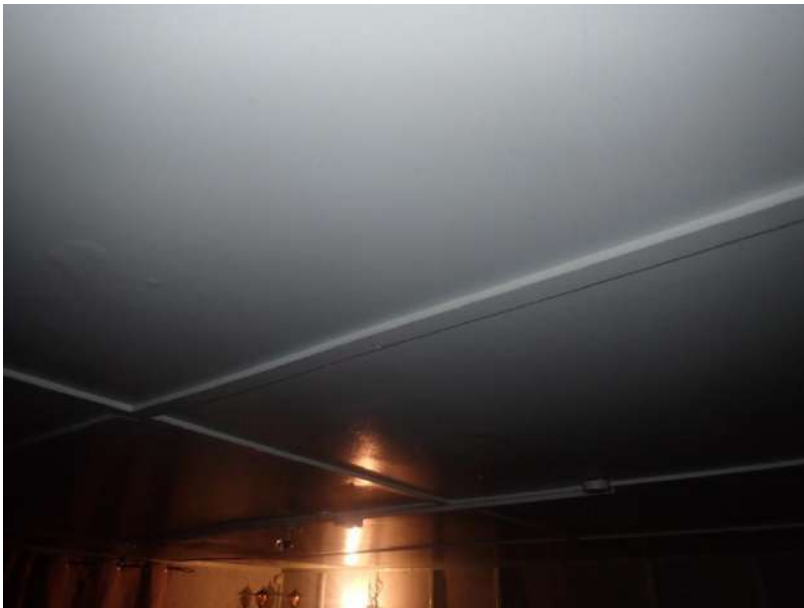
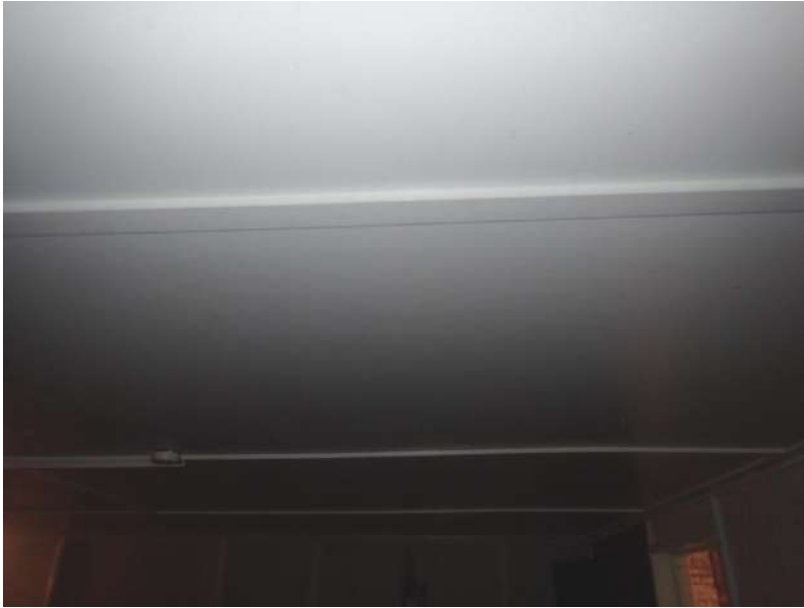
**Plates 469-474** feature a number of views from differing positions of the nature of the ceiling structure of **Cell 24**. This consists of a timber framework within which the ceiling surface has been rendered over with modern plasterwork.

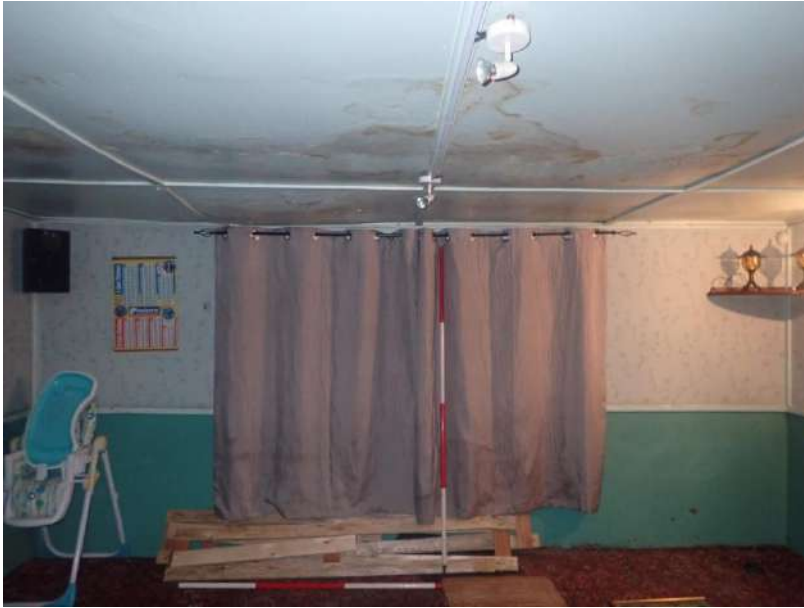
**Plate 475: View of the south wall of Cell 24, from the north-west**

**Plate 475** presents a detailed view of the south wall of **Cell 24**. The wall fabric here has been covered over with modern wallpaper with horizontal timber dado rails inserted into this fabric at mid levels. Also shown is the inner face of the south facing window opening that was recorded externally at the South Elevation of this building and which was boarded over.

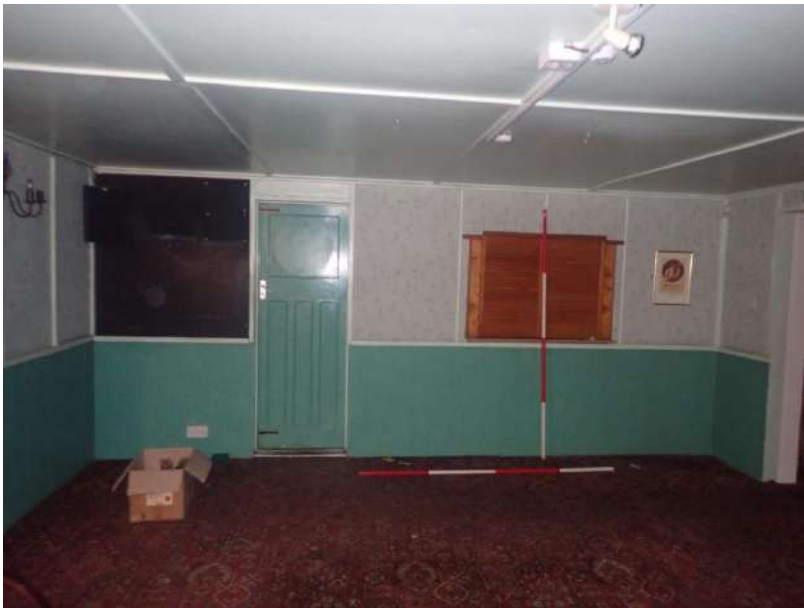
**Plate 476: View of the north wall of Cell 24, from the south-east**

**Plate 476** furnishes a view of the north wall of **Cell 24**, which is also the internal dividing wall with the adjacent **Cells 22 and 23 of Building 5** to the north. The wall fabric here has also been covered over with modern wallpaper with horizontal timber dado rails inserted into this fabric at mid levels. Also shown is the inner face of the north facing entrance opening that leads onto **Cell 19** to the north. This opening is occupied by a timber frame of a head and surrounds and by a modern panelled timber door. To the right (east), is the outer face of the modern timber serving hatch, that was also recorded within the adjacent **Cell 22 of Building 5** to the north.

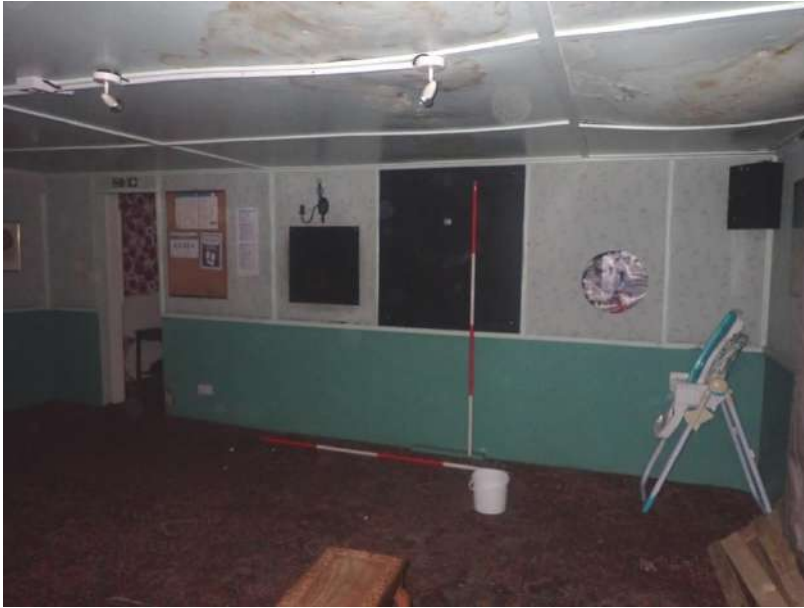
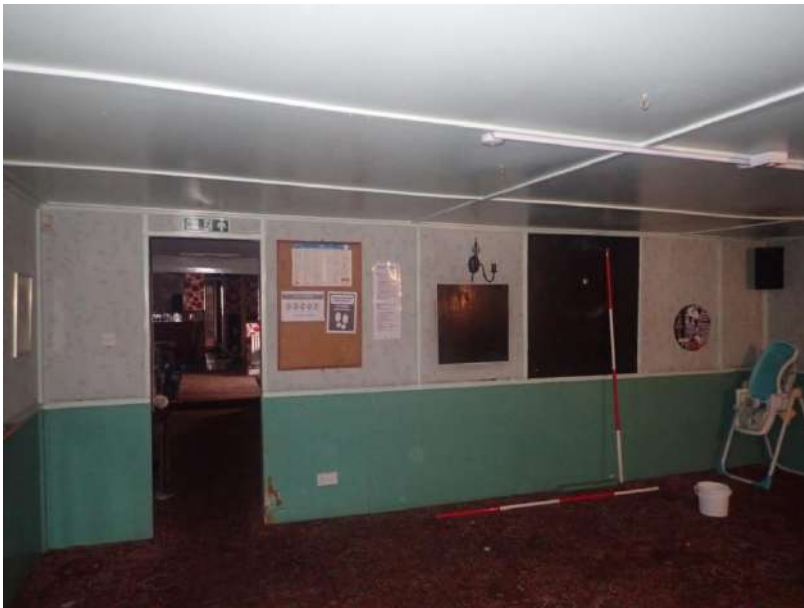
**Plates 477 and 478** present views of the east wall of **Cell 24**, which has also been covered over with modern wallpaper with horizontal timber dado rails inserted into this fabric at mid levels. To the left (north), is the open access which leads onto **Cell 16 of Building 4** to the east.
