HISTORIC BUILDING RECORDING AT THE  
FORMER DUKE OF YORK PUBLIC HOUSE,  
106, RISEGATE ROAD,  
GOSBERTON RISEGATE, LINCOLNSHIRE

**National Grid Reference: TF 2186 3004**  
**Planning Reference: H08-0964-21**  
**Site Code: RRGR22**  
**Accession Number: LCNCC: 2022.147**

PREPARED FOR MRS. S. GOODENOUGH

January 2023

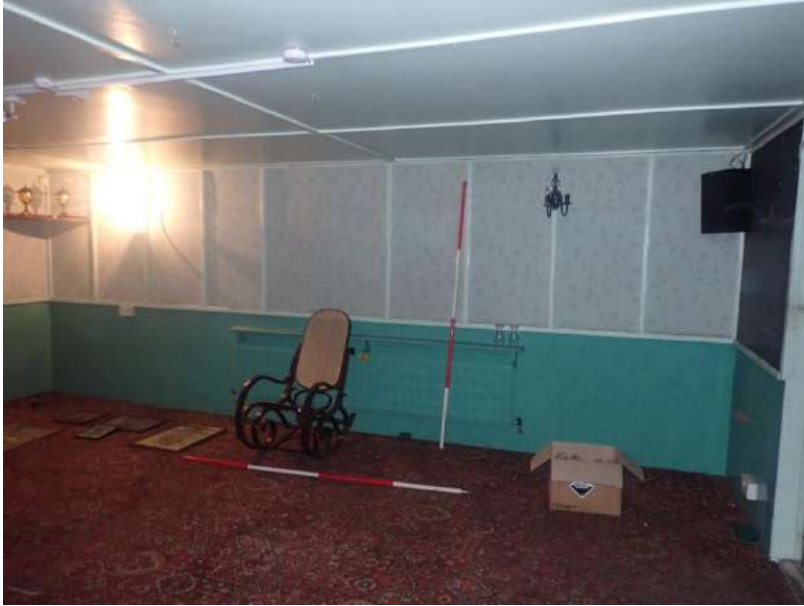
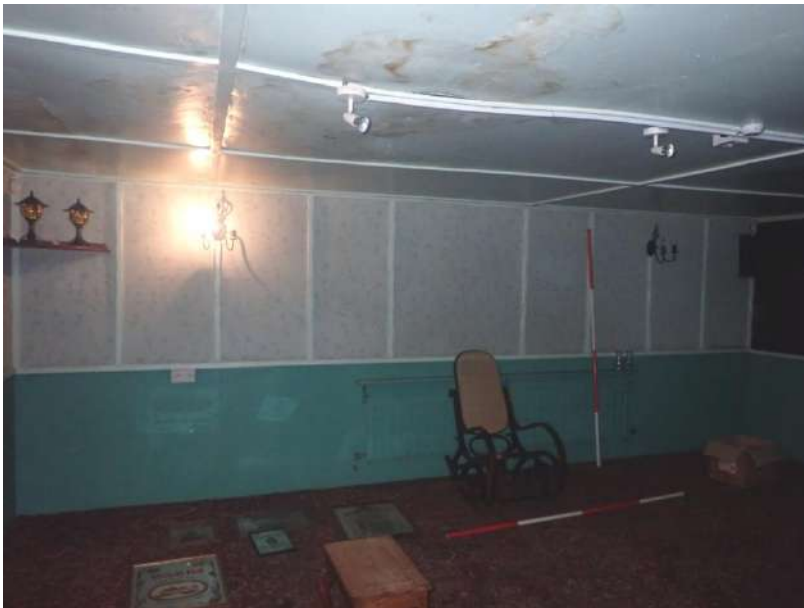
**Plates 479 and 480** provide views of the west wall of **Cell 24**, which has also been covered over with modern wallpaper with horizontal timber dado rails inserted into this fabric at mid levels.

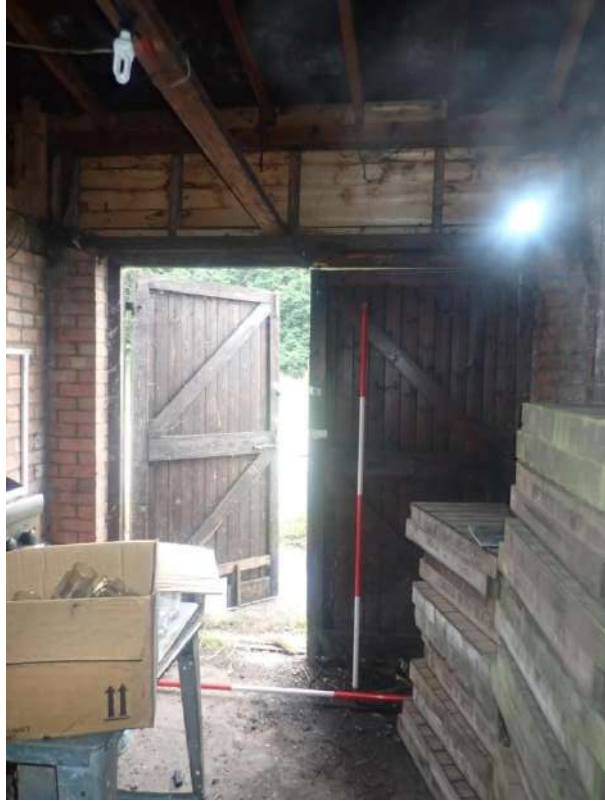
**Plate 481: View of the south wall of Cell 25, from the north-west**

**Plate 481** provides a view of the south wall of **Cell 25** and features the inner face of the south facing entrance opening that was recorded externally at the South Elevation of this building. The central feature here is the entrance opening that is occupied by a pair of timber doors, each composed of a series of vertical tongued and grooved timber planks that are in turn affixed to an internal framework of angled, vertical and horizontal timbers. The opening is flanked to either side by vertical brick columns, composed of courses of brick stretchers. Above the opening is external horizontal timber weatherboarding that is attached to an internal timber framework of vertical and horizontal timbers.

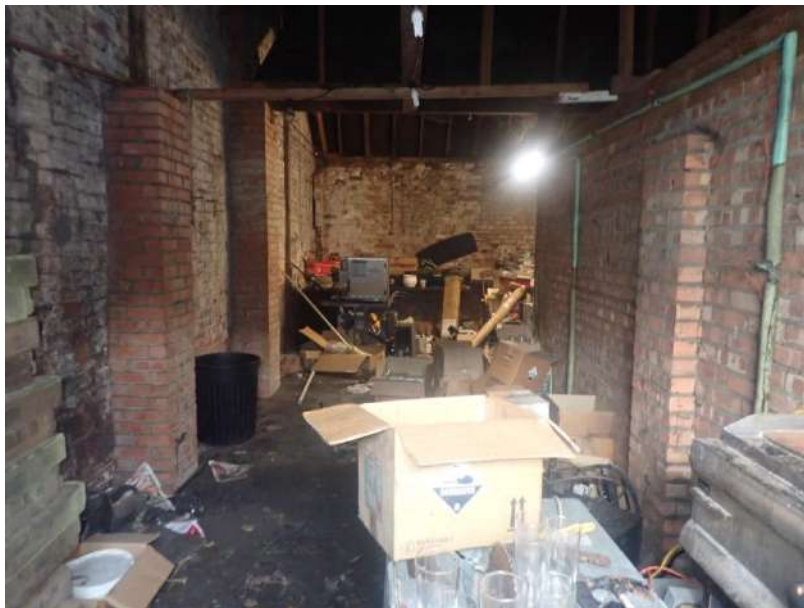
**Plate 482: General view of the interior of Cell 25, from the south-east**

**Plate 482** provides a general view of the interior of **Cell 25** from a south-eastern position. This formerly functioned as a garage. This space is incorporated with the adjoining **Cell 19 of Building 5** to the north. This combined formed the whole former garage space. A portion of the original South Elevation of the older **Building 5**, would have been removed to accommodate this modern function.

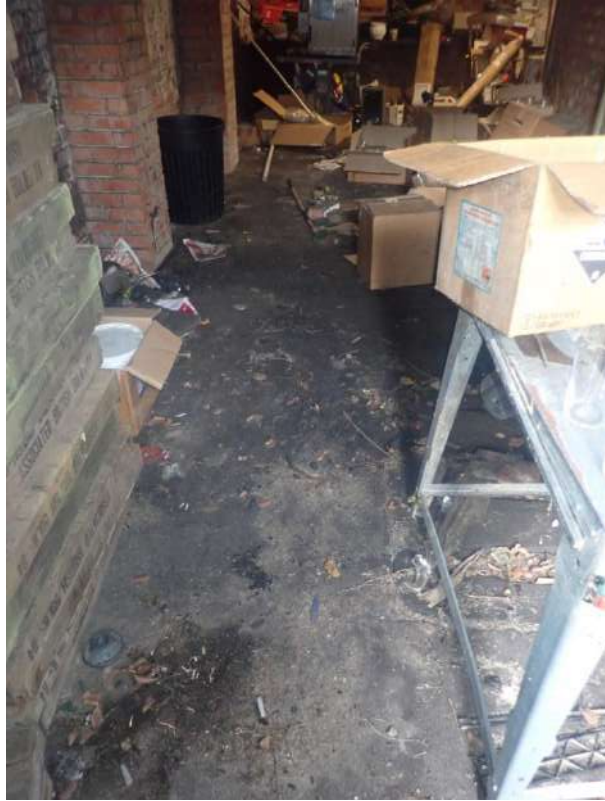
**Plate 483: View of the flooring of Cell 25, from the south-east**

**Plate 483** provides a view of the nature of the flooring of **Cell 25**, which is of modern concrete.

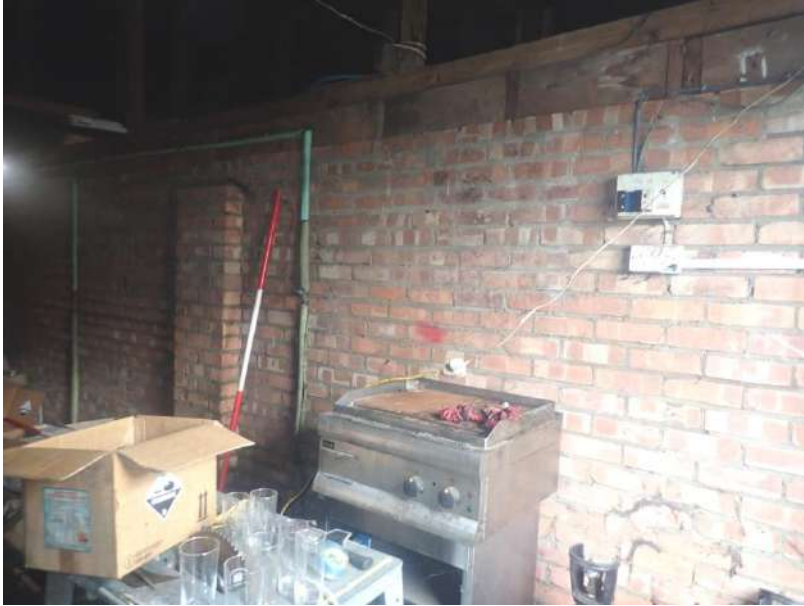
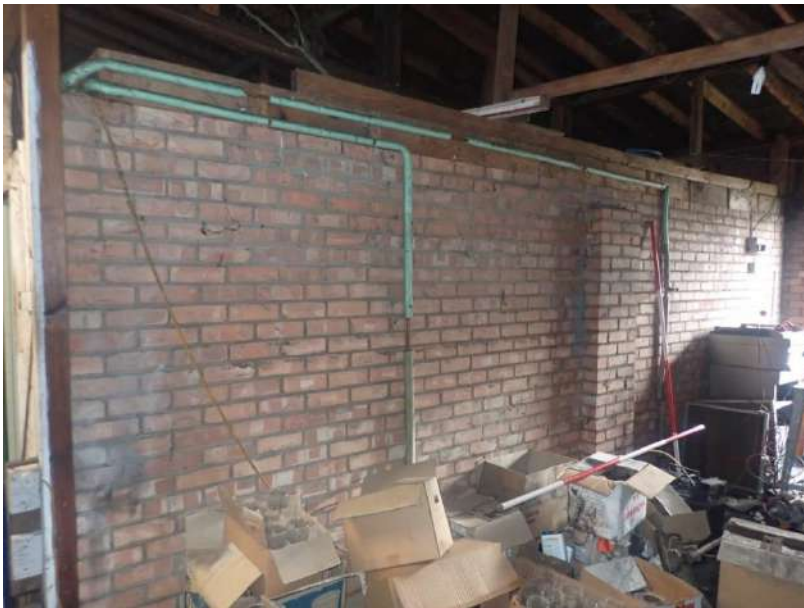
**Plates 485 and 486** furnish views of the east wall of **Cell 25**, which is also the internal dividing wall with the adjacent **Cell 24** to the east. The brickwork wall fabric here, including that of the bonded vertical brick column is composed of courses of brick stretchers in Stretcher Bond.

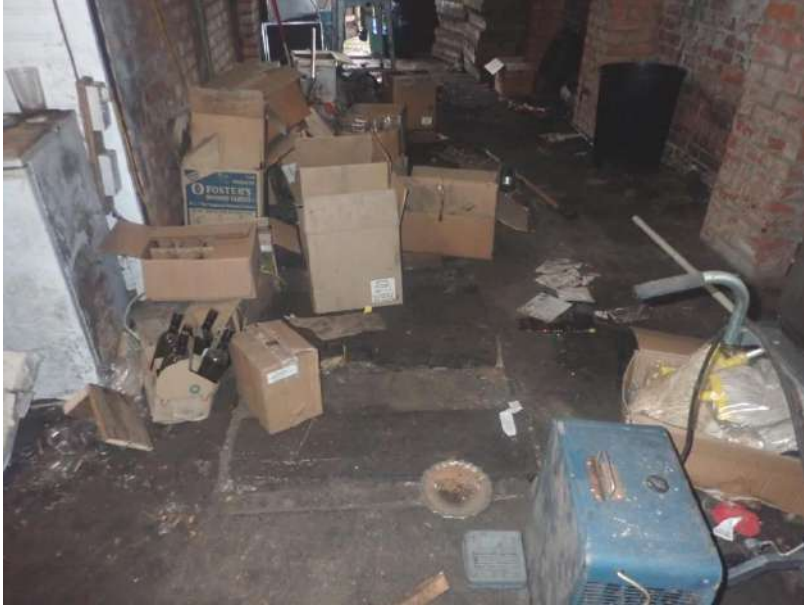
**Plate 487** View of the flooring of Cell 25, from the north-west

**Plate 487** provides a further view of the nature of the flooring of **Cell 25**, from a different north-western perspective, which is of modern concrete. Sunk into this flooring is a former vehicle inspection pit.

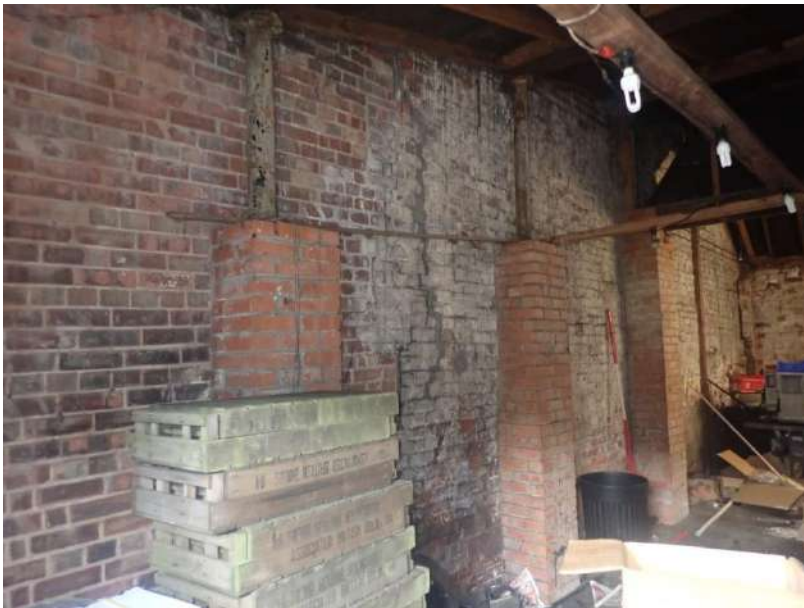
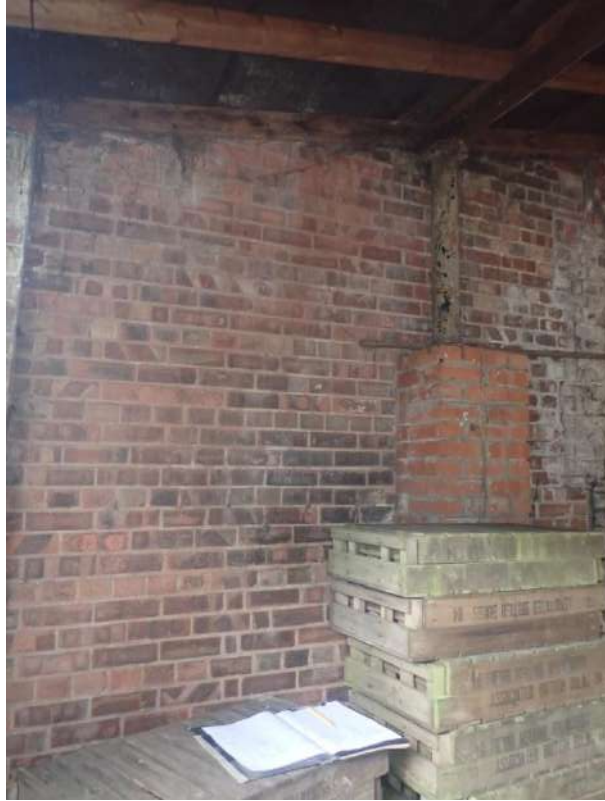
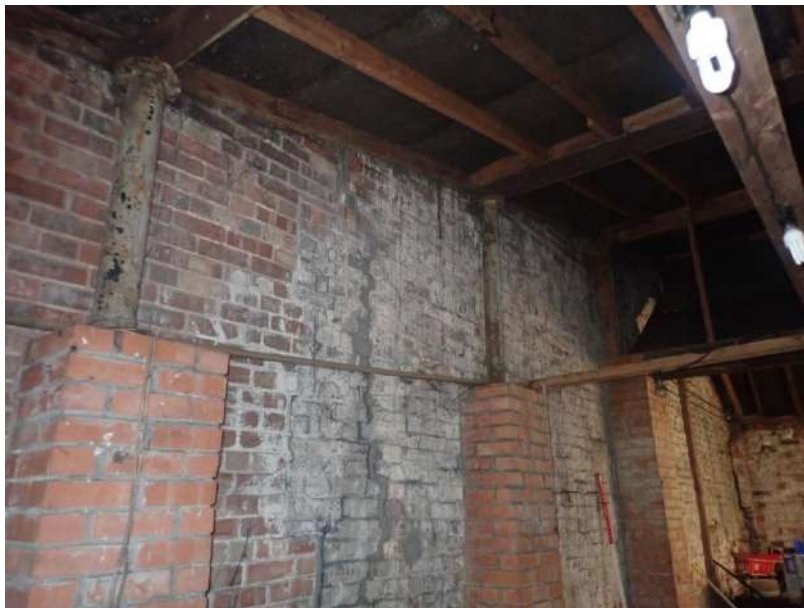
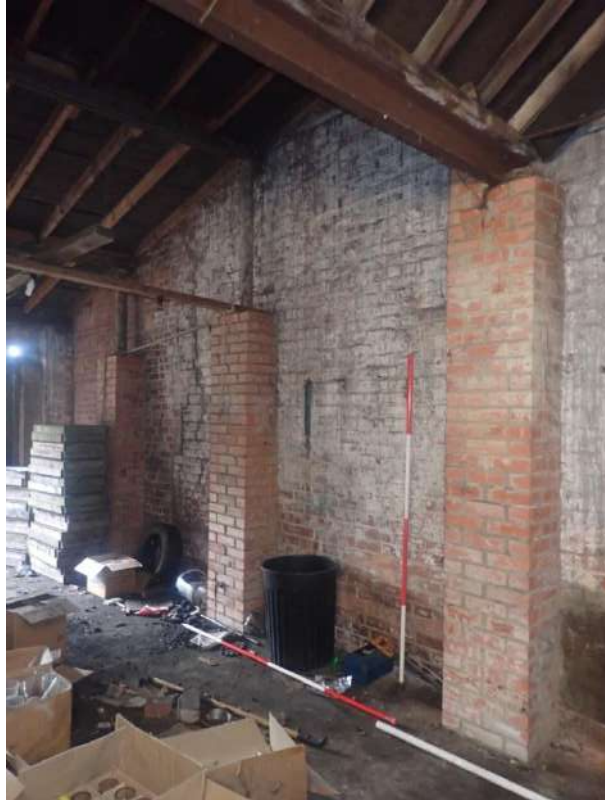
**Plates 488-491** provide several images of the west wall of **Cell 25**. Most of this wall fabric pertains to the East Elevation of an adjoining building, which is outside of the scope of this survey. Additional new brickwork associated with the construction of the modern **Building 6** is featured to the south. This brickwork is composed of three courses of brick stretchers that alternate with single courses of brick headers in English Garden Wall Bond. The three bonded vertical brick columns are part of this modern construction and are each composed of courses of brick stretchers.

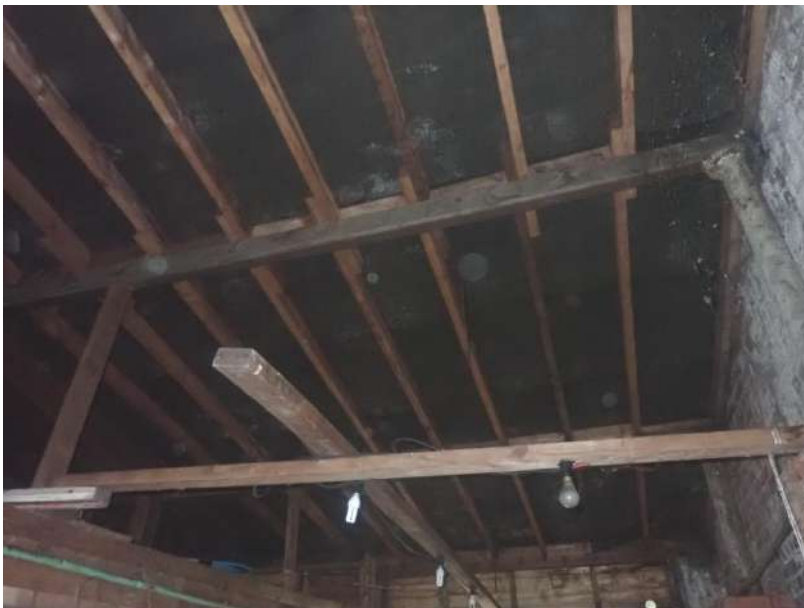
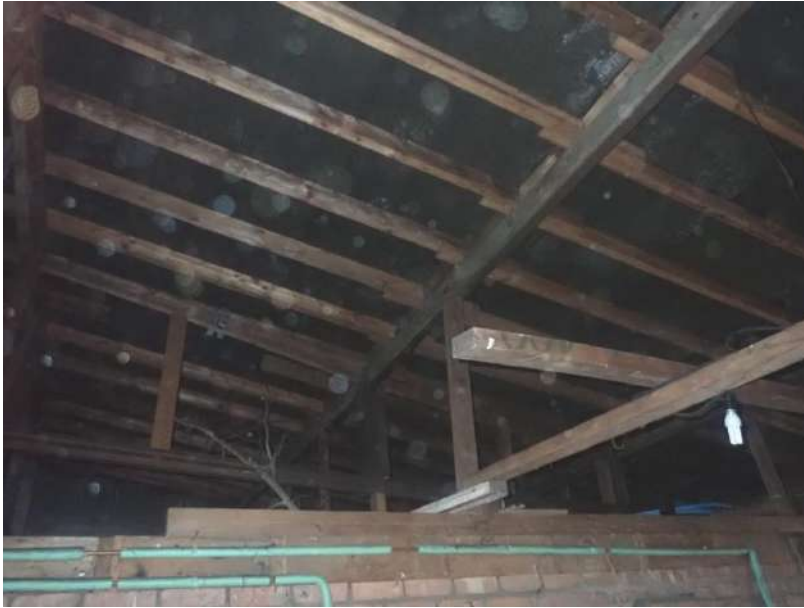
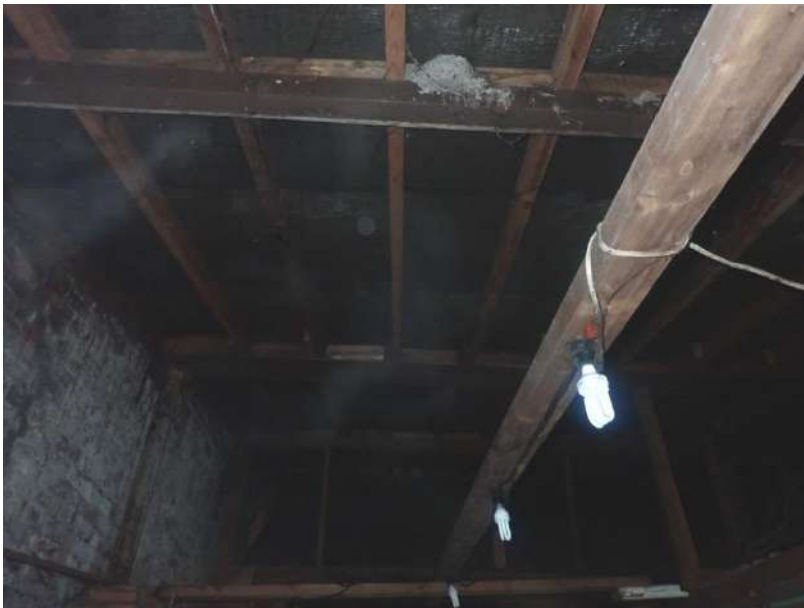
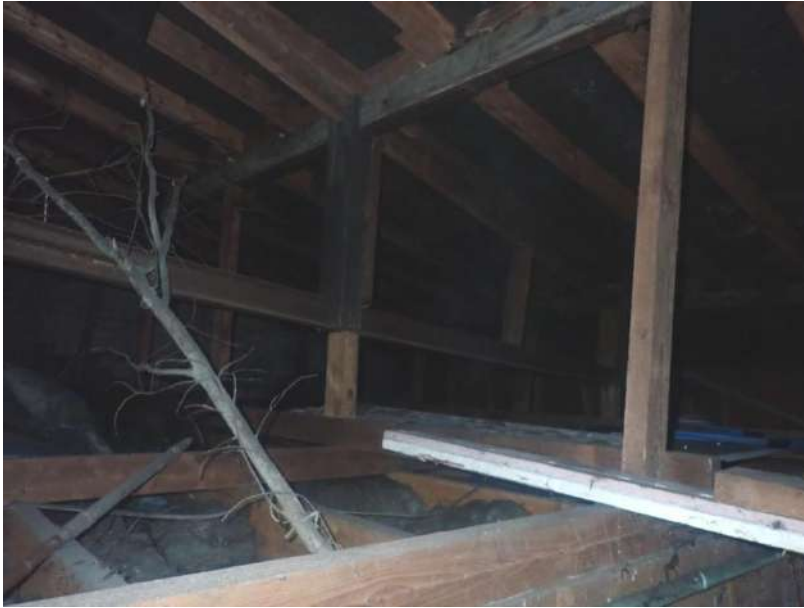
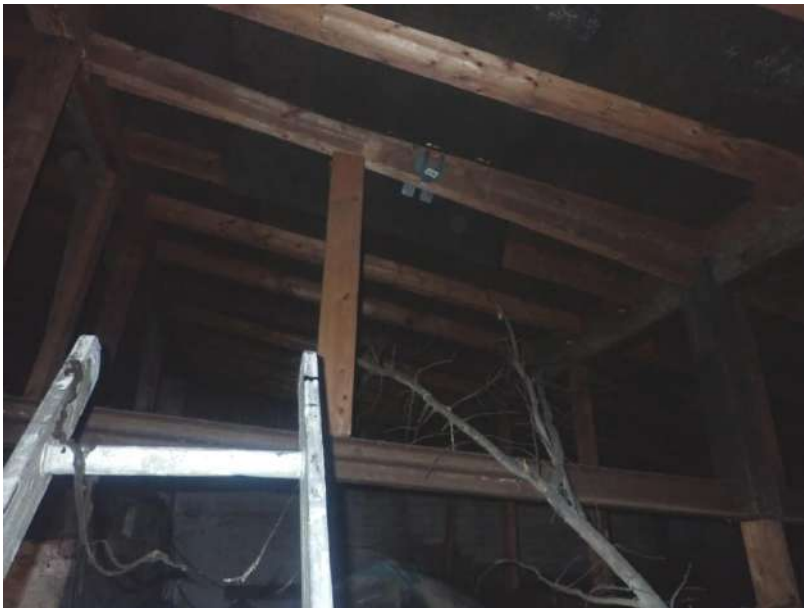
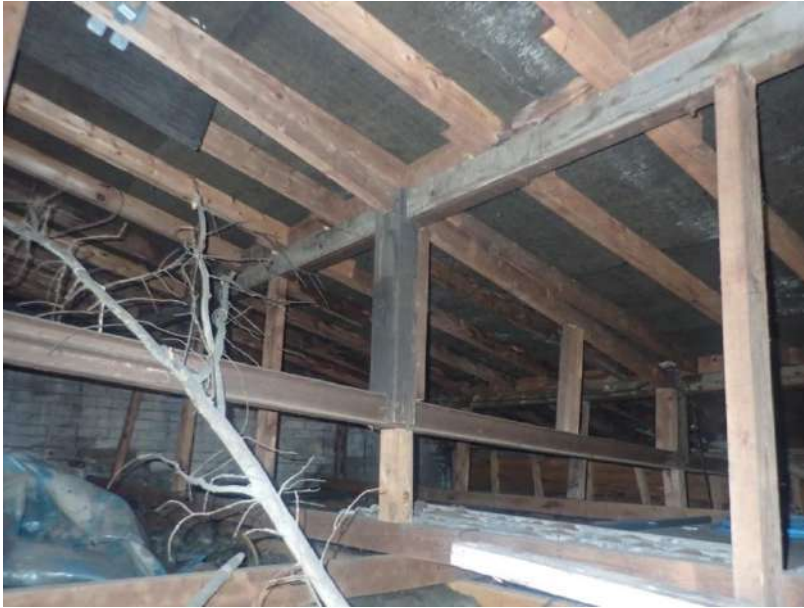
**Plates 492-503** present a number of views of the nature of the roof supporting structure of **Building 6**. This is a low angled half gabled roof structure, which consists of a framework of a series of north-south orientated timber rafters and east-west aligned timber purlins. Providing additional strength and reinforcement to this structure are several half gabled timber roof trusses.

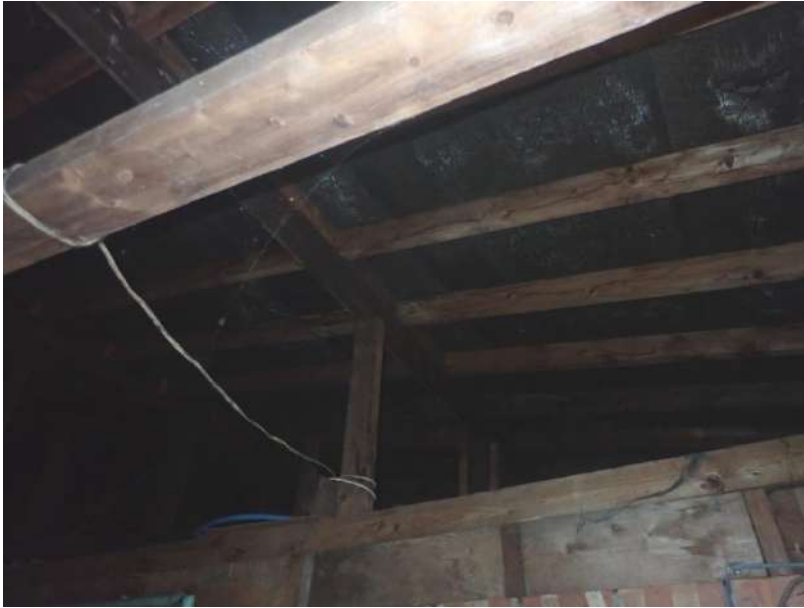
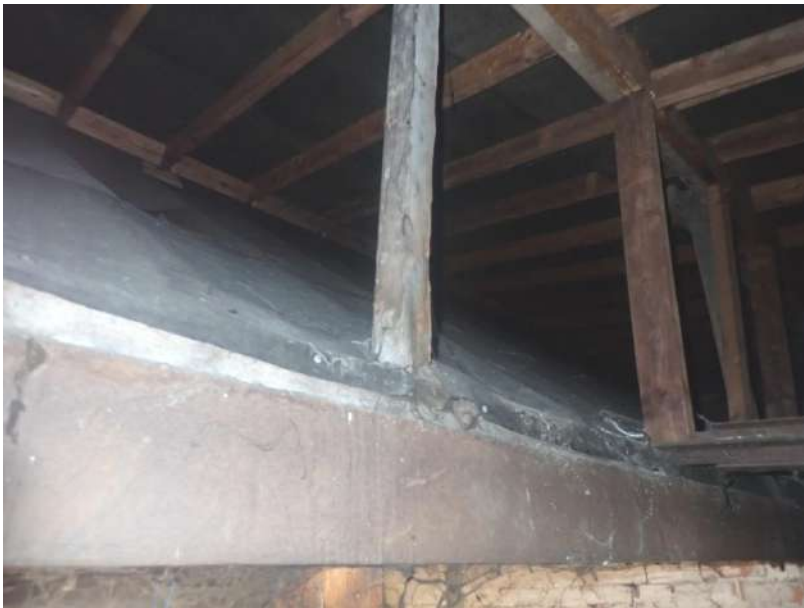
**Plates 495 and 500** show the southern side of the by now submerged former gabled roof structure of the adjoining and earlier **Building 5**. This earlier roof structure has become subsumed by the subsequent construction and addition of the modern roof structure of **Building 6**.
