# **GROUND CONTAMINATION INVESTIGATION AND ASSESSMENT**

## **PHASE 2 - INTRUSIVE**

**cnr. Cheal Road/Saltfleet Lane,  
Surfleet  
PE11 4BD**

**Report on:** Phase 2 investigation with trialpits

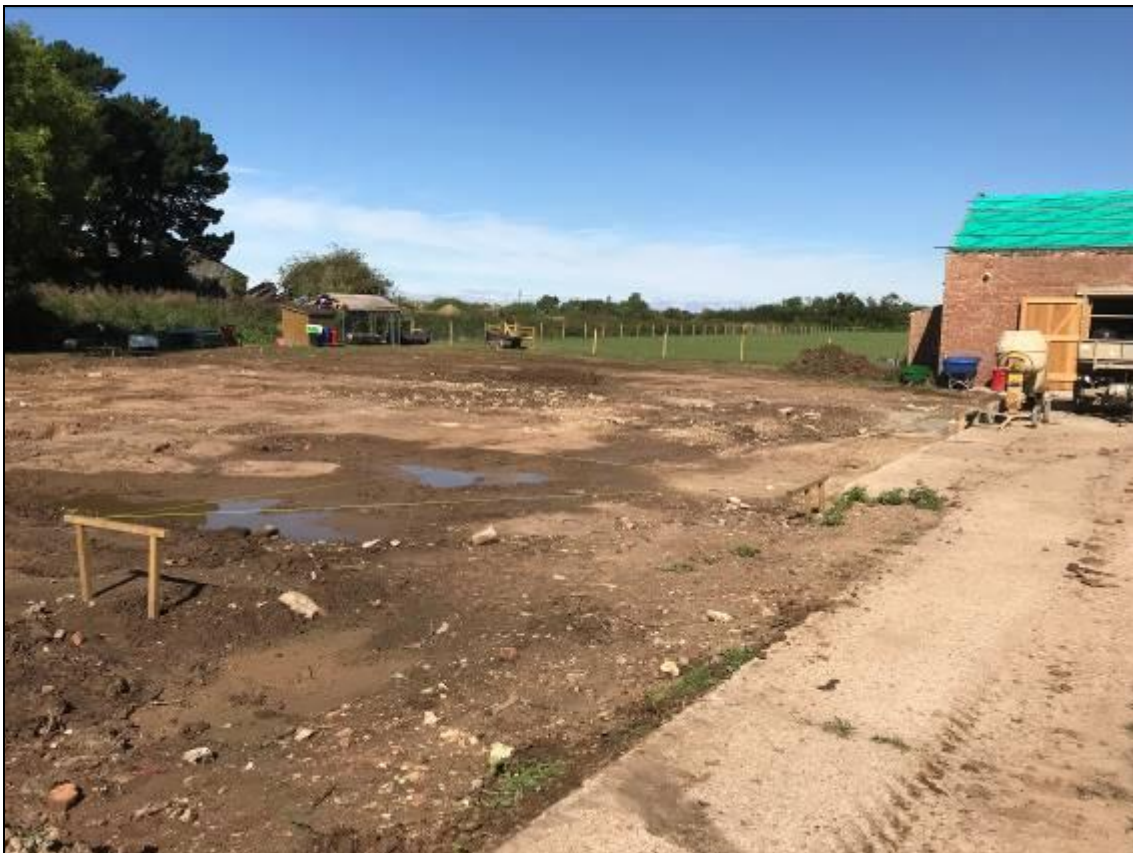
Fig 1 – view to northwest across site after stripping

All above-ground infrastructure has been removed and site has been stripped to expose the natural soil at the site.

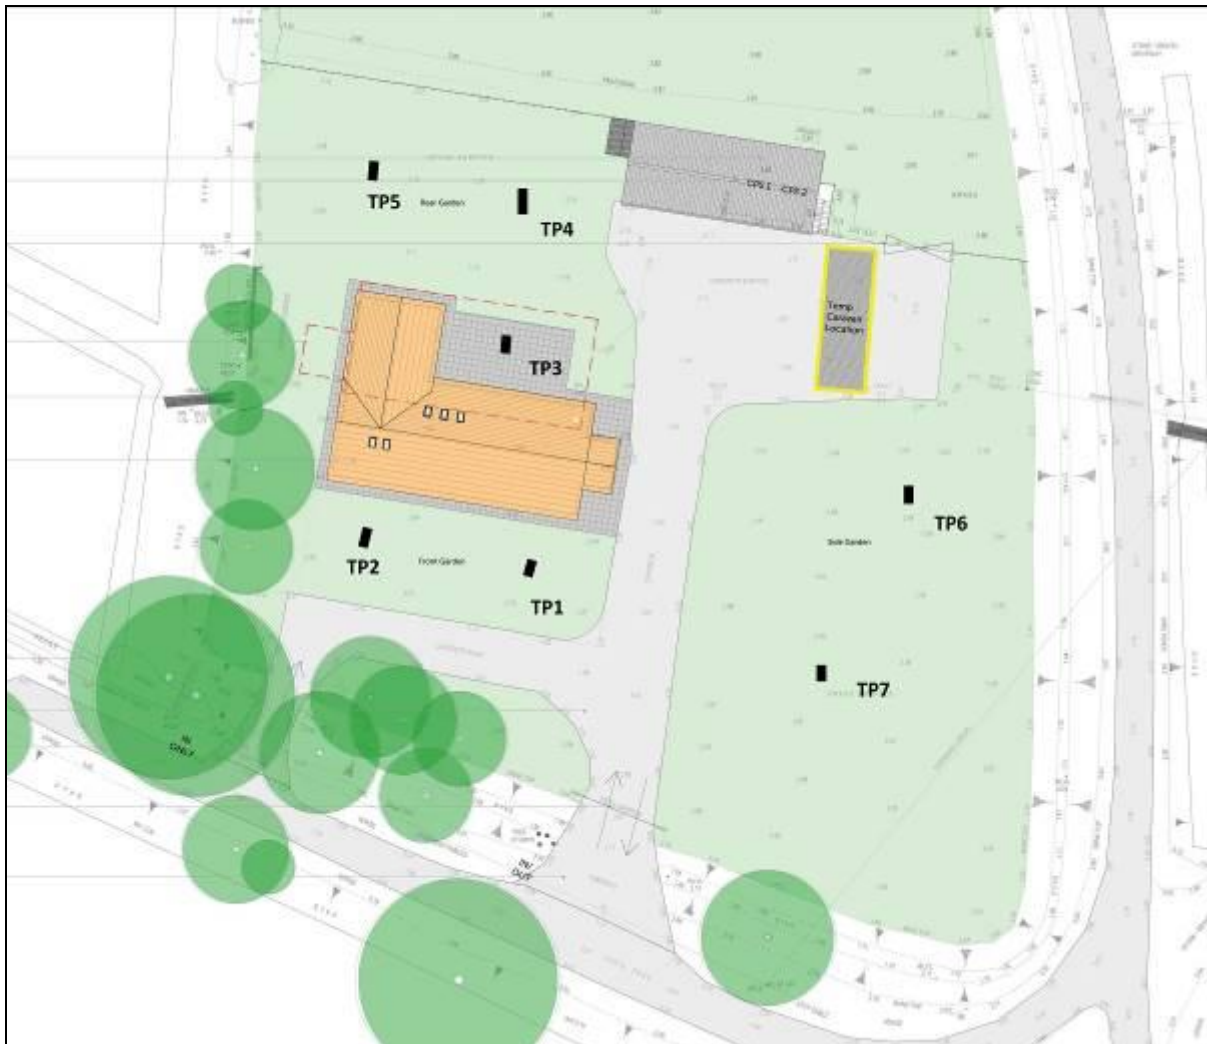
Fig 3 – trialpit location plan

5 No. trialpits (TP1 – TP5) were excavated by a client-supplied 3.5 tonne tracked 360 with 2ft bucket, to 1.8 m bgl.

Additionally 2 No. trialpits (TP6 and TP7) were excavated to 0.4 m by hand.

- 0.0 – 0.3 m loose brown sandy TOPSOIL
- 0.3 – 1.3 m firm/stiff yellow/brown sandy very clayey SILT
- 1.3 – 1.8 m firm yellow brown sandy very clayey SILT
