Project: 23042 The Old Ship Inn, Gosberton Clough

# Site Survey Report

Report Title: The Old Ship Inn, Gosberton Clough – Site Survey Report  
Report Number: 23042  
Revision Number: V1

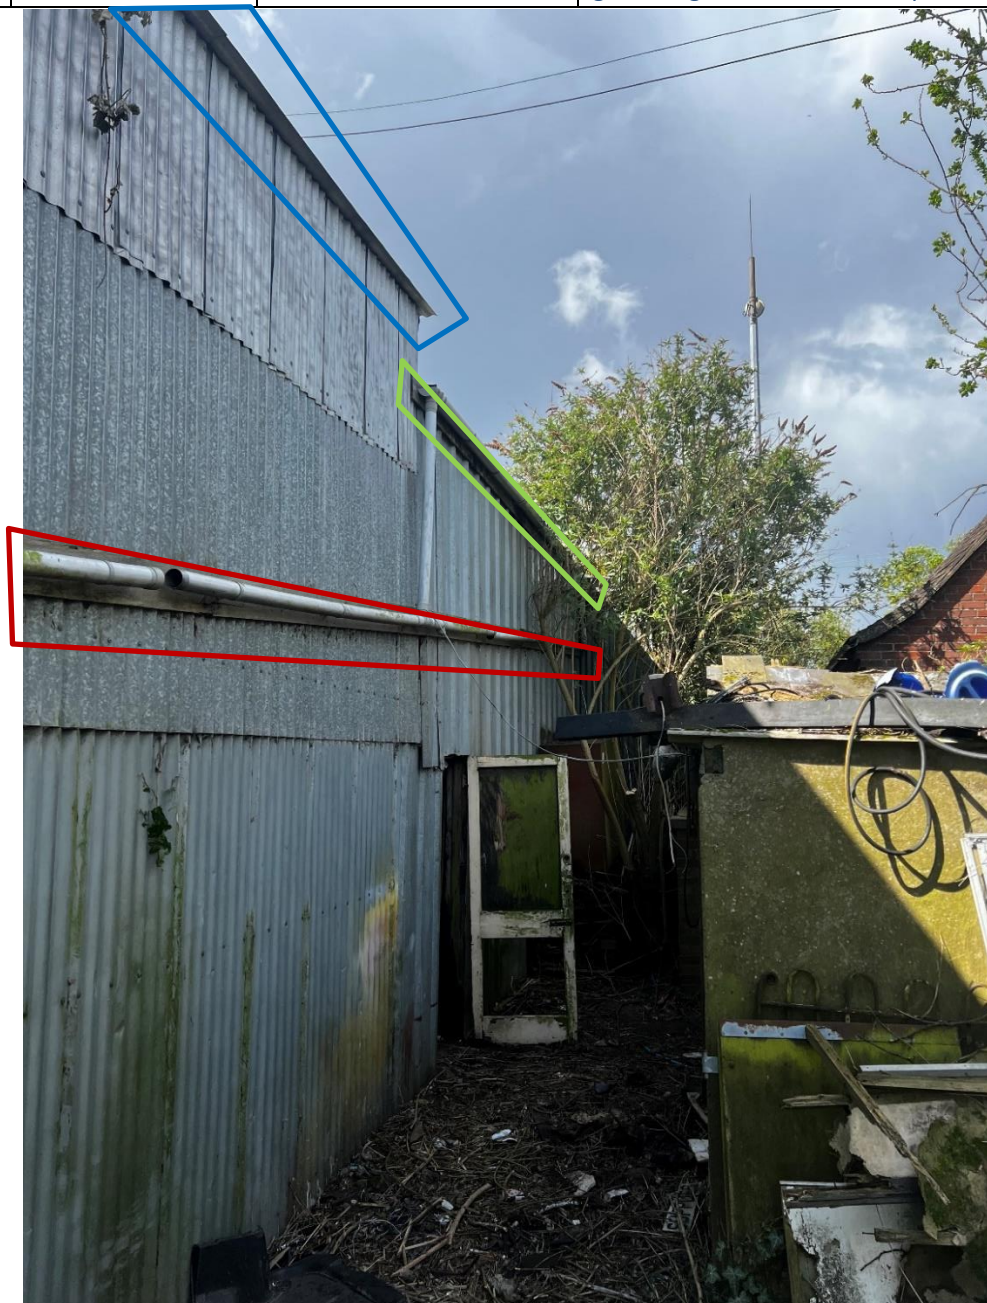
| Survey Ref. | Instructure Type | Location | Description |
|---|---|---|---|
| B-01 | Building | East Side | Operational top guttering, down pipes from guttering onwards to be replaced. |

### Remedial Work / Action

Red = Remove existing pipework from exterior of building. Replace with new PVC pipework and connect into proposed sewer system

Green = Existing Guttering believed to be in suitable condition to remain

Blue = No existing Drainage. New Guttering and downpipes to be provided and connected into proposed sewer system.

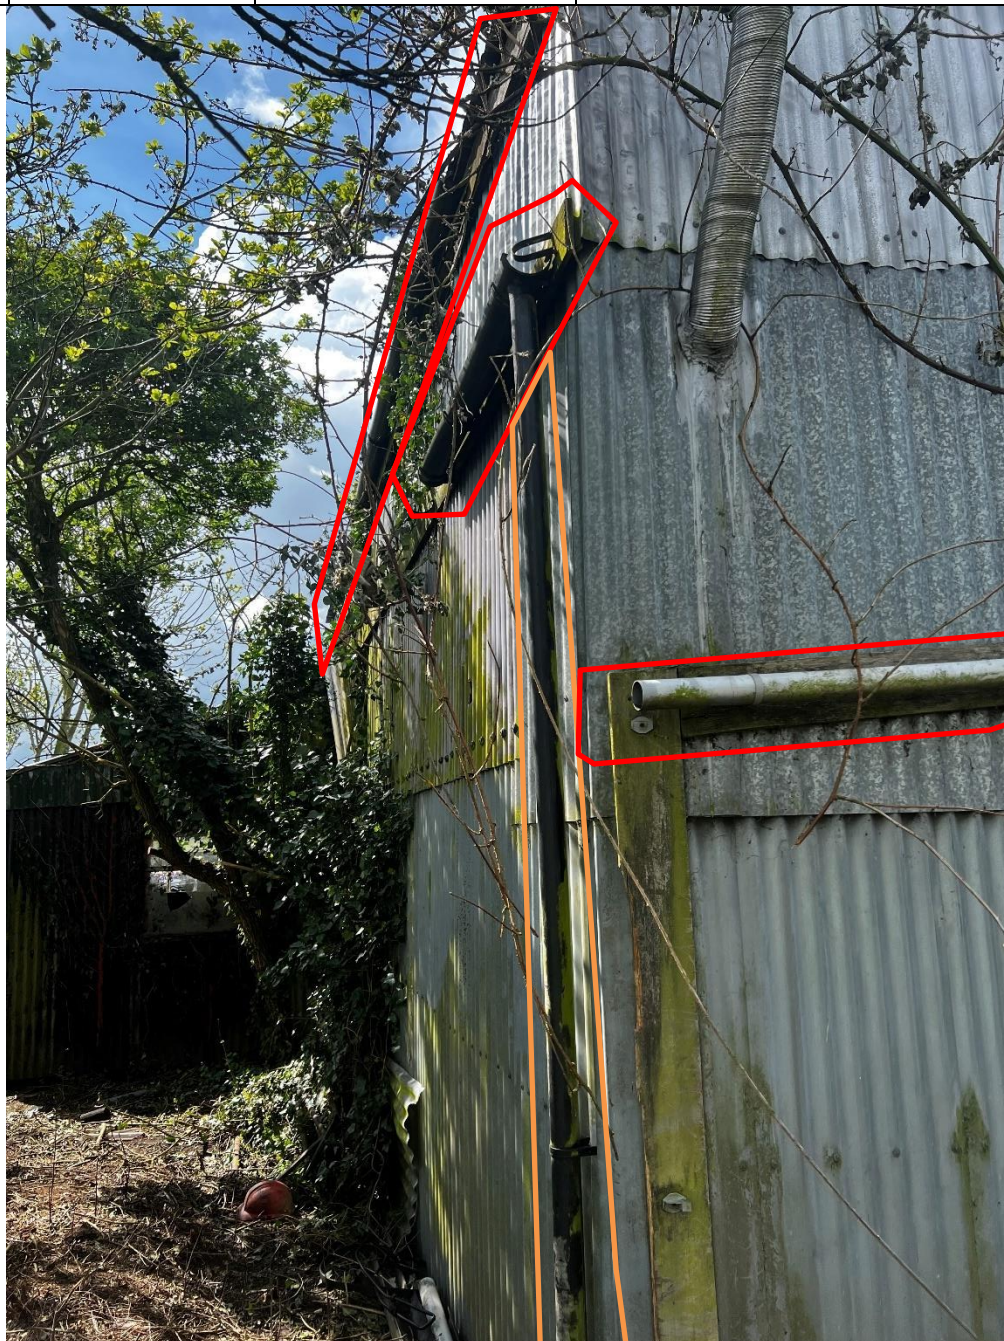
| Survey Ref. | Instructure Type | Location | Description |
|---|---|---|---|
| B-02 | Building | East/South Side Corner | Existing gutters not connected to underground system and/or broken. |

#### Remedial Work / Action

Red = Sections of Guttering requiring replacement or removal. Pipework to be replaced and new gutters provided along roof eaves and connected in to proposed new system underground.

Orange = Section of Gutter to remain, however it needs connecting to new proposed underground system as pipework currently stops at ground level.

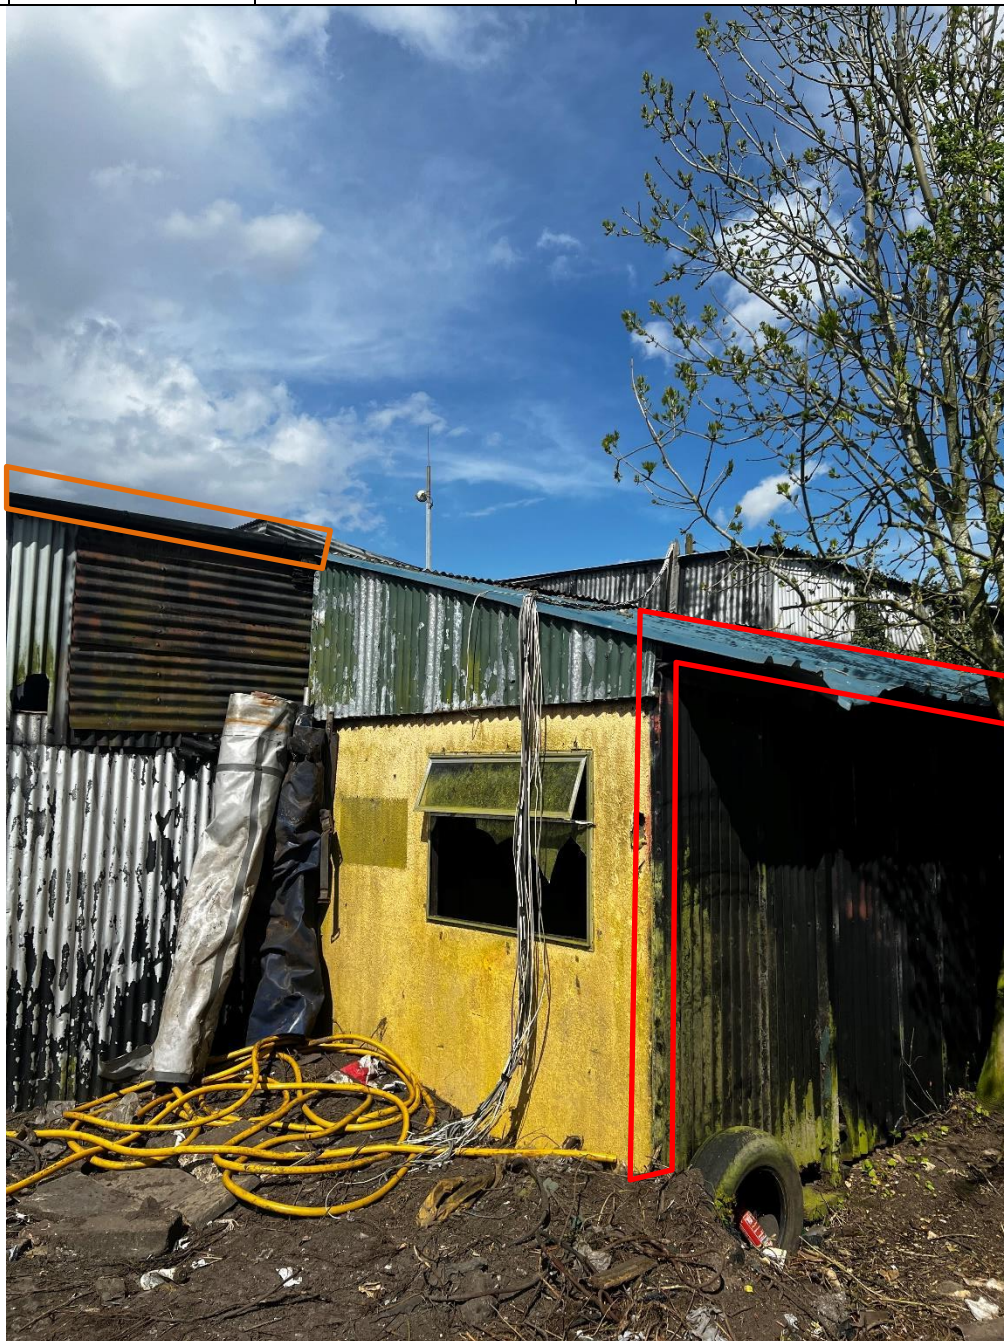
| Survey Ref. | Instructure Type | Location | Description |
|---|---|---|---|
| B-03 | Building | Southern Side | No existing drainage on south side of building, new downpipes, guttering and underground pipework required. |

#### Remedial Work / Action

Red = Areas with no existing drainage. New guttering to be provided along roof eaves, discharging to proposed new downpipe and then finally, discharging into the proposed new underground drainage system.

Orange = Section of guttering requiring repair work or replacement.

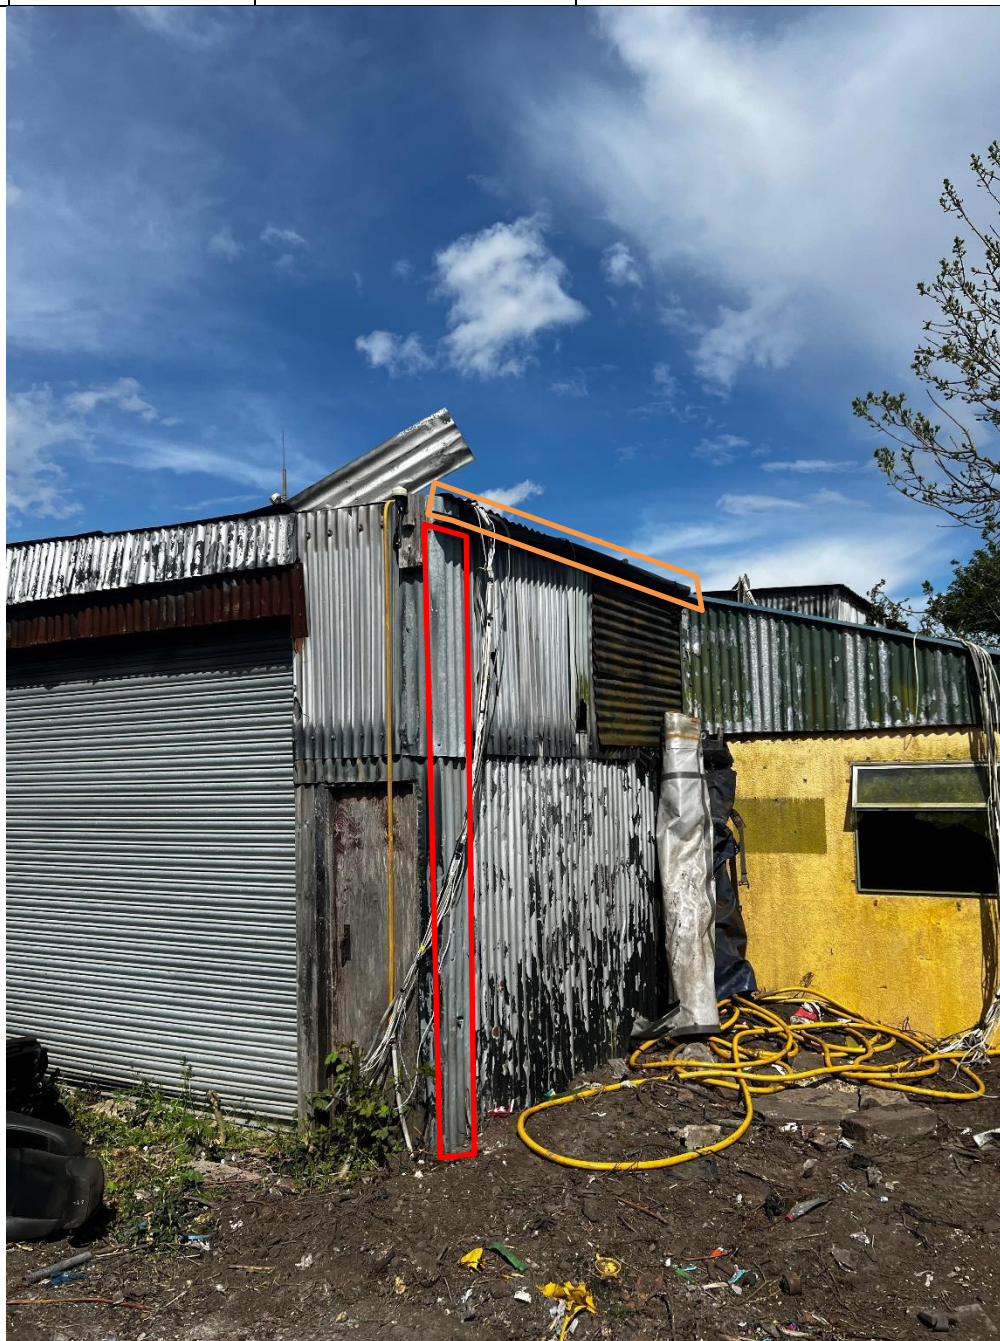
| Survey Ref. | Instructure Type | Location | Description |
|---|---|---|---|
| B-04 | Building | Southwestern Corner | No existing drainage on Southwestern corner of building, new downpipes, guttering and underground pipework required. |

#### Remedial Work / Action

Red = Areas with no existing drainage. New downpipe discharging into the proposed new underground drainage system required.

Orange = Section of guttering requiring repair work or replacement. Once repaired/replaced the guttering can be connected to a proposed new downpipe and discharge into a proposed new underground drainage system.

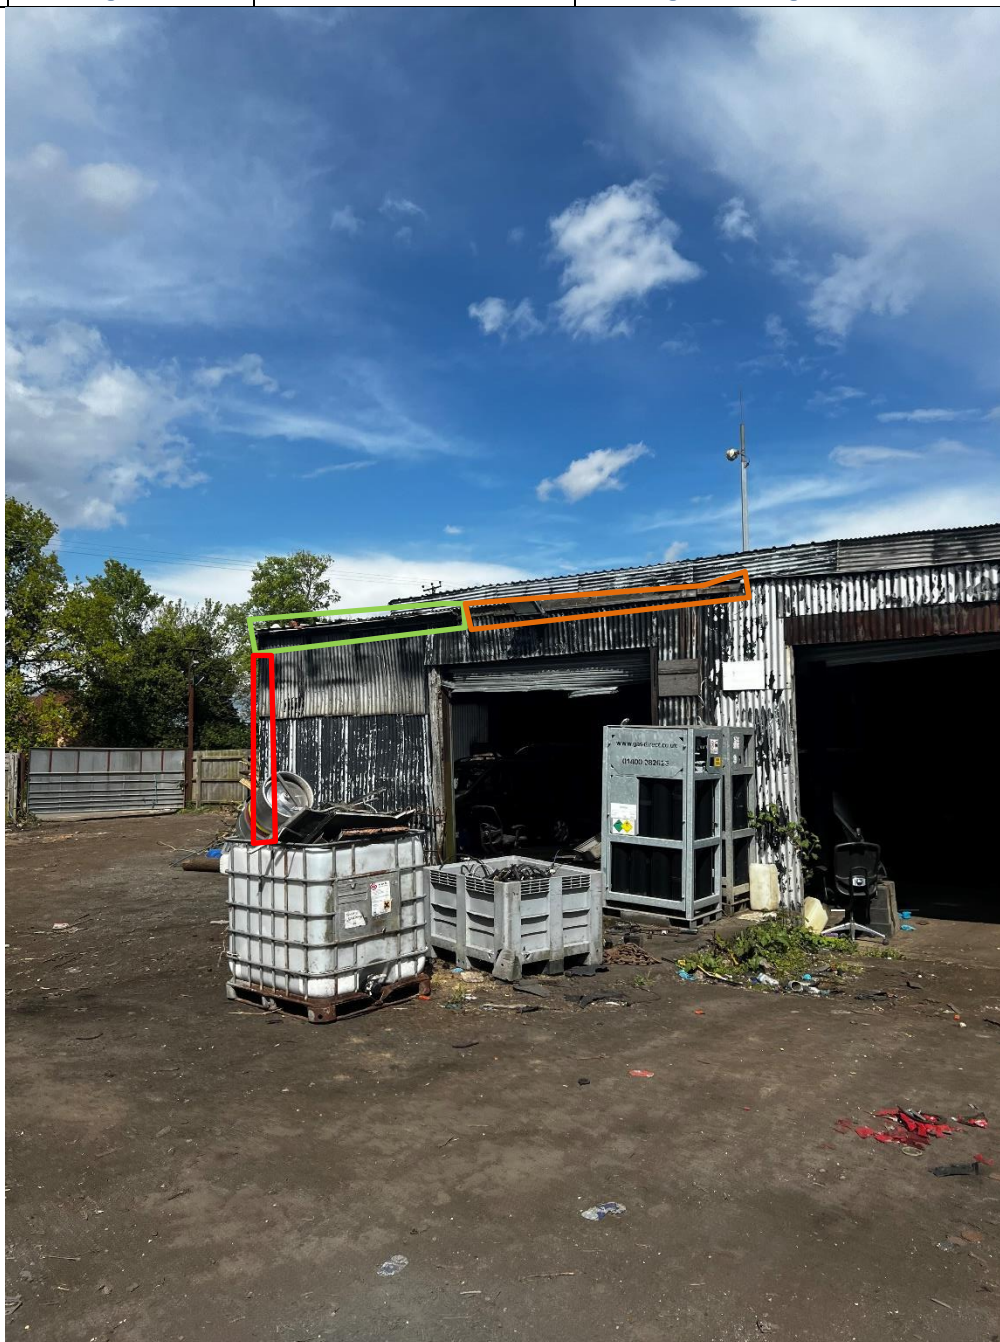
| Survey Ref. | Instructure Type | Location | Description |
|---|---|---|---|
| B-05 | Building | Western Side | Existing Guttering to be extended. |

#### Remedial Work / Action

Green = Existing Guttering to remain.

Orange = Additional guttering required to cover full length of roof Eaves.

Red = No existing downpipe. New downpipe to be installed and connected into underground drainage system.

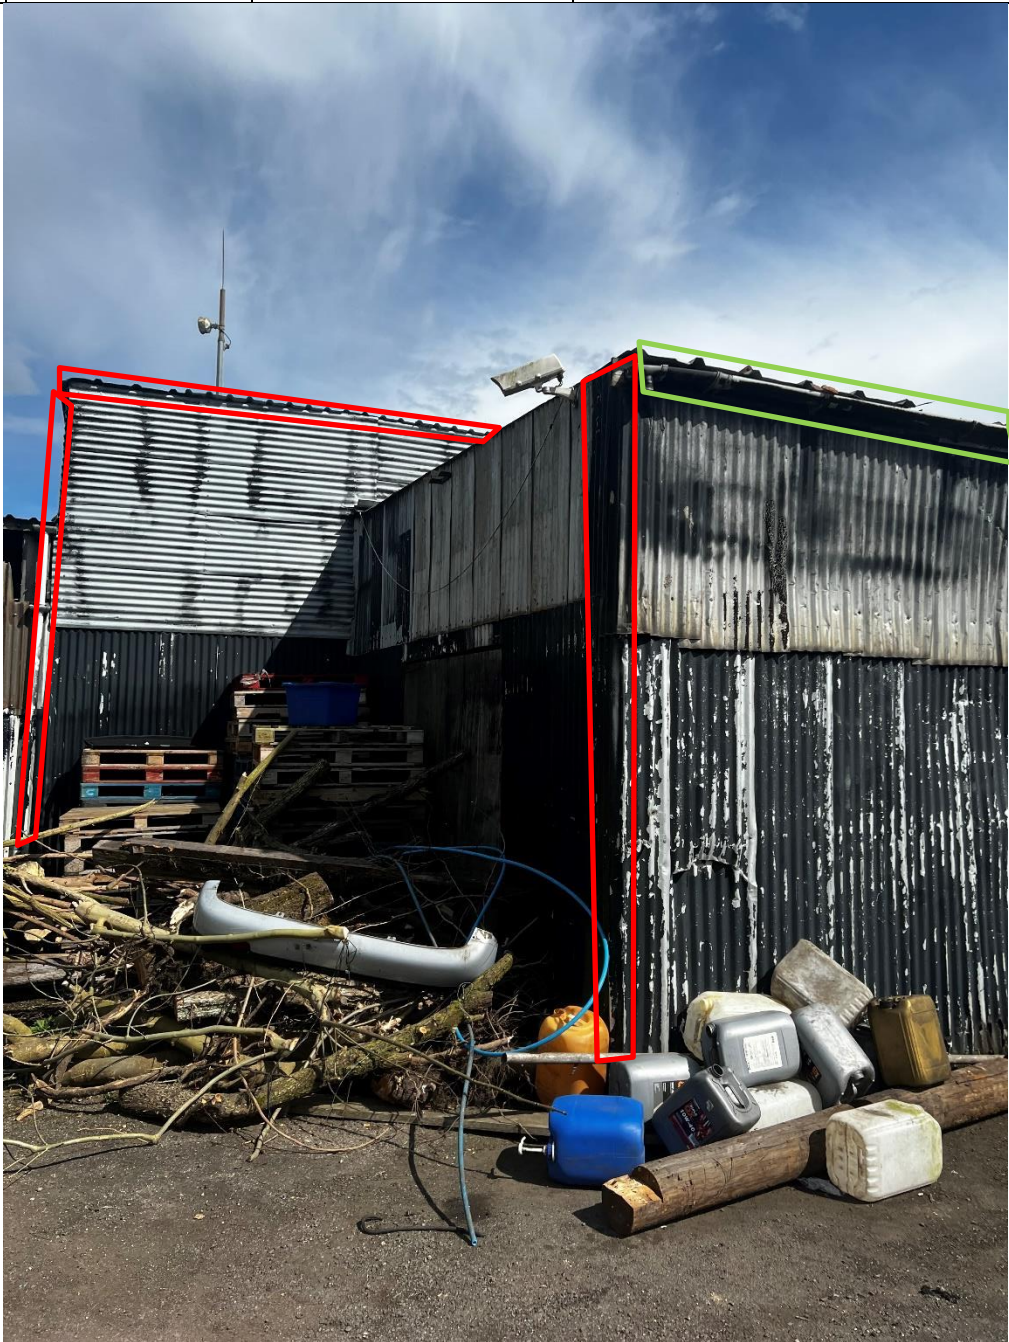
| Survey Ref. | Instructure Type | Location | Description |
|---|---|---|---|
| B-06 | Building | Western Side | No existing guttering or downpipe. |
| <p>The photograph shows a building with a corrugated metal roof and walls. A red outline highlights the roofline and walls of a section where no existing guttering or downpipes are present. A green outline highlights a section of the roofline where existing guttering is to remain. The foreground is cluttered with debris, including logs, branches, and various plastic containers.</p> | | | |

| Survey Ref. | Instructure Type | Location | Description |
|---|---|---|---|
| Remedial Work / Action | | | |
| <p>Red = No existing guttering or downpipes. New downpipes and Guttering required with new connections into a proposed underground drainage system.</p> <p>Green = Existing Guttering to remain</p> | | | |

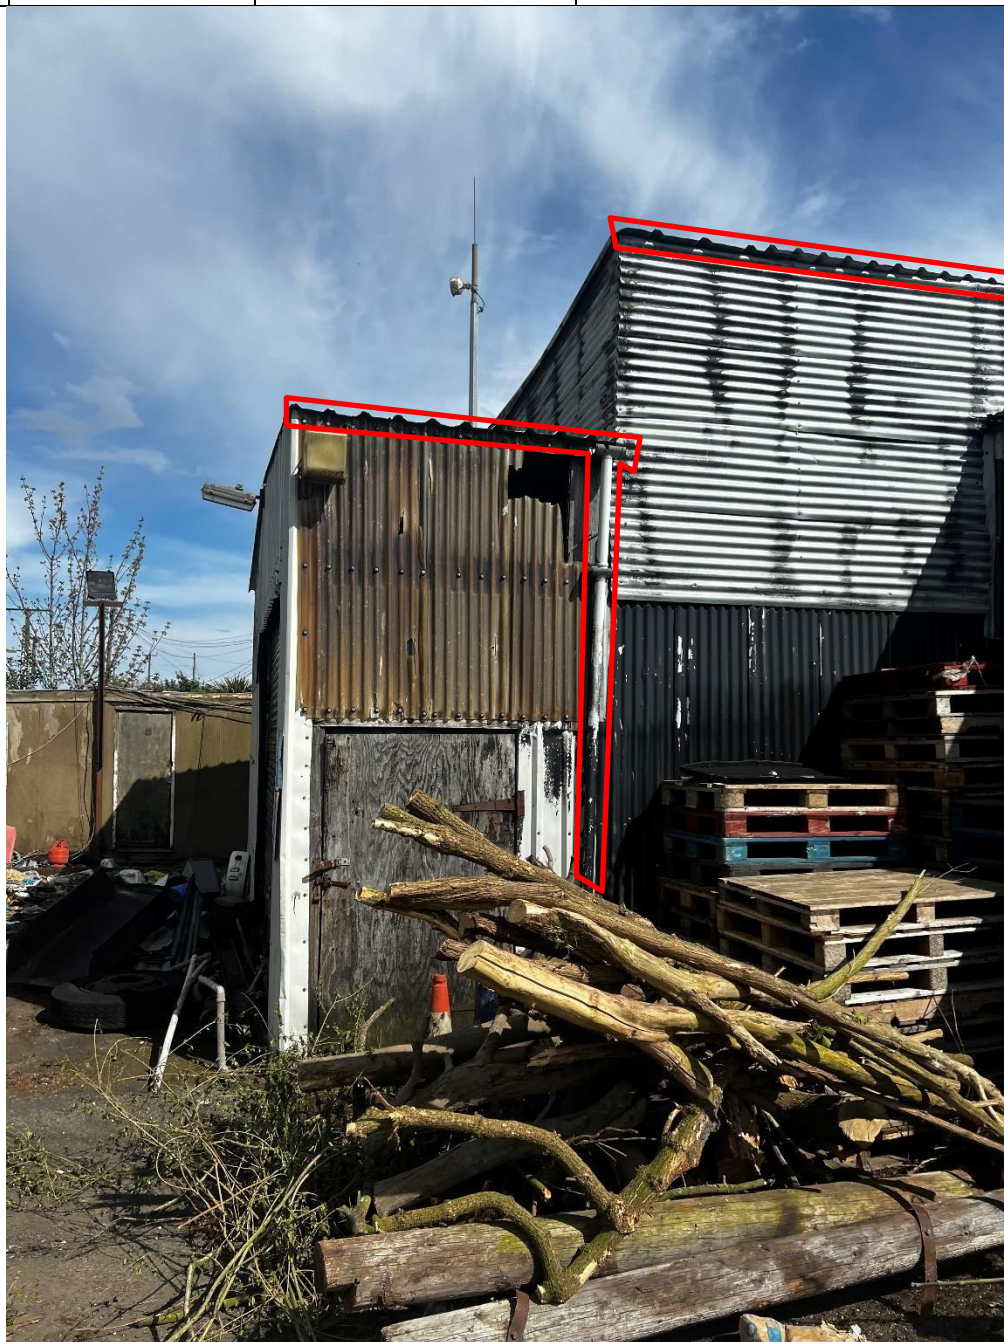
| Survey Ref. | Instructure Type | Location | Description |
|---|---|---|---|
| B-07 | Building | Western Side | Existing downpipe to be fixed, and existing guttering to be replaced. |

#### Remedial Work / Action

Red = Downpipes and guttering to be replaced and connected into proposed new underground drainage system. Due to obstruction it is unclear whether the existing downpipe connects into any form of drainage system.

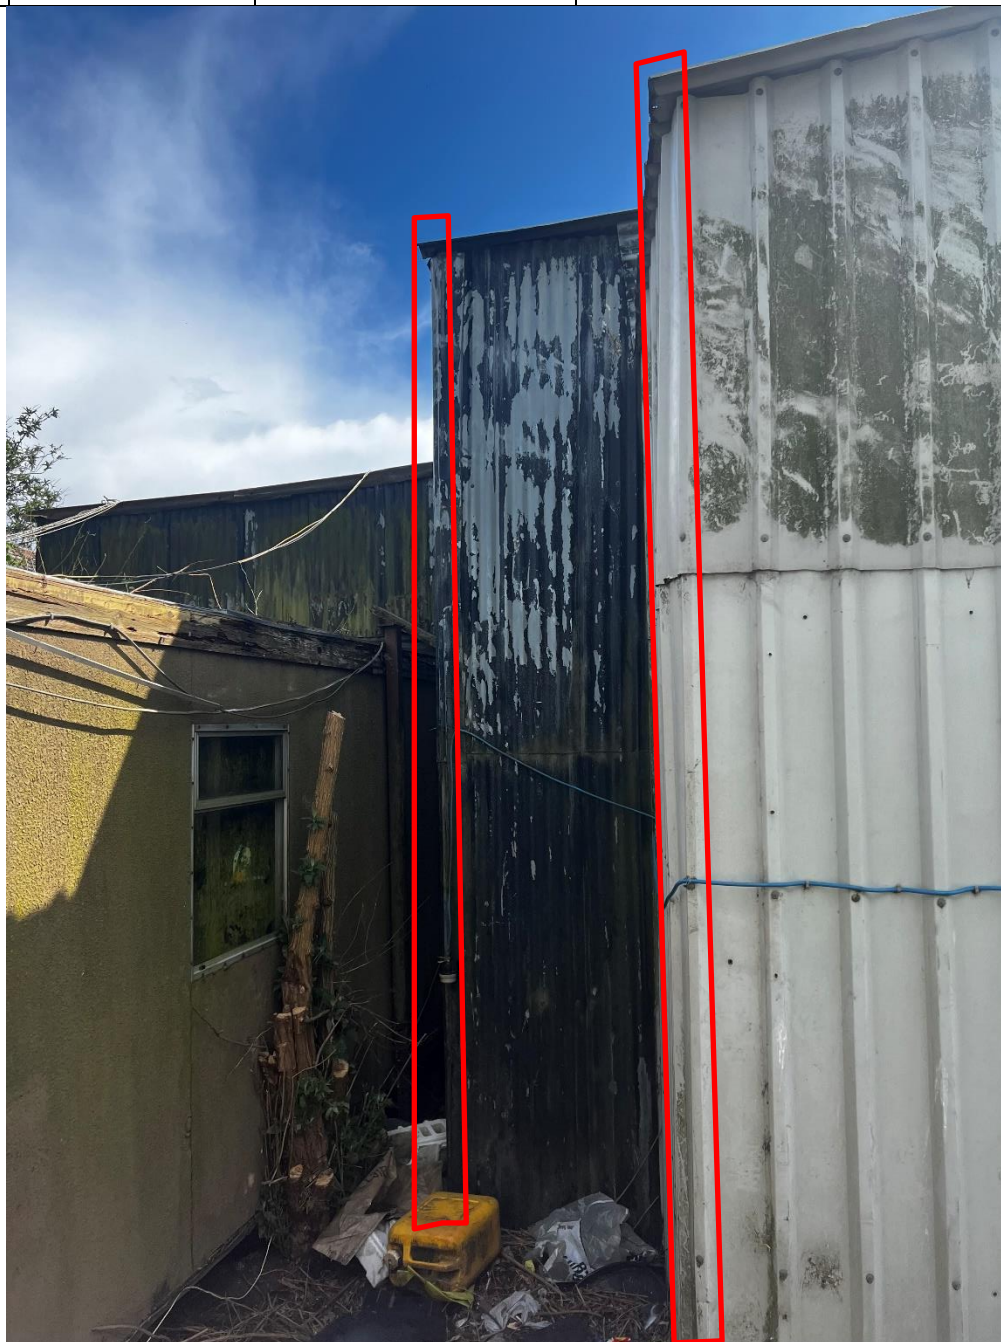
| Survey Ref. | Instructure Type | Location | Description |
|---|---|---|---|
| B-08 | Building | Northern Side | No existing downpipe or guttering |

#### Remedial Work / Action

Red = Areas requiring new downpipes and guttering with new connections into proposed underground drainage system.
