**Ground Investigation  
Report for  
High Street, Gosberton,  
Lincolnshire**

**21 April 2016**

**GROUND INVESTIGATION  
REPORT FOR  
HIGH STREET, GOSBERTON**

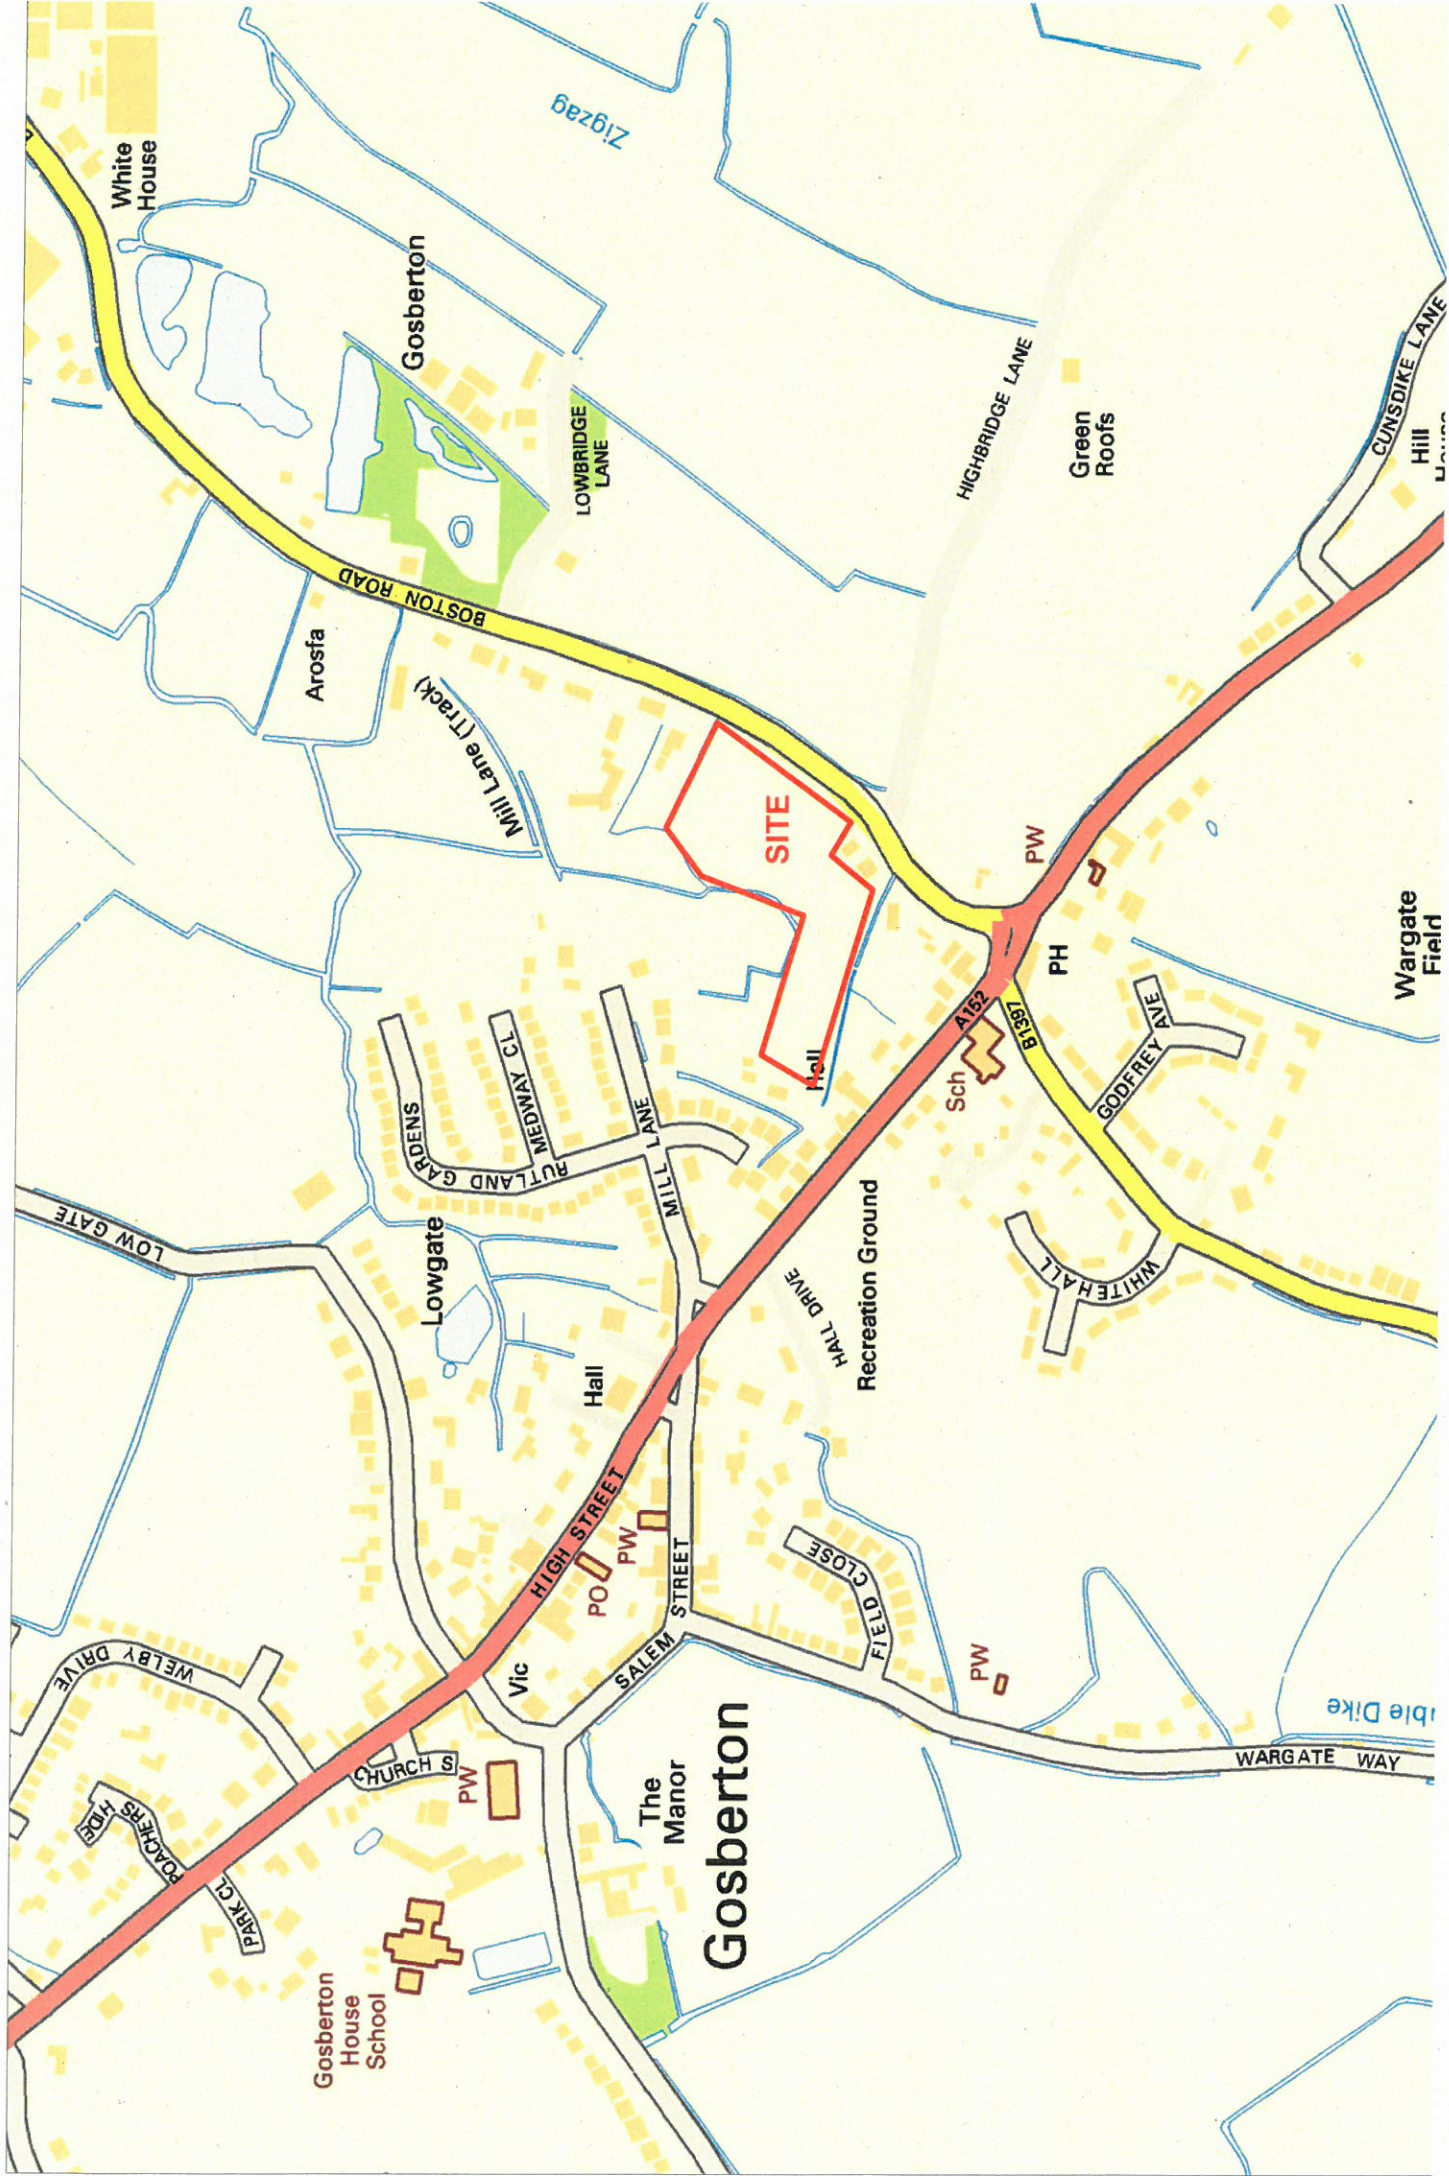
Drawing No. 1 - Site Location Plan

- 2.1 The site is situated to the south east of Gosberton. (Drawing Number 1, Appendix (i)). The site is considered greenfield and consists of two essentially rectangular shaped adjacent plots of land approximately 0.50 and 1.3 hectares in area. It is mostly bound by residential properties, with commercial properties to the north east and the B1397 Boston Road to the east.
- 2.2 The site is flat and is accessed from High Street via a narrow private access. (Drawing Number 2, Appendix (i)).
- 2.3 The British Geological Survey 1:50,000 geological sheet for the Spalding area <sup>(3)</sup> shows Kellaways Formation and Oxford Clay Formation consisting of mudstone, siltstone and sandstone. Superficial deposits of clay, silt and sand are recorded.

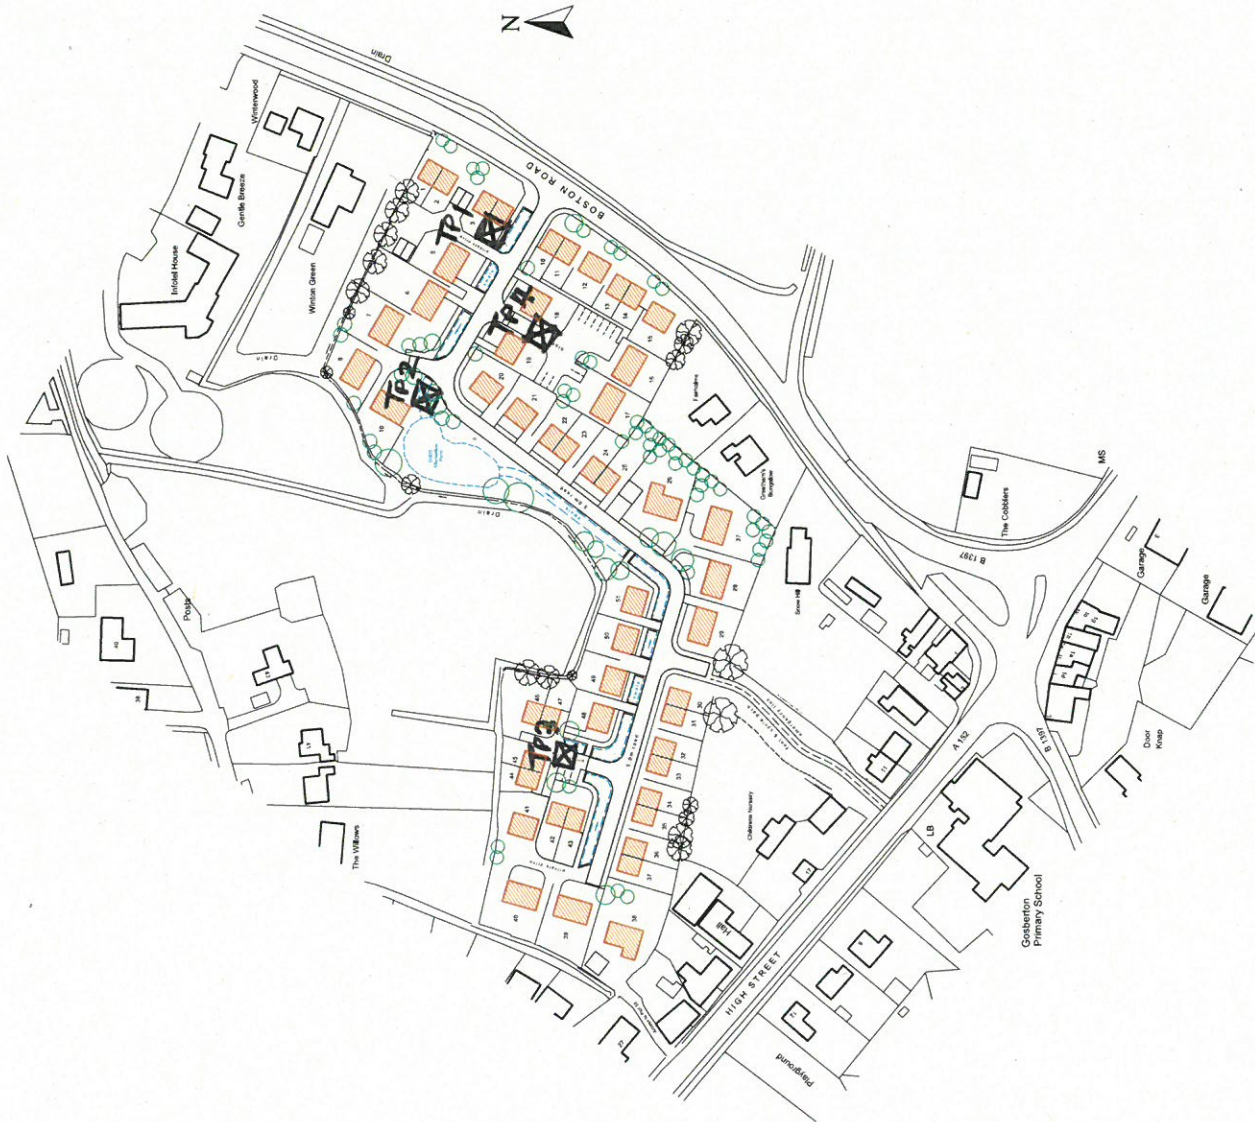
Land off High Street & Boston Road Gostberton  
Proposed Residential Development  
Site Layout Plan - PROPOSED

Drawing No. 2 - Trial Pit and Existing Soakaway Location Plan

- 3.1 All site work was carried out on the 14 April 2016. Four trial pits (TP's 1 to 4) were excavated using a mechanical backhoe loader in positions selected by Lincs Lab; TP's 1-3 to a maximum depth of 1.0m below ground level (BGL) with the view to targeting 0.5m to 1.0m BGL for subsequent infiltration testing. TP4 was excavated to 2.0m to establish the depth of ground water.
- 3.2 All trial pits were logged during excavation prior to infiltration testing. Once dimensions were noted each pit was filled with water to 0.5m BGL and allowed to drain naturally. The water level and time was recorded as the water drained away so that an assessment of infiltration rates could be completed in accordance with BRE Digest 365 <sup>(2)</sup>. Each pit, if considered feasible would then be filled and allowed to drain a total of three times.
