**YORK GARDENS, GOSBERTON  
for Gleeson Homes**

**LANDSCAPE STATEMENT**

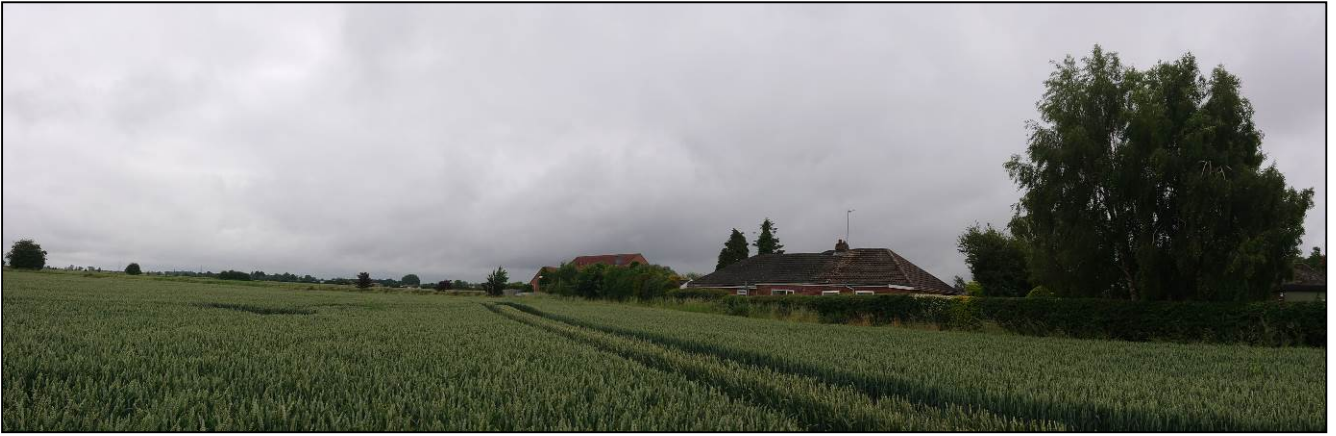
Photo 1: View east from within site showing character of vegetation along eastern part of southern boundary – primarily a well-established hedge (shown as V14 on drawing 3796/2) containing occasional trees (V1, extreme right).

- 3.3 Photos 1-3 are views of the southern site boundary taken from within the site. All three views show the open nature of the site itself, the maturity of the boundary hedge (where it exists) and the frequency and character of trees that lie within it. Given the fact that most existing dwellings adjacent to the site are bungalows, it is assessed that the residents of these properties would be relatively well screened from views of the new dwellings (although some gaps exist where clear, open views would be possible).

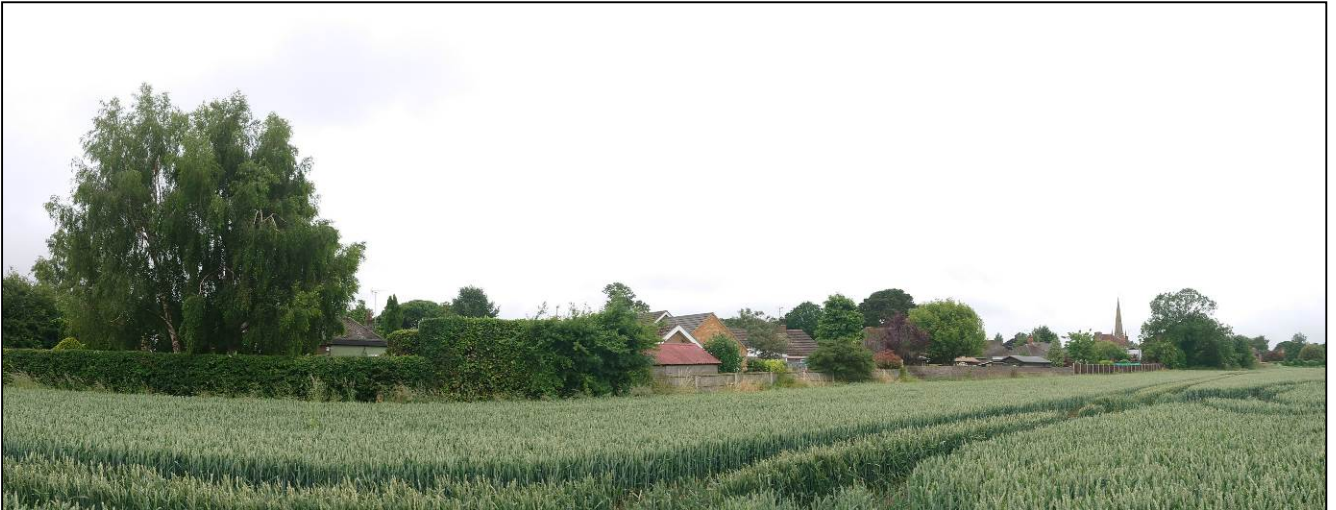
Photo 2: View west from within site showing character of vegetation within central part of southern boundary - intermittent hedge (V14 left and V4 right) with occasional trees (V1, extreme left, V3 right).

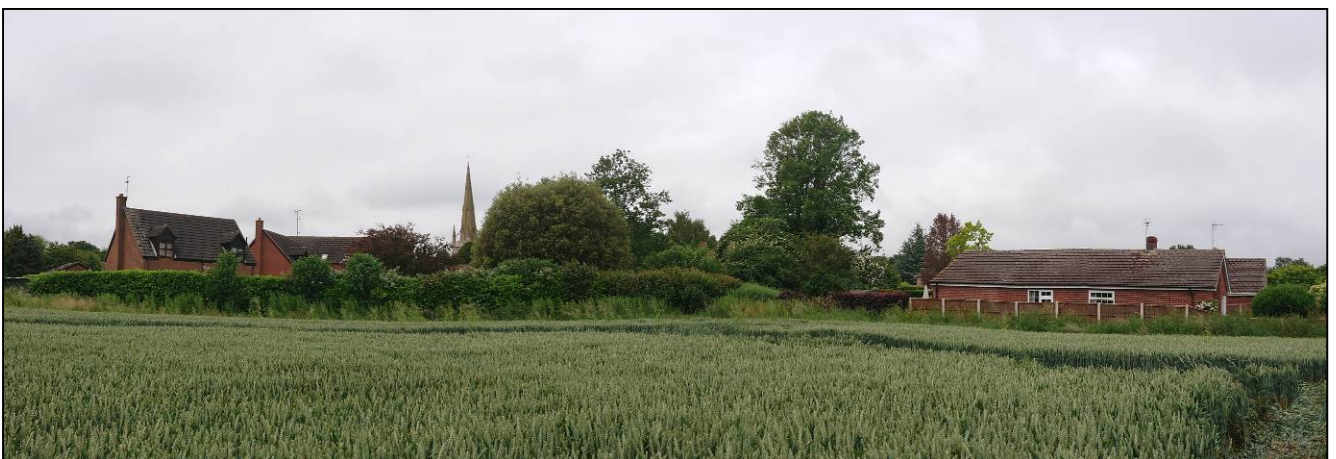
Photo 3: View south from within site showing character of vegetation within southwest corner of site, namely a well-established hedge (V5 left and centre) with adjacent dwellings beyond. The mature trees in this view all lie some distance offsite.

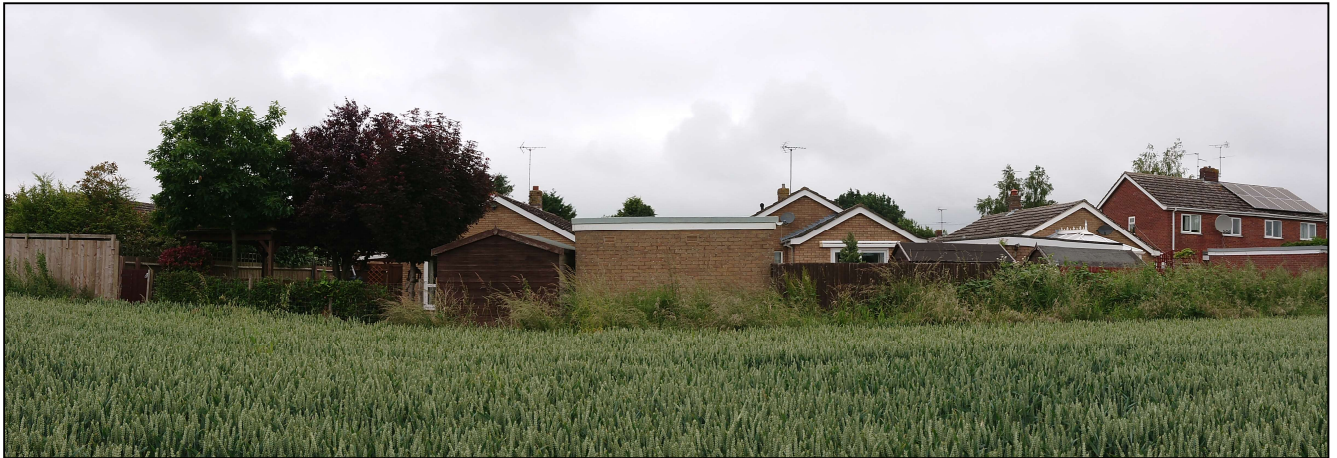
Photo 4: View west from within site showing character of vegetation towards southern end of western boundary, i.e., ornamental tree group V6 (entre left). Existing bungalows lie beyond this.

- 3.4 Photos 4-6 are views of the western site boundary taken from within the site. As above, these views show the boundary fence and hedge together with trees that lie along this boundary (mostly smaller, ornamental species. Towards the southern end the existing dwellings adjacent to the site are bungalows, so residents of these properties would be relatively well screened from views of development on site. Towards the northern end the dwellings are two-storey in nature - from these clear, open views of the new dwellings would be possible.

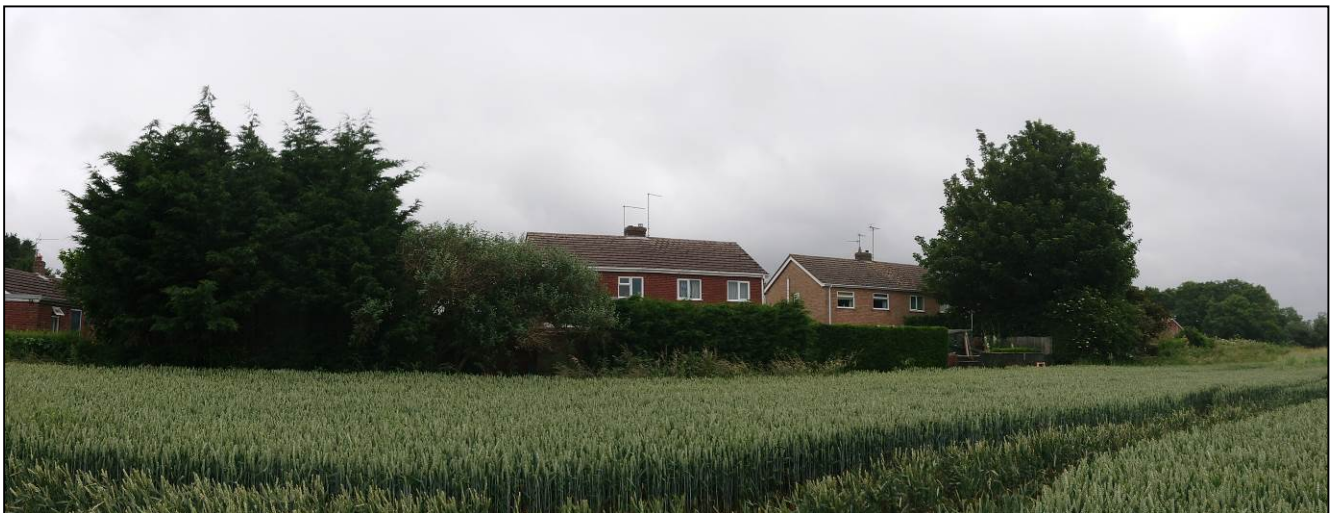
Photo 5: View west from within site showing character of vegetation towards northern end of western boundary - conifer hedge V7 (left & centre) and Sycamore V8 (centre right). Existing dwellings are all two-storey so clear open views of the site from first floor windows are possible.

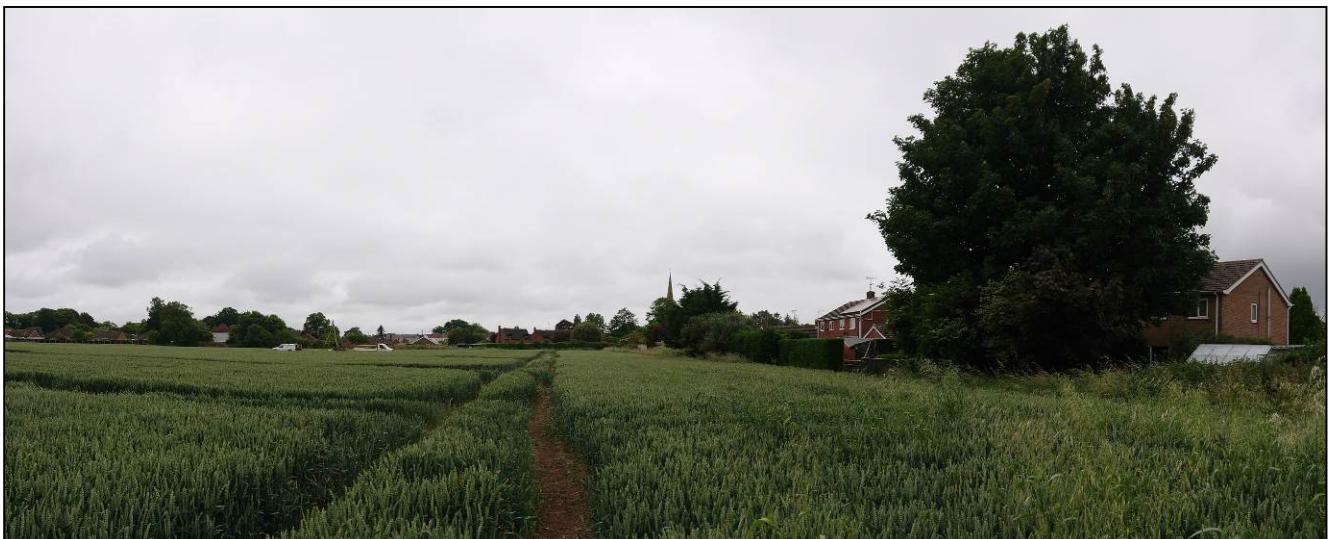
Photo 6: View south from northwest corner of site showing Sycamore V8 on right, character of western boundary (centre right) and southern boundary in middle distance (left and centre).

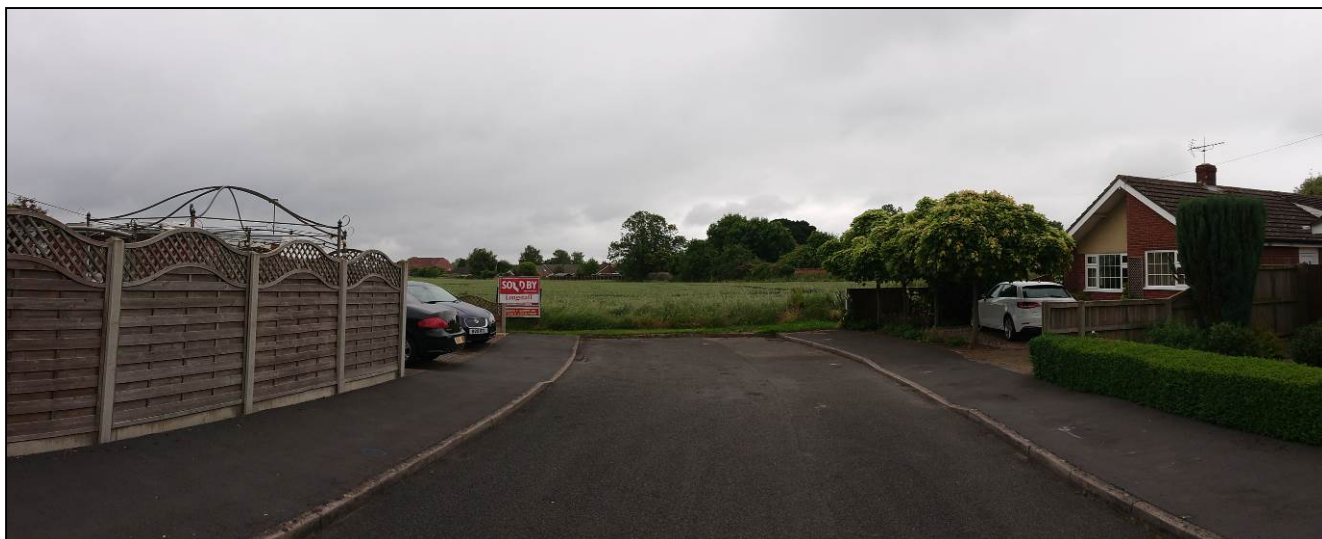
Photo 7: View east from York Gardens showing ornamental planting within gardens of adjacent dwellings with vegetation along southern boundary beyond (centre right, middle distance).

- 3.5 Photo 7 is a view of the site from York Gardens. Those travelling eastwards along this road would have a clear open view of the new dwellings.
- 3.7 Photos 8 & 9 are views of the site from public viewpoints to the east. Clear, open views of the whole site would be possible from Low Gate but views from the recently built Medial Centre adjacent would be most screened by intervening vegetation.

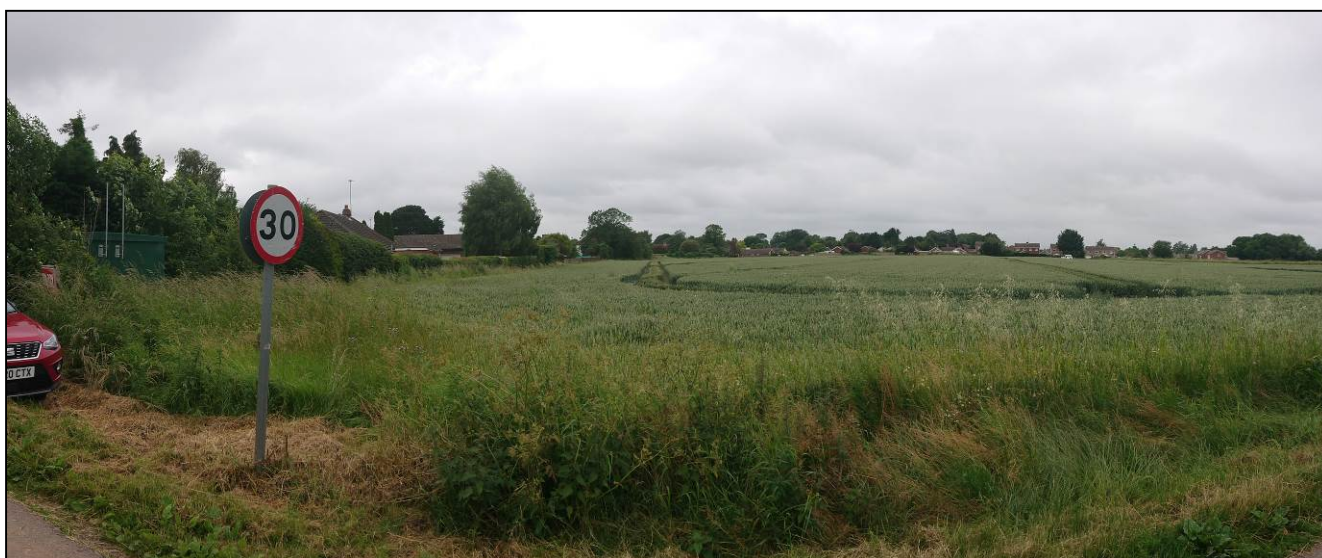
Photo 8: ▲  
View west from Low Gate showing character of southern boundary (left) and western boundary (in middle distance, centre and right).

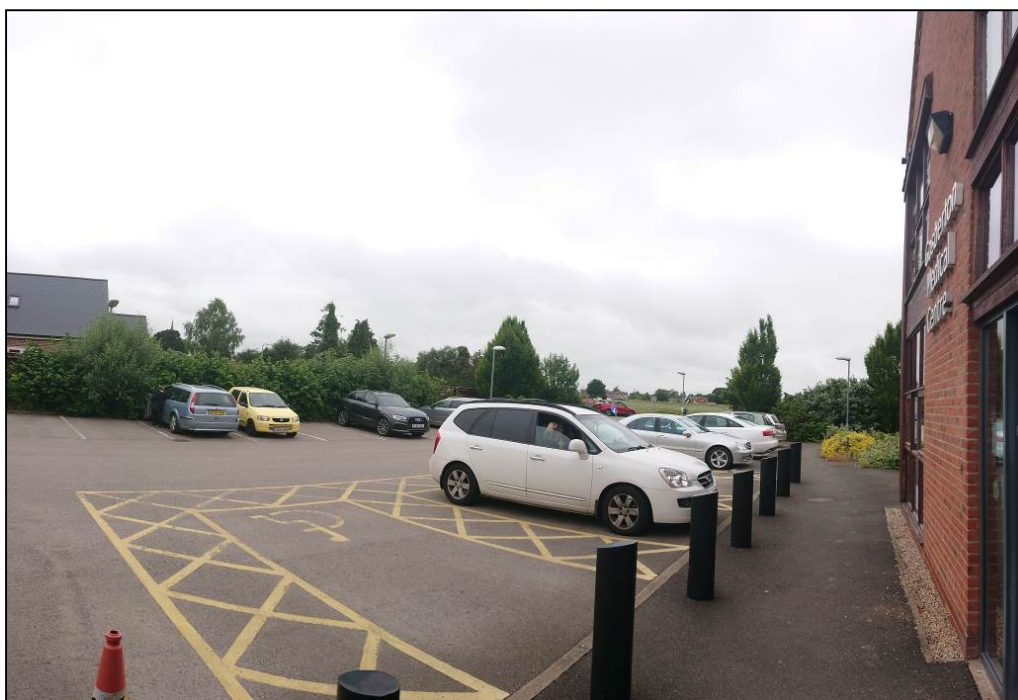
Photo 9: ◀  
A glimpsed view of site (beyond intervening vegetation) is possible from Gosberton Medical Centre.

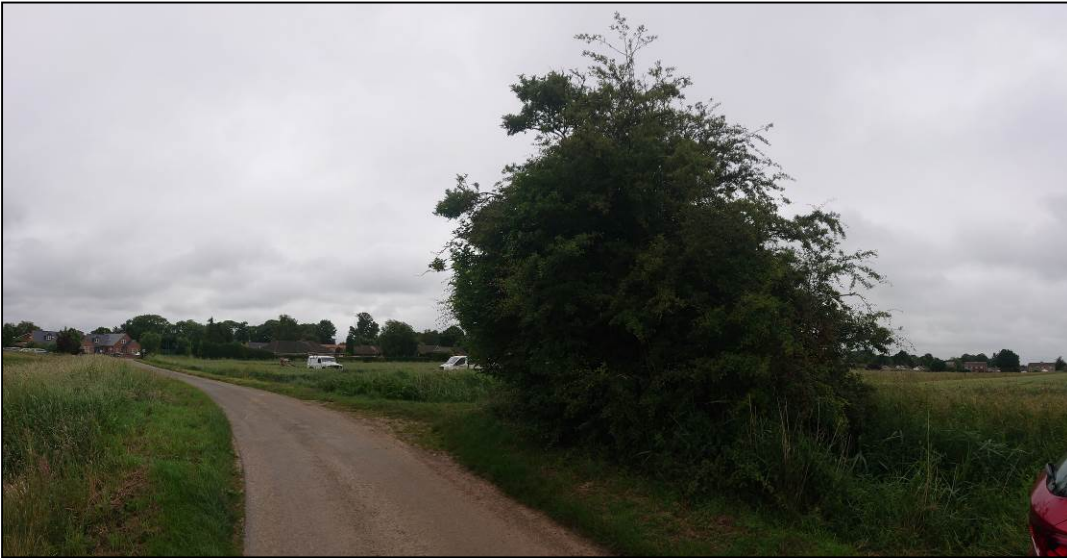
Photo 10:

View south from Low Gate just beyond northwest corner of site showing isolated Hawthorn V13 (centre right).

- 3.8 Photos 10-12 are views of the site from public viewpoints to the north. Due to almost complete lack of vegetation within the surrounding fields clear, open views of the whole site would be possible from Low Gate. Views from Churchfleet Lane (around 400m distant, photo 12) would be insignificant, however.

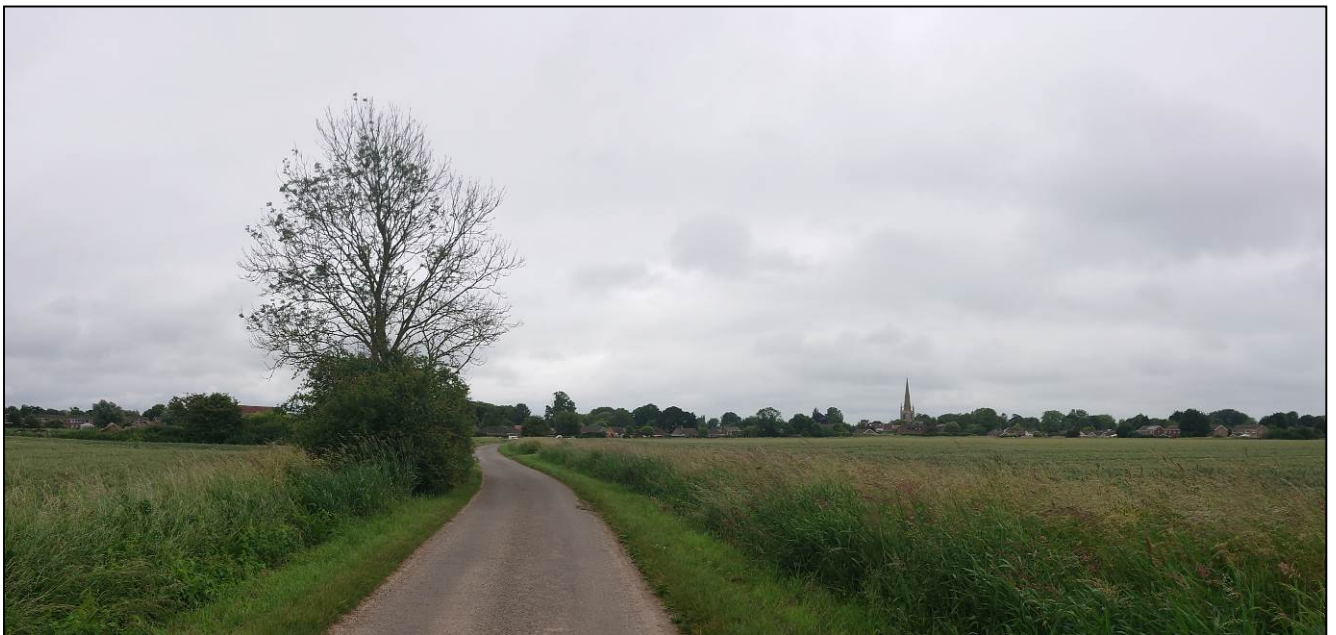
Photo 11: View south from Low Gate around 200m to north of site showing isolated Ash V12 (centre left). Study site lies to right of road.

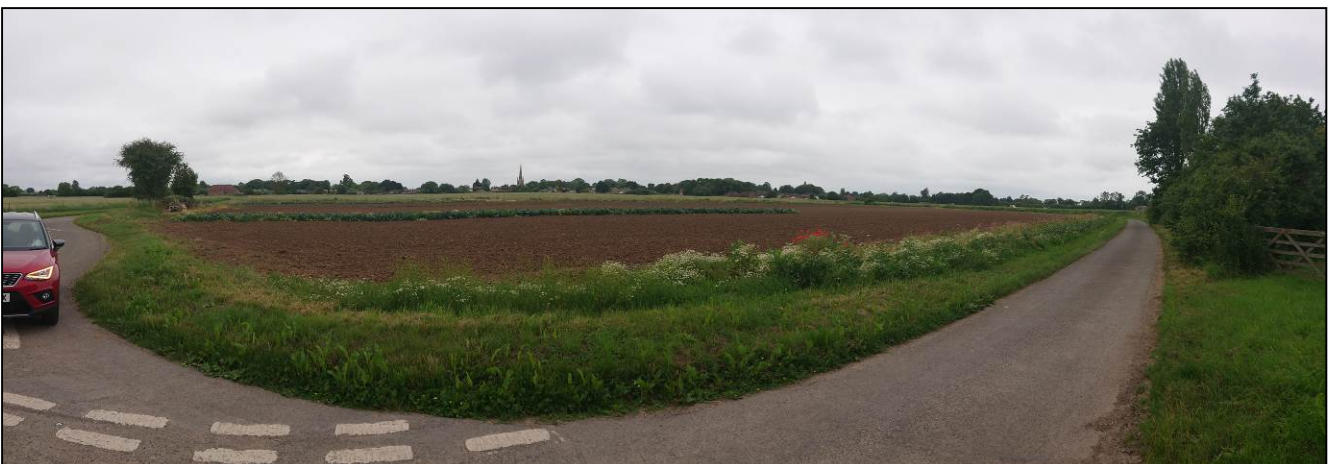
Photo 12: View south from junction of Low Gate and Churchfleet Lane around 400m to north of site showing Lombardy Poplars within block of dense roadside shrubs V11 (extreme right). Gosberton village and study site lies in middle distance centre left
