**GROUND INVESTIGATION REPORT****UPON****23 JEKILS BANK,****HOLBEACH ST. JOHN,****LINCOLNSHIRE, PE12 8RF****PROJECT No: SW 22-245****DOCUMENT REF: SW 22-245-GI-01**

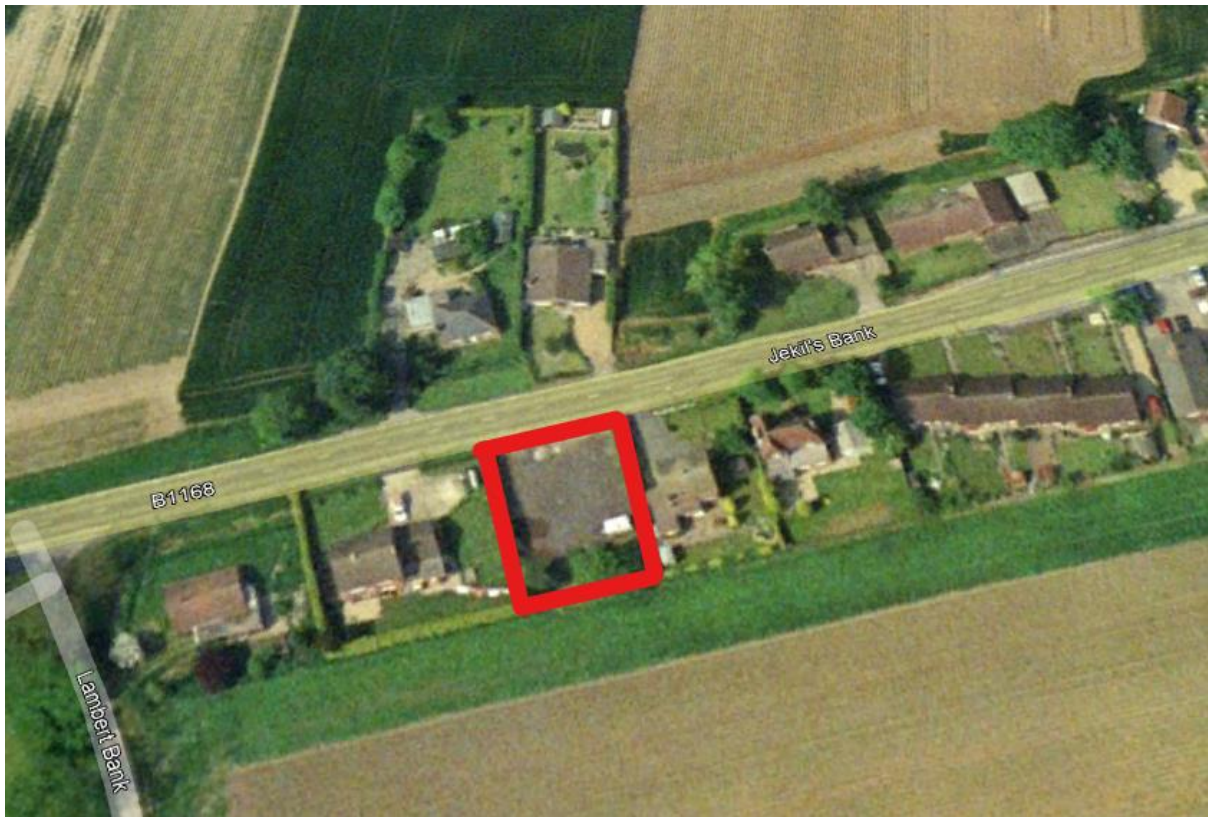
Extract of 1999 Google Map

Desktop study of publicly available historical maps has been undertaken and found the site has not been developed in the last 20 years and has stood as a tarmacked car park.

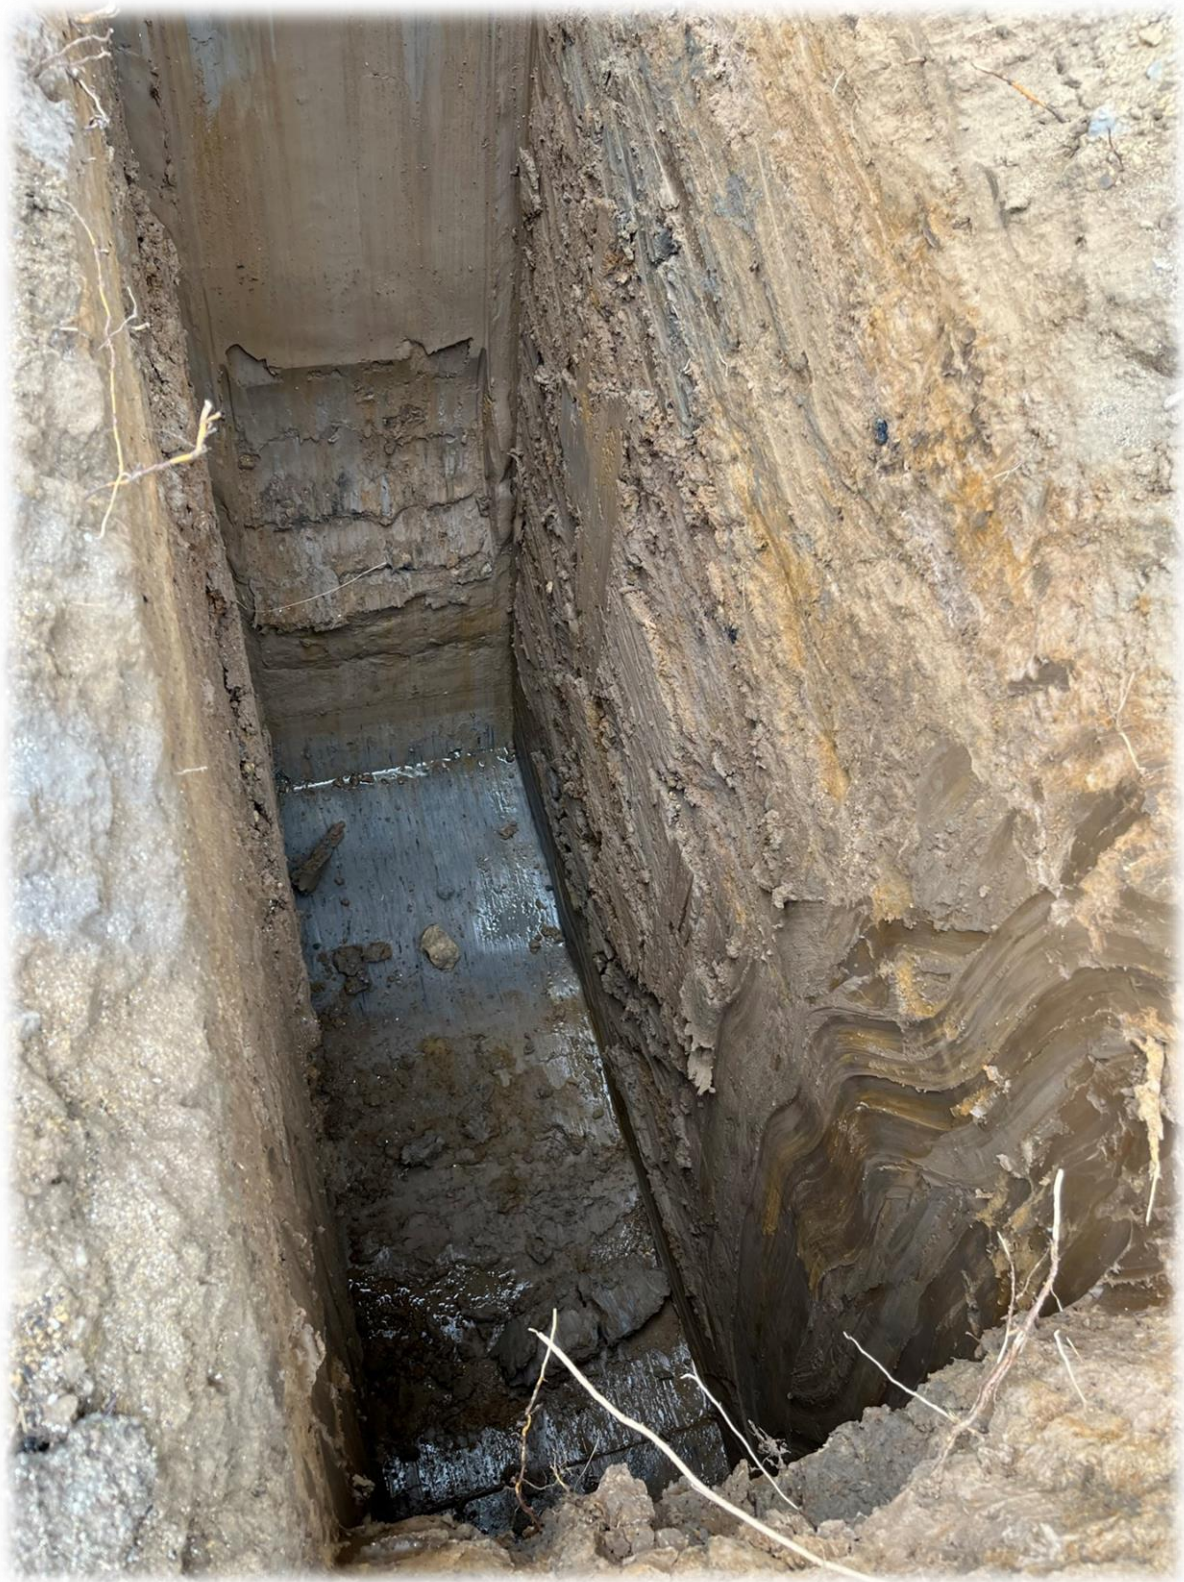
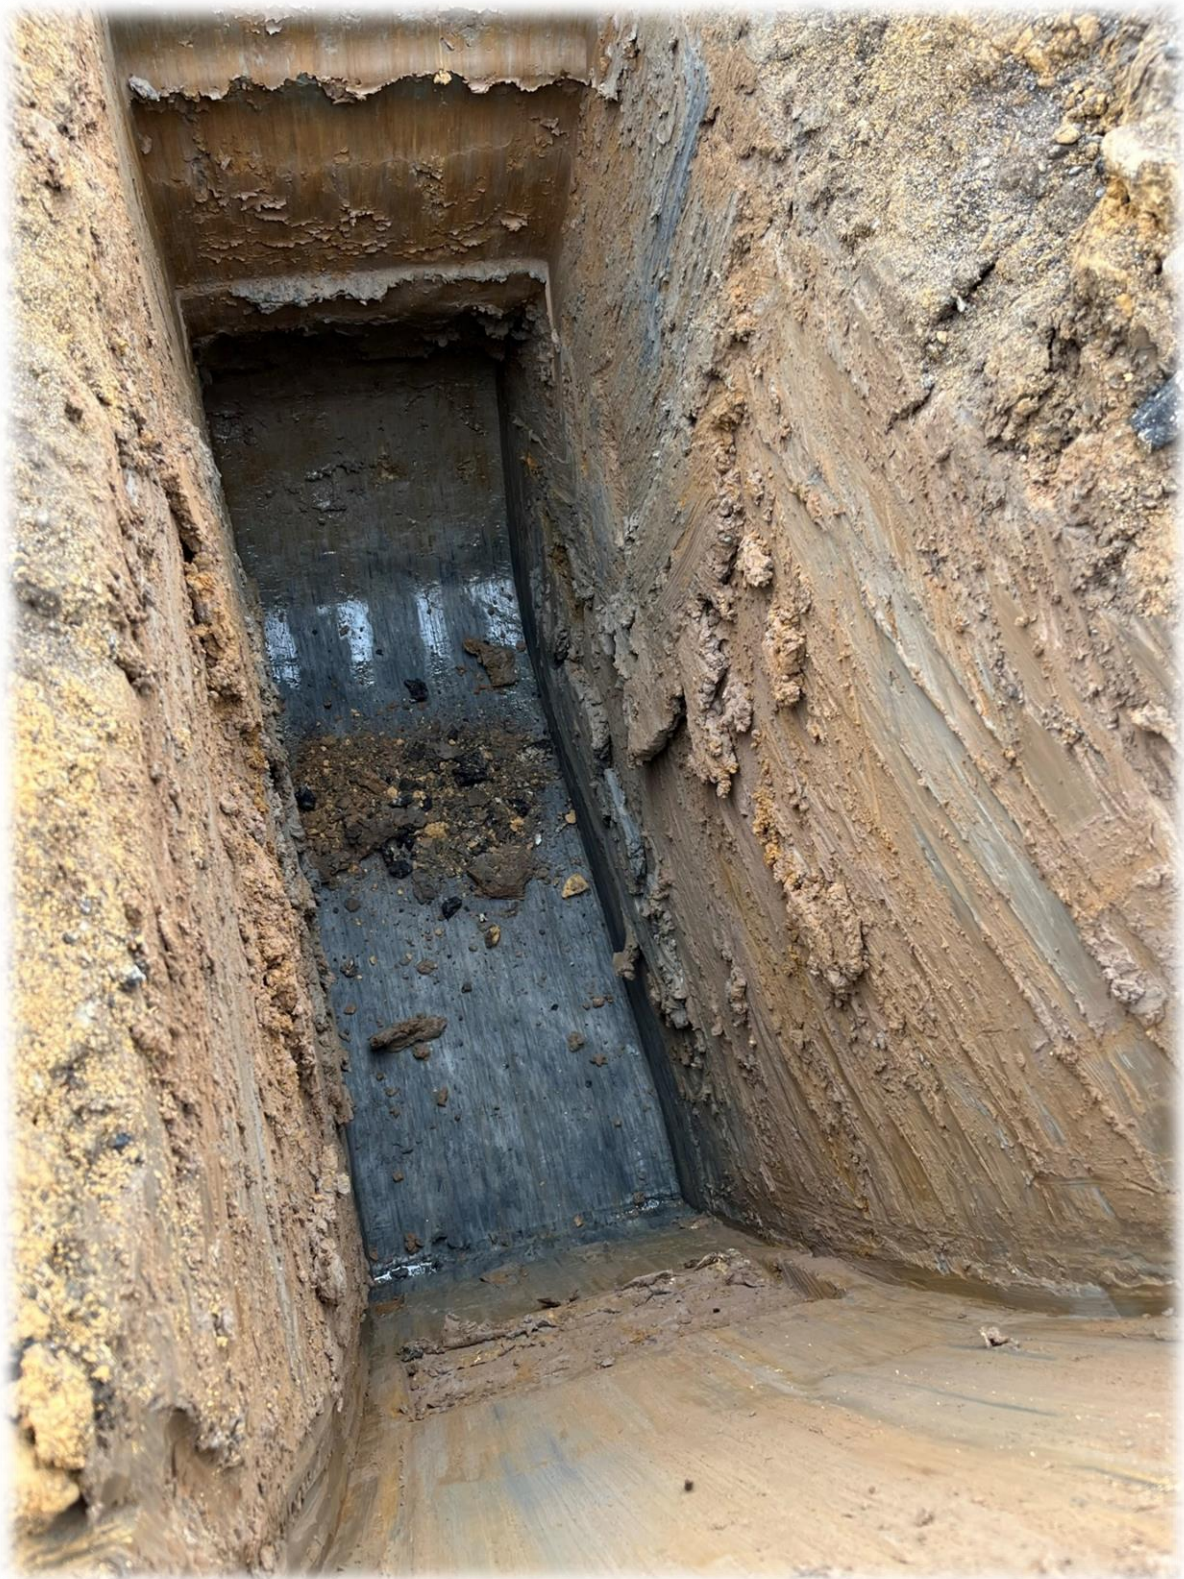
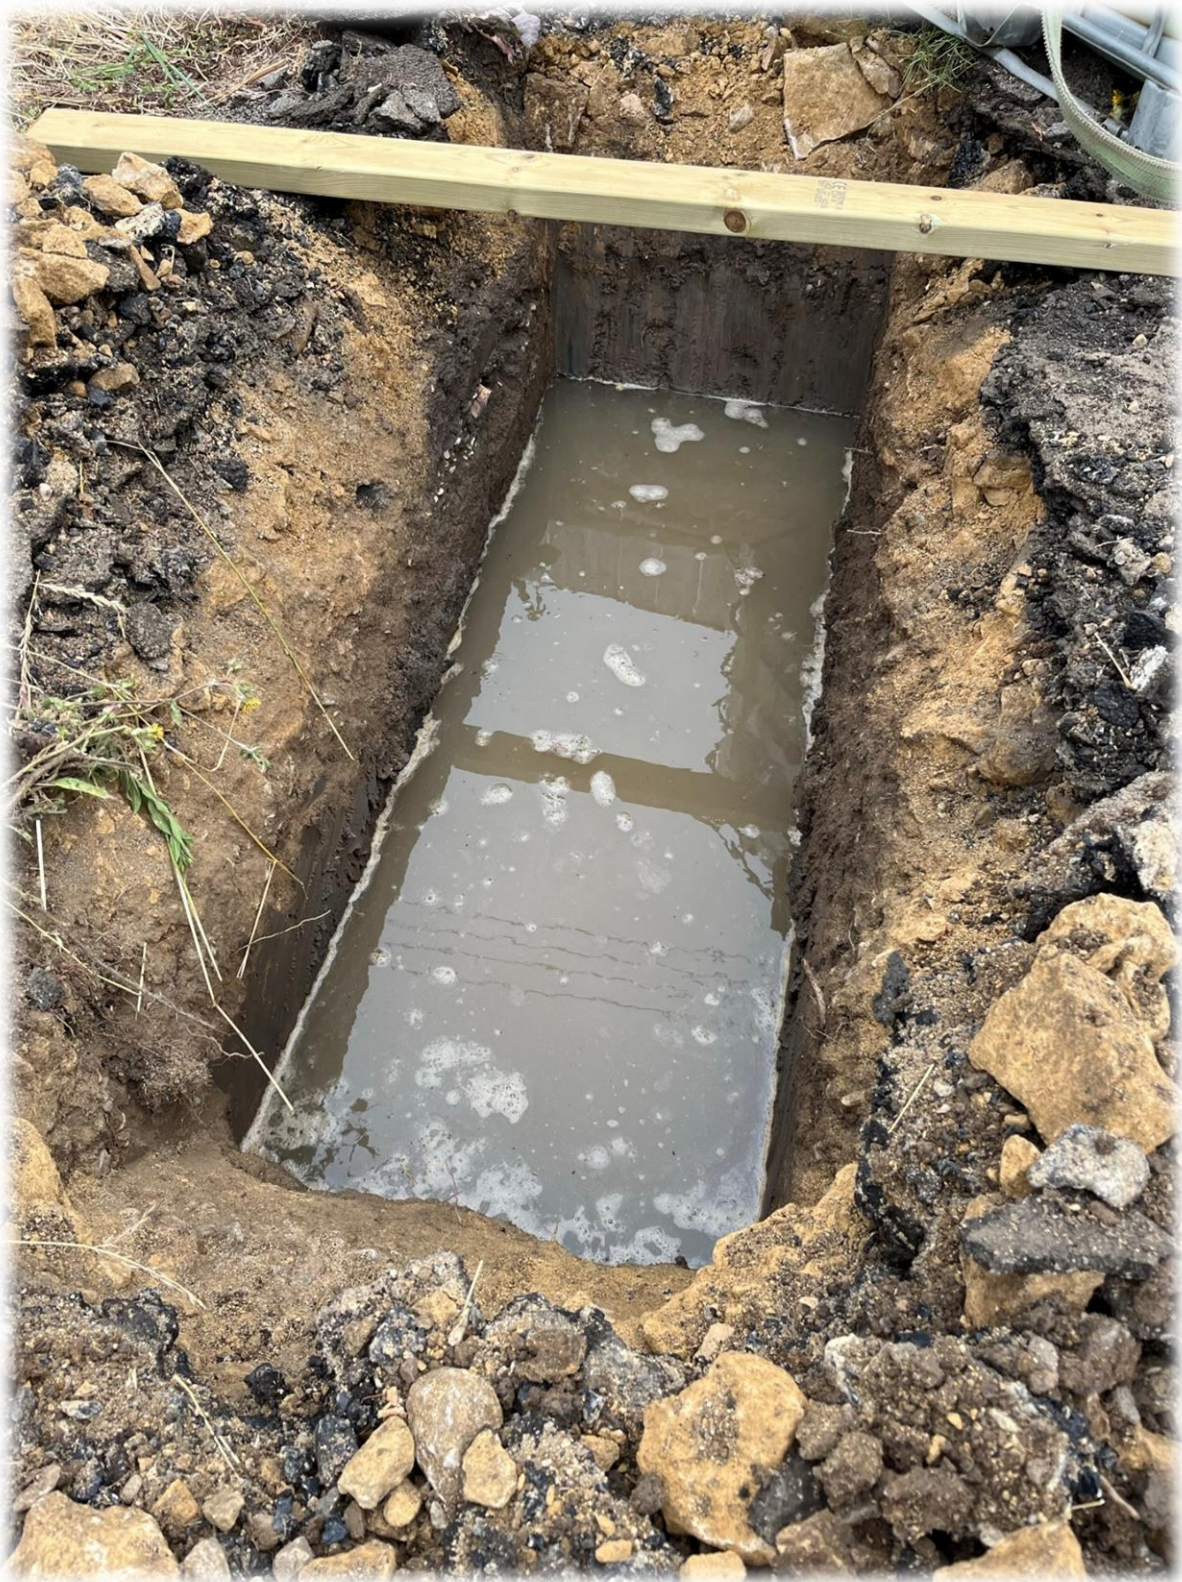
## APPENDIX E

A photographic record of site explorations is contained within Appendix E.
